Flood Investigation Report

Brooke

Church of England V.C Primary School

Report Reference: 000162

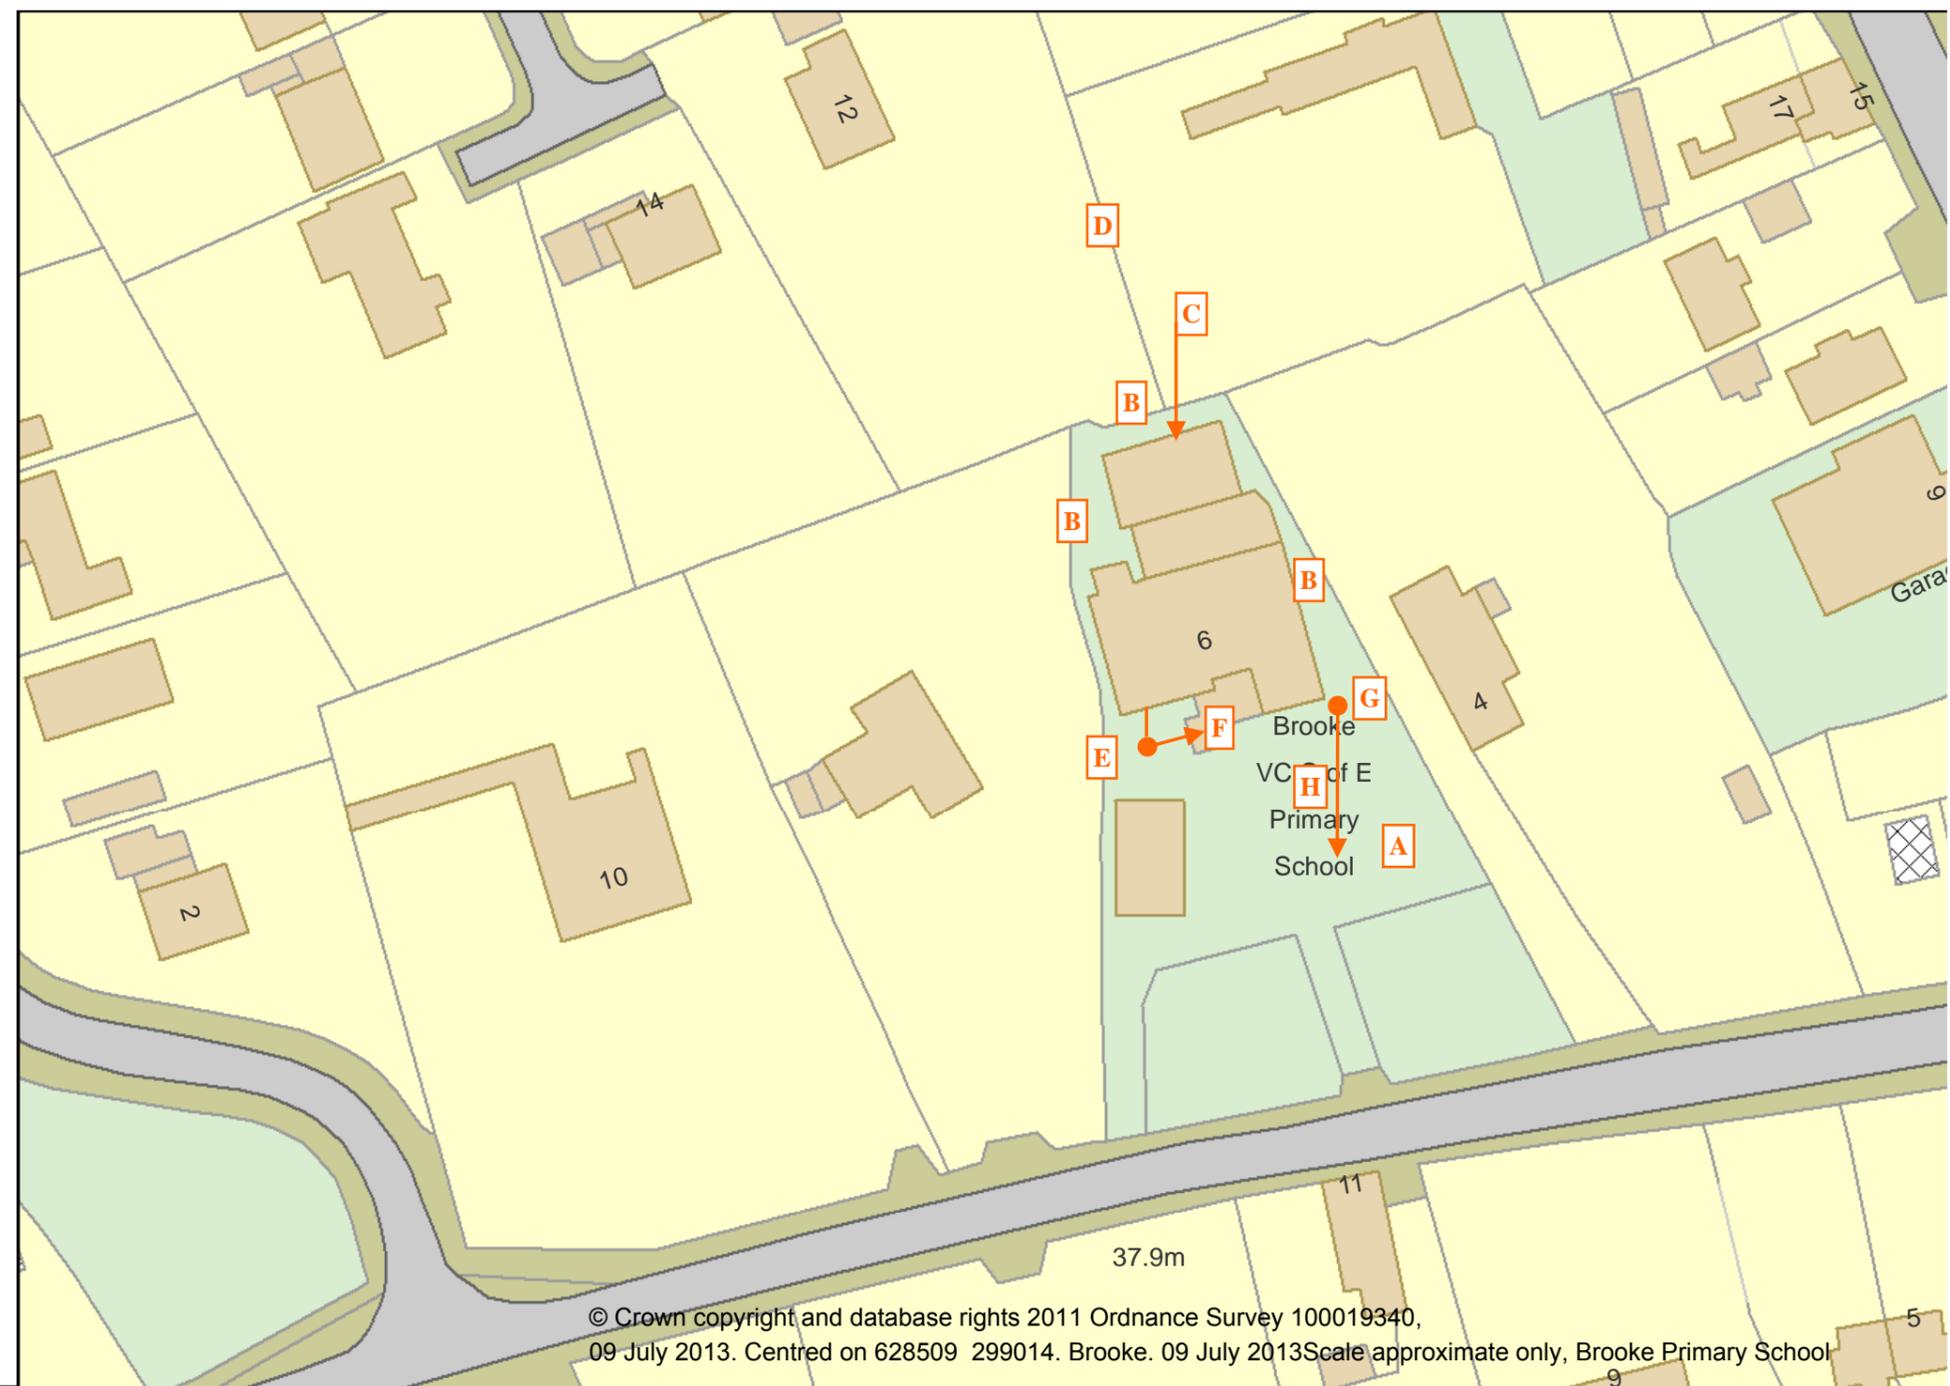
Annotated Map

A	On the outside of the building the entire school grounds are asphalted. The levels of the asphalt consistently fall from the extremities of the site downwards toward the building. This raised level of asphalt is also at a level which is consistent with that of the damp-proof membrane designed to prevent both the ingress of water and protect the superstructure of the main building from rising damp from the ground. Air vents within the fabric of the walls were also found below the asphalt. At every door opening the asphalt was level with the internal floor levels.
B	There are 3 domestic sized drainage gully pots which are located one each side of the main building and one to the rear of the building. These appear to be the only form of drainage to remove surface water runoff from the immediate area surrounding the school. Other isolated drainage gullies exist within the play ground areas of the school. These have a negative gradient and were found to be approximately 50% efficient.

C	Works were ongoing to remove the northern access to the building and to infill the space to prevent flood water entering the building.
D	There is a ditch which requires maintenance but this falls toward the school which would be the natural direction of flow
E	A well has been identified which is located south of the main building, with in a few meters of the wall outside the most south-western classroom. One pipe leads northerly away from the well chamber to a buried chamber not visible on the asphalt surface
F	A second pipe from the chamber is laid in an east-west direction and would appear to terminate under the front office/entrance lobby of the school. Condition of chambers and/or pipes are not clear in the report.
G	The Surface water drainage system includes a manhole chamber at the south east corner of the building.
H	A drain runs in a southerly direction from this chamber. The condition of this drain is not known due to heavy siltation and poor access at the time of survey. The ability of flow and general integrity was not determined.
