Flood Investigation Report

Rose Farm Barn and Market Street

Tunstead

Report Reference: 000336

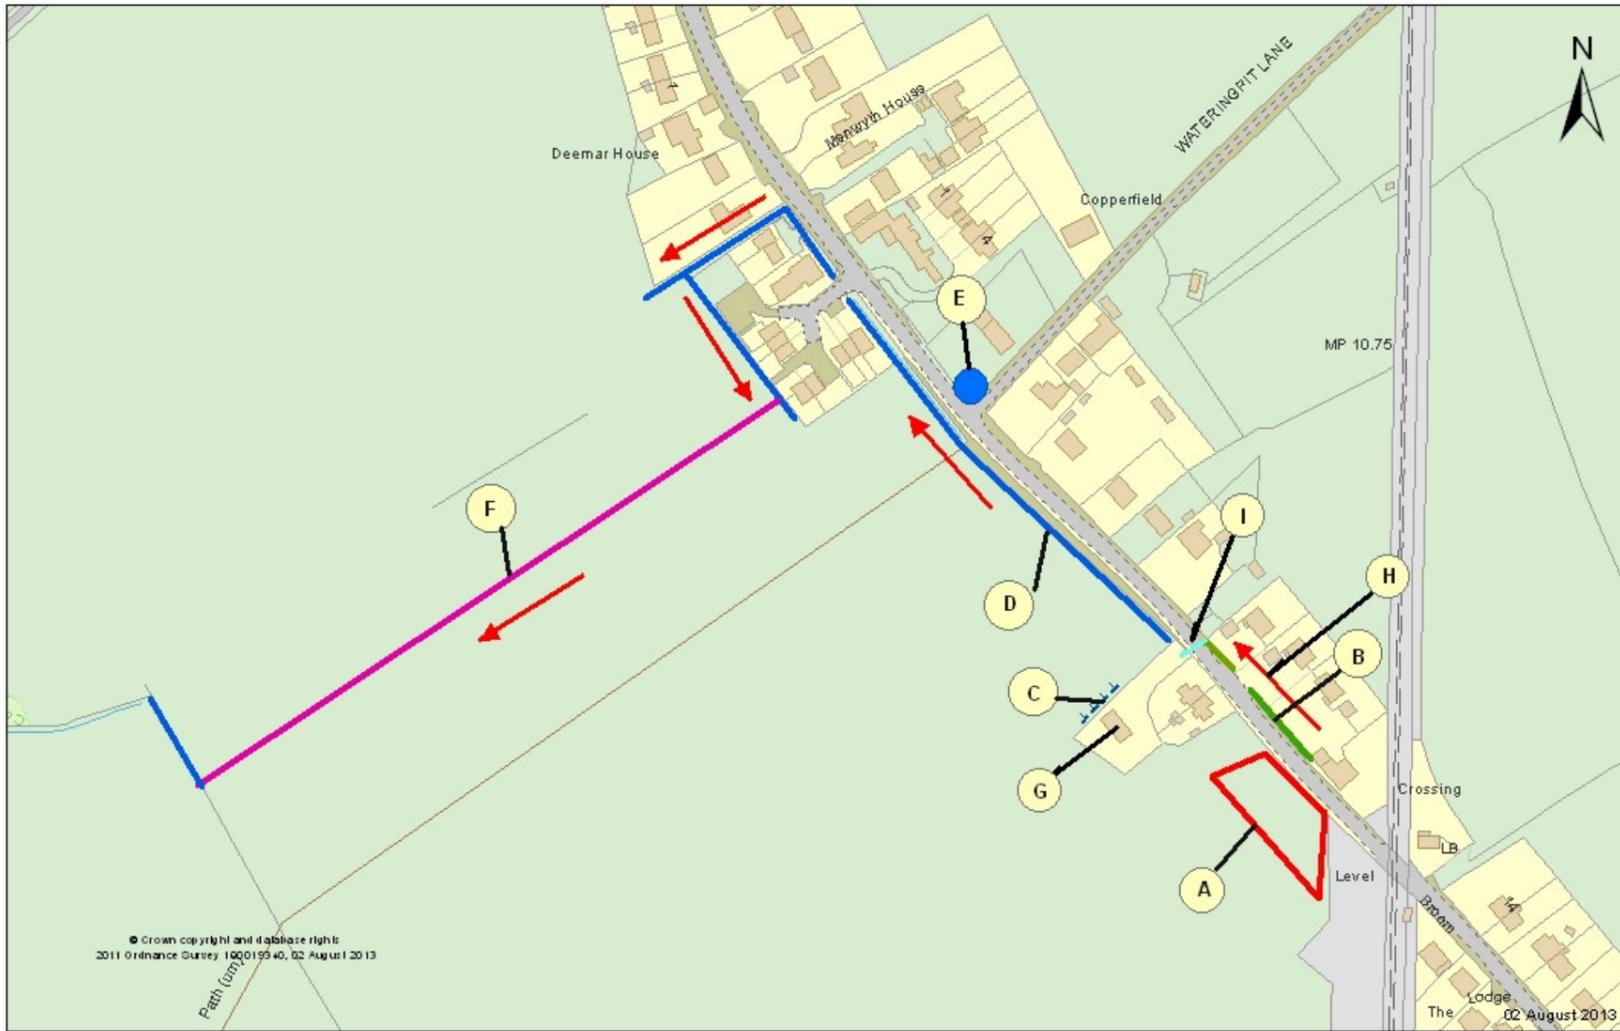
Tunstead flow map
Tunstead

- A** A large area of surface water run-off flooded the field. This water then flowed onto the highway and exacerbated an already flooded highway and adjacent private road and riparian owned ditch system.

- B** Water from the highway (via a series of gullies) and the adjacent field flowed into the ditch within the private road. This ditch has limited capacity and is the responsibility of the riparian owners. The ditch then flows into a culvert under the highway (marked I on the map) that links the private ditch to a manhole cover in the front of Rose Farm Barn (marked G on the map). It is not clear as to the ownership of the culvert and whether it is linked to the wider drainage system downstream or if it is functioning.

- C** It has been reported that a pipe in the curtilage of Rose Barn Farm exists but it is not currently connected to the main ditch system on Market Street.

- D** This is the current extent of the open ditch system (marked blue) on Market Street and surface water flows to a land drain (see D). There is a gully on the Highway near to the entrance to Rose Farm Barn but is not clear whether this is linked to the wider drainage system.

- E** This pond is in one of the lowest points of Market Street and attenuates a large amount of surface water from the highway.
- F** This land drain (in Pink) connects to an open drain on the other side of the field which in turn outfalls to the River Bure.

- G** Rose Farm Barn
- H** Red arrow also denote private road (as well as flow path)
- I** Culvert which connects (ditch B) to an inspection chamber within the boundary of Rose Farm Barn (G)

- 8.1 The recommendations highlighted below are referenced against the factors detailed above and should not be considered in isolation.
- 8.2 The riparian owners responsible for the main open ditch and culverts on Market Street (marked blue on the attached map) need to maintain their watercourse and structures.

- 8.3 Norfolk County Council Highways could investigate and assess the current adequacy and integrity of the gullies that discharge into the ditch (marked D on the annotated map) and whether there is a need for maintenance.

- 8.5 Norfolk County Council's Flood and Water Management Team will investigate the ownership of the culvert that is under the highway and adjacent to Rose Farm Barn to enable an investigation into its adequacy and integrity.
