NORWICH: A1270 BROADLAND NORTHWAY

STAGE 4 SAFETY AUDIT

REPORT REF: GEN/188 September 2019

Highways and Waste Norfolk County Council

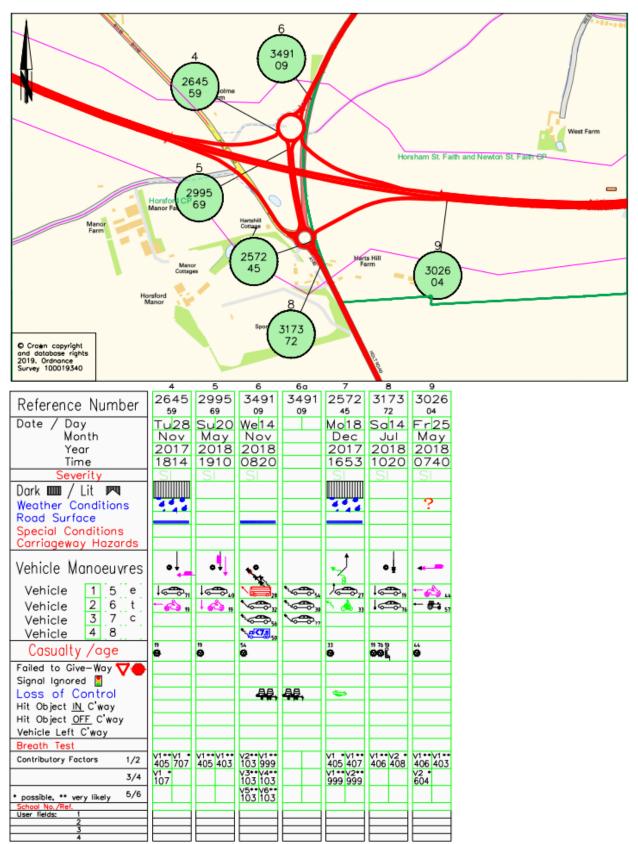
A140 Interchange

Note: a multiple vehicle pia (stick diag 6) was found to have occurred on A140 due to a large fuel spillage on the carriageway. It is unrelated to the scheme and has therefore been excluded from the following analysis.

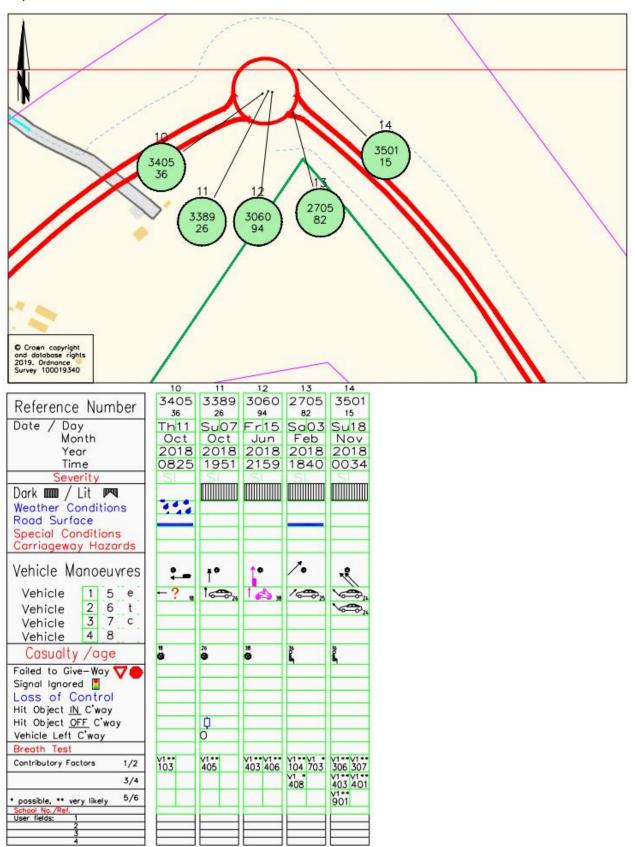
Airport Roundabout

5 at Airport roundabout

- 3 NEbound overshoot in dark (only 1 since countdown signs/ enhanced markings in Sep 2018);
- 2 loss of control (1 motorcyclist on wet circulatory and 1 involving police pursuit);
- suggests excessive speed of approach, perhaps due to low likelihood of needing to give way on entry.

- Accidents may be diminishing.
- Record suggests excessive speed of approach, perhaps due to low likelihood of needing to give way on entry.
- Site inspection identified:
 - eastbound mainline approach median visibility screening not fully effective due to spacing of 'baffles' and screen ends too far from roundabout (due to VRS terminating at that point);
 - westbound mainline approach suffers from excessive approach visibility of circulatory traffic across flat central island; planting does not currently obstruct

this and will take several years to mature; the area of planting does not appear to be maximised.

Measures to reduce excessive approach/entry visibility:-

- improved spacing of 'baffles' on the median visibility screens is recommended (closer spacing is needed nearer the roundabout).
- due to the difficulty in extending the length of screening nearer to the roundabout (VRS terminates too soon for this purpose), reducing excessive visibility across the central island is also recommended. Doming the central island would be expensive and may not conform with the project Development Consent Order due to a change in approved ground levels. Instead, alternative methods of screening should be explored on a short to medium term basis until the existing planting matures. The area within should be maximised commensurate with maintaining 50m entry/circulatory visibility (TD16 table 8/1). This would enable additional planting, particularly some evergreen species (more driving in darkness occurs during winter).

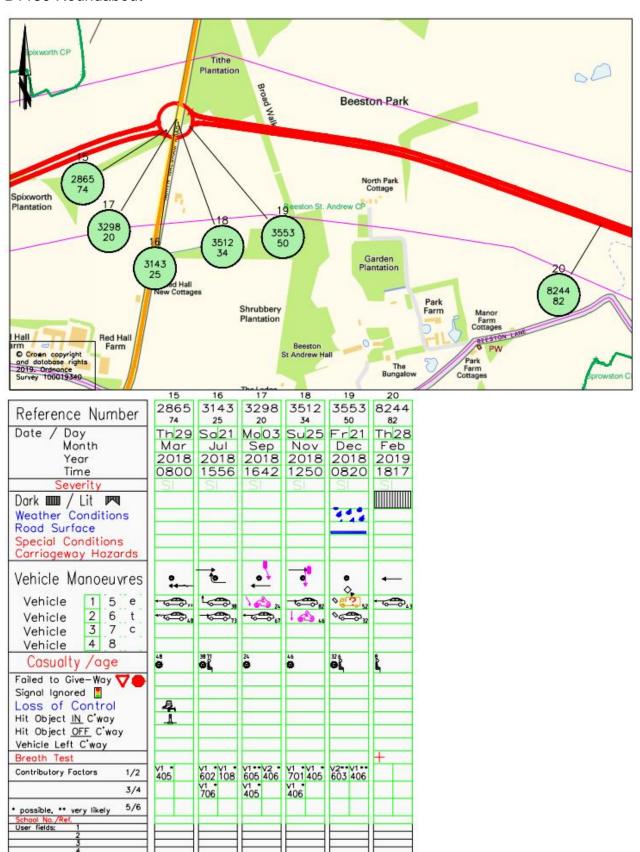
B1150 Roundabout

5 at North Walsham Rd roundabout

- only 1 since countdown signs/ enhanced markings installed in November 2018;
- all daylight; 4 on mainline (2 on entry, 2 on exit); 2 motorcyclist;
- mixed causation (2 fail to give way, 1 tail-end, 2 lane change on exit);

- Only 1 accident since countdown signs/ enhanced markings introduced.
- Mixed causation; all daylight.
- Site inspection identified:
 - westbound mainline approach chevrons too far to the left for optimum conspicuity at the stopping sight distance.

• the westbound mainline approach would benefit from an additional chevron sited to the right of existing to improve roundabout conspicuity at the stopping site distance.

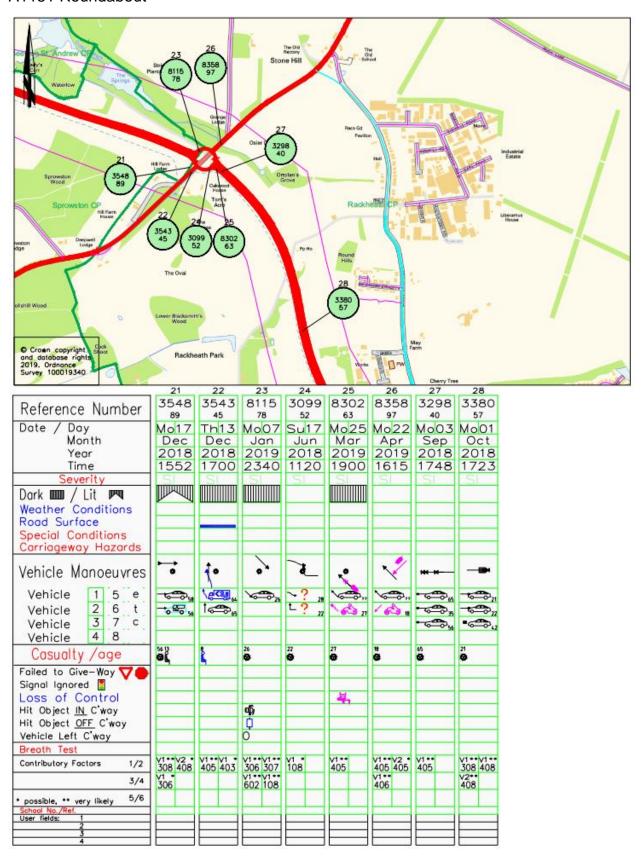
A1151 Roundabout

7 at Wroxham Rd roundabout

- 5 since countdown signs/ enhanced markings in September 2018;
- 4 dark; 6 on mainline (4 on entry, 2 on exit); 2 motorcyclist;
- mixed causation (1 overshoot, 1 fail to give way, 3 tail-end, 2 lane change on exit);
- dark & speed/close following implicated; 1 involved peak-hour mainline queuing.

- 5 pias since countdown signs/enhanced markings September 2018, of which 4 dark.
- 86% on mainline (4 on entry, 2 on exit).
- Mixed causation; dark & speed/close following implicated; 1 involved peak-hr mainline queuing.
- Site inspection identified:
 - westbound mainline approach chevrons too far to the left for optimum conspicuity at the stopping sight distance;
 - both mainline approaches suffer from excessive approach visibility and seethrough across flat central island, planting does not currently obstruct this and will take several years to mature, the area of planting does not appear to be maximised;
 - coupled with the straight approach alignment, the above may result in headlight dazzle/ driver confusion at night-time.

• the westbound mainline approach would benefit from an additional chevron sited to the right of existing to improve roundabout conspicuity at the stopping site distance.

Measures to reduce excessive approach/entry visibility and potential headlight dazzle/confusion across the flat central island:-

- Doming the central island would be expensive and may not conform with the project Development Consent Order due to a change in approved ground levels.. Therefore, alternative semi-permanent screening methods are recommended to obstruct visibility until planting matures sufficiently. The area within should be maximised commensurate with maintaining 50m entry/circulatory visibility (TD16 table 8/1). This would enable additional planting, particularly some evergreen species (more driving in darkness occurs during winter).
- Also hedge planting on NE and SW quadrants is recommended to screen minor road approaches from mainline traffic.

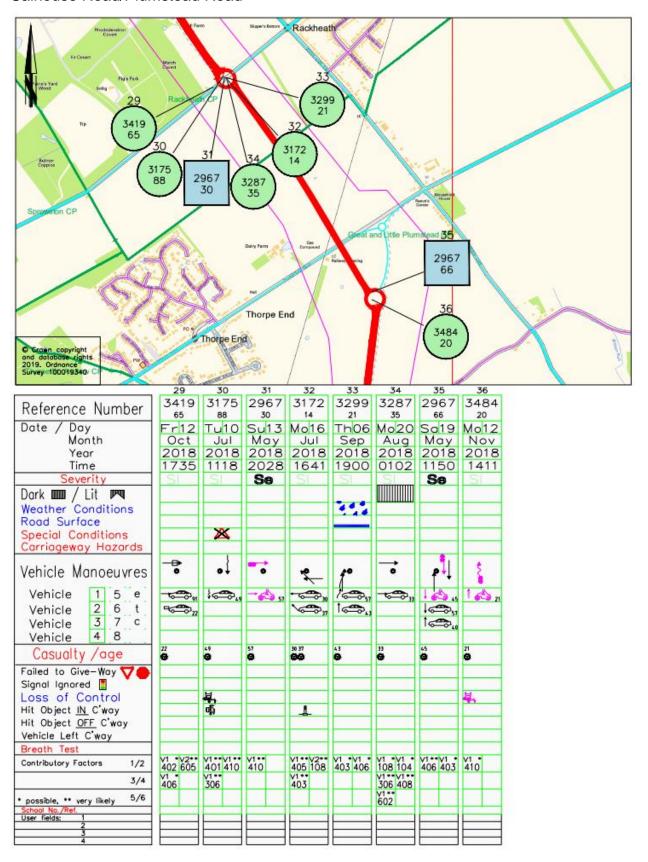
Salhouse Road/Plumstead Road

6 at Salhouse Rd roundabout

3 SEbound overshoot in dark (none since countdown signs/ enhanced markings installed November 2018);

3 other mixed causation (1 very elderly driver tail end, 1 sideswipe on circulatory, 1 merging on exit).

- No accidents since countdown signs/ enhanced markings installed.
- Site inspection identified no issues which relate to the accident record.

Further measures are not considered justified at this stage, and monitoring should continue.
