## Flood Investigation Report

Report Title:  
South Norfolk  
Little Melton  
Mill Road

Report Reference: 000089

## **Mill Road, Little Melton, South Norfolk**

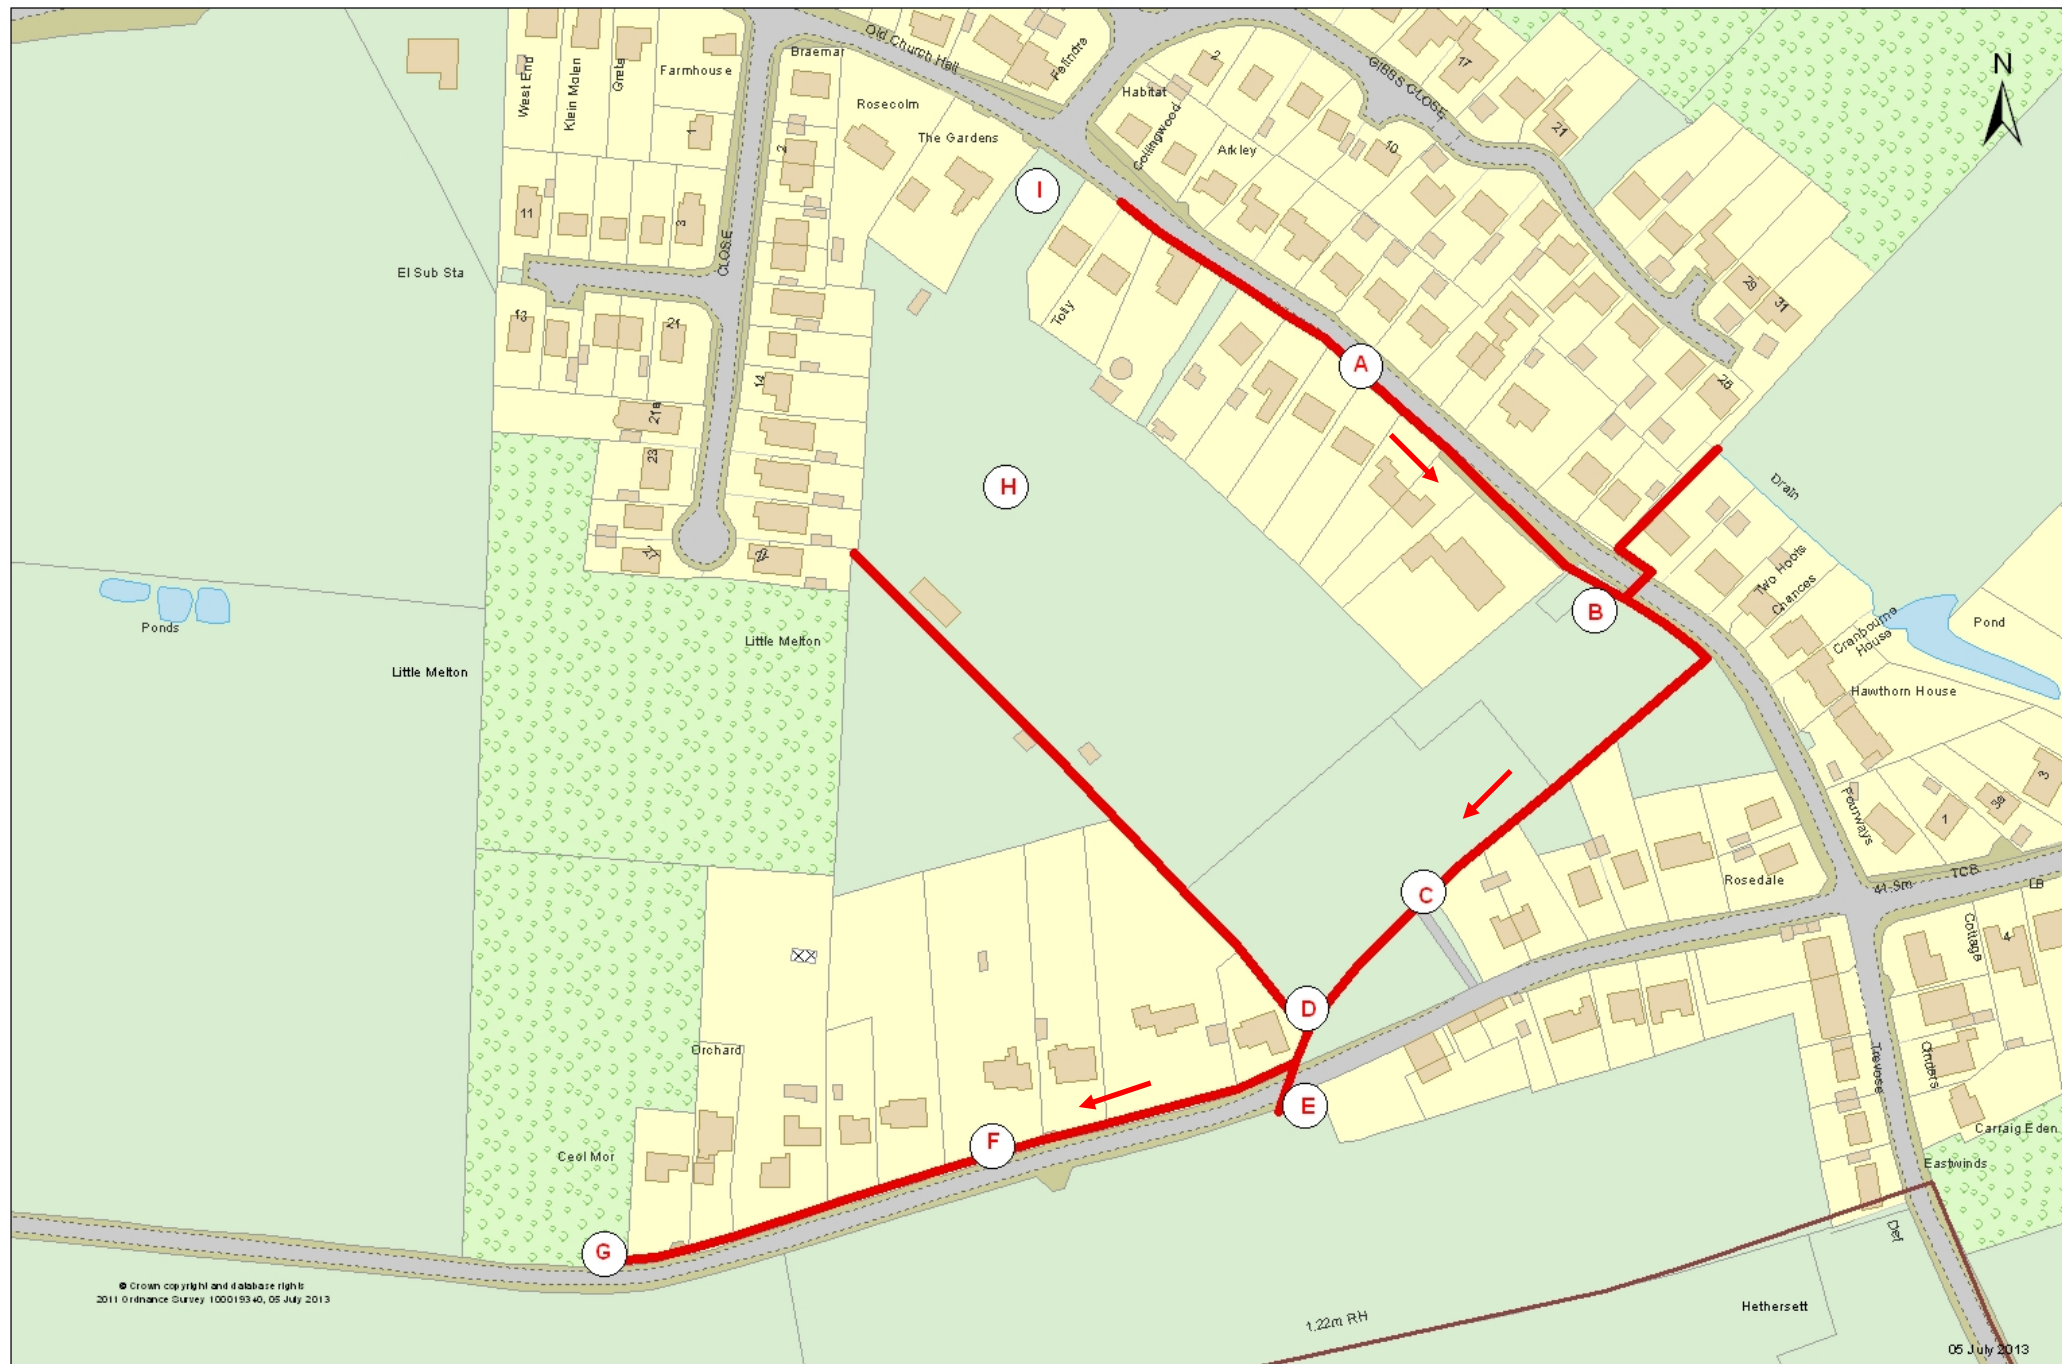
## Annotated Map

A	There are a series of NCC Highways gullies along Mill Road that feed into a NCC Highways pipe.
B	This NCC Highways pipe outfalls to a ditch at the allotments on Mill Road..
C	The ditch then runs through the allotments to the south west corner (within the allotment ditch there is a culvert, through the track, which is a restriction)
D	The ditch connects to an enclosed chamber at the south west corner of the allotments at which point the chamber connects two culverted systems.
E	The first culvert has been surveyed by a drainage contractor and was found to be blocked. The culvert is not adopted by Norfolk County Council Highways and is a privately owned culvert.
F	The second culvert runs along the northern side of Great Melton Road. There was evidence of a number of access chambers to the culverted watercourse that runs along Great Melton Road .
G	The culverted pipe along Great Melton Rd outfalls into an open ditch.

H	There is a proposed development site which has the potential to mitigate and potentially resolve some of the existing flooding issues on Mill Road.
I	The proposed development site will have an access point within Mill Road.
N.B.	South Norfolk District Council have been in discussions with the developers for the site adjacent to Mill Road to assess the potential to mitigate the flooding as part of the proposed development. An attenuation tank and swale adjacent to the junction of Mill Road and Gibbs Close has been incorporated into the designs for the outline application. NCC Developer Services have assessed the potential for the attenuation tank to mitigate the flooding on Mill Road and have confirmed that this feature will hold back any additional flows from the new development site on to Mill Road but will not mitigate the existing flooding problem on Mill Road. The drainage from the site of the proposed new development will outfall into the private drainage system.
