Norfolk County Council

Investigation Report into the flooding in South Norfolk between 2013 - 2016

Report Reference: FIR036

Report prepared by Abygail Hadley on 2 July 2019

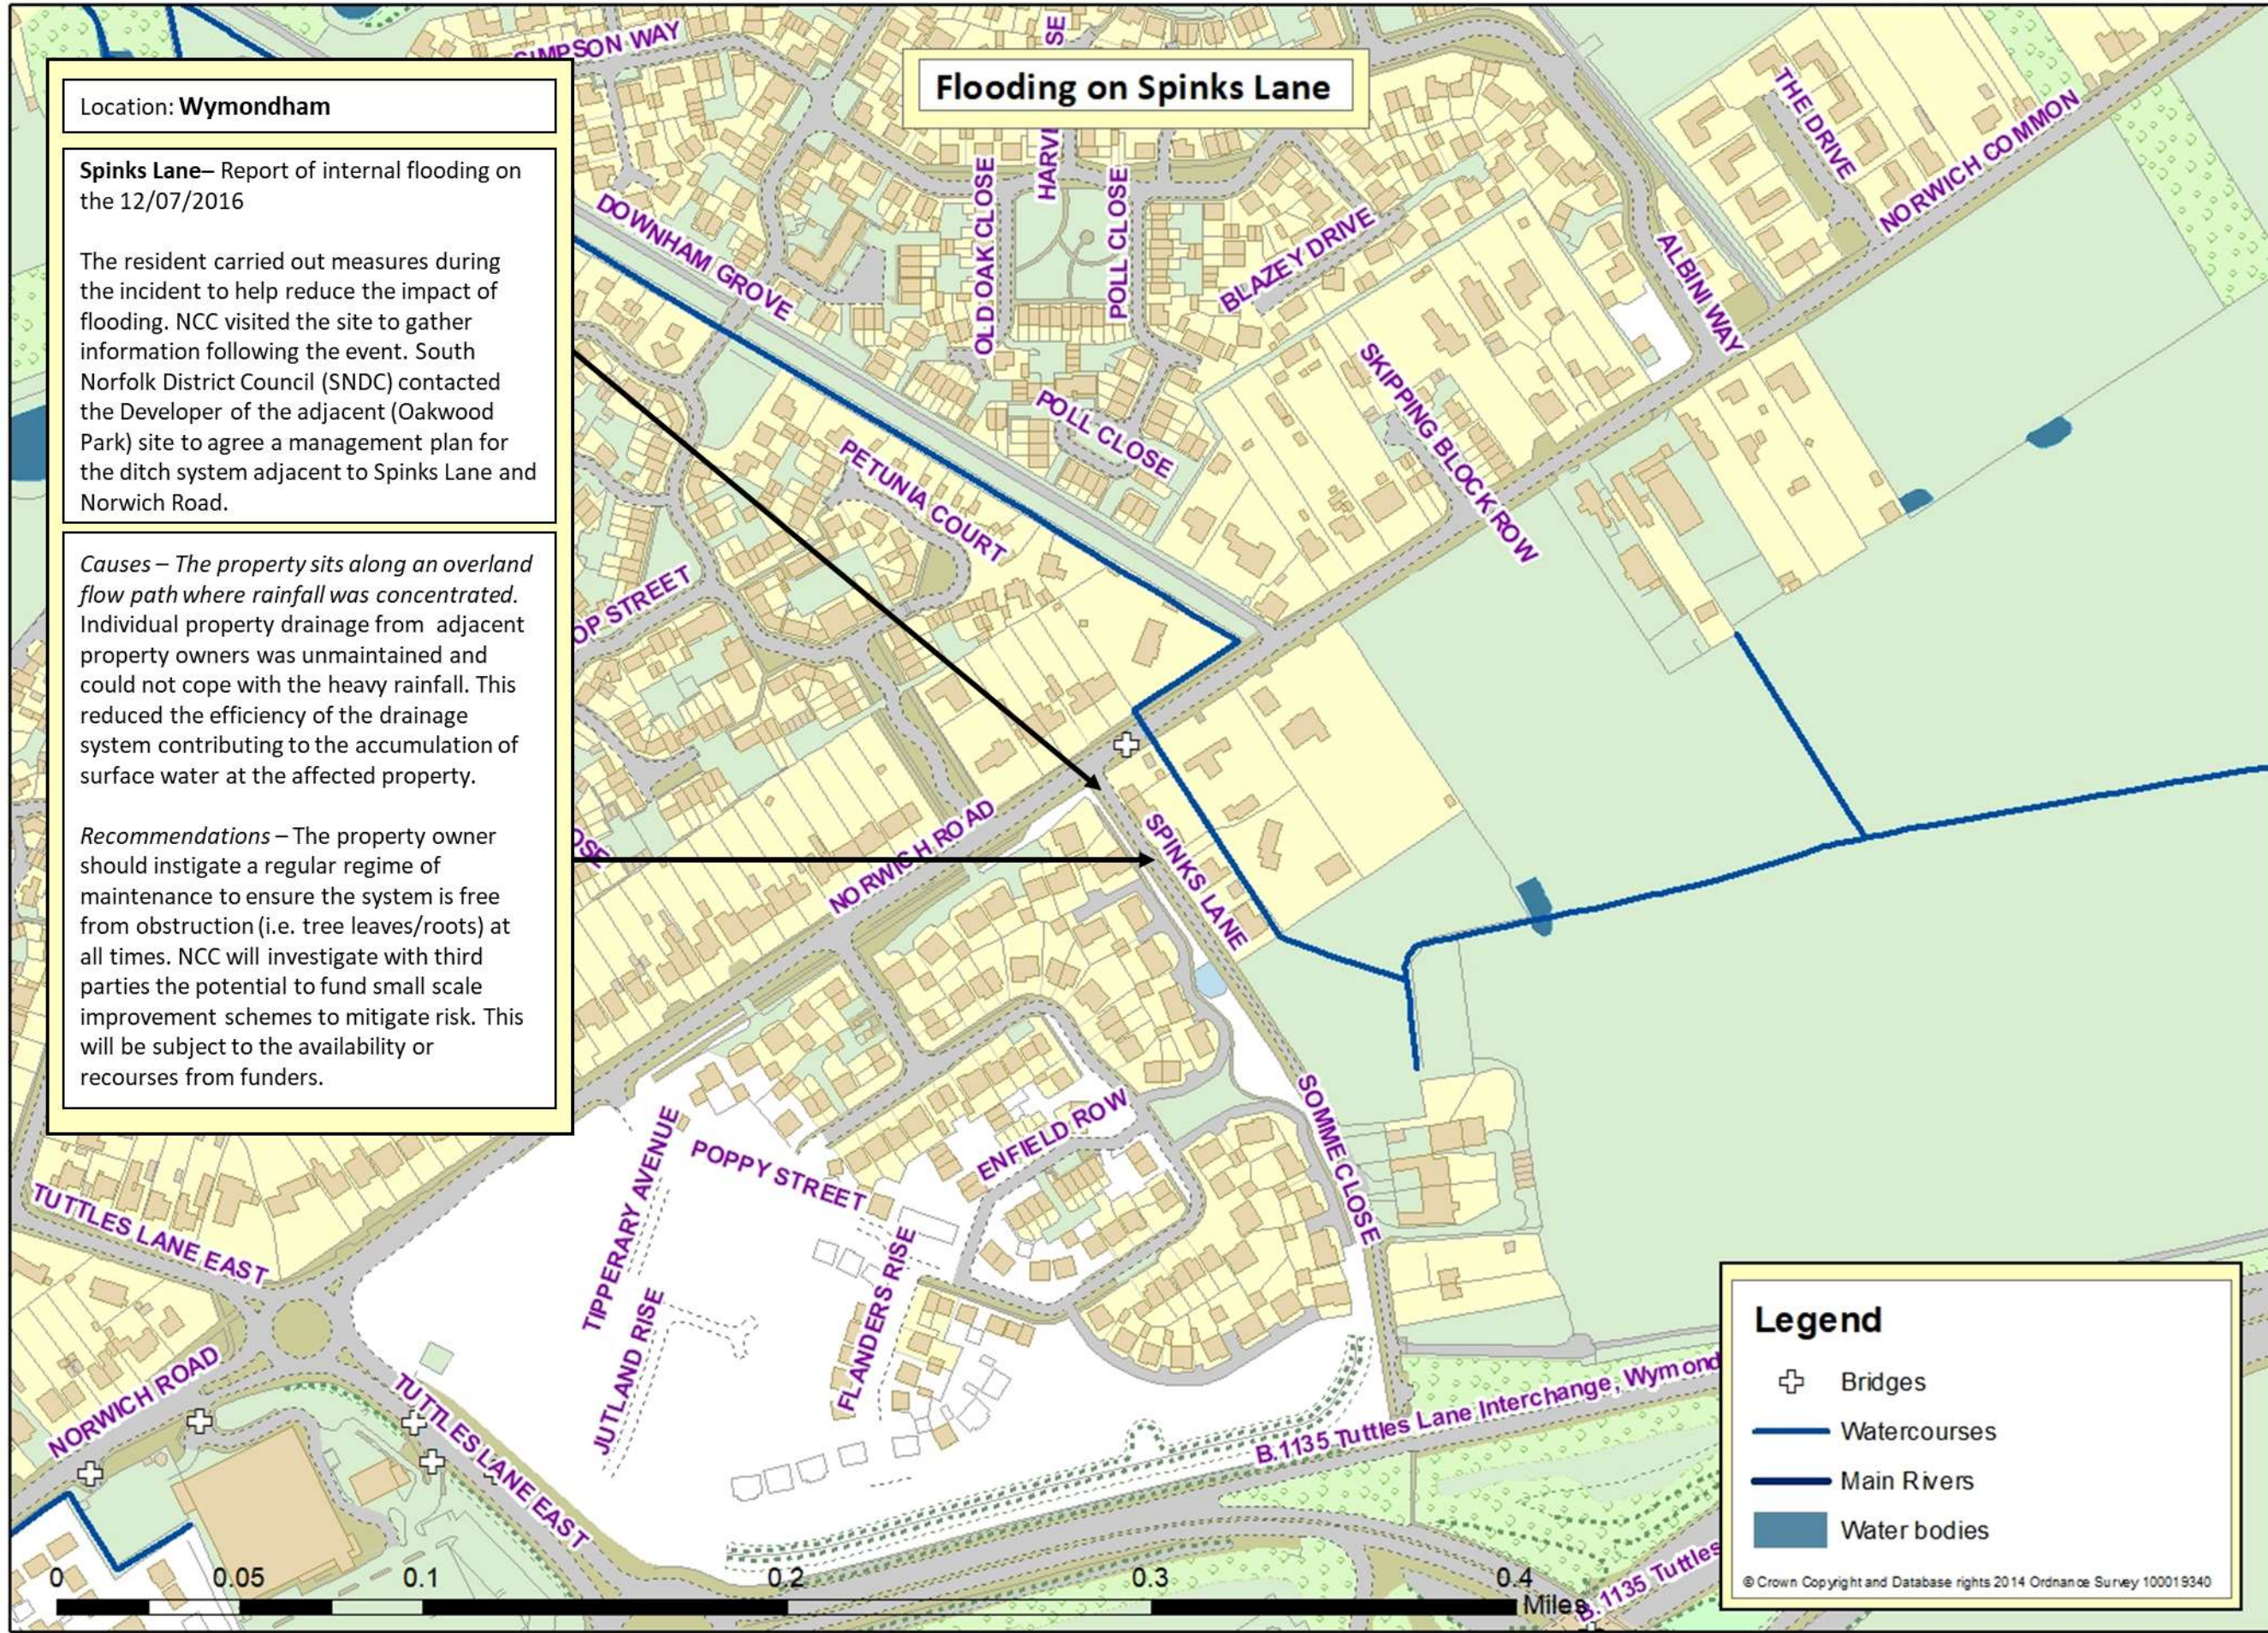
Flooding on Spinks Lane

Causes – The property sits along an overland flow path where rainfall was concentrated. Individual property drainage from adjacent property owners was unmaintained and could not cope with the heavy rainfall. This reduced the efficiency of the drainage system contributing to the accumulation of surface water at the affected property.

Recommendations – The property owner should instigate a regular regime of maintenance to ensure the system is free from obstruction (i.e. tree leaves/roots) at all times. NCC will investigate with third parties the potential to fund small scale improvement schemes to mitigate risk. This will be subject to the availability or recourses from funders.

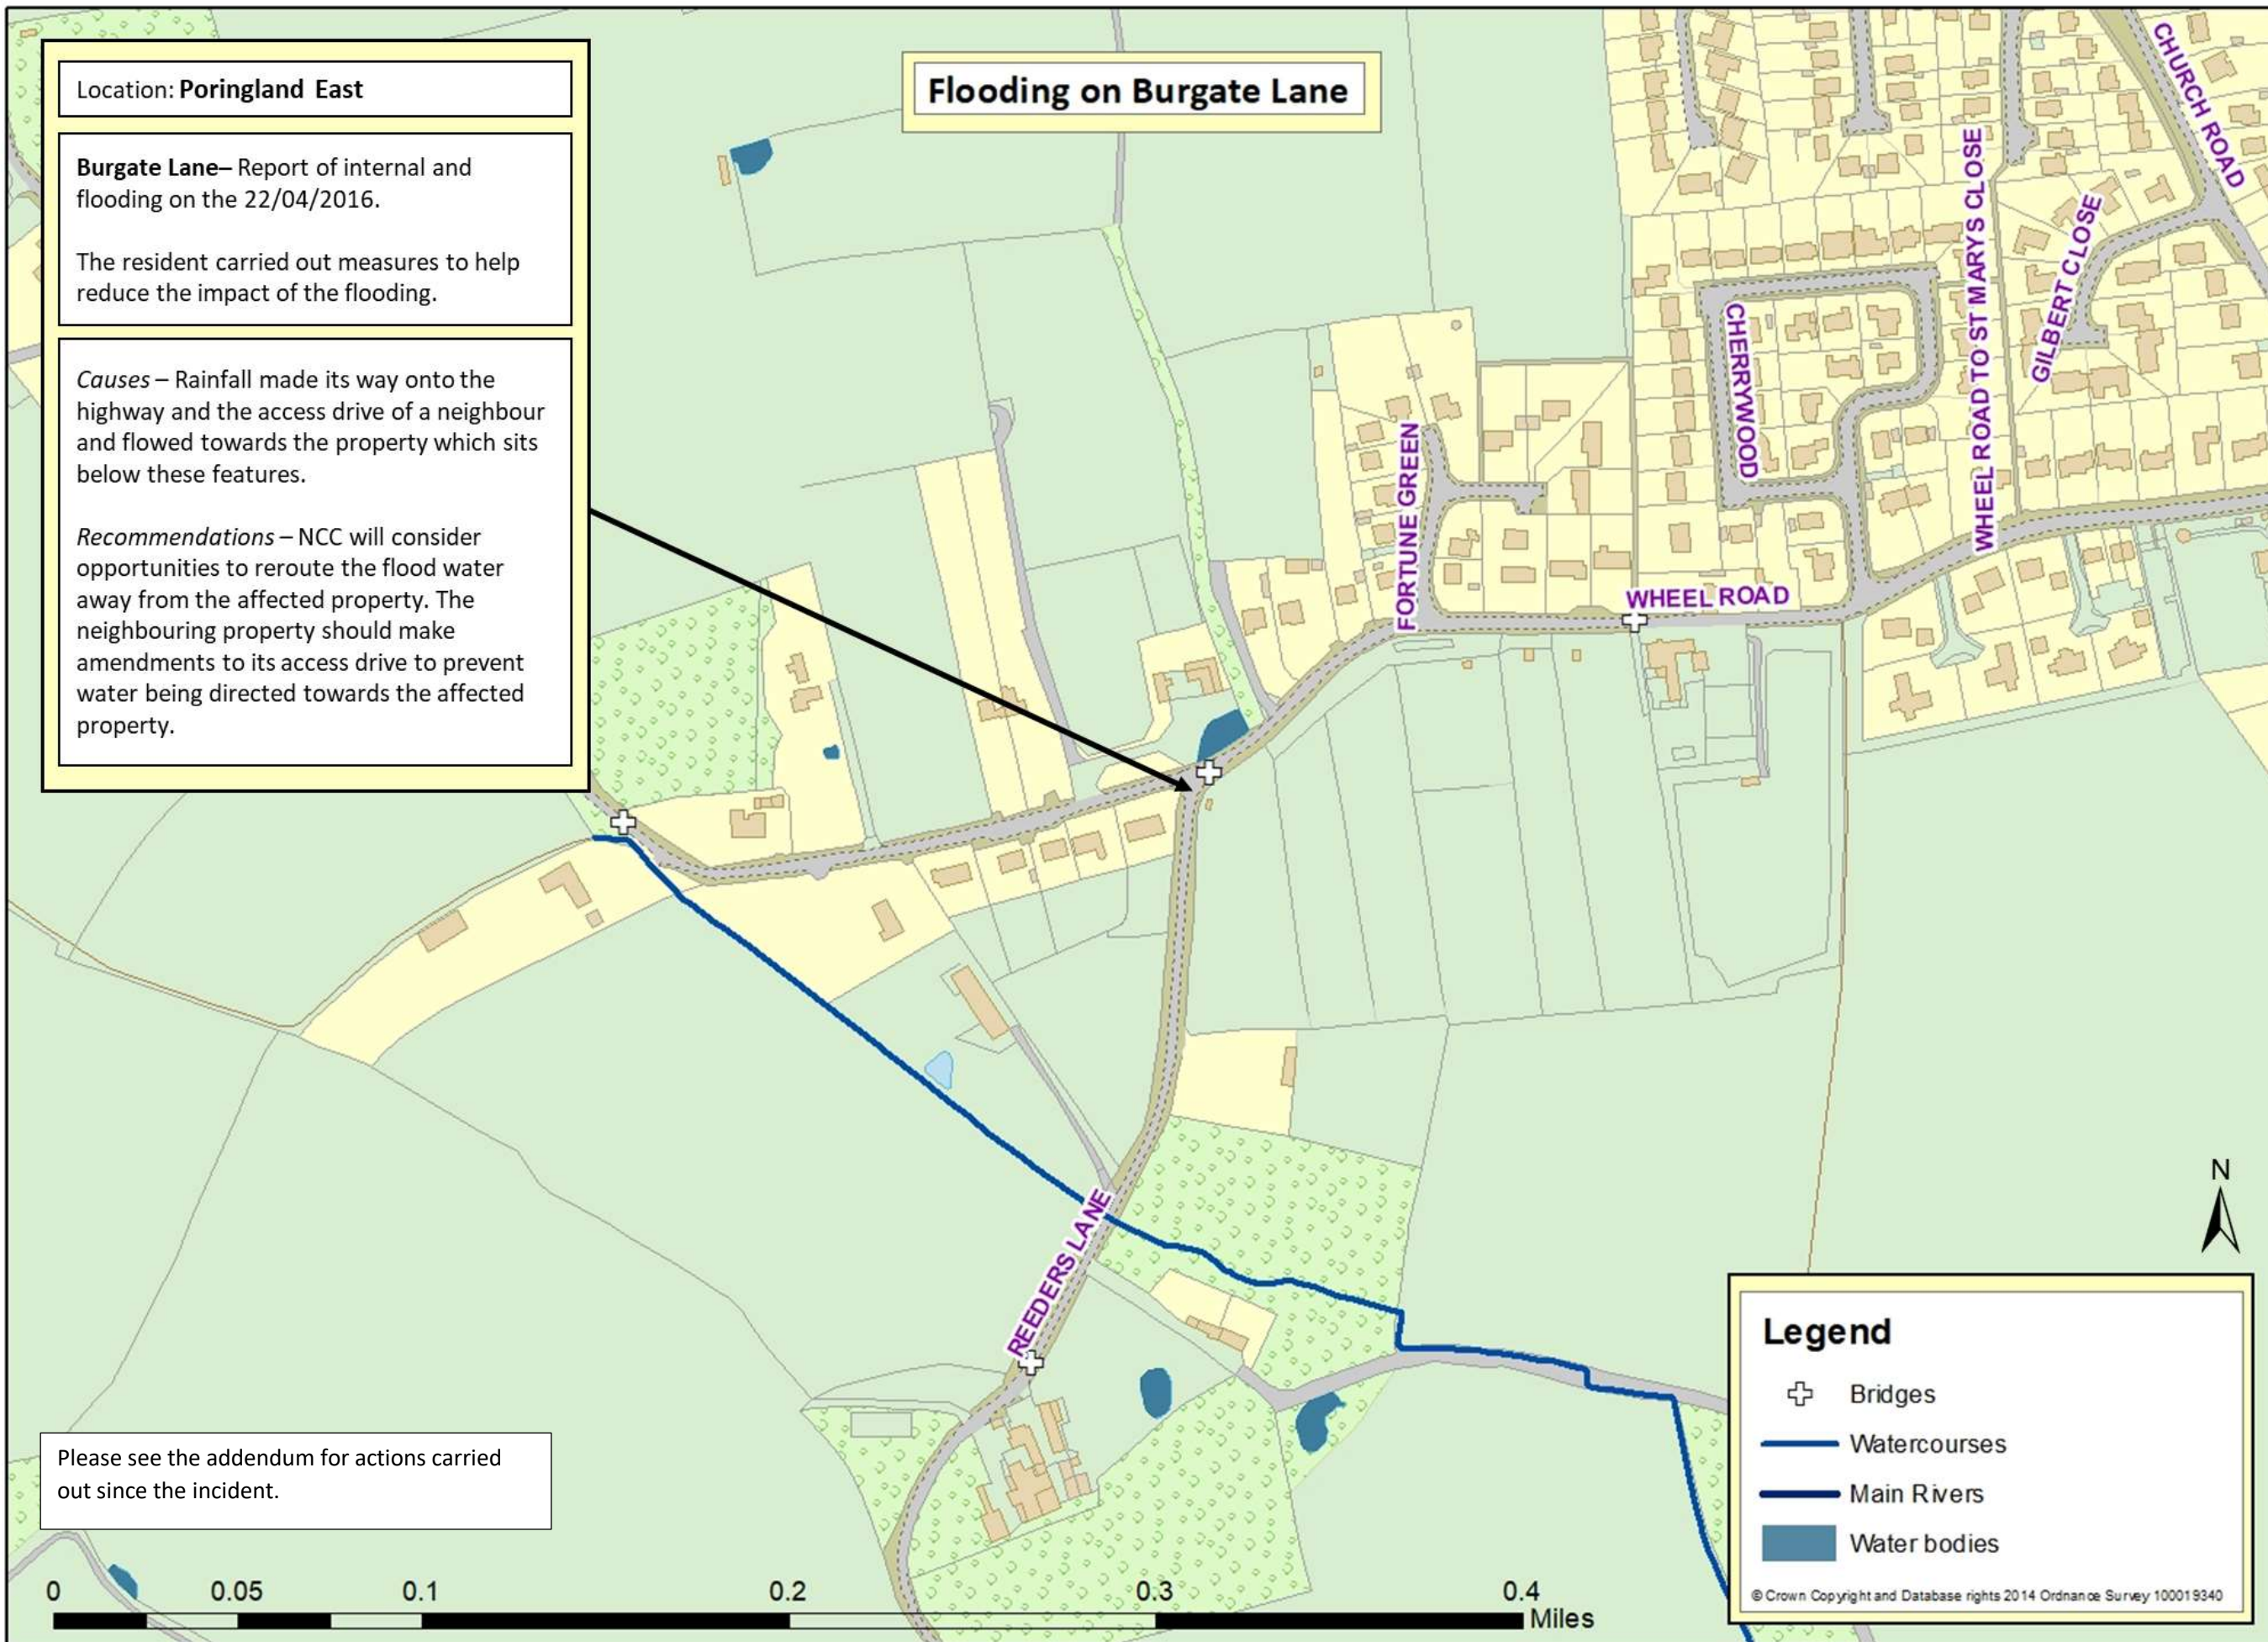
Flooding on Burgate Lane

Causes – Rainfall made its way onto the highway and the access drive of a neighbour and flowed towards the property which sits below these features.

Recommendations – NCC will consider opportunities to reroute the flood water away from the affected property. The neighbouring property should make amendments to its access drive to prevent water being directed towards the affected property.

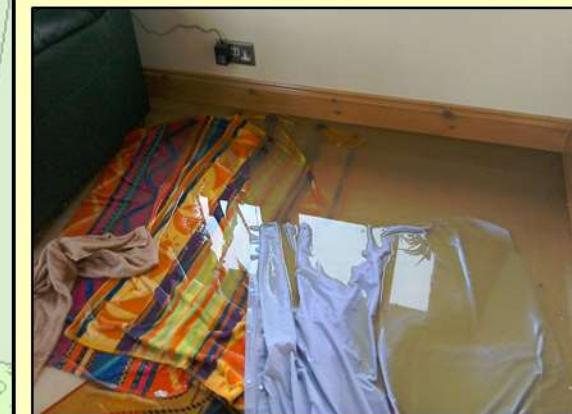
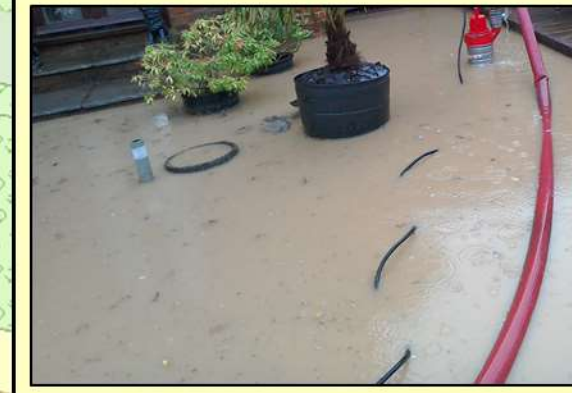
Flooding on Scole Common Road

Causes – Run off from rainfall was concentrated an overland flow path on which the property sits. Water was directed from neighbouring land towards the affected property. The run-off was directed towards the individual property drainage which was unable to cope with the capacity of water causing flooding at the affected property.

Recommendations – NCC will work with the land owner to ensure that water is not directed towards the effected property, for example through land management techniques. The property owner should ensure that ditches around the property continue to be well maintained for sufficient drainage.
