Flood Investigation Report

Walpole Cross Keys

Sutton Road

Report Reference: 000117

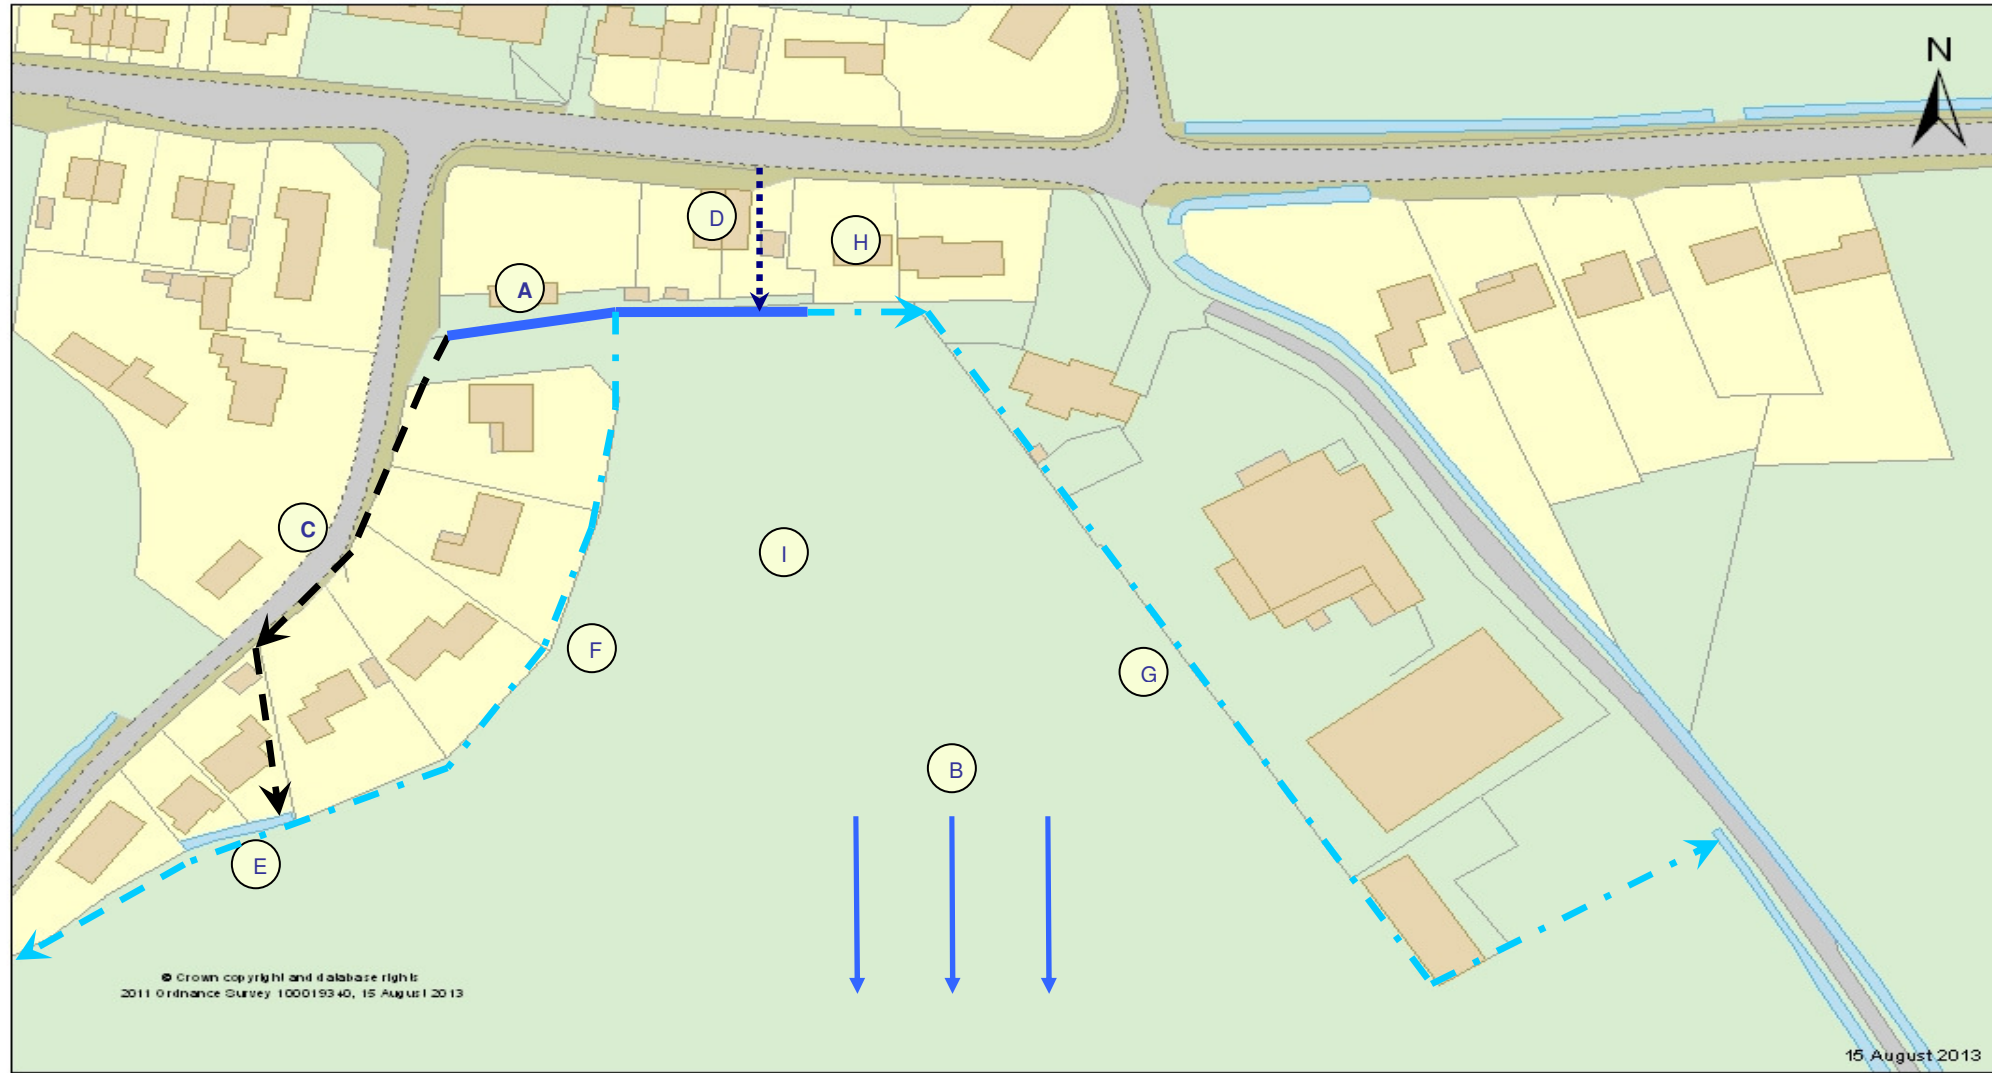
Sutton Road
Walpole Cross Keys

- A Location of open watercourse. Initial site investigations found this watercourse to be full and poorly maintained. Due to the connection to the downstream watercourse being in disrepair, this can not outfall effectively causing a backflow of water within the ditch.

- B General direction of surface water flow.
- C Assumed path of existing culvert (pending a camera survey to assess the extent and integrity of the system). King's Lynn & West Norfolk Borough Council have attempted to jet the system but this could not be completed due to the poor condition of the culvert.

- D Highways drainage found to run parallel with the affected property's boundary which outfalls into the open watercourse to the South. A site visit found the outfall pipe to be submerged approximately 0.3 to 0.4m below the water's surface and the chamber cover on the property's driveway to be damaged allowing additional surface water to enter the system.

- E The open trench as shown on the OS map is no longer apparent, this may have been culverted to join an open watercourse to the South but there is no evidence to support this and this would need further investigation.

- H Reports of high water levels at neighbouring properties but no internal flooding, septic tanks also reported to be inundated with surface water and needing continual pumping at the time of the event.

- I It is believed that ground water levels were very high at the time of the flooding..

- F Possible route for new open trench to connect with existing watercourse to the South.
- G Possible route for new open trench to connect with existing open watercourses to the East - as per the pre-existing drainage system shown on the 1905 map. Refer to IDB letter for detail

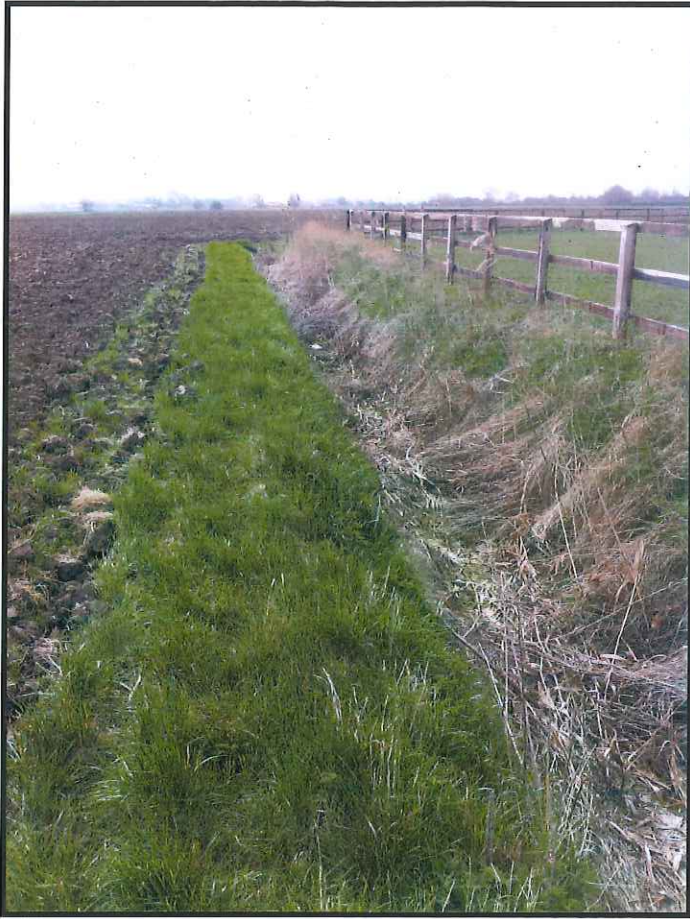
Photo 1

The drain heading generally southwards from point 3 is shallow and poorly maintained – see photograph 1 at the end of this letter. The section near 4 on my plan appears to have had some maintenance or minor improvement works carried out relatively recently, and although the drain seems to get slightly deeper as you go further along, it also reverts to being heavily-vegetated and with a significant build-up of silt.

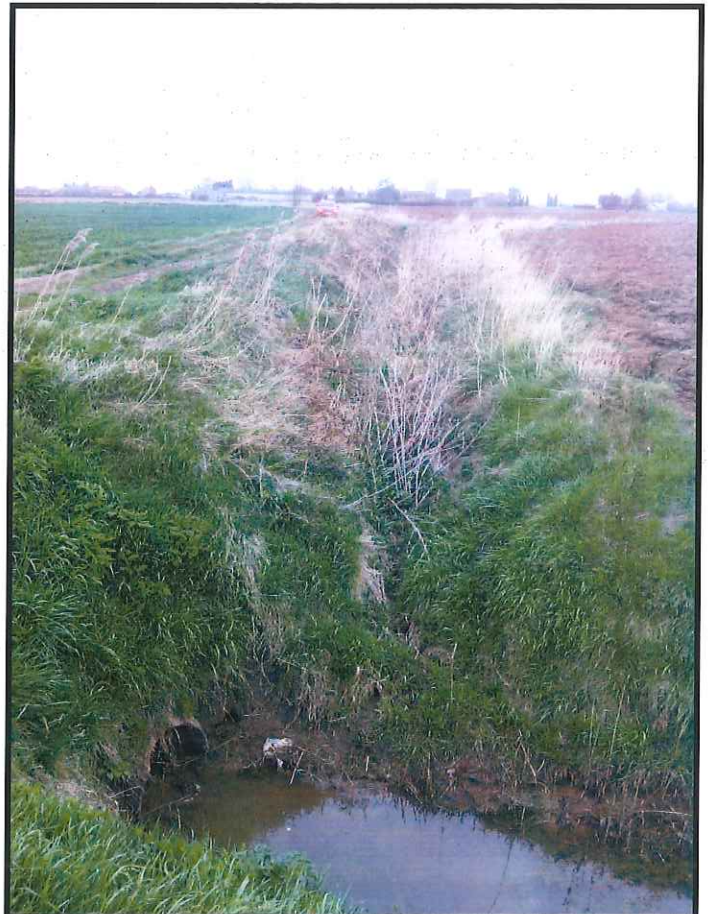
Photo 2

Considering the area more generally, there is a watercourse to the east of Fence Bank, marked as 9 on my plan (see also photo 2), which, although currently quite narrow and poorly-maintained, could potentially help to convey water from the rear of the properties on Sutton Road to Cross Keys Drain (see photo 3), if a connection is made to it. Although there is currently no continuation of the drain to the east of 27 Sutton Road, I believe it may be possible, subject to landowner agreement, to construct a new drain along a route similar to the one indicatively shown by a dashed red line on my plan, and then install a new culvert under Fence Bank. Maintenance or improvement works may also be needed along the drain to the east of Fence Bank, but the extent of these and the size of any new drain could only be determined following a level survey from Cross Keys Drain back to the properties on Sutton Road.

In my opinion, the best way to try and improve flows from the watercourse to the rear of the properties on Sutton Road would be to construct a new drain from there as far as the east side of Fence Bank, and then, if necessary, for maintenance/improvement works to be undertaken downstream to Cross Keys Drain. However, survey works would be needed to check that this suggestion could be translated into an effective drainage scheme, and agreement would also be required from the relevant landowners (I believe there would be three, or possibly four, affected). I understand that planning permission may also need to be sought.
