Flood Investigation Report

Breckland

Dereham

Yaxham Road

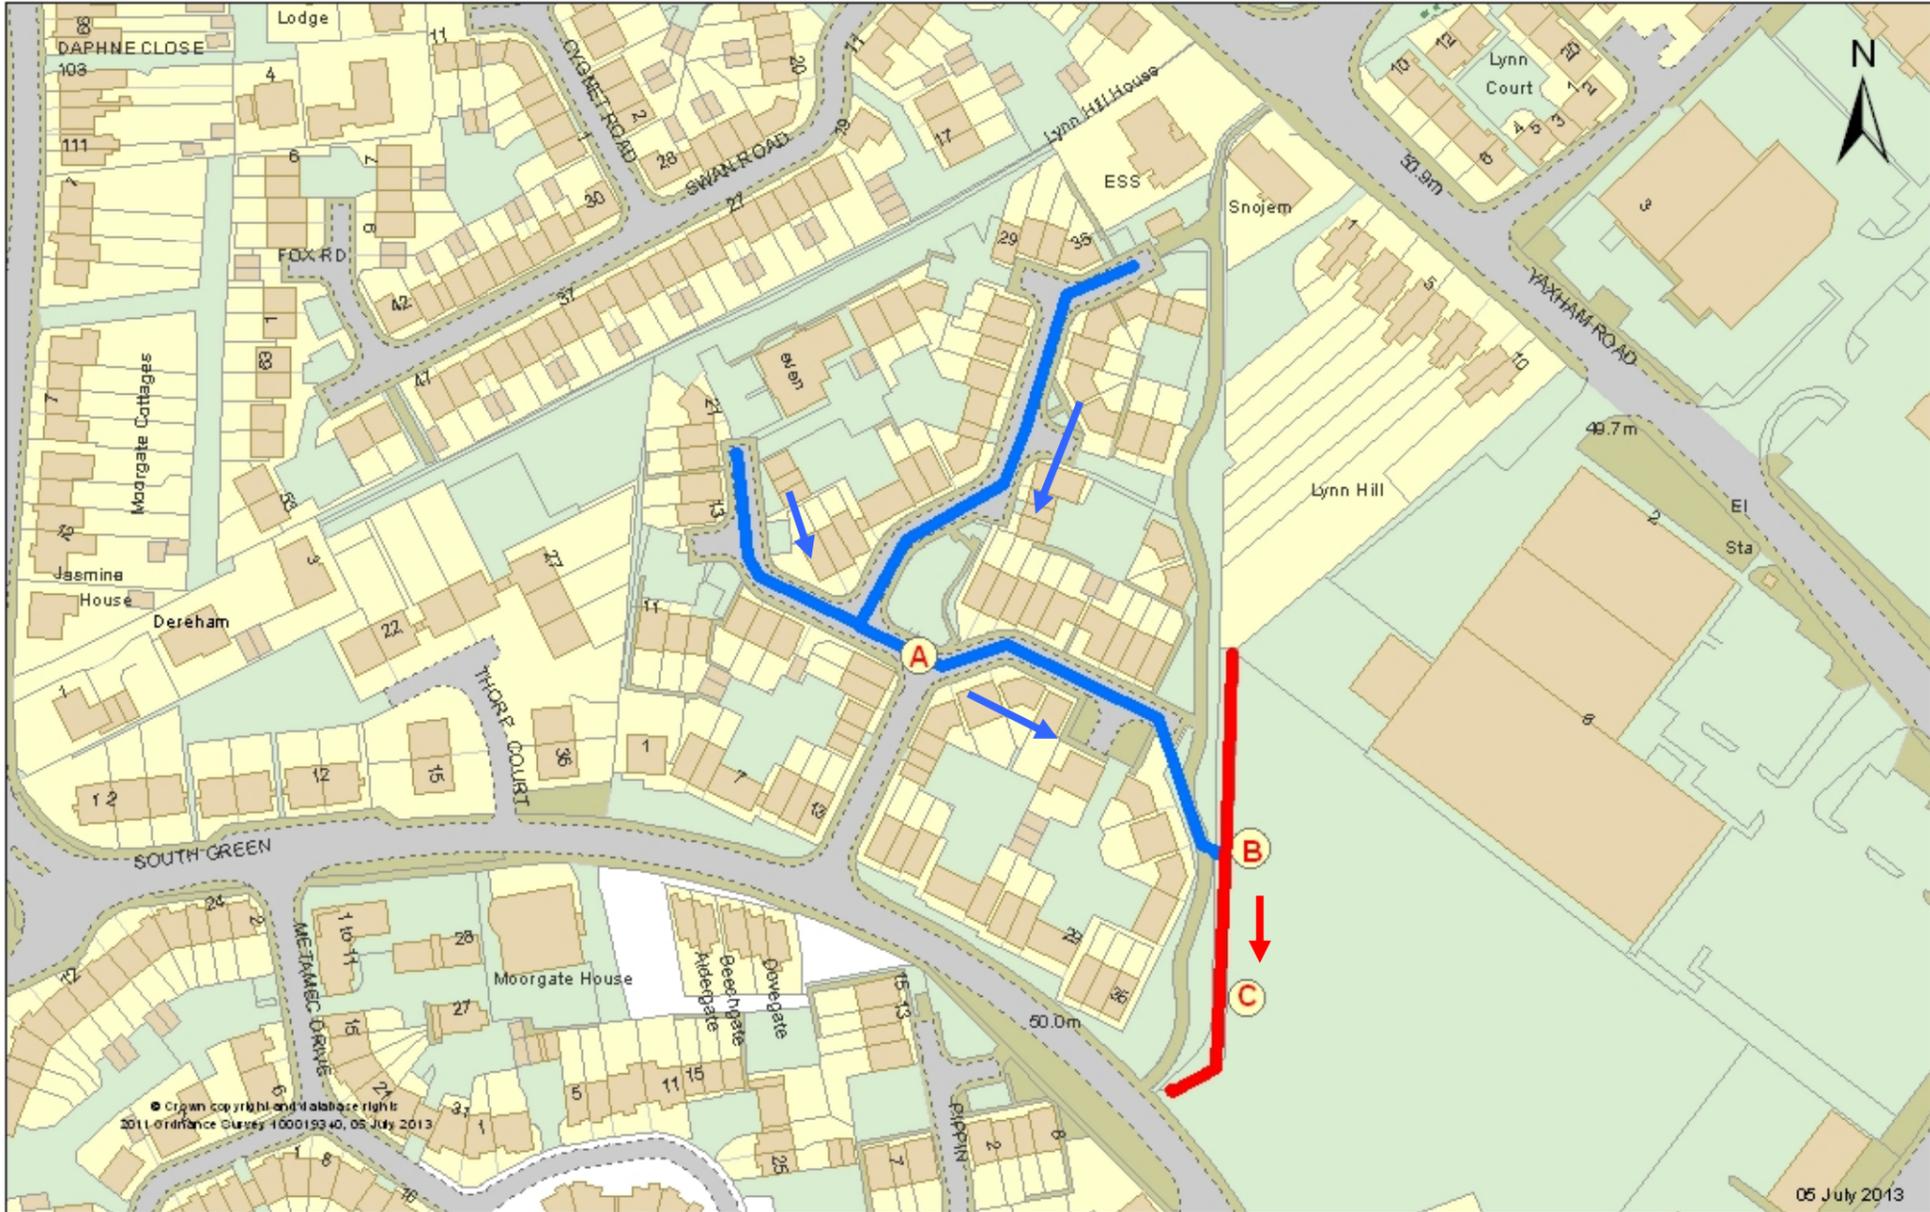
Annotated Map

A	The surface water drainage system on the South Green site
B	Outfall for the surface water drainage system on the South Green site at the headwall adjacent to the ditch
C	Dereham Stream – This falls from the Yaxham Rd towards South Green

- 4.3 Correspondence with Anglian Water established that;
- The surface water drainage system on the South Green site (see point A on the attached map) outfalls at the headwall adjacent to the ditch (Safari Way) (see point B on the attached map) and was adopted by Anglian Water in April 2010.

- 4.4 A site visit was conducted in October 2012 by a Norfolk County Council officer.
- 4.5 No outfall point was identified for the open ditch (see point C on the attached map), confirming that the ditch is not connected to any other drainage system. The ditch stretches for approximately 100m adjacent to the Safari Way footpath, which runs for 200m between Yaxham Road and South Green.
