## Investigation Report into the flooding on Upper Staithe Road, Stalham in 2017 - 2018

Report Reference: FIR041

Report prepared by Abygail Hadley on 25/03/2020

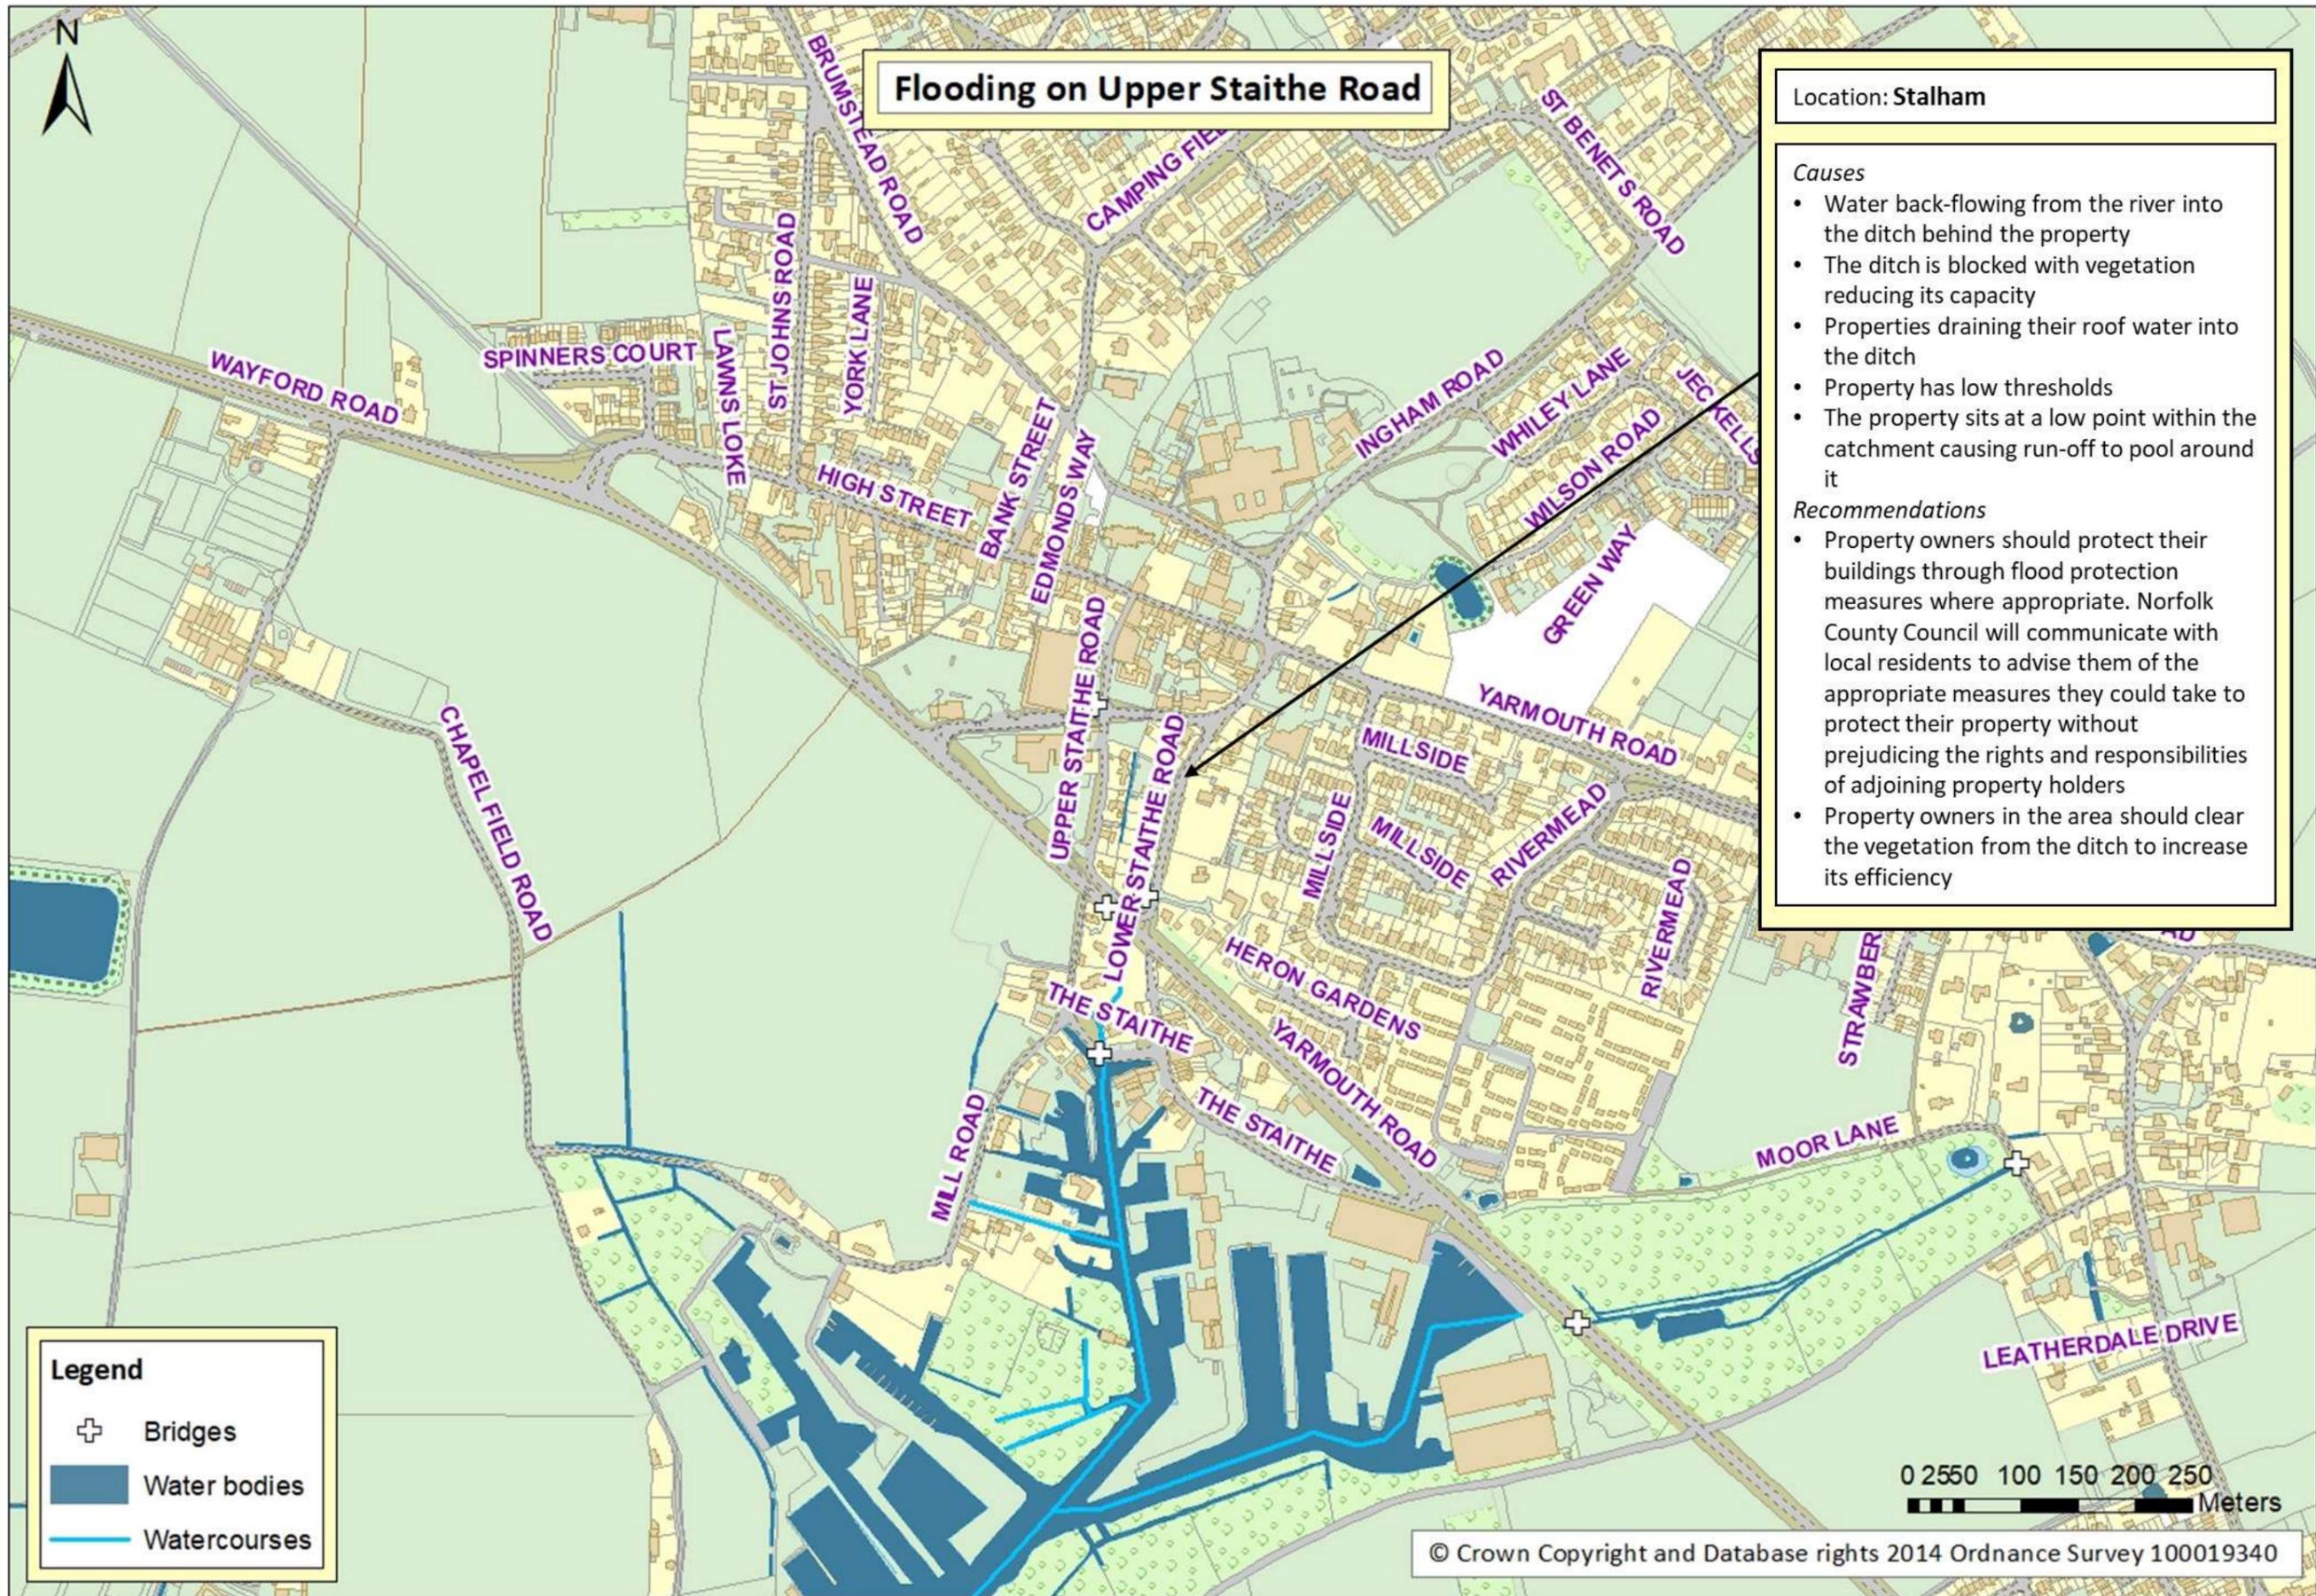
### Flooding on Upper Staithe Road

- Causes**
- Water back-flowing from the river into the ditch behind the property
  - The ditch is blocked with vegetation reducing its capacity
  - Properties draining their roof water into the ditch
  - Property has low thresholds
  - The property sits at a low point within the catchment causing run-off to pool around it
- Recommendations**
- Property owners should protect their buildings through flood protection measures where appropriate. Norfolk County Council will communicate with local residents to advise them of the appropriate measures they could take to protect their property without prejudicing the rights and responsibilities of adjoining property holders
  - Property owners in the area should clear the vegetation from the ditch to increase its efficiency
