Investigation Report into the flooding in Breckland Various in 2014-2017

Report Reference: FIR039

Draft Report prepared by Nathalie Harris on 17 July 2019

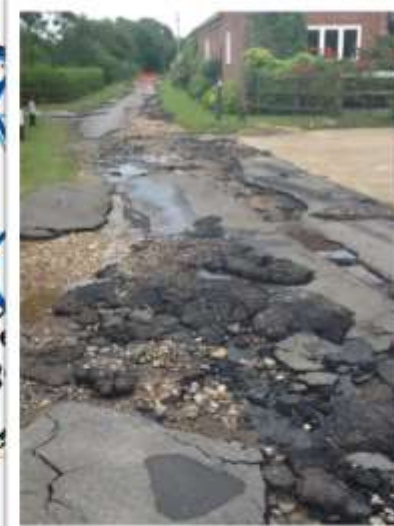
Flooding on Watery Lane

Watery Lane, Scarning: External flooding experienced on 23rd June 2016

- A watercourse adjacent to the highway was fully obstructed by debris and silt due to lack of maintenance by the riparian owner.
- This combined with run-off from significant rainfall that concentrated along surface water flow paths.
- This blocked a culvert causing the failure of the drainage system contributing to flooding at the affected property.
- The Met office reports localised flooding across Norfolk which is thought to have contributed.

- Norfolk County Council will communicate with riparian owners reminding them of their duties.
- Riparian owners should review the level of maintenance required to sustain the design efficiency of their drainage systems and identify the potential for managing the amount of surface water entering their drainage system in flood events.
- Property owners should protect their buildings through flood protection measures where appropriate. Norfolk County Council will communicate with local residents to advise them of the appropriate measures they could take to protect their property without prejudicing the rights and responsibilities of adjoining property holders
- Property owners should determine the adequacy of the on-site drainage and where appropriate increase on-site storage capacity and system efficiency through measures such as reinstating the watercourse.

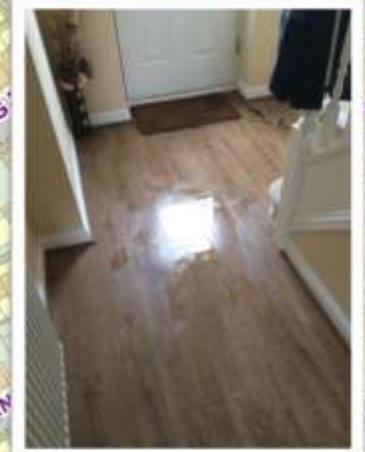
Flooding on Wavell Road

Wavell Road, Dereham: Internal flooding experienced on the 27th June 2014.

- Run-off from significant rainfall was directed towards the surface water drainage network. These flows could not be accommodated as the system was already overloaded.
- This flood water pooled at a low point within the catchment and the flood water entered the properties through low thresholds at entrances.
- The property is located at the foot of a hill and so it was determined that the sheer volume of rainfall that day temporarily overwhelmed the system and caused the flooding. The Met office reports thunderstorms across Norfolk on this day and the local monitoring station recorded an intensity of rainfall for equating to a 105 year rainfall event.

- Property owners should protect their buildings through flood protection measures where appropriate. Norfolk County Council will communicate with local residents to advise them of the appropriate measures they could take to protect their property without prejudicing the rights and responsibilities of adjoining property holders.

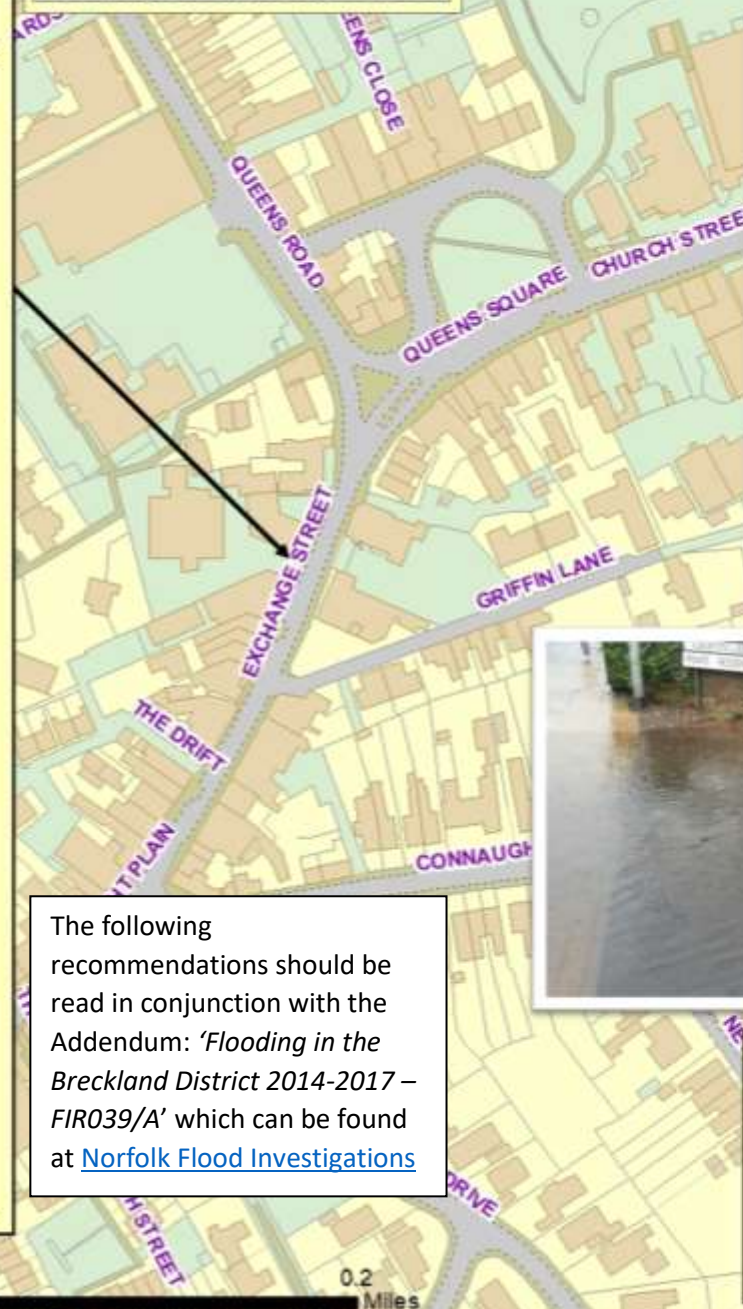
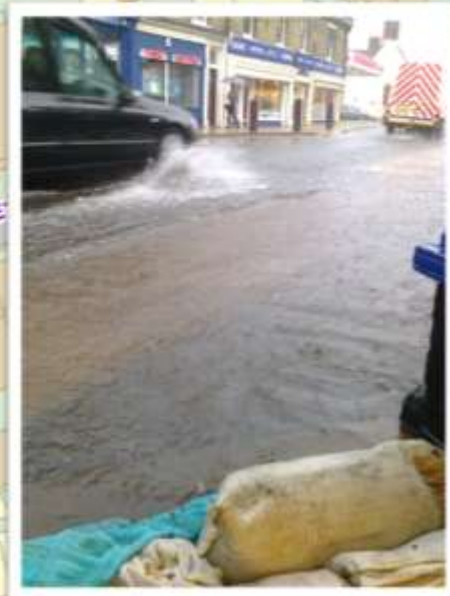
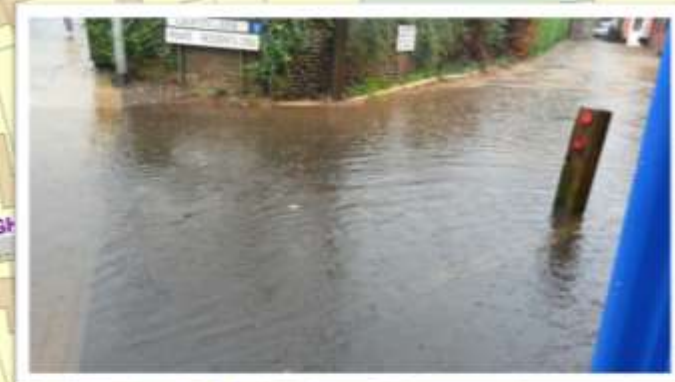
Flooding on Exchange Street

Exchange Street, Attleborough: Internal flooding experienced on the 31st August 2014

- Run-off from rainfall was directed towards the drainage network. These flows could not be accommodated as the system is of insufficient capacity to deal with this amount of water. This directed flood water towards the affected property.
- Rainfall was concentrated on the highway. Vehicles using the highway passed through the flood water causing it to wash towards the affected property.

- Norfolk County Council will investigate with third parties the potential to fund small scale improvement schemes to mitigate the risk experienced at this location. This could be either through the submission of a bid to secure Partnership funding or through negotiation with other organisations and the local community. It is important to note this recommendation will be subject to the priorities and availability of resources of funders. It may be dependent on those property owners affected contributing towards a solution.

- The property owner should determine the adequacy of the on-site drainage and where appropriate increase on-site storage capacity and system efficiency.

- Property owners should protect their buildings through flood protection measures where appropriate. Norfolk County Council will communicate with local residents to advise them of the appropriate measures they could take to protect their property without prejudicing the rights and responsibilities of adjoining property holders.

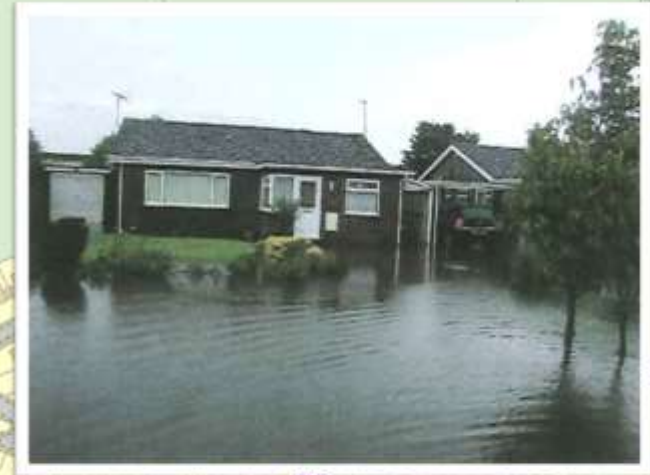
Flooding on Goffe Close

Goffe Close, Watton: Internal flooding experienced on 31st August 2015

- Surface run-off from rainfall made its way onto roads and flowed along the road network and onto the accesses of affected properties that were situated lower than these features. Rainfall was directed into the foul drainage system causing it to surcharge elsewhere. This surcharging contributed to the flooding at the affected property.

- Norfolk County Council will investigate with third parties the potential to fund small scale improvement schemes to mitigate the risk experienced at this location. This could be either through submission of a bid to secure Partnership funding or through negotiation with other organisations and the local community. It is important to note this recommendation will be subject to the priorities and availability of resources of funders. It may be dependent on those property owners affected contributing towards a solution.
- Norfolk County Council will determine an appropriate maintenance regime in line with the risk identified and communicate with affected parties and riparian owners.
- Norfolk County Council will consider opportunities to route flood water on the highway away from affected properties to alternative points of discharge, or other solutions as practicable.
