Investigation Report into the County Wide flooding in Norfolk on 6th October 2019 – Added Properties

Report Reference: FIR052

Draft Report prepared Oct 2020

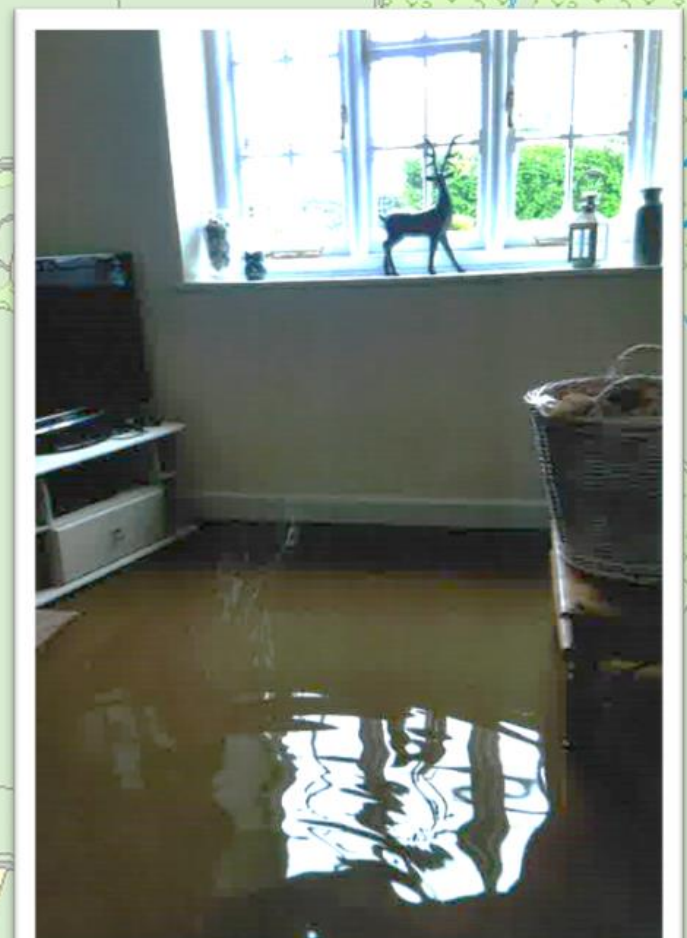
Flooding in Horstead

Location: **Heggatt Street- Report of internal flooding to one property on 6th October 2019**

- Run-off from significant rainfall pooled at a low point within the catchment affecting property.
- Surface run-off from significant rainfall flowed off nearby fields and onto the accesses of affected properties that were situated lower than these features.

- Property owners should protect their buildings through flood protection measures where appropriate. Norfolk County Council will communicate with local residents to advise them how they may apply for grants available. These grants are subject to a funding application. Property owners could also carry out their own measures where funding is not forthcoming or residents are unwilling to wait.
- Norfolk County Council could approach landowners to seek improvements in land management to reduce the levels of run-off from agricultural land.

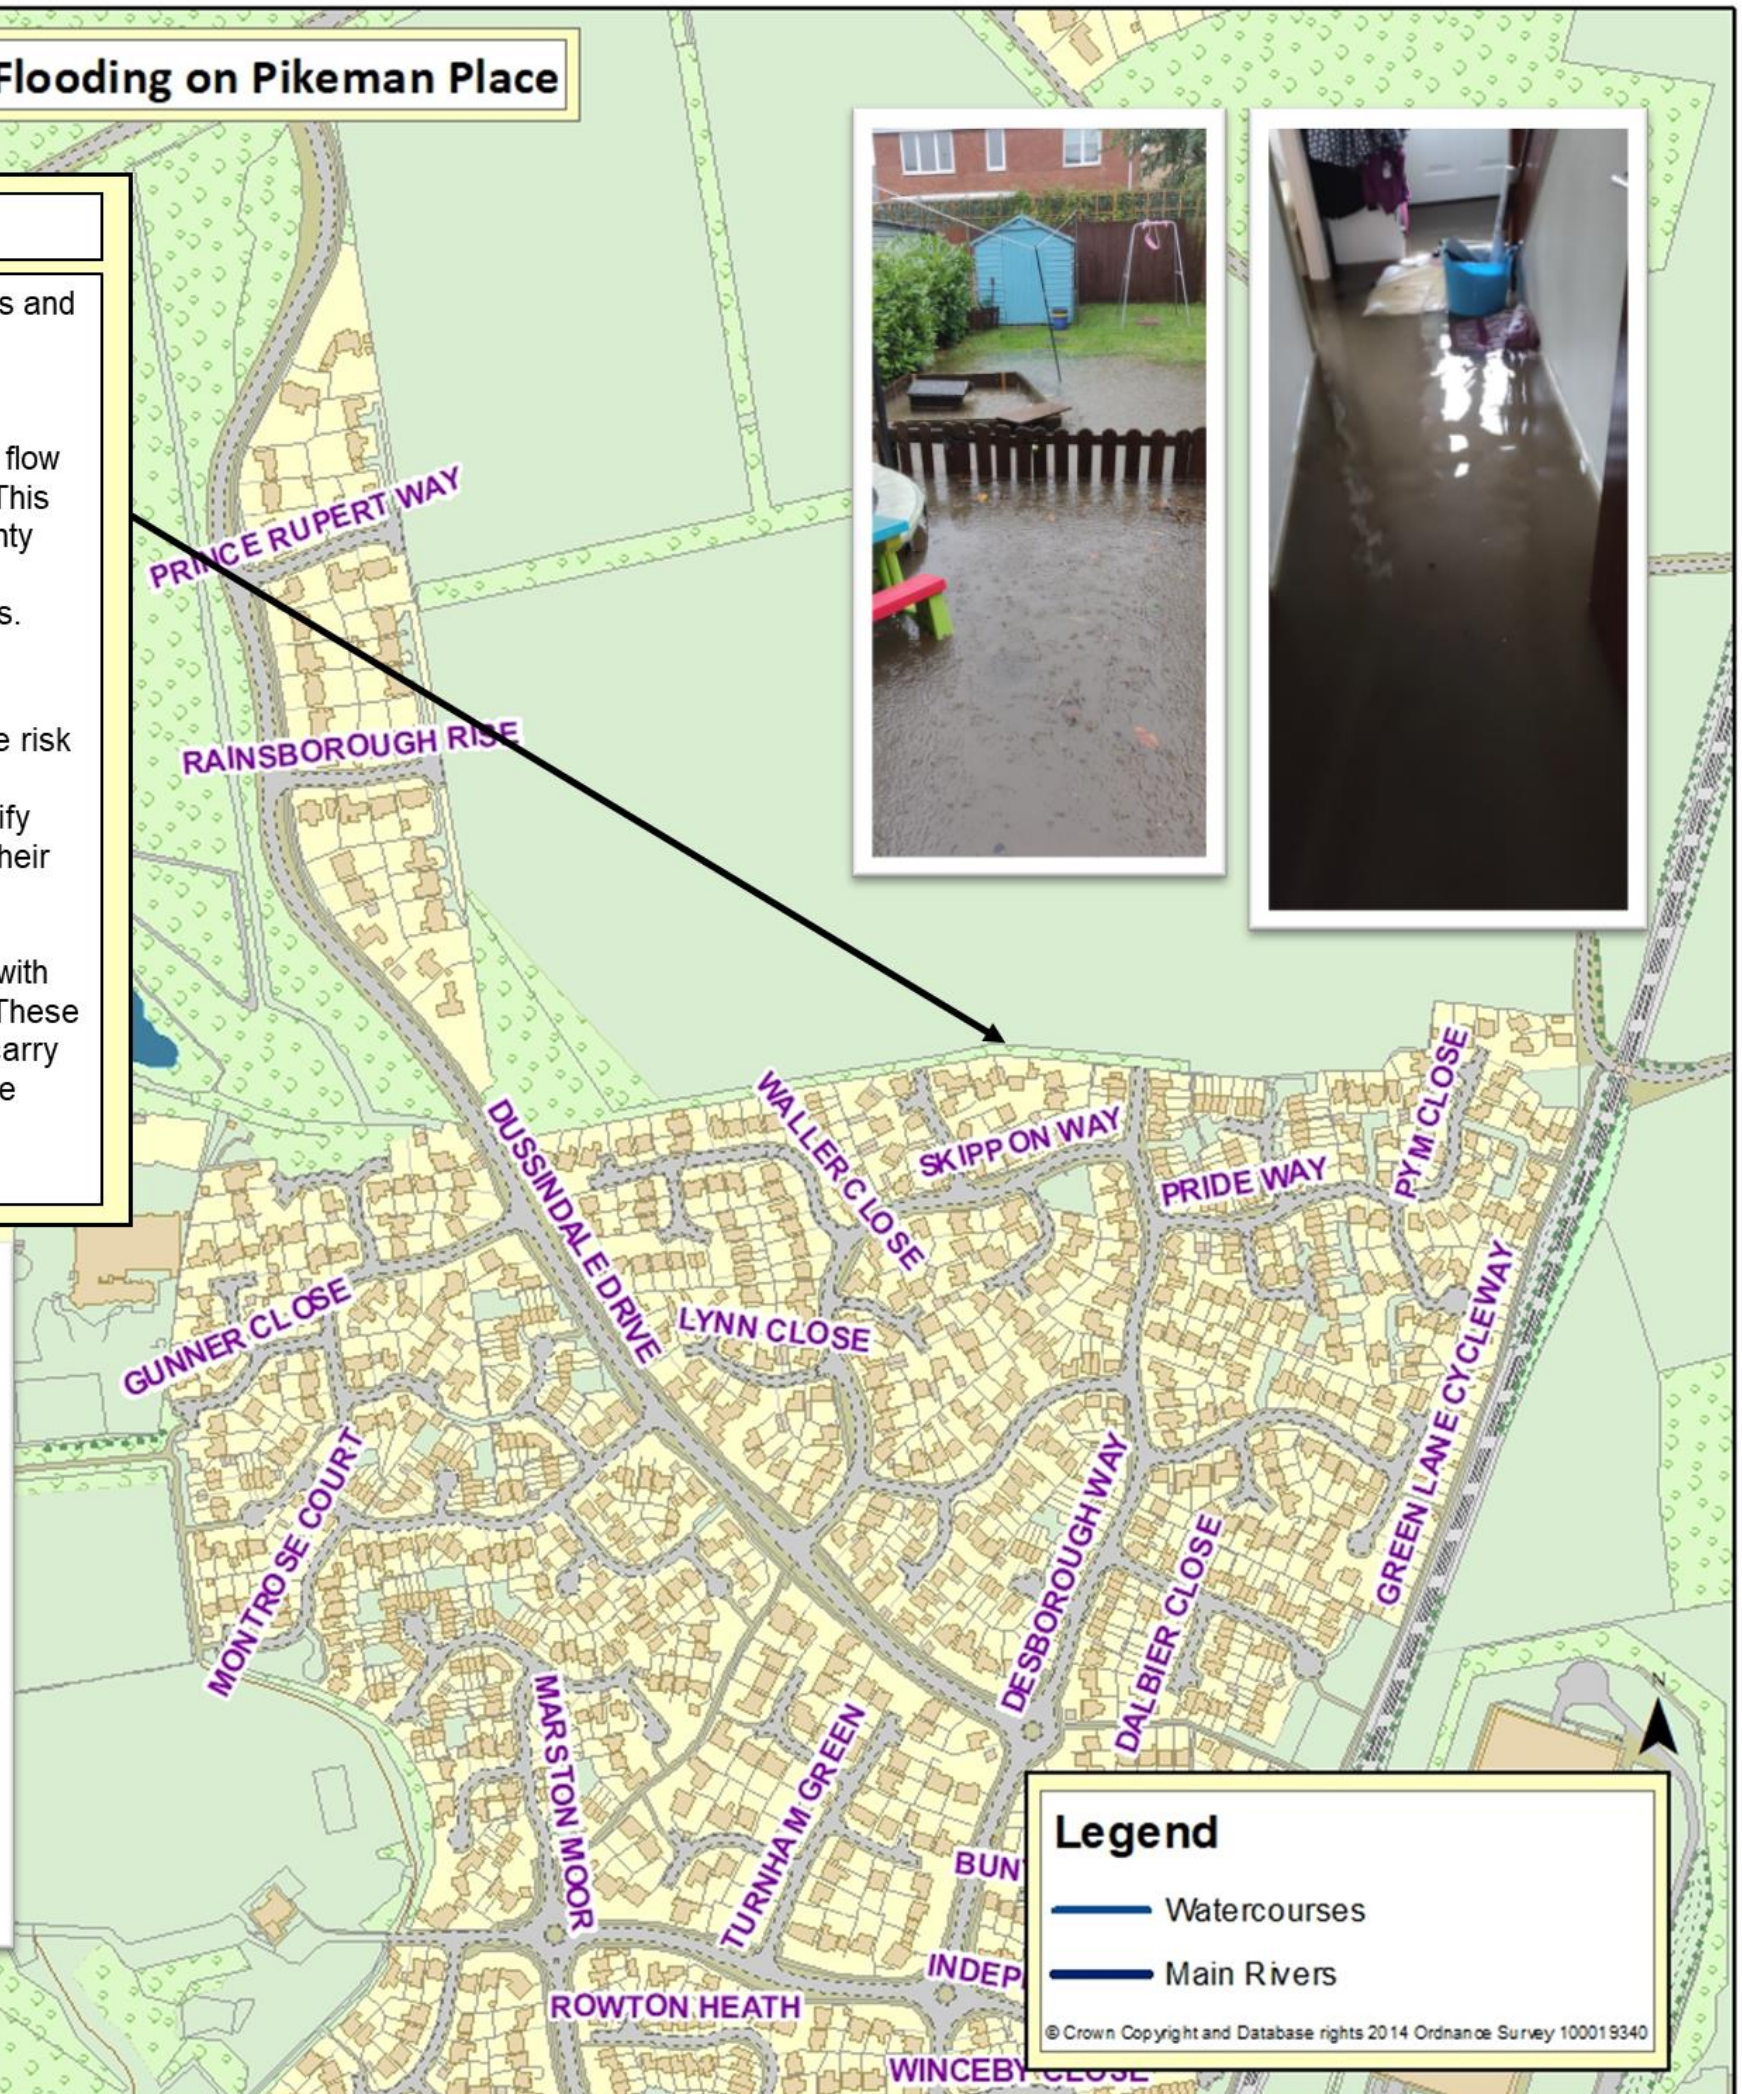
Flooding on Pikeman Place

Pikeman Place— Report of internal flooding on 6th October to two properties and external flooding to neighbouring properties.

- Surface run off from significant rainfall was concentrated along overland flow paths from a neighbouring field pooling at a low point in the catchment. This run off brought silt from the field into the Anglian Water and Norfolk County Council drainage networks causing an obstruction to flow.
- The flood water entered the property through low thresholds at entrances.

- Norfolk County Council will work with adjacent landowners to remove the risk of debris being directed into the drainage systems.
- Norfolk County Council and Anglian Water should work together to identify the potential for managing the amount or rate of surface water entering their drainage systems in flood events.
- Property owners should protect their buildings through flood protection measures where appropriate. Norfolk County Council will communicate with local residents to advise them how they may apply for grants available. These grants are subject to a funding application. Property owners could also carry out their own measures where funding is not forthcoming or residents are unwilling to wait for measures to be approved through national funding schemes.

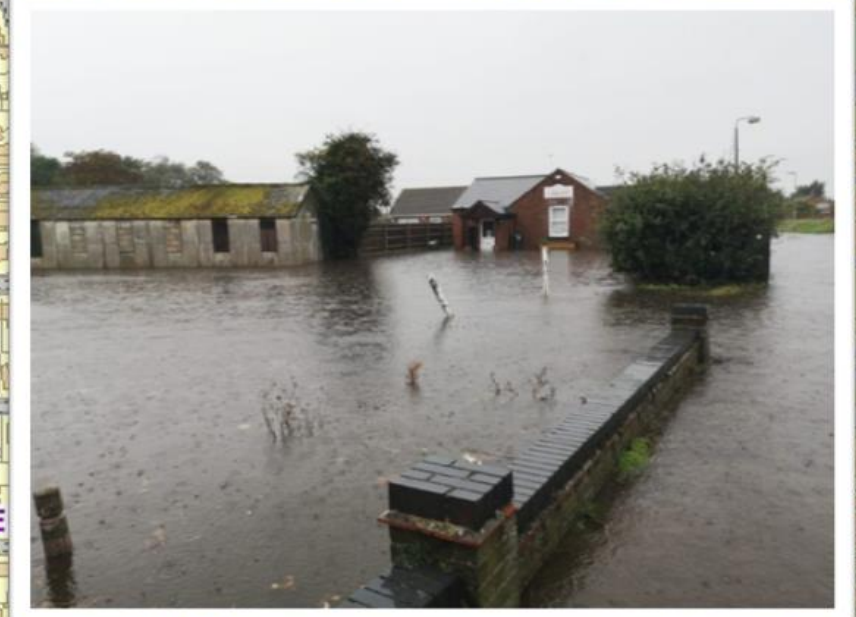
- Run-off from significant rainfall was concentrated along overland flowpaths and pooled at a low point within the catchment affecting the property.
- The run-off from was directed towards the drainage network. These flows could not be accommodated as the system was already overloaded. This directed flood water towards the affected property. Due to the development of impermeable surfaces localised ground conditions caused run-off to be directed quickly from where it fell as to low points causing localised pooling.

- Norfolk County Council will consider opportunities to route flood water on the highway away from affected properties to alternative points of discharge, or other solutions as practicable.
- Property owners should protect their buildings through flood protection measures where appropriate. Norfolk County Council should work with partner organisations to communicate with and support residents in identifying and accessing funding for property level measures. Property owners could also carry out their own measures where funding is not forthcoming, or residents are unwilling to wait for measures to be approved through national funding schemes. Property Owners should consider the potential to retrofit permeable areas and other methods of small scale sustainable drainage systems.
