Norfolk County Council

Investigation Report into the flooding in South Norfolk & Breckland on the 2nd June 2018

Report Reference: 032

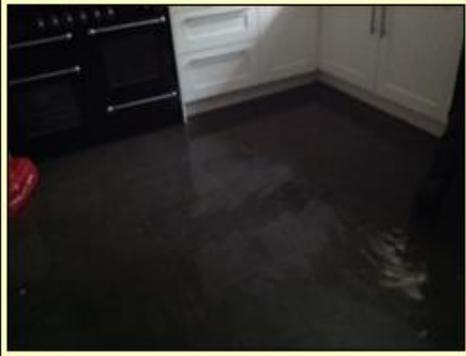
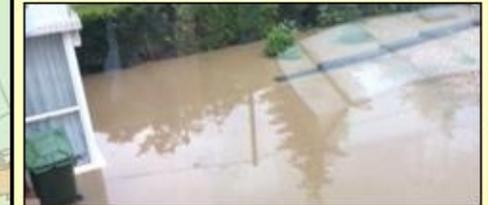
Causes – Run-off from significant rainfall was concentrated along overland flowpaths, this made its way onto the highway, flowed along the road network and onto the access points of affected properties. Drainage system was partially blocked with debris/silt reducing its efficiency. Periods of dry weather prior to rainfall decreased ground permeability increasing run-off. Water entered properties through low thresholds and airbricks.

Causes – Surface run-off from significant rainfall that had made its way onto the highway flowed along the road network and onto the accesses of affected properties that were situated lower than these features. Drainage systems unable to cope with volume of water, water surcharged from drains contributing to flooding.

Recommendations – Norfolk County Council to explore funding opportunities to allow flood mitigation measures to be installed. NCC will consider opportunities to route flood water on the highway away from affected properties to alternative points of discharge or other solutions as practicable. NCC to assess drainage maintenance. Homeowners should protect their properties through flood protection measures where appropriate.

Recommendations – NCC will investigate with third parties the potential to fund small scale improvement schemes to mitigate the risk experienced at this location. NCC will consider opportunities to route flood water on the highway away from affected properties to alternative points of discharge, or other solutions as practicable. Anglian Water and NCC to assess maintenance requirements of drainage system. Homeowners should protect their properties through flood protection measures and consider retrofitting permeable areas where appropriate.

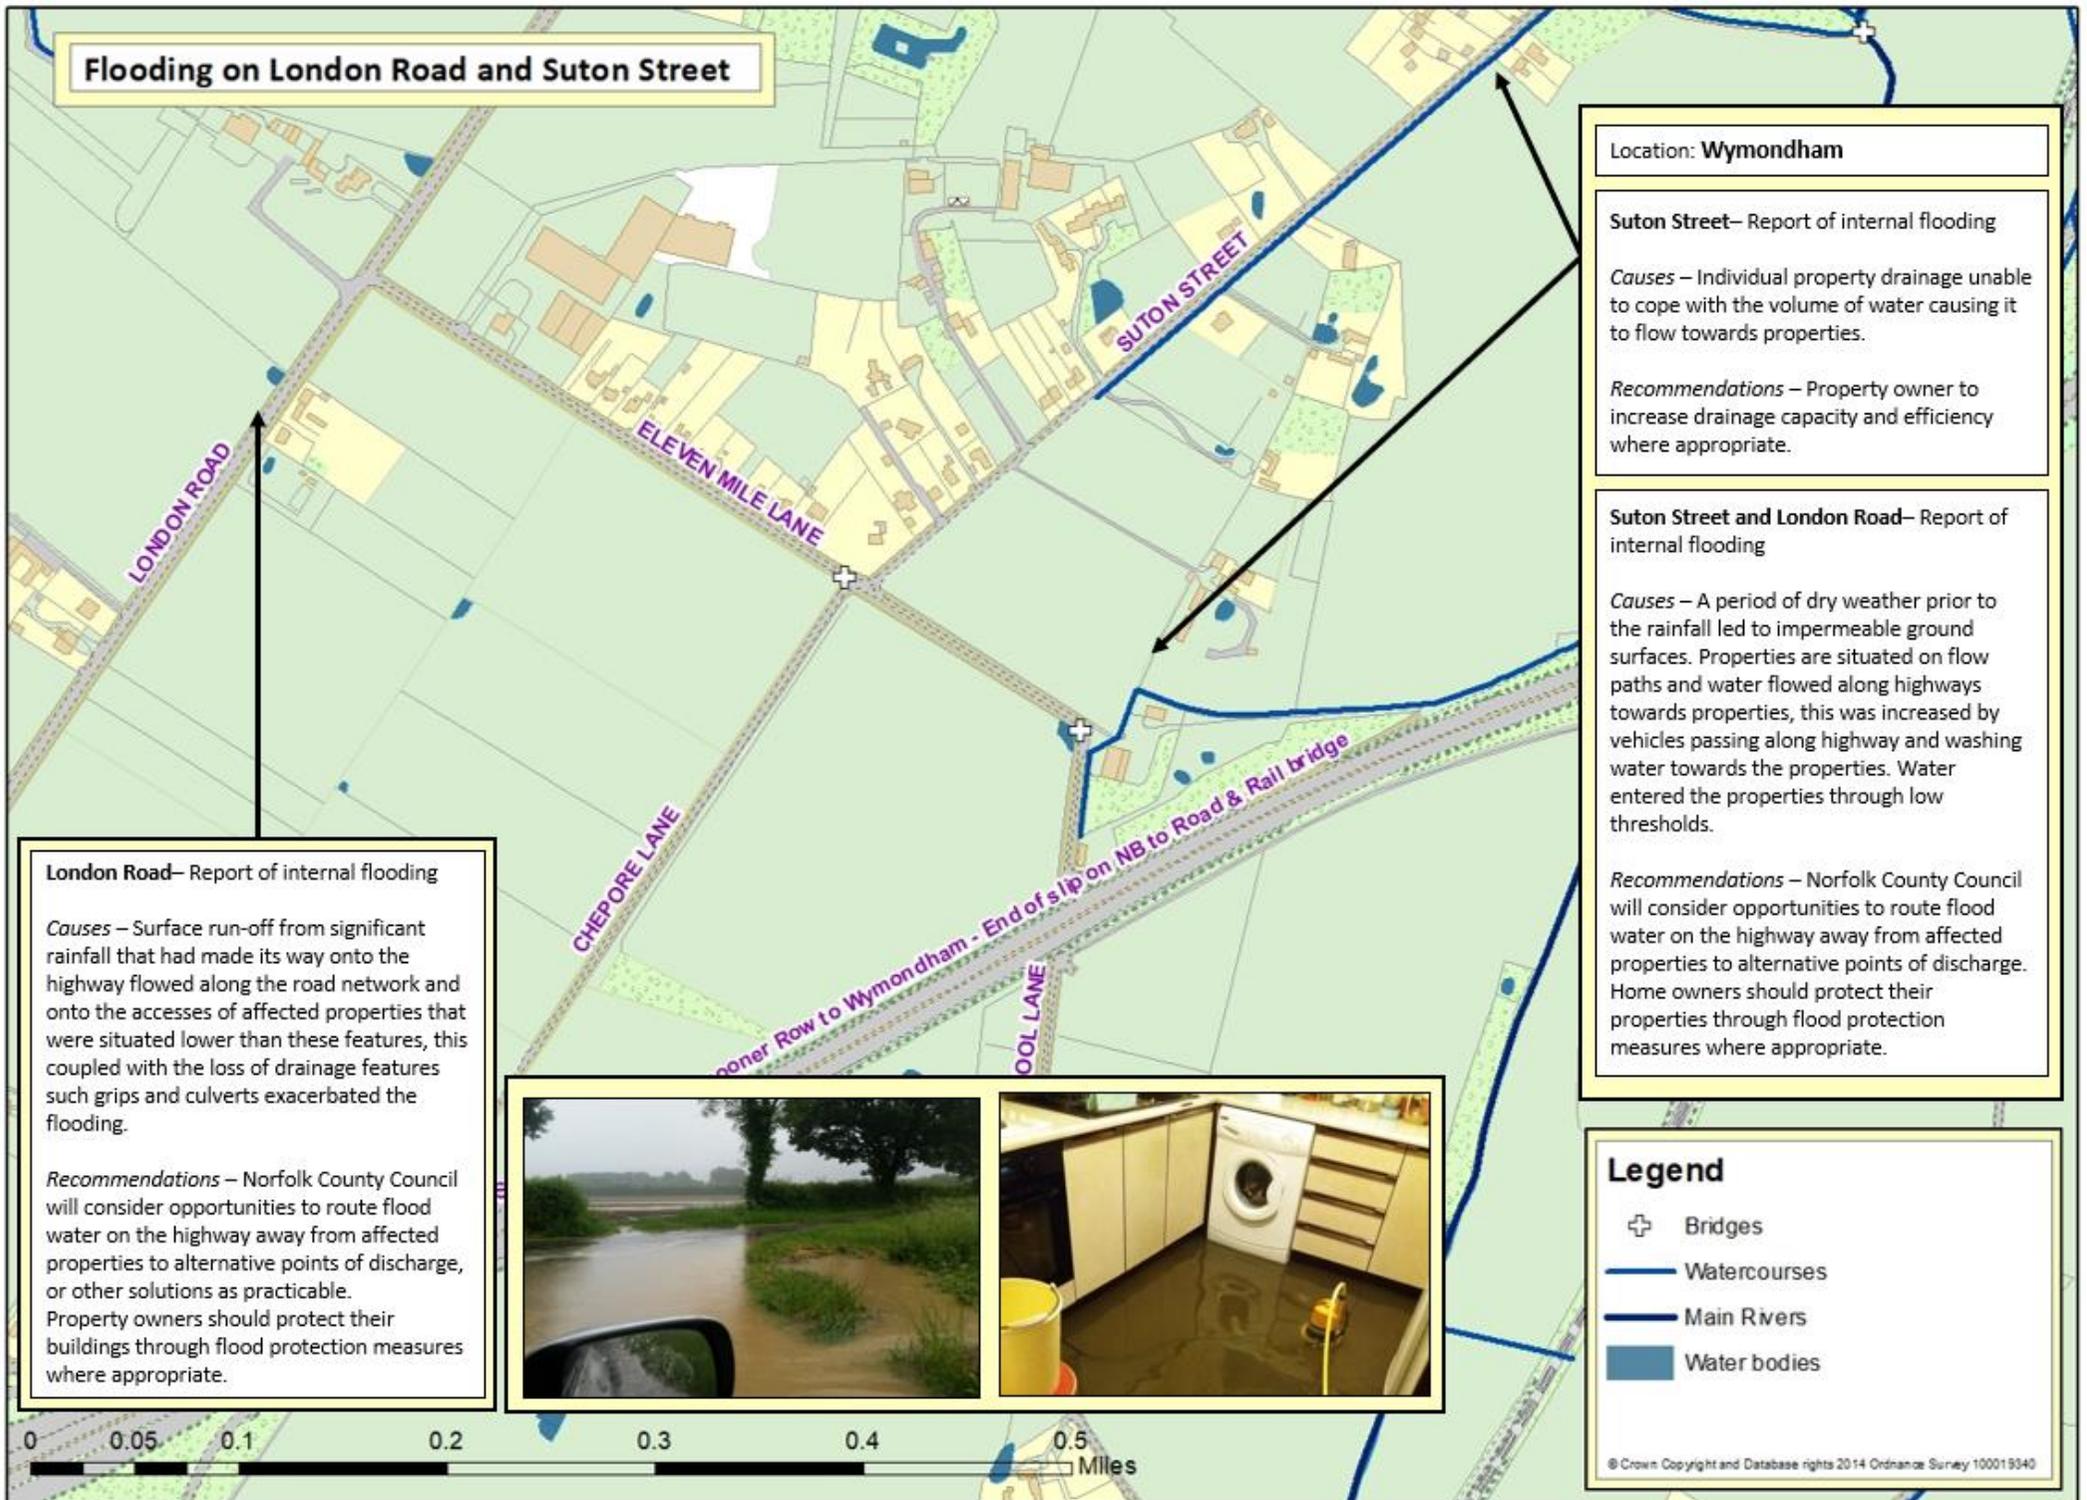
Flooding on London Road and Sutton Street

Sutton Street– Report of internal flooding

Causes – Individual property drainage unable to cope with the volume of water causing it to flow towards properties.

Recommendations – Property owner to increase drainage capacity and efficiency where appropriate.

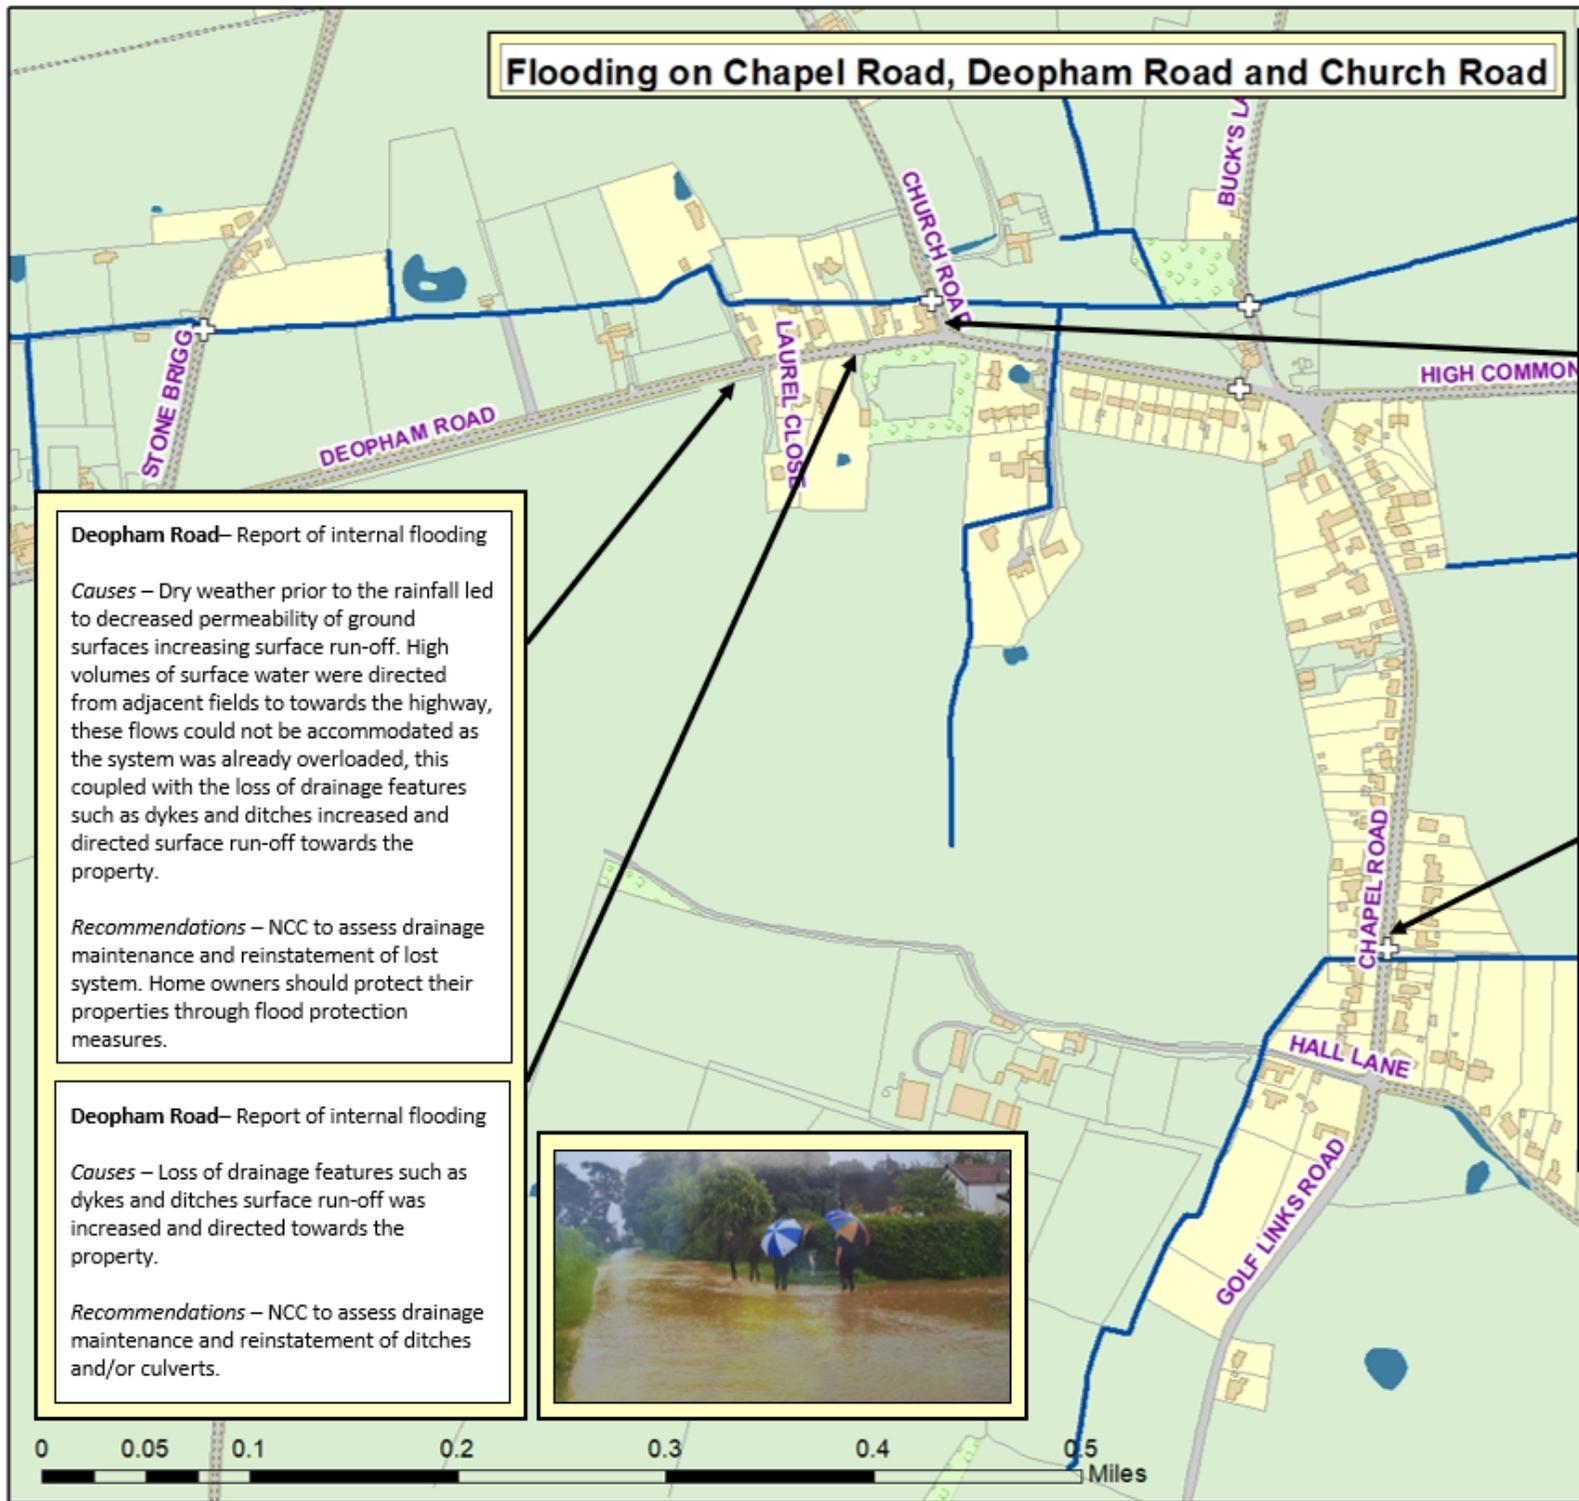
Flooding on Chapel Road, Deopham Road and Church Road

Church Road– Report of internal flooding

Causes – Surface run-off from significant rainfall that had made its way onto the highway flowed along the road network and onto the accesses of affected properties that were situated lower than these features. These flows were exacerbated by the loss of drainage features such as dykes and ditches.

Recommendations – Norfolk County Council will consider opportunities to route flood water on the highway away from affected properties to alternative points of discharge, or other solutions as practicable, possibly with provision of raised kerbs to property frontage. Home owners should protect their properties through flood protection measures.

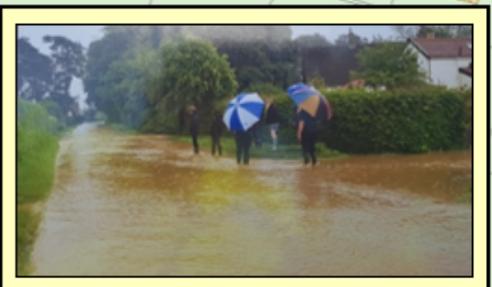
Chapel Road– Report of internal flooding

Causes – Run-off from significant rainfall was directed towards the surface water drainage network, these flows could not be accommodating as the system was already overloaded coupled with the property being situated on a flow path.

Recommendations – NCC will review the level of maintenance required to sustain the design efficiency of their drainage systems that serve the flooding location along with the potential for providing or increasing attenuation to reduce the amount of water entering drainage systems.

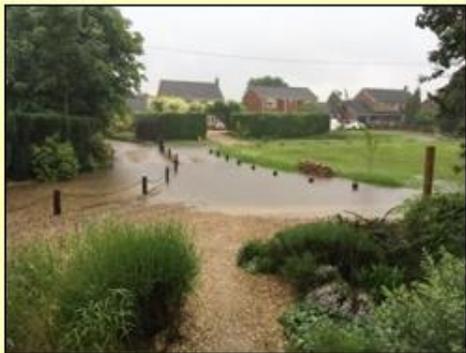
Causes – Dry weather prior to the rainfall made ground surfaces impermeable. Surface run-off was concentrated on the highways and was washed towards the affected property by passing vehicles. The drainage system was obstructed by high levels downstream, reducing its efficiency and causing the drains to surcharge near the property. Water entered the property through low thresholds and air bricks.

Recommendations – NCC will consider opportunities to route flood water on the highway away from affected properties to alternative points of discharge. NCC and Anglian Water to review maintenance level required to keep drainage system efficient. Homeowner to install flood protection measures where appropriate and consider the potential for retro-fitting permeable areas and other methods of small scale sustainable drainage systems .

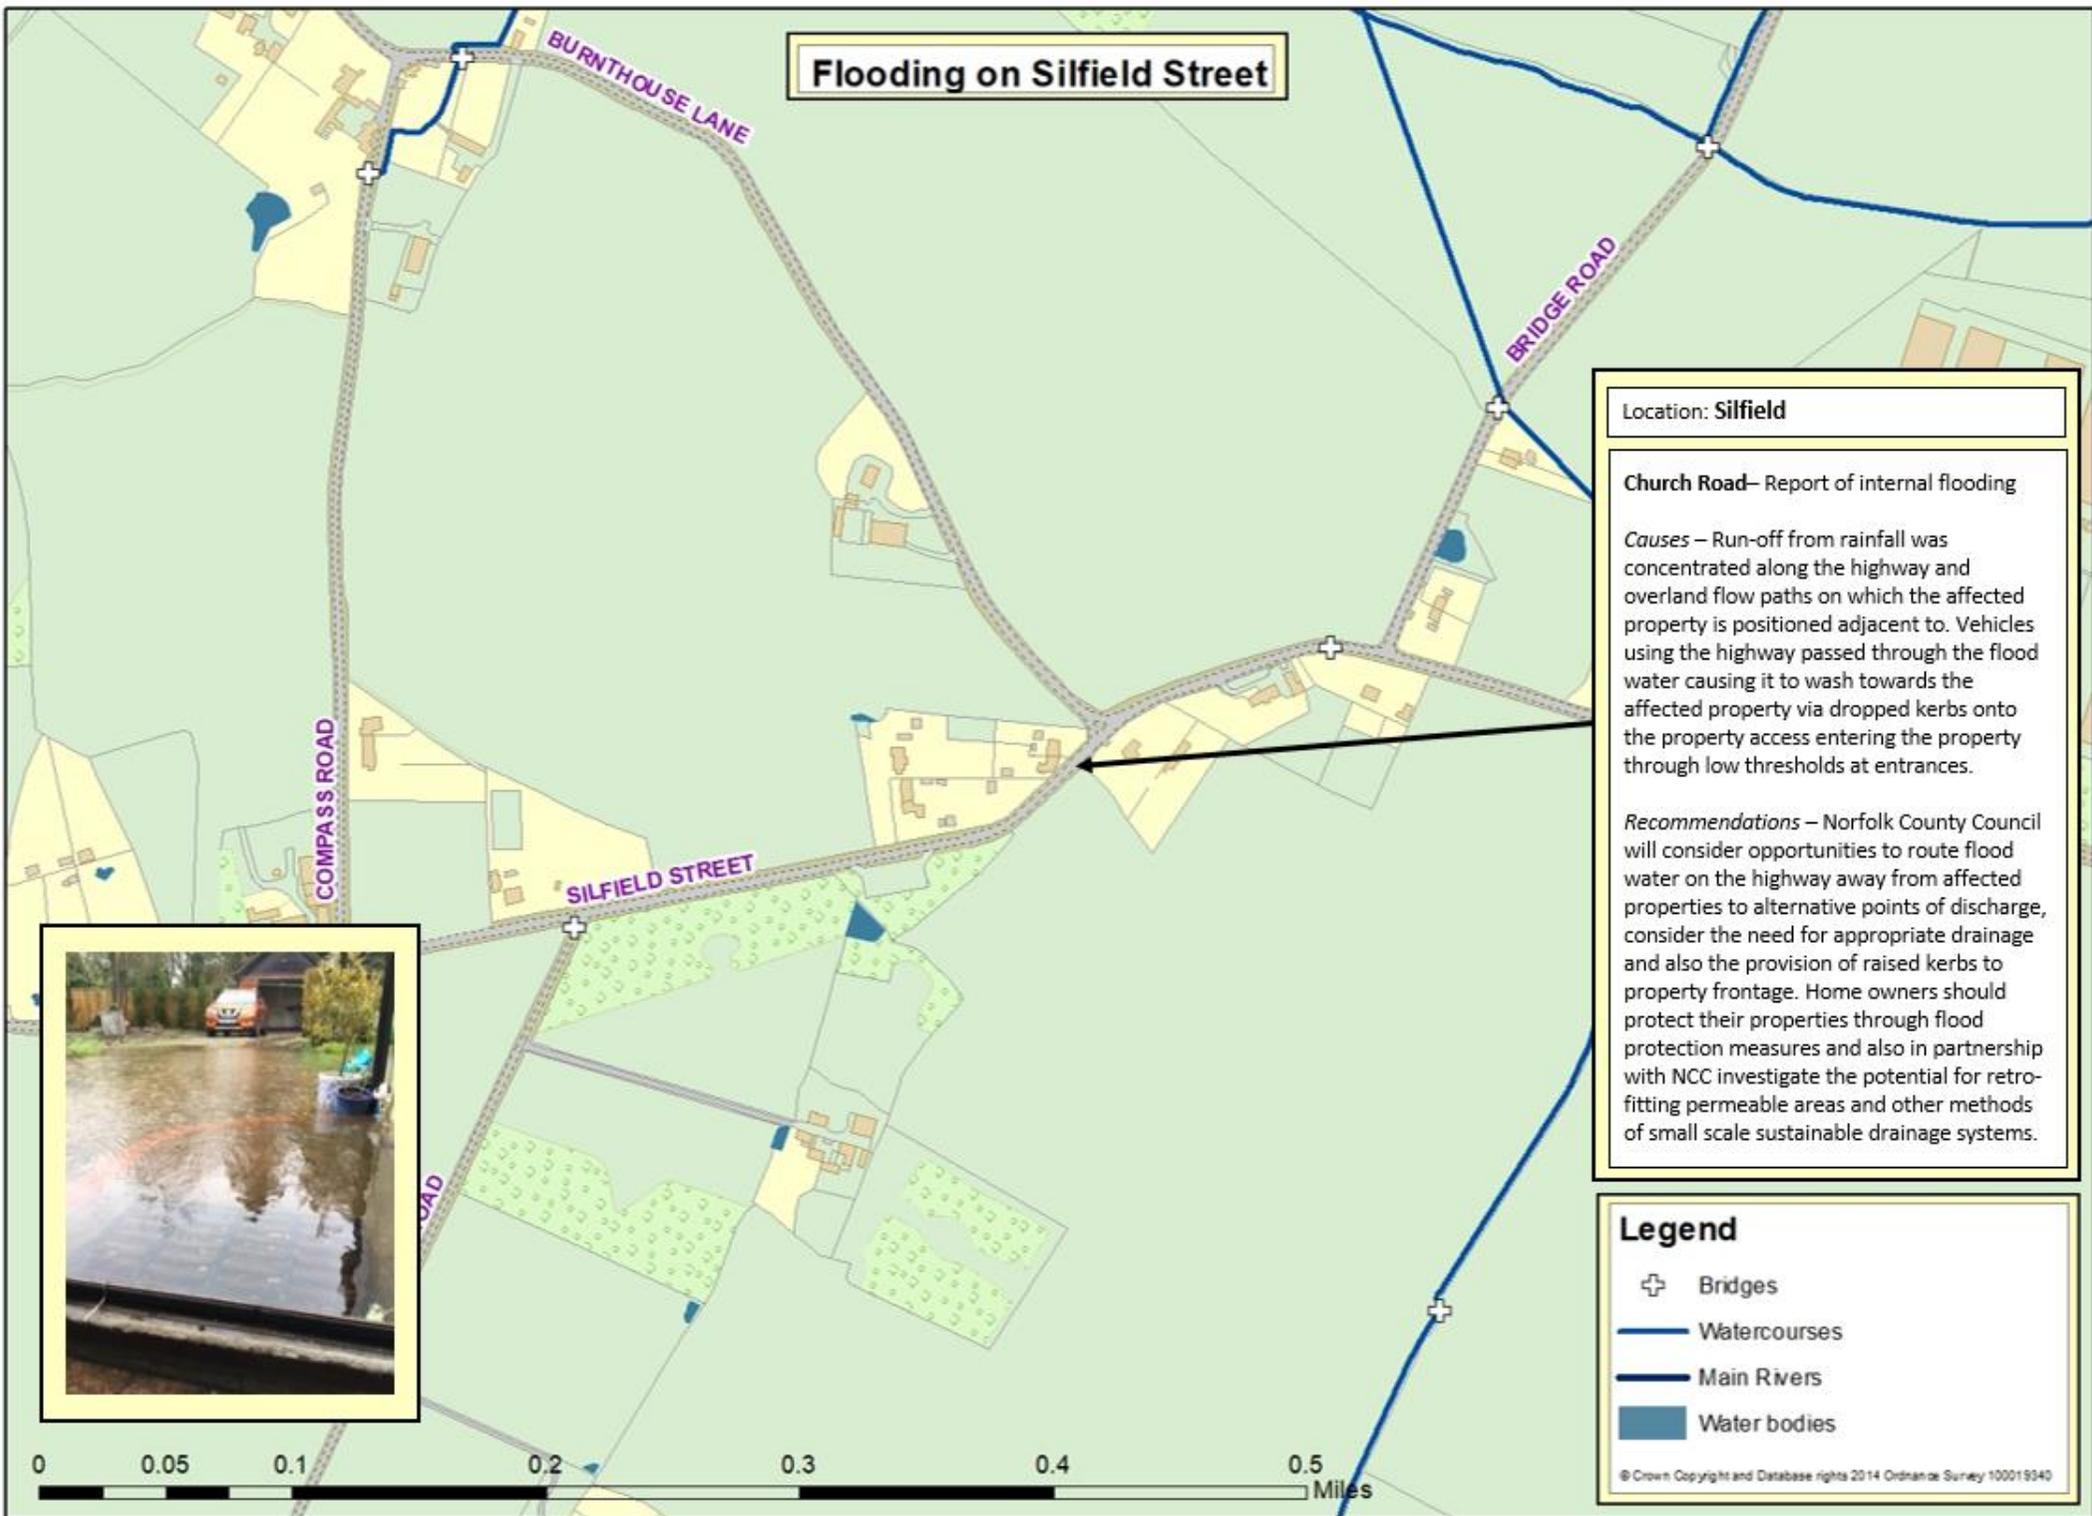
Flooding on Silfield Street

Church Road— Report of internal flooding

Causes – Run-off from rainfall was concentrated along the highway and overland flow paths on which the affected property is positioned adjacent to. Vehicles using the highway passed through the flood water causing it to wash towards the affected property via dropped kerbs onto the property access entering the property through low thresholds at entrances.

Recommendations – Norfolk County Council will consider opportunities to route flood water on the highway away from affected properties to alternative points of discharge, consider the need for appropriate drainage and also the provision of raised kerbs to property frontage. Home owners should protect their properties through flood protection measures and also in partnership with NCC investigate the potential for retrofitting permeable areas and other methods of small scale sustainable drainage systems.
