Great Yarmouth Third River Crossing

Application for Development Consent Order

Document 6.2: Environmental Statement Volume II: Technical Appendix 8A: Legislation, Policy and Guidance

Document Reference: 6.2 – Technical Appendix 8A

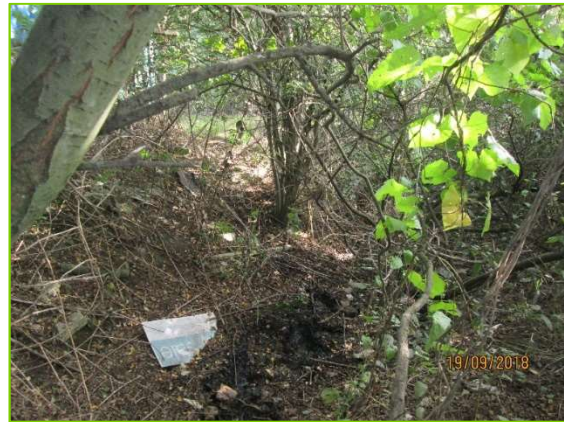
Plate 8 – Dry ditch running parallel to the west of the A47, north of the roundabout

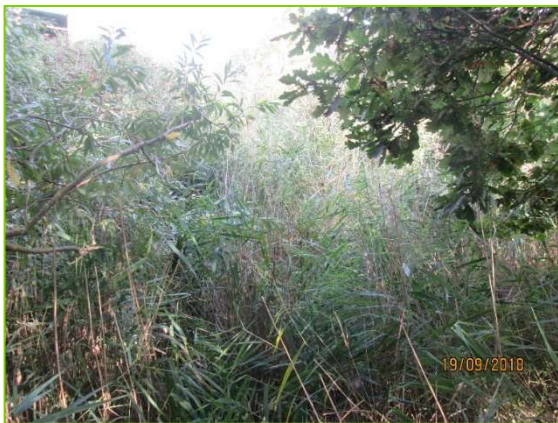
Plate 9 – Partly dry watercourse running parallel to the western edge of the A47, south of the roundabout

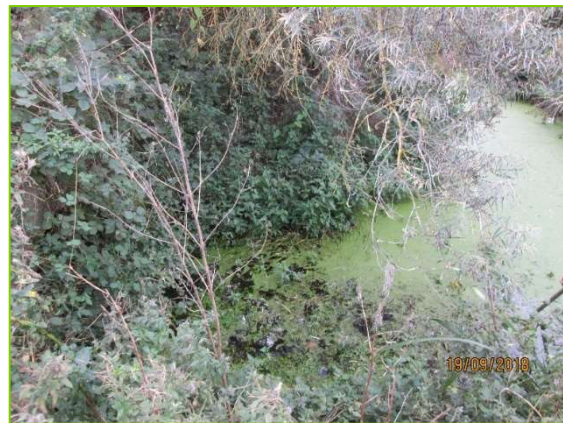
Plate 10 – Partly dry watercourse running parallel to the western edge of the A47, south of the roundabout

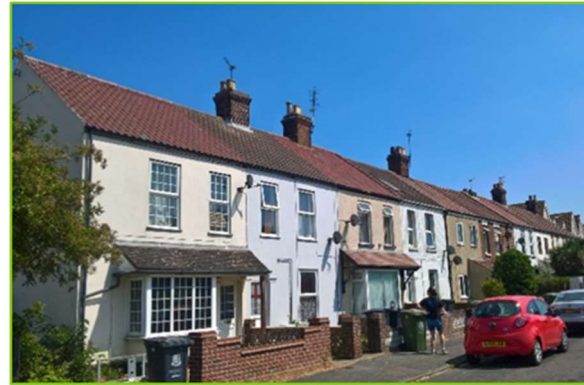
Plate 12 – Buildings B1, assessed for bat roost potential

- 4.1.4 If buildings assessed as of low suitability to support roosting bats are to be demolished, these will be subjected to internal inspections to confirm whether or not they are roost sites and if further actions in respect of bats are required.

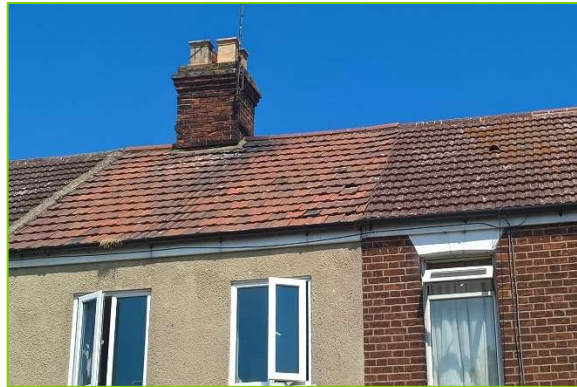
Plate 13 – Features on B1 assessed as providing low suitability for roosting bats

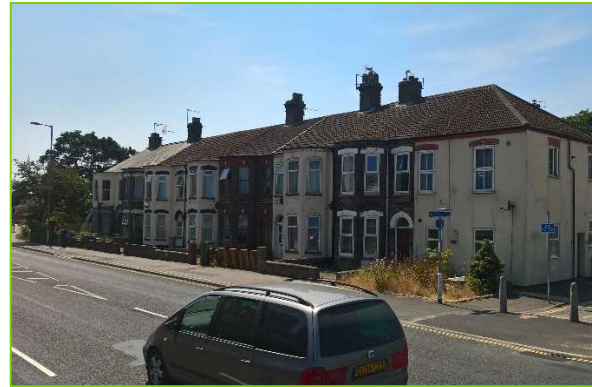
Plate 14 – Buildings B2, assessed for bat roost potential

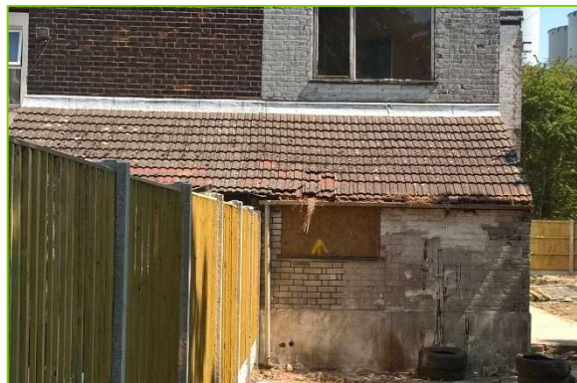
Plate 15 – Features on B2 assessed as providing low suitability for roosting bats

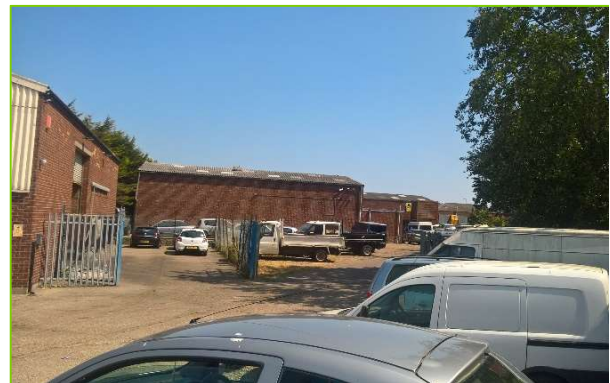
Plate 16 – Example warehouse structures

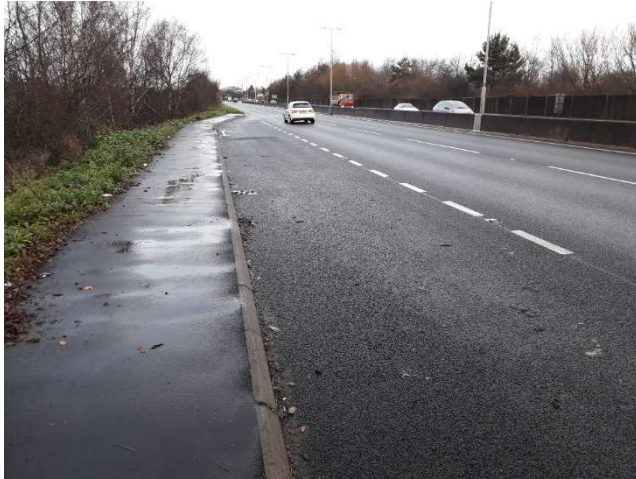
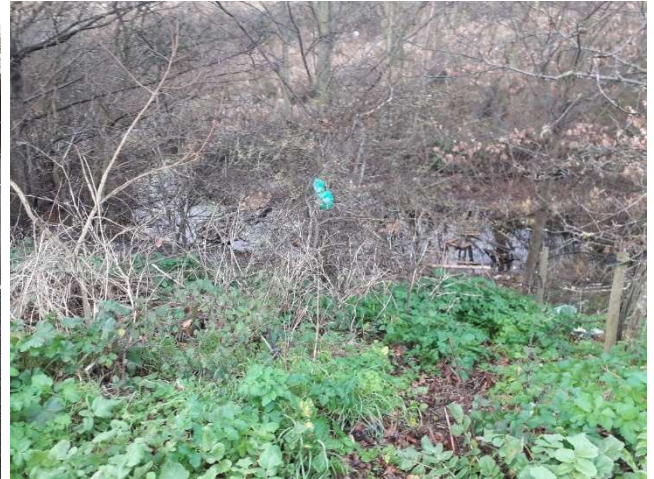
Satellite Sites 5-01 and 5-02

Plates 17 and 18 – Hardstanding layby adjacent to the A47. Beyond the layby was a steep scrubby bank leading down to a small watercourse. Habitats were of negligible value

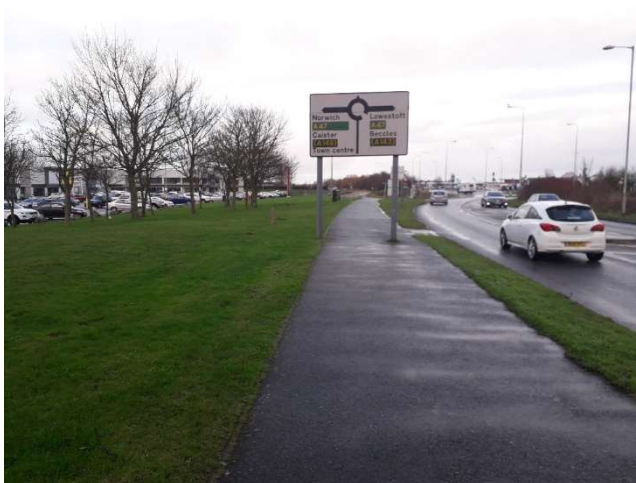
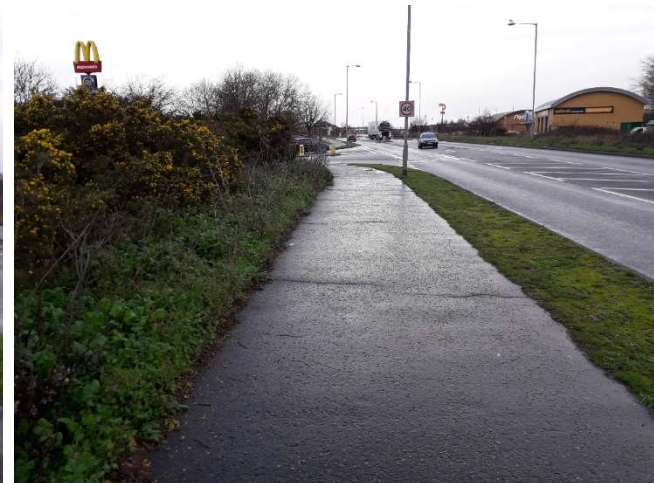
Satellite Sites 6-01 and 6-02

Plates 19 and 20 – Habitats comprised mainly of hardstanding and short amenity grassland of negligible value

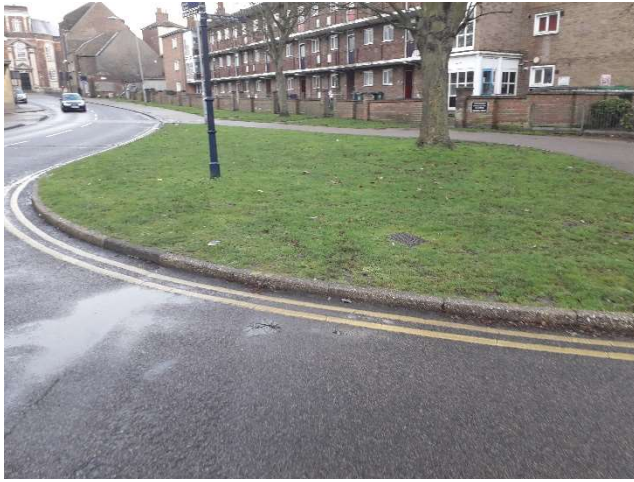
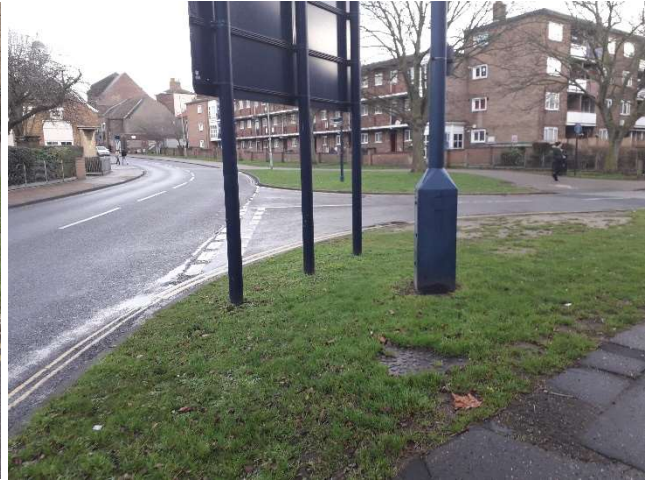
Satellite Sites 7-01 to 7-07

Plates 21 and 22 – Habitats comprised hardstanding and short amenity grassland of negligible value

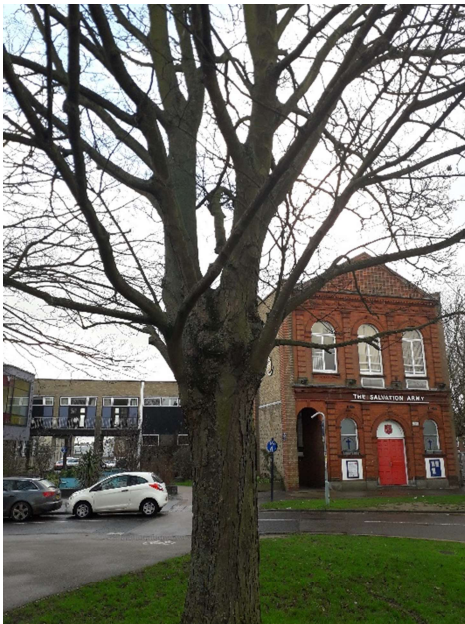
Plate 23 – Mature broadleaved tree present, but considered unlikely to be impacted (see Detailed Arboriculture Report Appendix 8H)

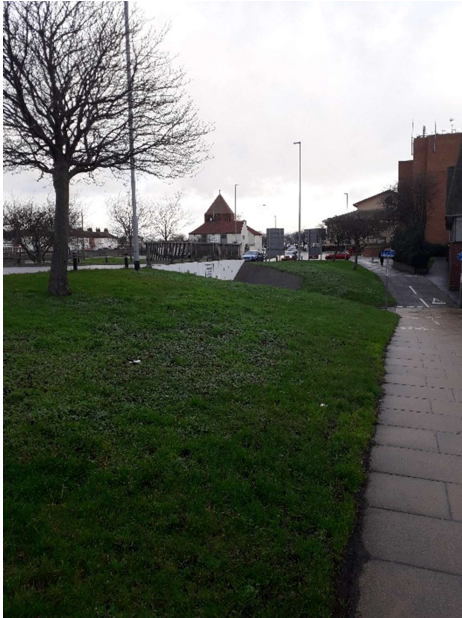
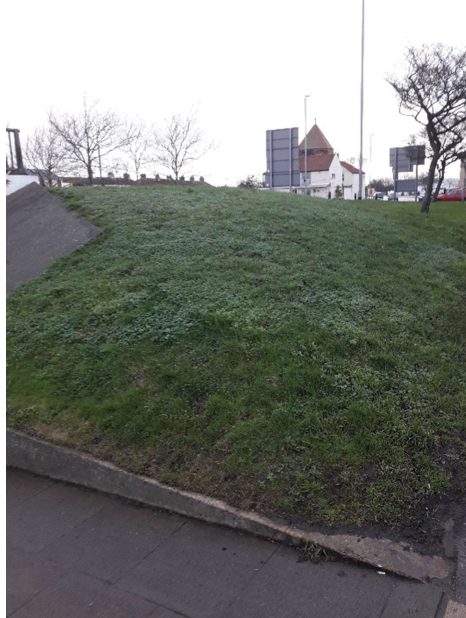
Satellite Sites 8-01 and 8-02

Plates 24 and 25 – Habitats comprised hardstanding and short amenity grassland of negligible value

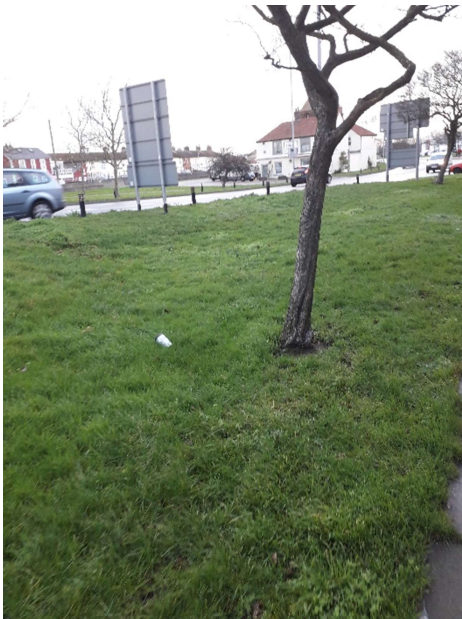
Plate 26 – Young broadleaved trees also present, but considered unlikely to be impacted (see Detailed Arboriculture Report Appendix 8H)

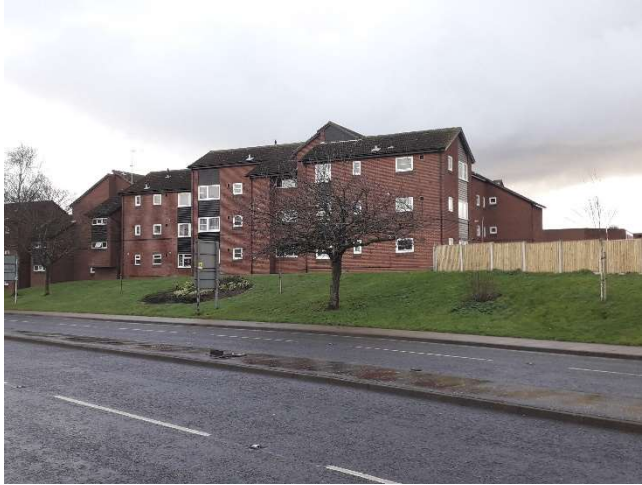
Satellite Sites 8-03 and 8-04

Plate 27 – Habitats comprised hardstanding, introduced shrubs (young) and short amenity grassland of negligible value. Additionally, young broadleaved trees were present, but considered unlikely to be impacted (see Detailed Arboriculture Report Appendix 8H)

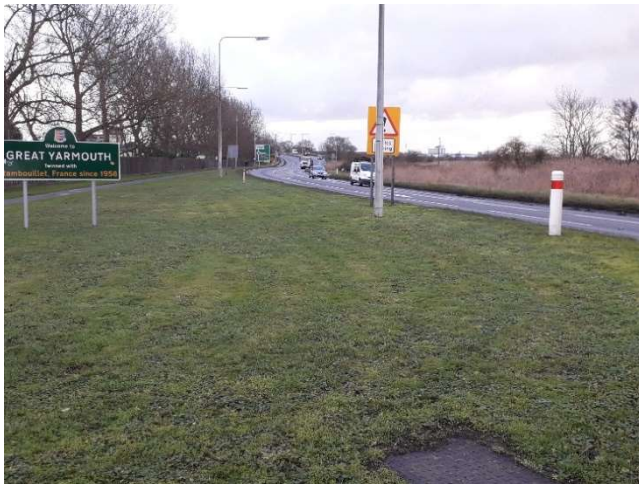
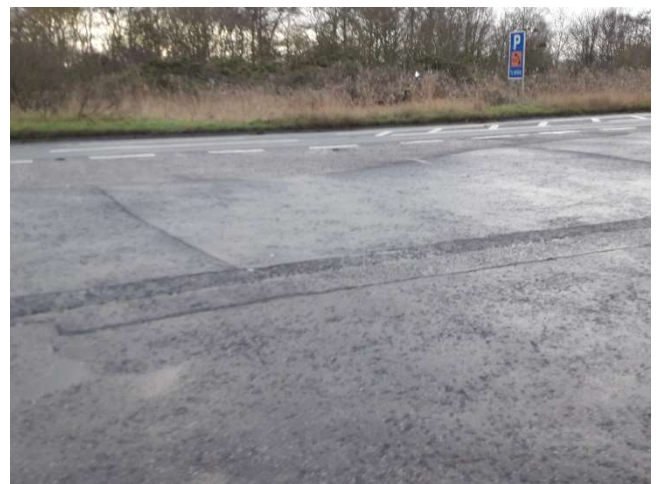
Satellite Site 9-01

Plates 28 and 29 – Habitats comprised hardstanding and short amenity grassland of negligible value

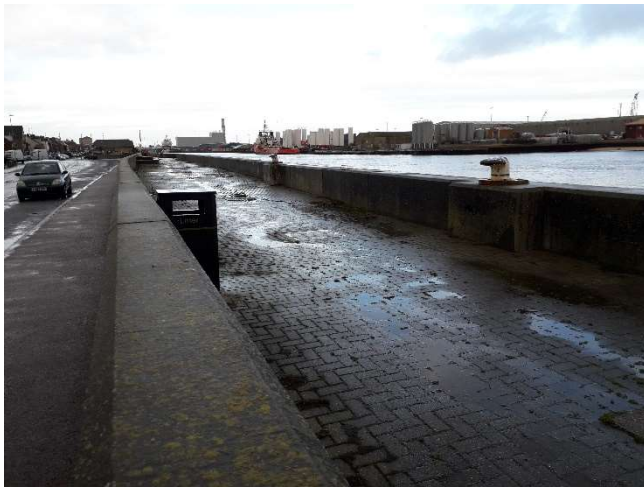
Satellite Sites 10-01 to 10-03

Plate 31 – Area dominated by hardstanding

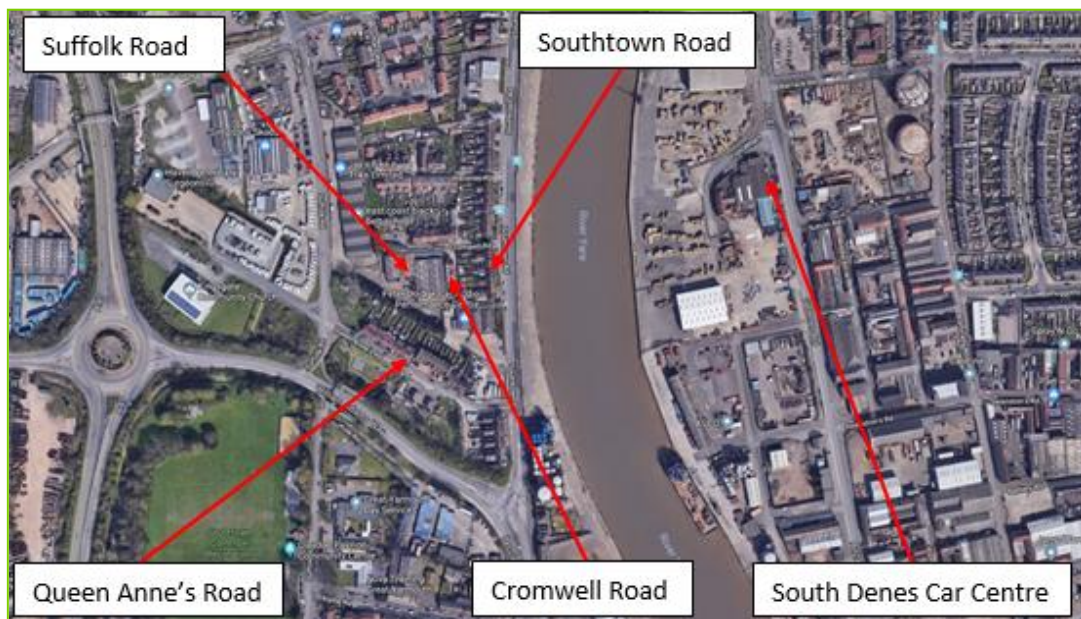
Figure 2.1: Location of Survey Areas

2.2.1 The Principal Application Site consists of a number of buildings and structures located in the centre of Great Yarmouth, Norfolk, between the A47 at Harfrey's roundabout on the western side of the River Yare and South Denes Road on the eastern side of the river. Figure 2.1 shows the locations of the areas surveyed; with details of the specific buildings surveyed set out in Section 5.

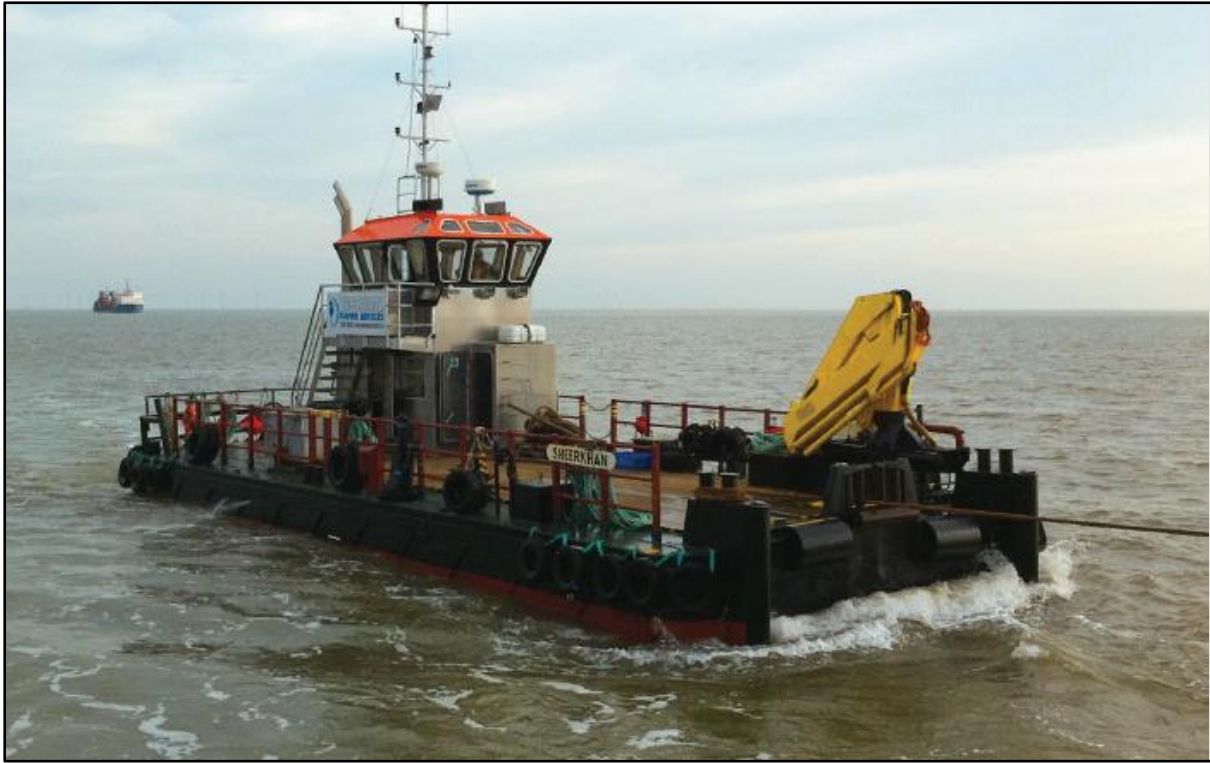
Figure 2. The survey vessel MV Sheerkhan used for the survey work. (Image reproduced by kind permission of Technical Marine Services Ltd. ©Technical Marine Services)

MV Sheerkhan is a 17.5 m survey vessel with a 45 square meter deck and is classified by the UK Maritime Coastguard Authority to work up to 60 nautical miles offshore (MCA workboat code category 2). She is fitted with a Braden 15 tonne handling winch, a Spencer Carter 1 tonne split trawl winch and a Bonfiglioli 24t/m crane.

All survey work was undertaken from the MV Sheerkhan (Figure 2) which is based in Great Yarmouth and owned and operated by Technical Marine Services Ltd.

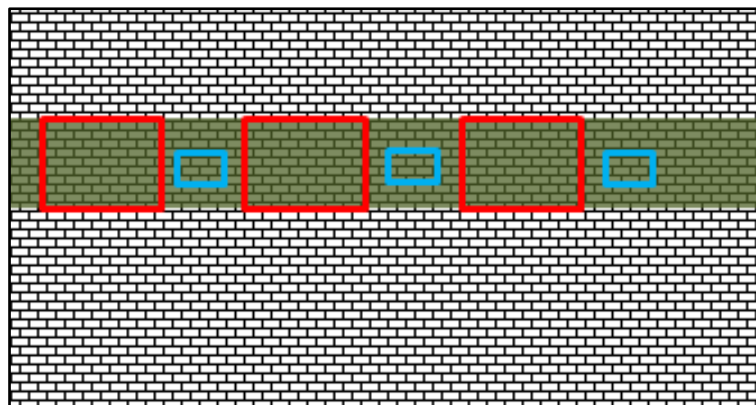
Figure 3. Example section of harbour wall indicating how the quadrat (red squares) and wall scrape samples (blue) were positioned at each station within the algal zone

At each wall scrape sampling station, a 0.01 m² sample was obtained of the biotic community at approximately mid tide level, in accordance with the methodologies described by Worsfold (1998).

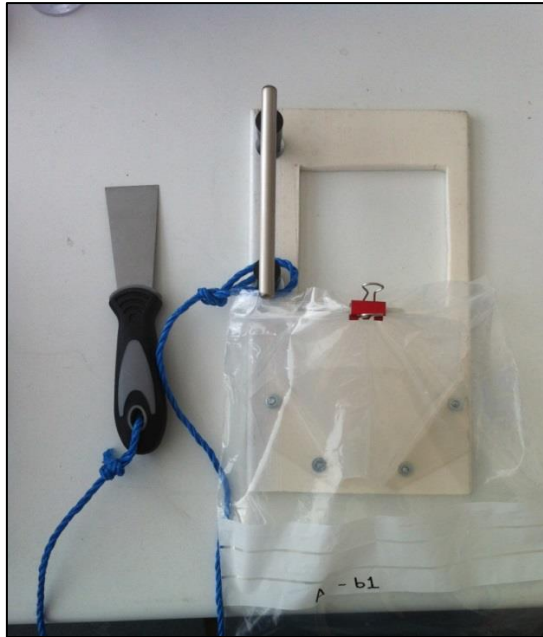
Figure 4. APEM's wall scrape sampling device

Using a 0.01 m² sampling device (Figure 4), marine growth was scraped into a bag. Samples were not sieved on board but were transferred to an appropriate container and fixed with 4% buffered formaldehyde solution in seawater. Samples were sieved on return to the laboratory over a 0.5 mm sieve.

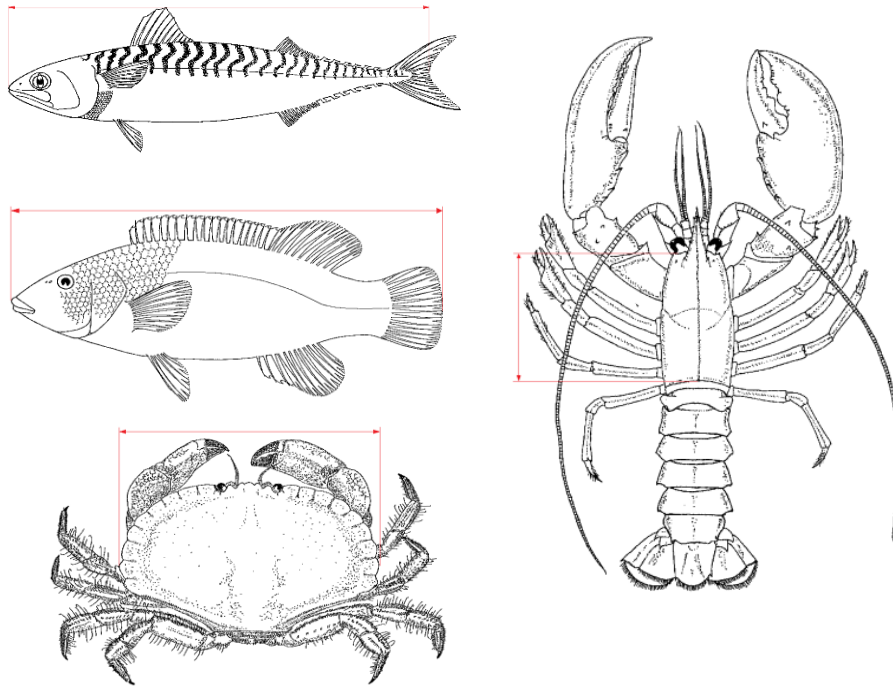
Figure 5. Schematic for points of measurement for concave tailed fish, convex tailed fish and commercially important crustacean species.

The catch of each trawl was placed into a calibrated container and the net was then checked for any remaining epibiota and fish. Sediment was rinsed away and the approximate total unsorted volume of the catch estimated. The samples were initially cleared of large debris and the total catch photographed. When there were large abundances of a particular species, subsampling was carried out for that species only. All other organisms were counted. Fish were sorted from invertebrates, divided into groups, identified to species level and counted. Fish and commercially important crustaceans were measured to the nearest millimetre using a fish board or callipers, according to the schematic below (Figure 5.).

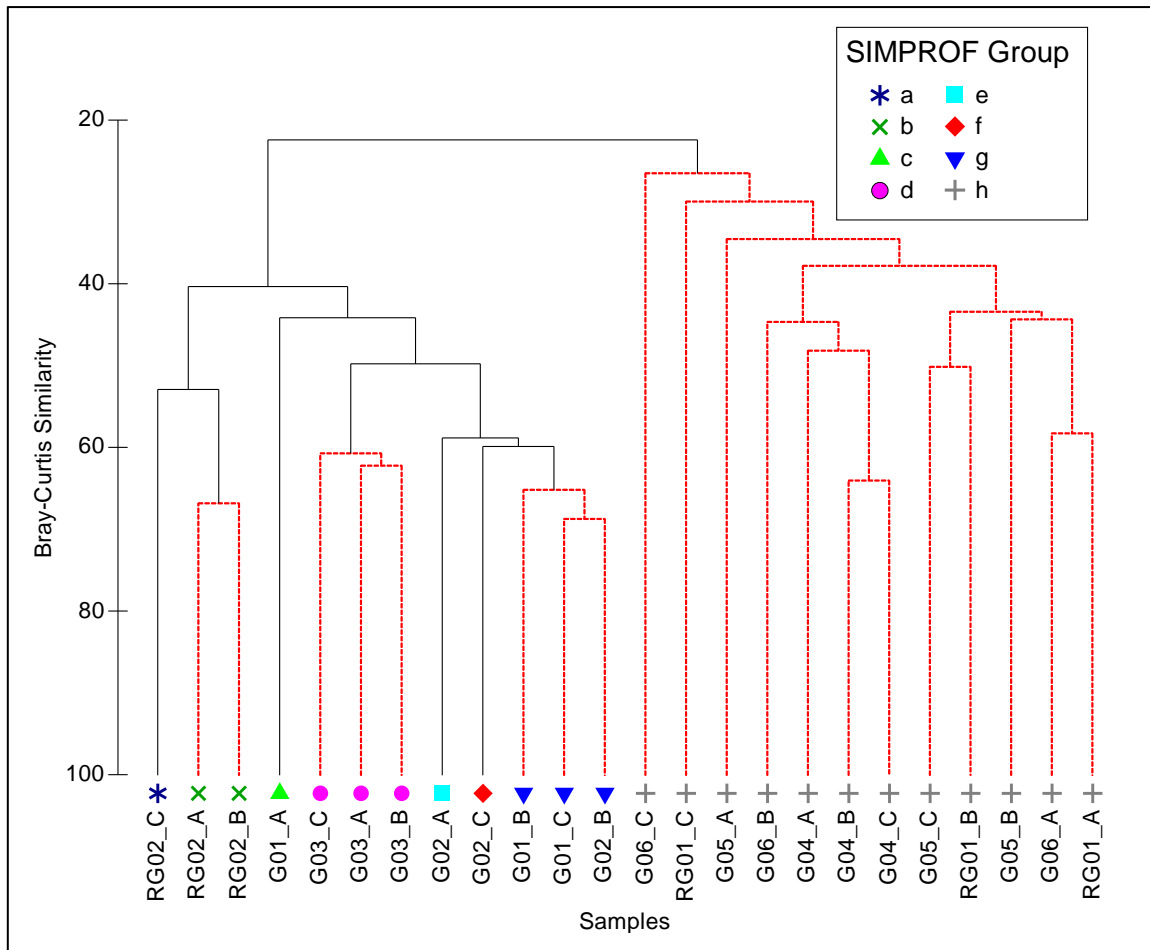
Figure 8. SIMPROF Cluster dendrogram of Bray-Curtis similarity between square-root transformed macrobenthic data for each grab sample.

Group G included three samples: G01b, G01c and G02b and separated from Group F at just under 60% similarity. The faunal assemblages in this group were dominated by oligochaetes, *Tharyx* and *L. balthica*.

The remaining twelve samples formed a single group: H, which separated from the other groups at 22% similarity. This group was characterised by moderate numbers of Nemertea, mussel spat and infaunal worms and bivalves. Group H also had generally lower diversity than the other groups, with a mean of 14 taxa per sample, compared to means of 34-75 taxa per sample in other groups.

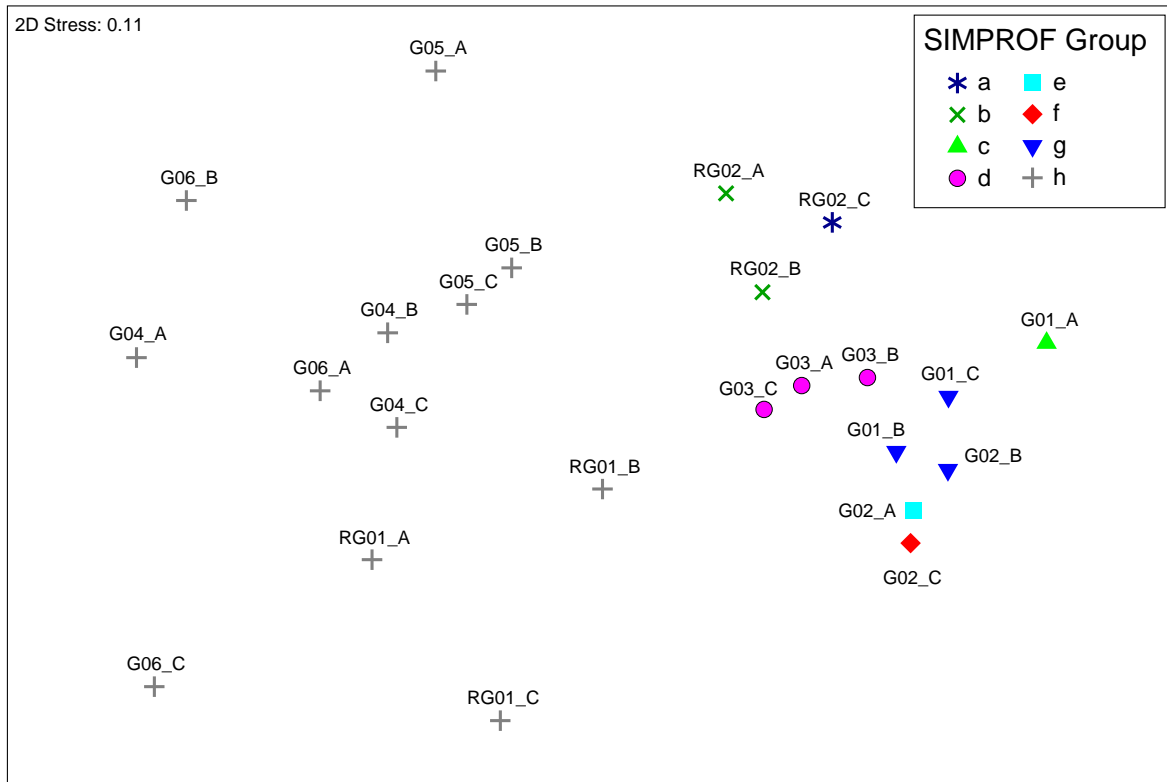
Figure 9. MDS plot of Bray-Curtis similarity between square-root transformed macrobenthic data for each grab sample

The MDS plot for the macrobenthic data is presented in Figure 9. The stress value of 0.11 is low, suggesting a good two dimensional picture of the higher dimensional relationships between samples with no real prospect of a misleading interpretation (Clarke & Warwick, 2001). The plot complements the pattern seen in the cluster dendrogram, with the samples from SIMPROF group H clearly separated from groups A-G. The samples in SIMPROF groups A-G show closer grouping of replicates from the same station, whereas those of group H show wider separation, suggesting more heterogeneity between replicates at the same station in group H.

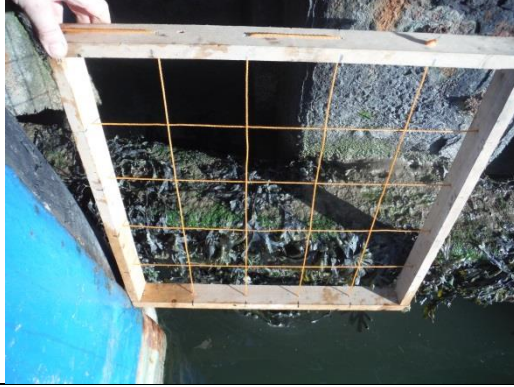
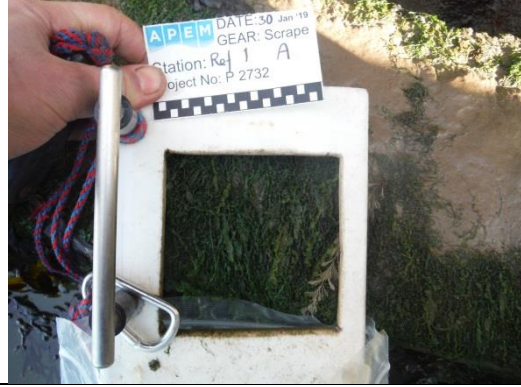
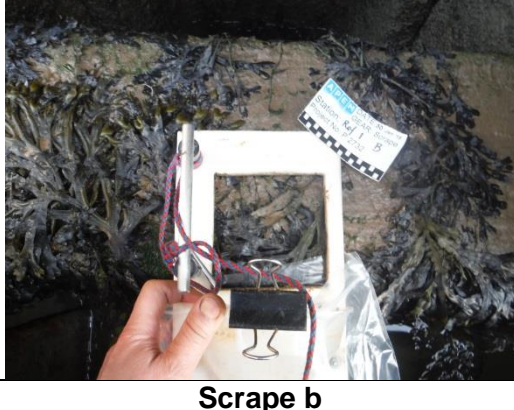
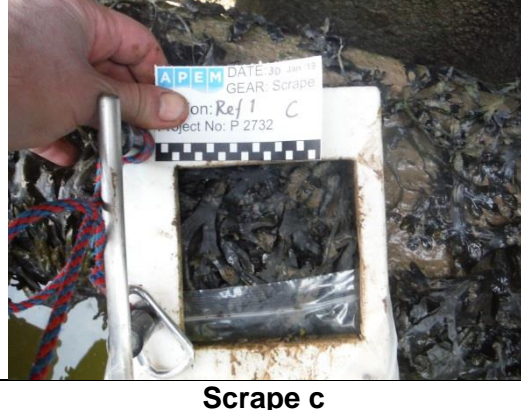
Reference station RS01 was relocated from the east bank target to the opposite bank as the frontage on the East bank has been replaced within the last 18 months (Peter Woods (Skipper of the MV Sheerkahn), pers comm.) and the western bank was considered more comparable to the scrape sites within the proposed development area.
