# **Great Yarmouth Third River Crossing**

## **Application for Development Consent Order**

### **Document 6.2: Environmental Statement Volume II: Technical Appendix 16A: Legislation, Policy and Guidance**

Document Reference: 6.2 – Technical Appendix 16A

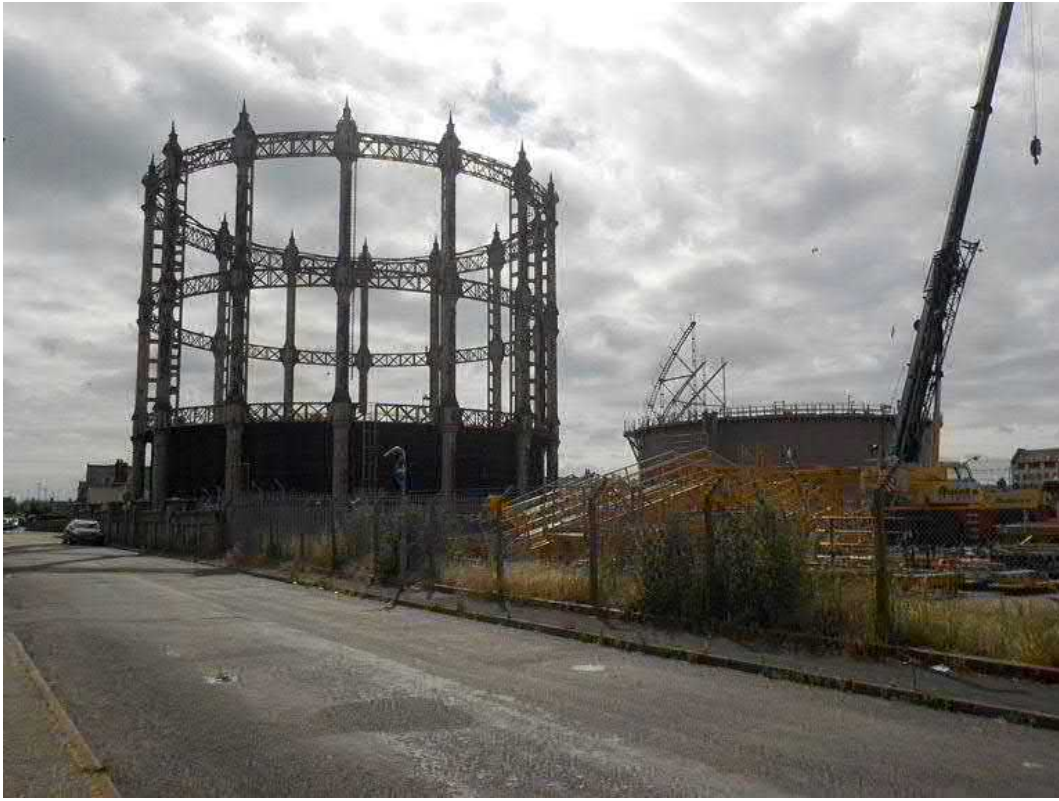
Photograph 1 – Barrack Road Gasworks

- commercial / industrial properties including oil / gas storage sites (including ASCO Ltd (Annex A, photograph 5) and Butler Fuels Ltd on the quayside,
- Barrack Road gas works (Annex A, photograph 1 and photograph 2) site adjacent to the eastern boundary),
- an operating port facility with associated hard standing and warehouses / depots (Annex A, photograph 9),
- residential properties (predominantly in the northern part of the area),
- a petrol filling station,
- car dealership.

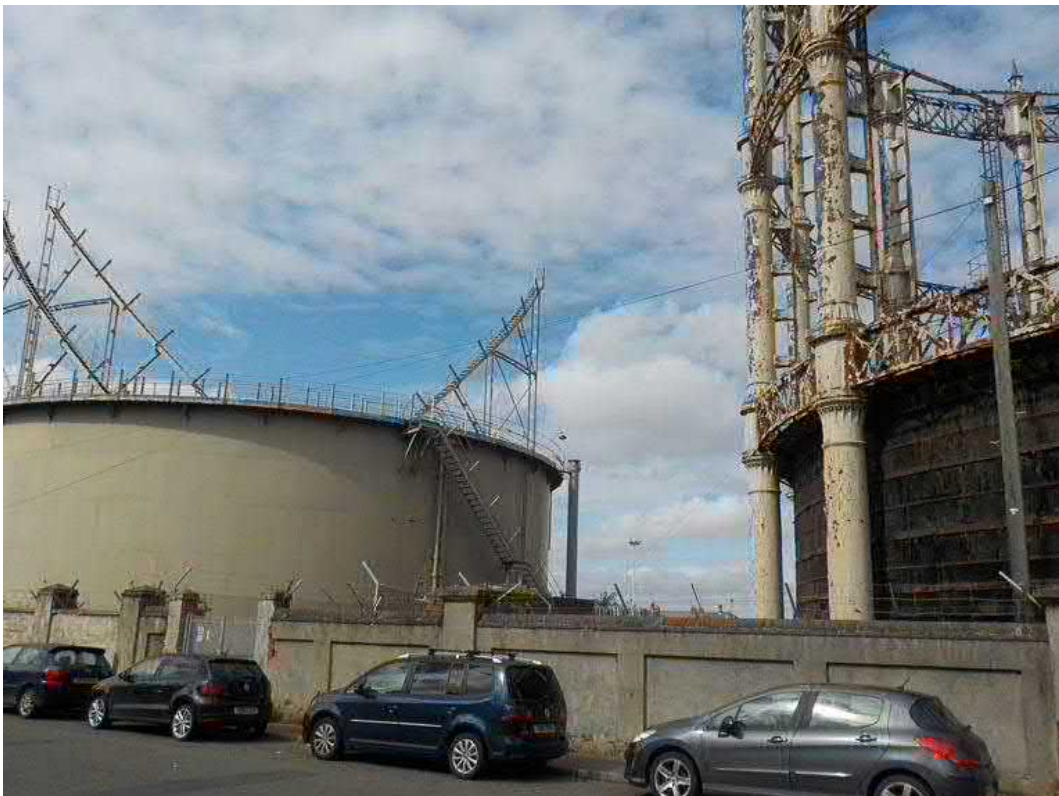
Photograph 2 – Barrack Road Gasworks

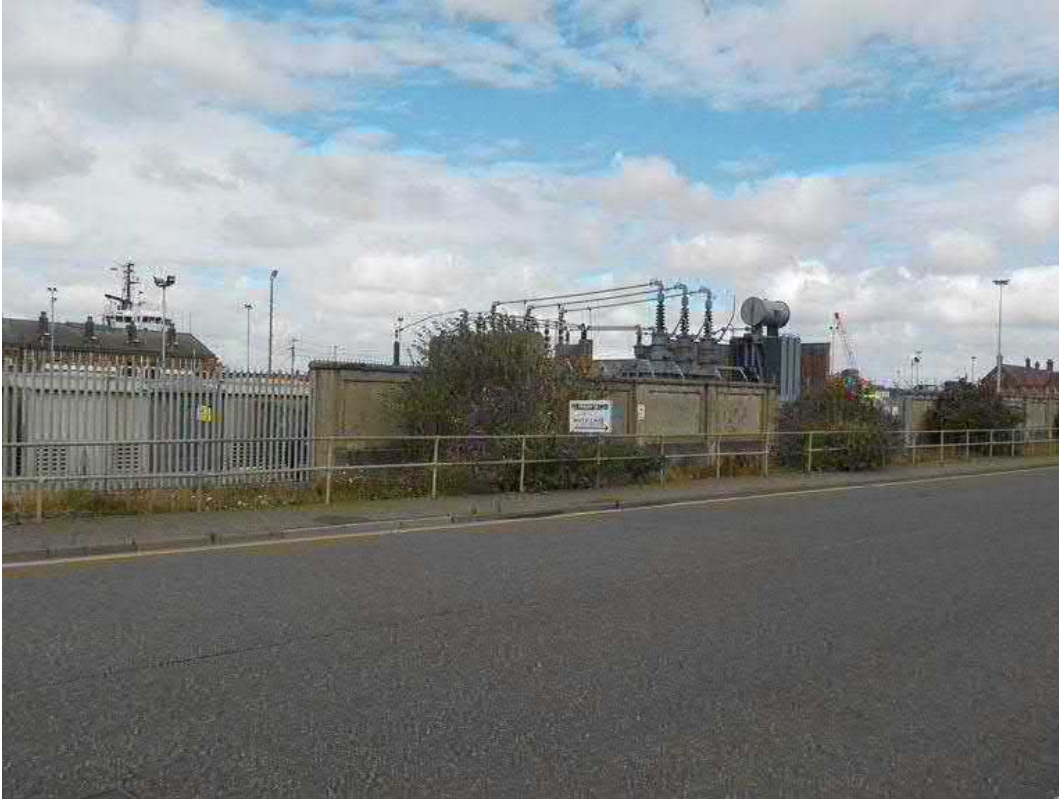
Photograph 3 – Electricity Substation on Southgates Road

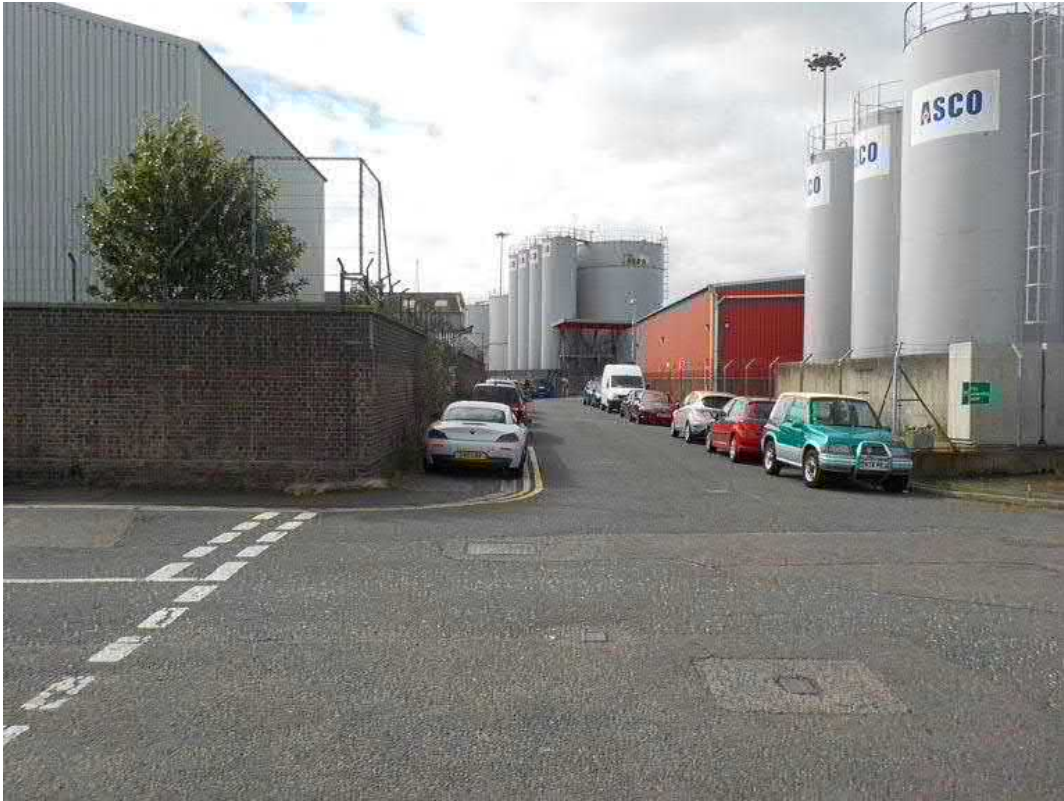
Photograph 5 – ASCO Ltd storage tanks

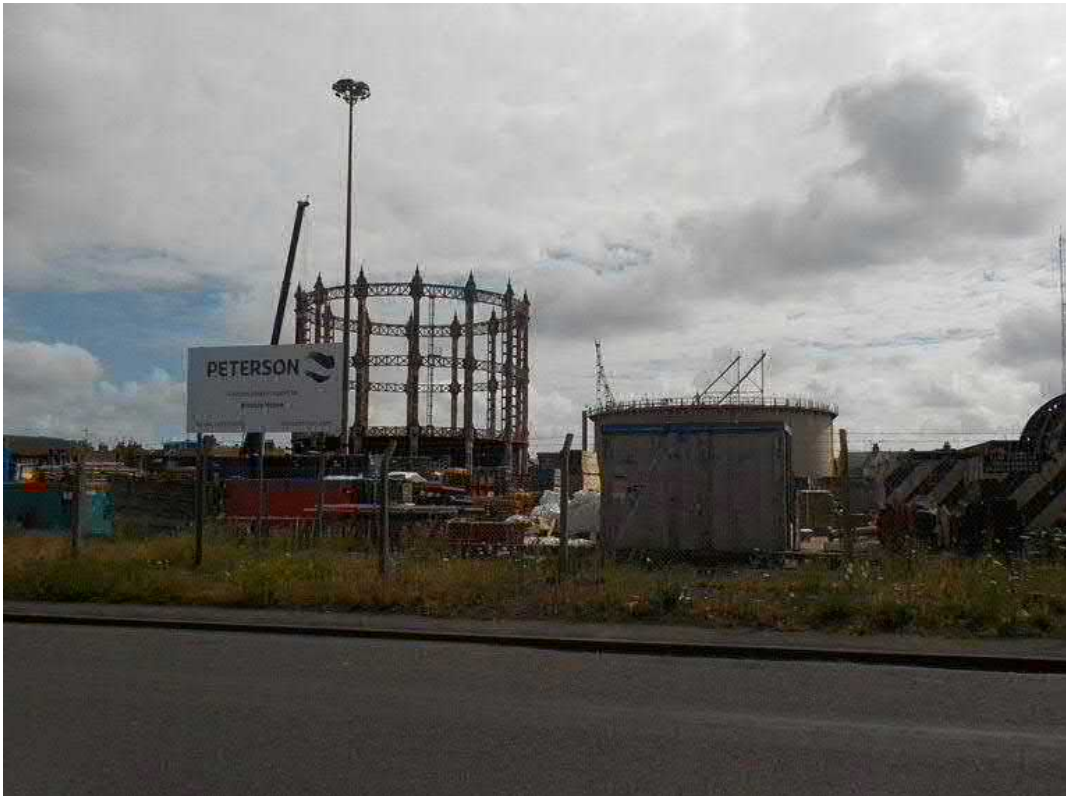
Photograph 10 – Peterson Ltd storage yard off South Denes Road with gasholder beyond.

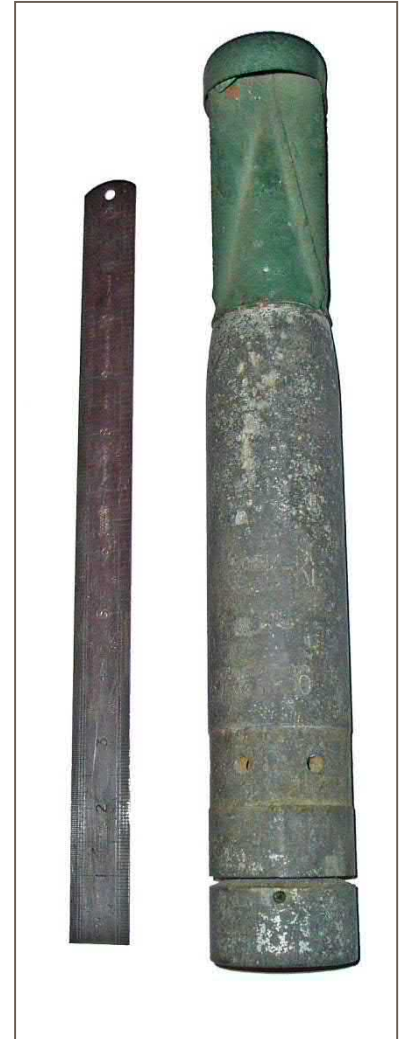
1kg German Incendiary Bomb next to a 30cm ruler

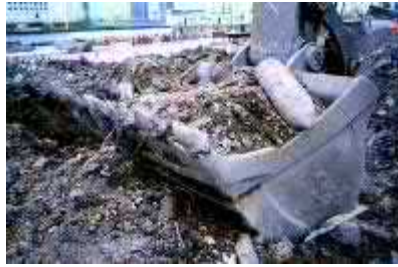
50kg bomb, London Docklands

**SC 50**

**Bomb Weight:** 40-54kg (110-119lb)  
**Explosive Weight:** c25kg (55lb)  
**Fuze Type:** Impact fuze/electro-mechanical time delay fuze  
**Bomb Dimensions:** 1,090 x 280mm (42.9 x 11.0in)  
**Body Diameter:** 200mm (7.87in)  
**Use:** Against lightly damageable materials, hangars, railway rolling stock, ammunition depots, light bridges and buildings up to three stories.  
**Remarks:** The smallest and most common conventional German bomb. Nearly 70% of bombs dropped on the UK were 50kg.

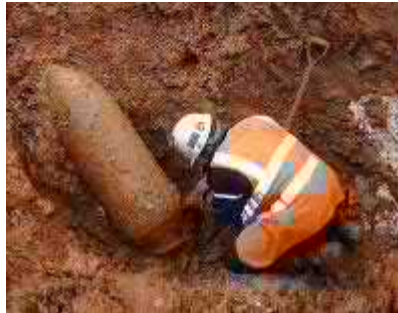
250kg bomb, Hawkinge

**SC 250**

**Bomb weight:** 245-256kg (540-564lb)  
**Explosive weight:** 125-130kg (276-287lb)  
**Fuze type:** Electrical impact/mechanical time delay fuze.  
**Bomb dimensions:** 1640 x 512mm (64.57 x 20.16in)  
**Body diameter:** 368mm (14.5in)  
**Use:** Against railway installations, embankments, flyovers, underpasses, large buildings and below-ground installations.

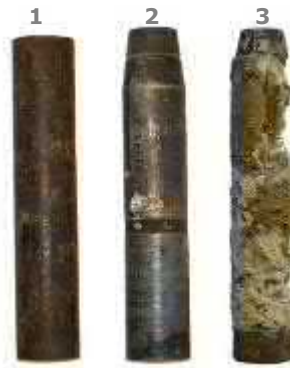
**1kg Incendiary Bomb**

**Bomb weight:** 1.0 and 1.3kg (2.2 and 2.87lb)  
**Filling:** 680gm (1.3lb) Thermite  
**Fuze type:** Impact fuze  
**Bomb dimensions:** 350 x 50mm (13.8 x 1.97in)  
**Body diameter:** 50mm (1.97in)  
**Use:** As incendiary – dropped in clusters against towns and industrial complexes  
**Remarks:** Jettisoned from air-dropped containers. Magnesium alloy case. Sometimes fitted with high explosive charge

1. Scaffold pipe
2. Incendiary 1kg bomb
3. Incendiary bomb recently found on site in UK

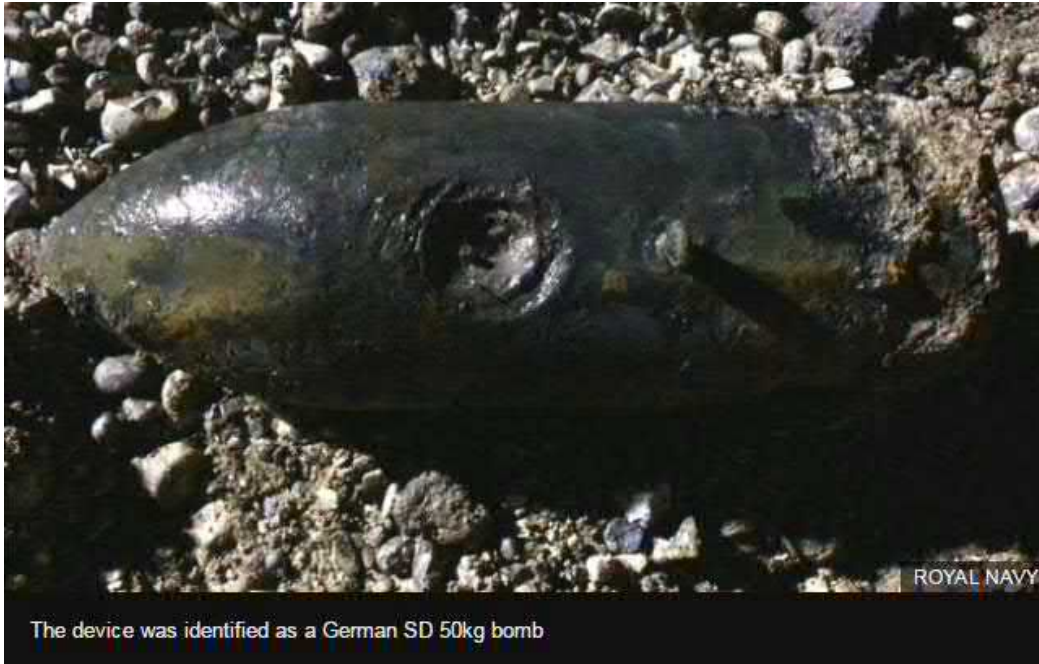
The device was identified as a German SD 50kg bomb

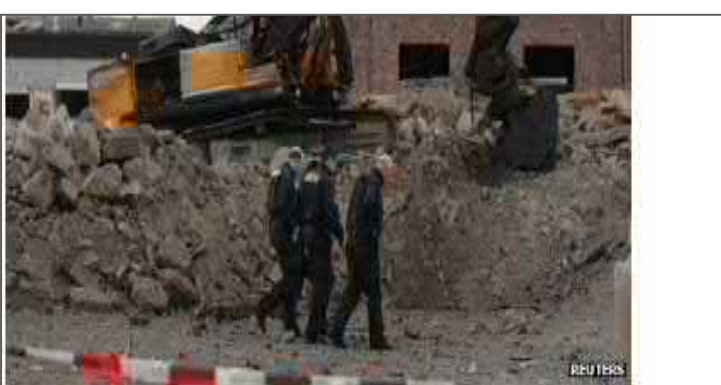
The bomb went off as the machine lifted up earth and debris

A World War Two bomb has exploded at a construction site near a west German town, killing a man and injuring eight others, police say.

The machine's operator died on the spot. Two of those hurt were critically wounded, the dpa news agency reports.

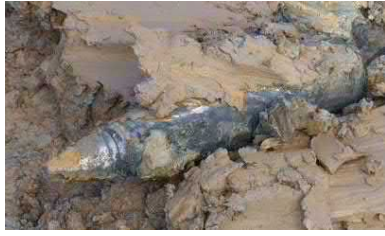
This AA shell was uncovered on a construction site in North London in February 2009.

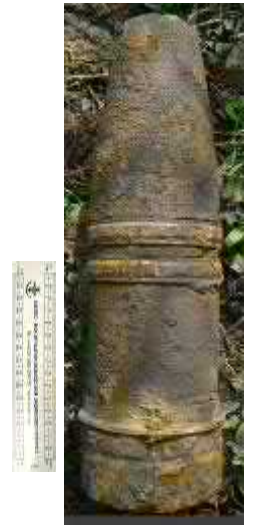
3.7 inch AA Projectile Minus Fuze

### 3.7 inch Anti-Aircraft Projectile

Weight: 12.7kg (28lb)  
 Dimensions: 94 x 360mm (3.7 x 14.7in)  
 Carriage: Mobile and Static Versions  
 Rate of Fire: 10-20 rounds per minute  
 Ceiling: 9-18,000m (29-59,000ft)  
 Muzzle Velocity: 792m/s (2,598ft/s)  
 Remarks: 4.5 inch projectiles were also commonly utilised

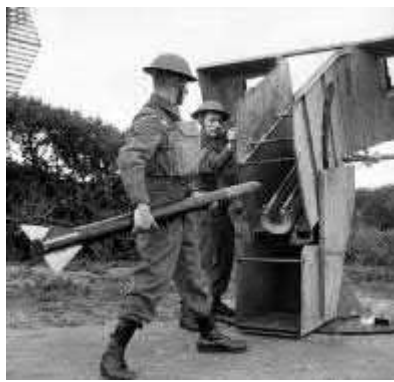
Home Guard soldiers load an anti-aircraft rocket at a 'Z' Battery

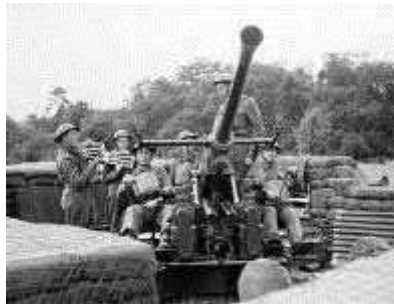
40mm Bofors gun and crew at Stanmore in Middlesex, 28 June 1940.

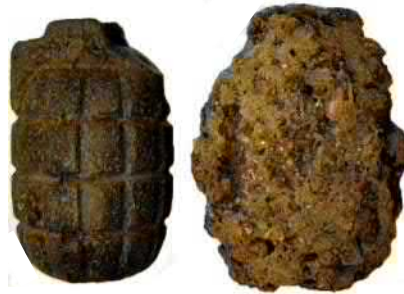
Grenade, .303 inch rifle, No. 36M, Mark I.

**No. 36 'Mills' Grenade**

Weight: 0.7kg filled (1lb 6oz)  
 Type: Hand or discharger, fragmentation  
 Dimensions: 95 x 61mm (3.7 x 2.4in)  
 Filling: Alumatol, Amatol 2 or TNT  
 Remarks: 4 second hand-throwing fuse with approximate 30m range. First introduced May 1918.

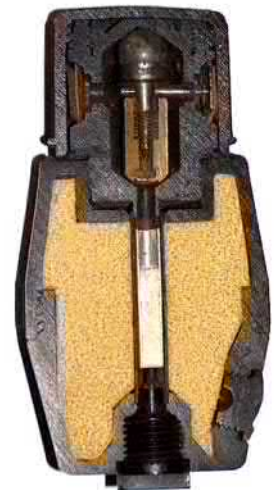
**No. 69 Grenade**

Weight: 0.38kg filled (0.8lb)  
 Type: Percussion/Blast  
 Date Introduced: December 1940  
 Remarks: Black Bakelite body. Blast rather than fragmentation type. After unscrewing the safety cap, a tape is held when throwing the grenade releasing the safety bolt in the throwing motion. Detection is problematic due to its very low metal content.

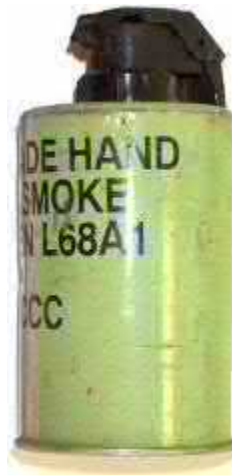
**Typical Smoke Grenade**

Dimensions: Approx. 65 x 115mm (2.5 x 4.5in)  
 Type: Smoke  
 Date Introduced: Current MoD issue  
 Remarks: Smoke grenades are used as ground-to-ground or ground-to-air signalling devices, target or landing zone marking devices, and screening devices for unit movement.

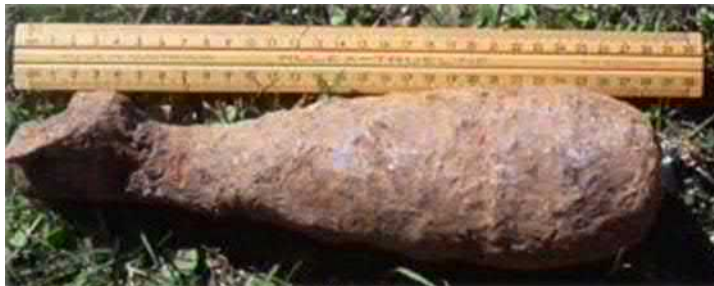
### Typical 3 inch Smoke Mortar

- Type: Smoke
- Dimensions: c490 x 76mm (19.3in x 3in)
- Filling: Typically white phosphorous
- Maximum Range: 2515m (2,750yds)
- Remarks: On impact, the fuze functions and initiates the bursting charge. The bursting charge ruptures the mortar bomb body and disperses the white phosphorous filler. The white phosphorous produces smoke upon exposure to the air.

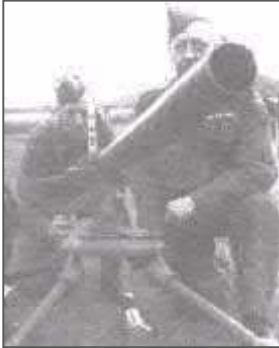
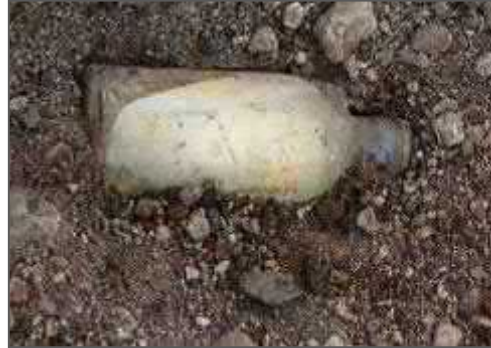
### Self Igniting Phosphorous (SIP) Grenades

**Filling:** White Phosphorous and Benzene  
**Remarks:** The grenade comprised a glass bottle with a total volume of approximately one pint. It was filled with White Phosphorus, benzene, a piece of rubber and water. Over time the rubber dissolved to create a sticky fluid which would self ignite when the bottle broke. Fired by hand or Northover Projector. Sometimes called the "A & W" (Albright & Wilson) grenade.

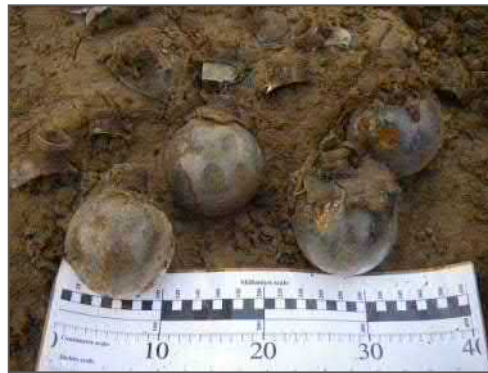
### No 74 Grenade (Sticky Bomb)

**Remarks:** Designed as an anti-tank grenade and used by the Home Guard. The grenade consisted of a glass ball on the end of a Bakelite (plastic) handle. Inside the glass ball was an explosive filling whilst on the outside was a very sticky adhesive covering. Until used, this adhesive covering was encased in a metal outer casing.

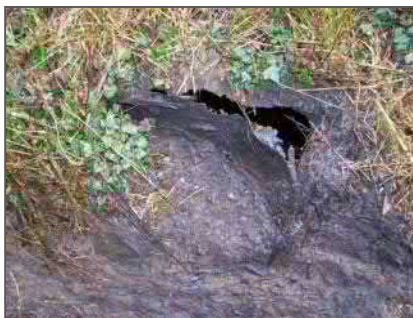
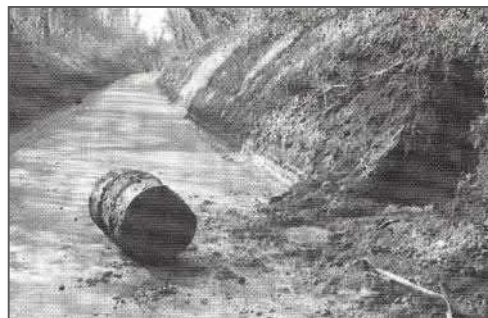
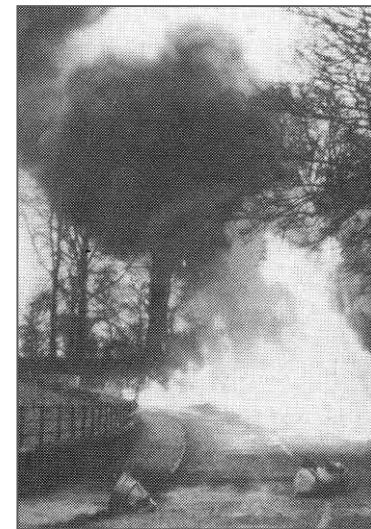
### Flame Fougasse Bomb

**Remarks:** A Flame Fougasse was a weapon in which the projectile was a flammable liquid, typically a mixture of petrol and oil. It was usually constructed from a 40-gallon drum dug into the roadside and camouflaged. Ammonal provided the propellant charge which, when triggered, caused the weapon to shoot a flame 3m (10ft) wide and 27m (30 yards) long. Initially a mixture of 40% petrol and 60% gas oil was used, this was later replaced by an adhesive gel of tar, lime and petrol known as 5B.

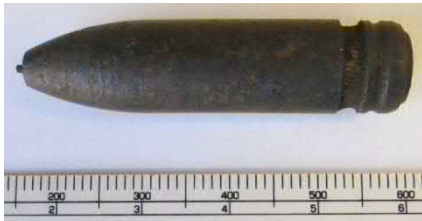
### 20mm Hispano HEI Ammunition

Type: Live canon round  
 Markings: Upper half of projectile painted 'buff' colour, lower half is red.  
 Cartridge Weight: 256 grams  
 Dimensions: Total cartridge / projectile length - 182mm  
 Fuzed: Contact fuze – No.253, No.254 or No.917  
 Filling: 108 grains of contact explosive + 68 grains of SR.379 incendiary composition.  
 Threat: Explosives within unspent cartridge as well as the projectile.  
 Deployment: Royal Navy, RAF and British Army Light Anti-Aircraft guns. Also RAF aircraft canons.  
 Remarks: Cartridges are belted or supplied lose in cartons.

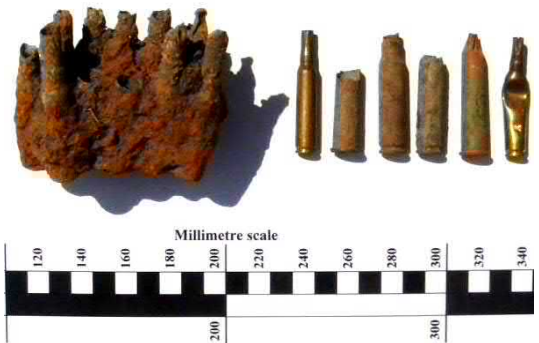
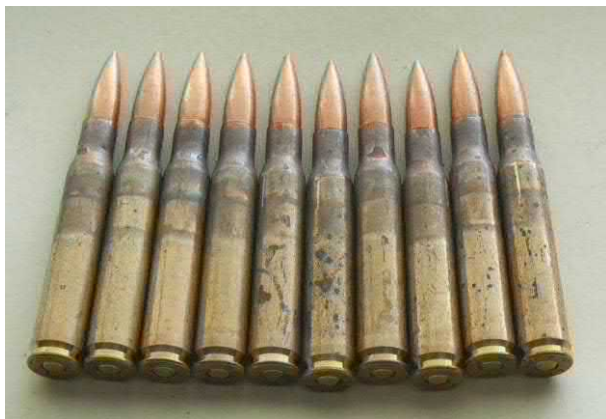
### .303" Ammunition

Type: Rifle / machine gun round  
 Markings: Regular round - none. Tracer round – red Primer  
 Bullet Weight: 150 - 180 grams  
 Dimensions: Total cartridge /projectile length - 78mm  
 Filling: Regular round – none. Tracer round - small incendiary fill  
 Threat: Explosive cordite within unspent cartridge  
 Deployment: Royal Navy, RAF and British Army Light Anti-Aircraft guns, machine guns and rifles. Standard British and Commonwealth military cartridge from 1889 until the 1950s.  
 Remarks: Cartridges are belted or supplied lose in cartons.

TYPES OF SMALL ARMS AMMUNITION  
 Fig. 1. Four types of ammunition used by modern infantry. 1 and 2 are ball cartridges, 3 is an armour-piercing bullet, and 4 a tracer bullet which burns and makes its flight visible.

TYPES OF SMALL ARMS AMMUNITION  
 Fig. 1. Four types of ammunition used by modern infantry. 1 and 2 are ball cartridges, 3 is an armour-piercing bullet, and 4 a tracer bullet which burns and makes its flight visible.

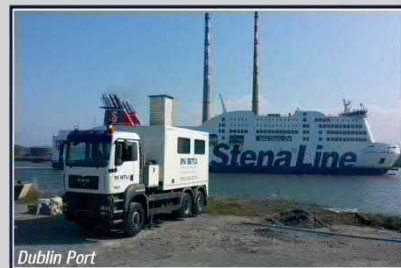
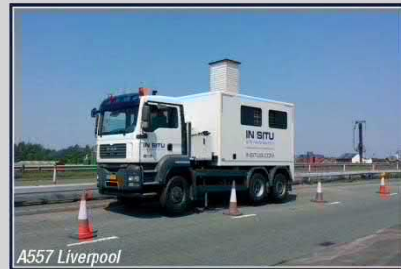
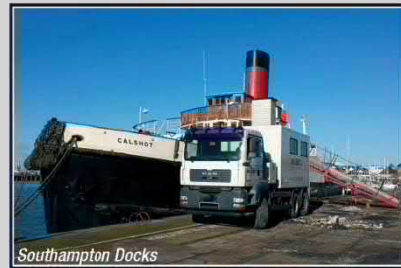
#### CPT RIG DETAILS

This rig is ideal for geotechnical testing on hardstanding sites such as car parks, motorways and docks. Fitted with reflective yellow and red chevrons, these high visibility rear markings meet the 'Chapter 8' requirements for vehicles working on highways. In addition, there are beacons fitted to the front and strobes to the back corners to ensure further safety and visibility for night work on the motorways. This efficient truck is capable of pushing to a depth of 30 to 40 metres depending on the ground conditions of the site. Furthermore, the interior is large enough to house our MiHpt equipment for environmental testing.

<b>DRIVE SYSTEM</b>	6 X 2 WHEELED DRIVE
<b>TOTAL WEIGHT</b>	21 TONNES
<b>GROUND BEARING PRESSURE</b>	75KPA
<b>CPT RAM THRUST CAPACITY</b>	20 TONNES
<b>MAXIMUM PENETRATION</b>	30-40M DEPENDING ON THE GROUND CONDITIONS.
<b>PERFORMANCE RATES</b>	100-150M CF TESTING A DAY, DEPENDING ON ACCESS TO POSITIONS.
<b>TYPICAL SITES FOR THIS RIG</b>	HARDSTANDING SITES E.G. ROADS INCLUDING MOTORWAYS, CAR PARKS, DOCKS. DRY NON HARDSTANDING SITES.

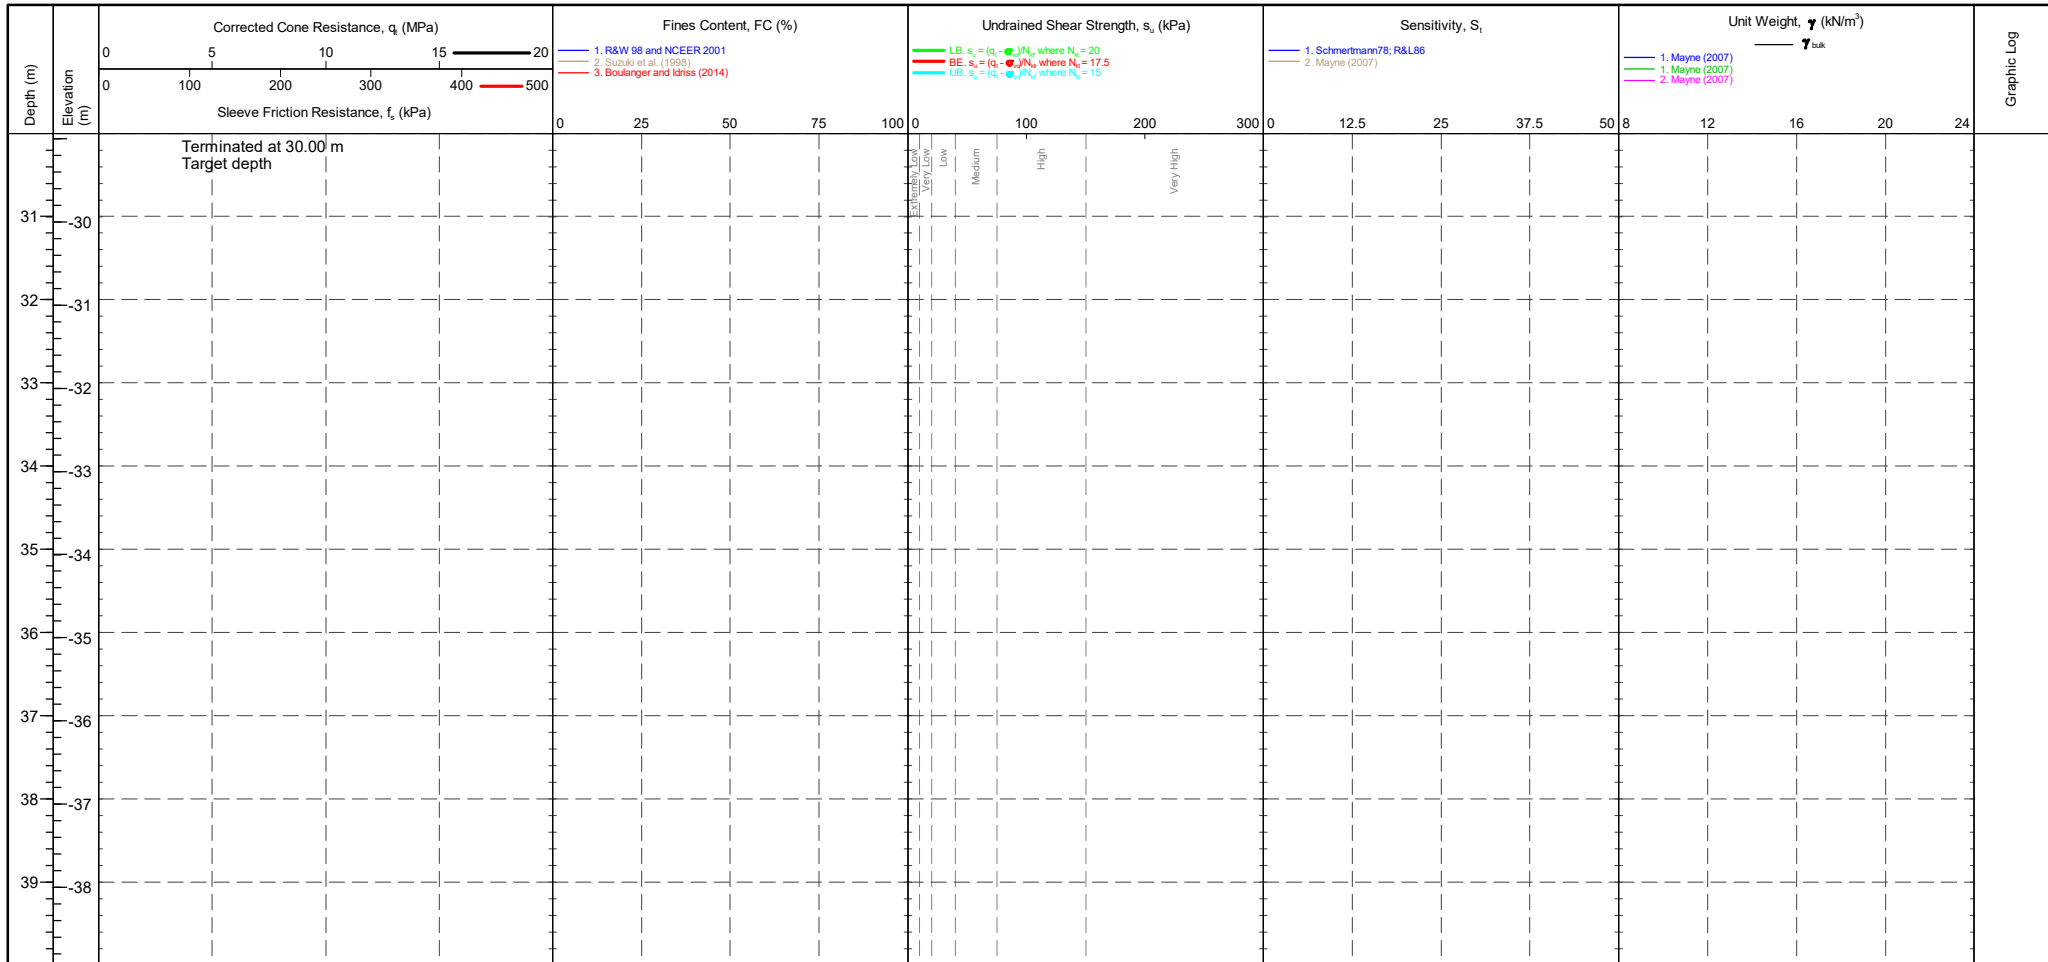
PointID  
**CPT 01**

<b>CLIENT</b> : Norfolk Partnership Laboratory <b>PROJECT</b> : Great Yarmouth 3rd River Crossing <b>LOCATION</b> : Great Yarmouth <b>PROJECT No.</b> : 1180180	<b>EASTING</b> : 652228.0 m <b>NORTHING</b> : 305894.9 m <b>ELEVATION</b> : 1.06 m <b>CHECKED BY</b> : LD <b>TERMINATION REASON</b> : Target depth	<b>Remark</b> : 0 Test completed at target depth.	<b>SHEET</b> : 4 OF 4 <b>STATUS</b> : Final <b>TEST DATE</b> : 20/03/2018 <b>PLOT DATE</b> : 19/04/2018 <b>METHOD</b> : ISO 22476-1 Application class 3
--	--	--	---

<b>CONE ID</b> : P15-CFPTxy.70080 <b>CONE AREA</b> : 15cm <sup>2</sup> <b>CONE AREA RATIO</b> : 0.85 <b>FILTER POSITION</b> : u2 <b>FILTER TYPE</b> : HDPE <b>FRICION REDUCER</b> : None	<b>TEST TYPE</b> : TE2 <b>APPLICATION CLASS</b> : 2 <b>RIG</b> : CPT010 Waller; Truck-based 20 Ton; No anchoring <b>OPERATOR</b> : DH & AE <b>FILE NAME</b> : 1180180-CPT 01 <b>WEATHER</b> : Overcast & Cold	<b>CPTU ZERO VALUES</b> Transducer Pre Post Difference Tip Sleeve Pore Pressure 2 X-Y Inclinometer	Groundwater Level Dissipation Test
---	---	---	---------------------------------------

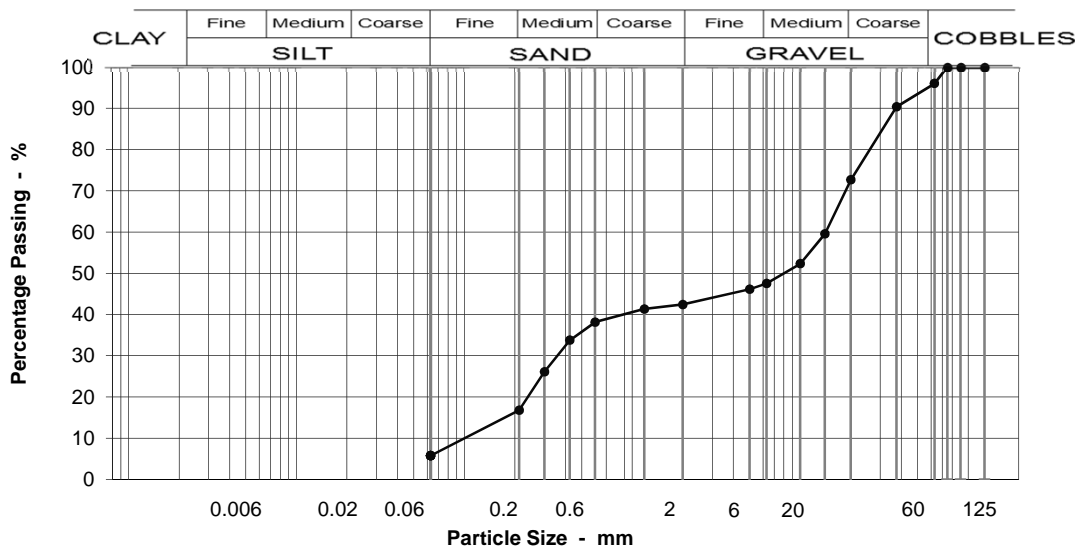
Bulk disturbed sample

Sieving		Specification for Highway Works Classification Table 6/2	Sample Proportions	
Particle Size mm	% Passing			
125	100		BOULDERS	0
90	100		COBBLES	4
75	100		Coarse GRAVEL	23
63	96		Medium GRAVEL	25
37.5	90		Fine GRAVEL	5
20	73		Coarse SAND	4
14	60		Medium SAND	21
10	52		Fine SAND	11
6.3	48		Silt & Clay	6
5	46			
2	42			
1.18	41			
0.600	38			
0.425	34			
0.300	26			
0.212	17			
0.063	6			
Moisture content %		9.6

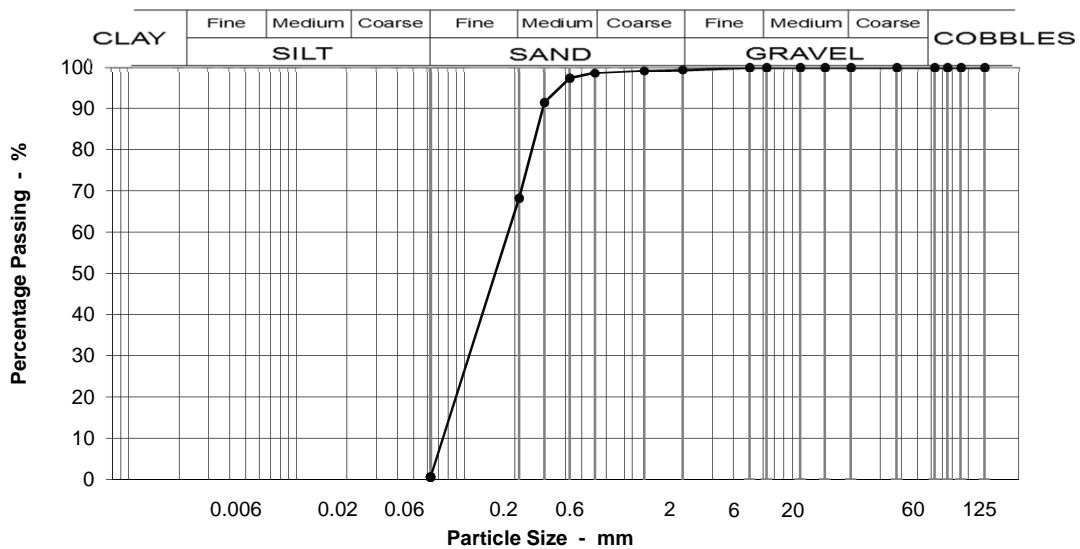
Bulk disturbed sample

Sieving		Specification for Highway Works Classification Table 6/2	Sample Proportions	
Particle Size mm	% Passing			
125	100	<b>This material complies with the following material classes 1B, 6E/6R, 6M.</b>	BOULDERS	0
90	100		COBBLES	0
75	100		Coarse GRAVEL	0
63	100		Medium GRAVEL	0
37.5	100		Fine GRAVEL	1
20	100		Coarse SAND	1
14	100		Medium SAND	30
10	100		Fine SAND	68
6.3	100		Silt & Clay	1
5	100		<b>Grading Analysis</b>	
2	99		D100	2
1.18	99		D60	0.19
0.600	99		D10	0.08
0.425	97		Uniformity Coefficient	2
0.300	91		<b>Description</b>	
0.212	68	Brown fine SAND.		
0.063	1

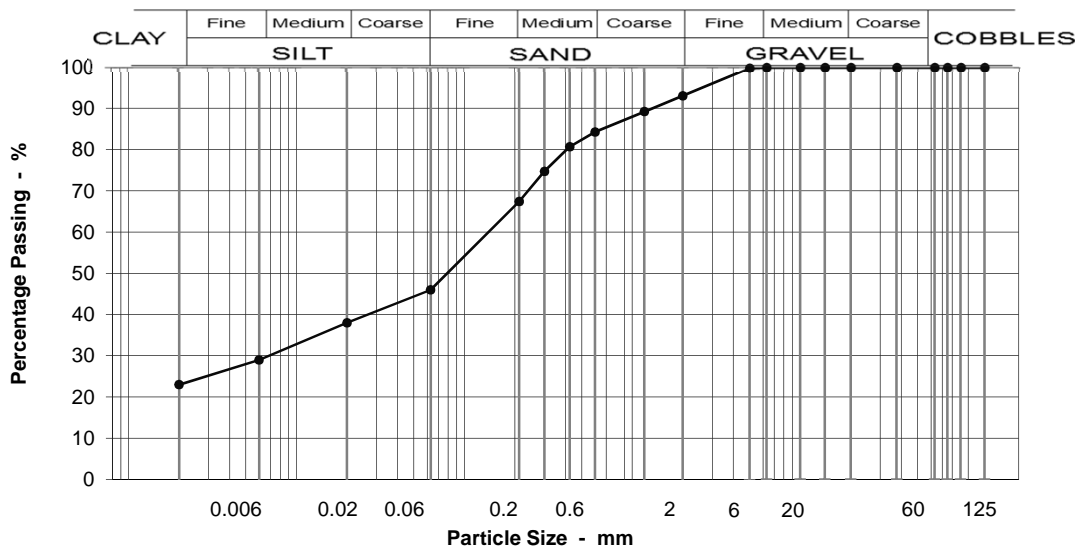
Bulk disturbed sample

Sieving		Specification for Highway Works Classification Table 6/2	Sample Proportions	
Particle Size mm	% Passing			
125	100		BOULDERS	0
90	100		COBBLES	0
75	100		Coarse GRAVEL	0
63	100		Medium GRAVEL	0
37.5	100		Fine GRAVEL	7
20	100		Coarse SAND	9
14	100		Medium SAND	17
10	100		Fine SAND	21
6.3	100		Silt & Clay	46
5	100			
2	93			
1.18	89			
0.600	84			
0.425	81			
0.300	75			
0.212	67			
0.063	46			
0.020	38			
0.006	29			
0.002	23			
		Moisture content %		95

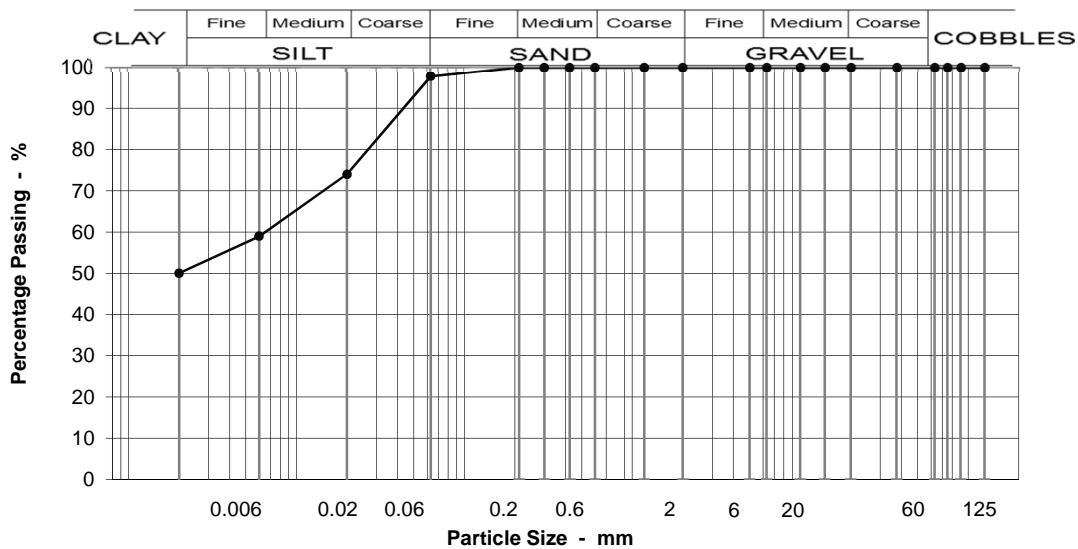
Disturbed sample

Sieving		Specification for Highway Works Classification Table 6/2	Sample Proportions	
Particle Size mm	% Passing			
125	100		BOULDERS	0
90	100		COBBLES	0
75	100		Coarse GRAVEL	0
63	100		Medium GRAVEL	0
37.5	100		Fine GRAVEL	0
20	100		Coarse SAND	0
14	100		Medium SAND	0
10	100		Fine SAND	2
6.3	100		Silt & Clay	98
5	100			
2	100			
1.18	100			
0.600	100			
0.425	100			
0.300	100			
0.212	100			
0.063	98			
0.020	74			
0.006	59			
0.002	50			
		Moisture content %		0

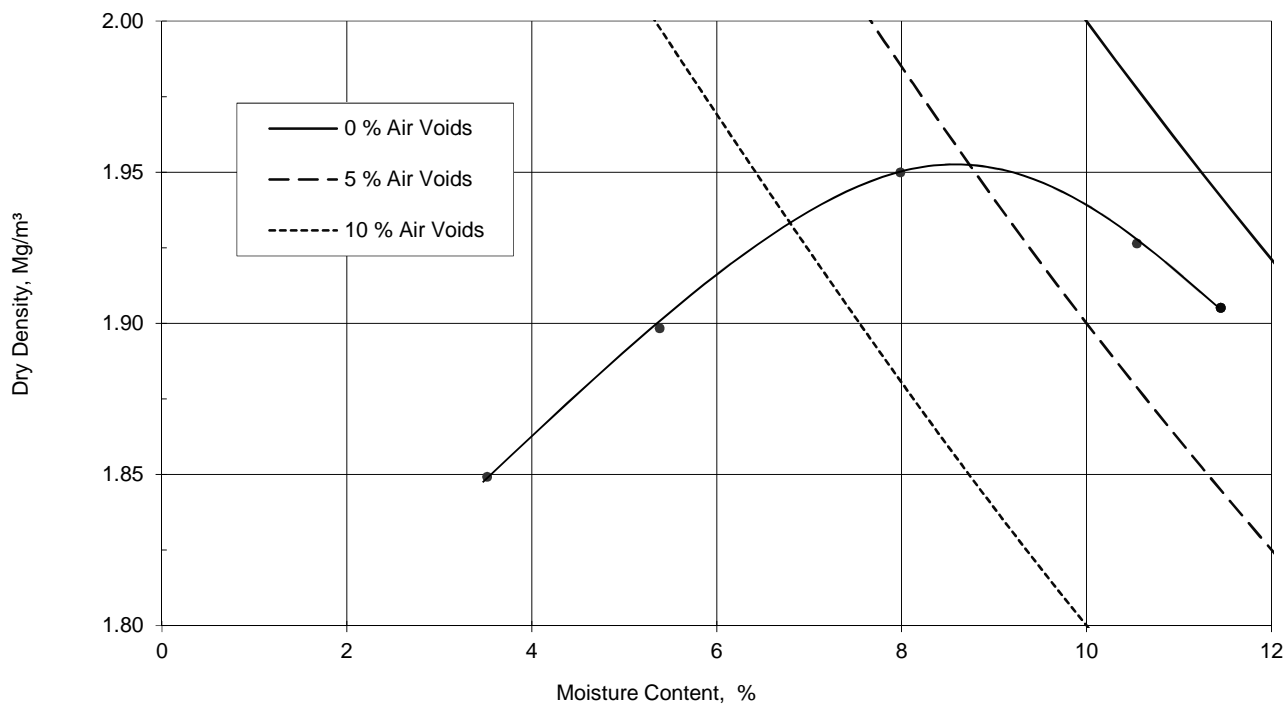
<b>Method of division</b>	Quartering	<b>Retained on 37.5 mm Sieve</b>	%	3.5
<b>Preparation</b>	Natural	<b>Retained on 20.0 mm Sieve</b>	%	14.5
<b>Test Method</b>	3.4 2.5kg	<b>Particle Density</b>	Assumed	Mg/m³ 2.50
<b>Mould Type</b>	CBR	<b>Maximum Dry Density</b>	Mg/m³	1.95
<b>Samples Used</b>	Seperate	<b>Optimum Moisture Content</b>	%	8.5

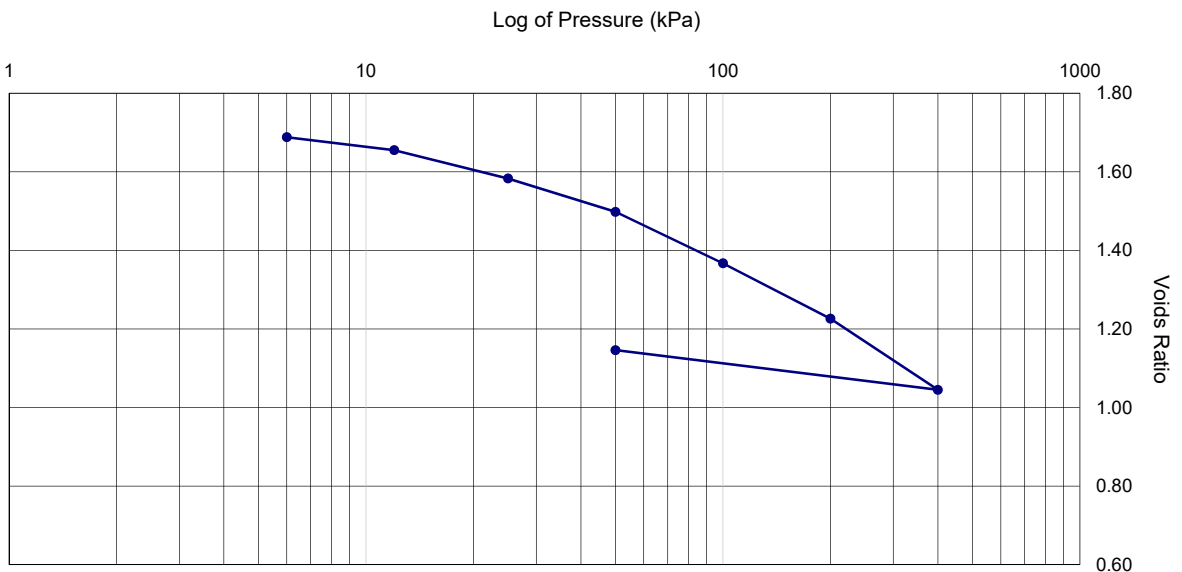
Pressure Range kPa	Time Fitting Method	Mv (m2/MN)	Voids Ratio	Cv M2/year
0 - 6	t90	4.0	1.688	0.20
6 - 12	t90	2.1	1.655	0.18
12 - 25	t90	2.1	1.583	0.22
25 - 50	t90	1.3	1.498	0.27
50 - 100	t90	1.1	1.367	0.27
100 - 200	t90	0.59	1.226	0.28
200 - 400	t90	0.41	1.045	0.26
400 - 50	t90	0.14	1.146

<b>Remarks</b> Swelling pressure determined in accordance with BS 1377 Part 5 Clause 4.1a Determination of swelling pressure not covered by UKAS accreditation.	Approved	Date	Sheet No.:
	MW	31/03/2018	1 of 1

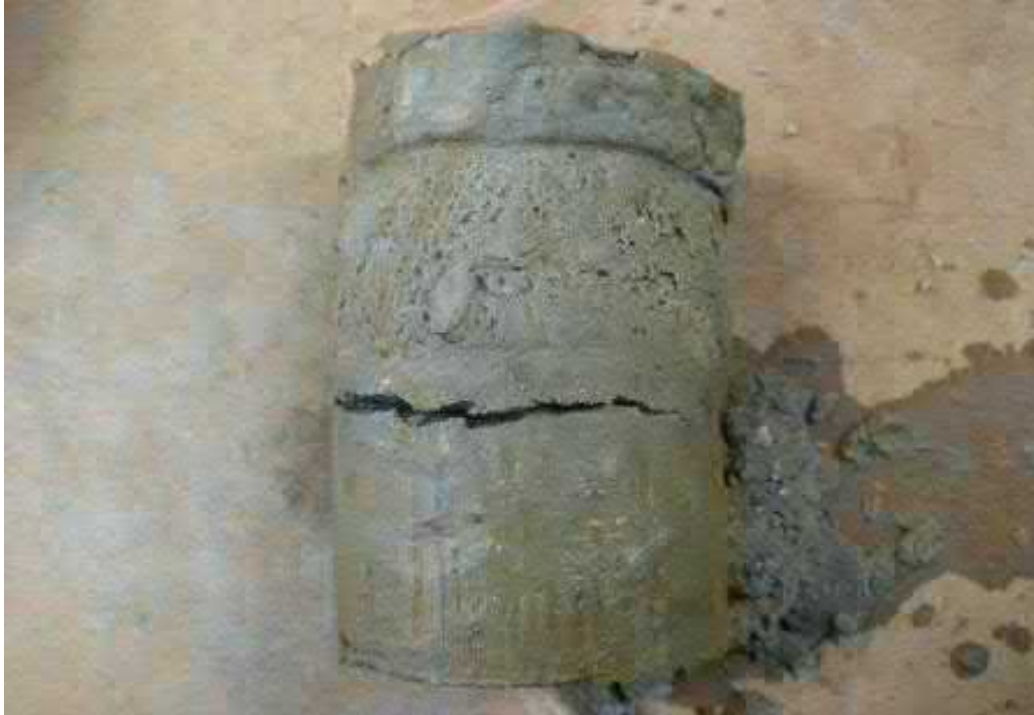
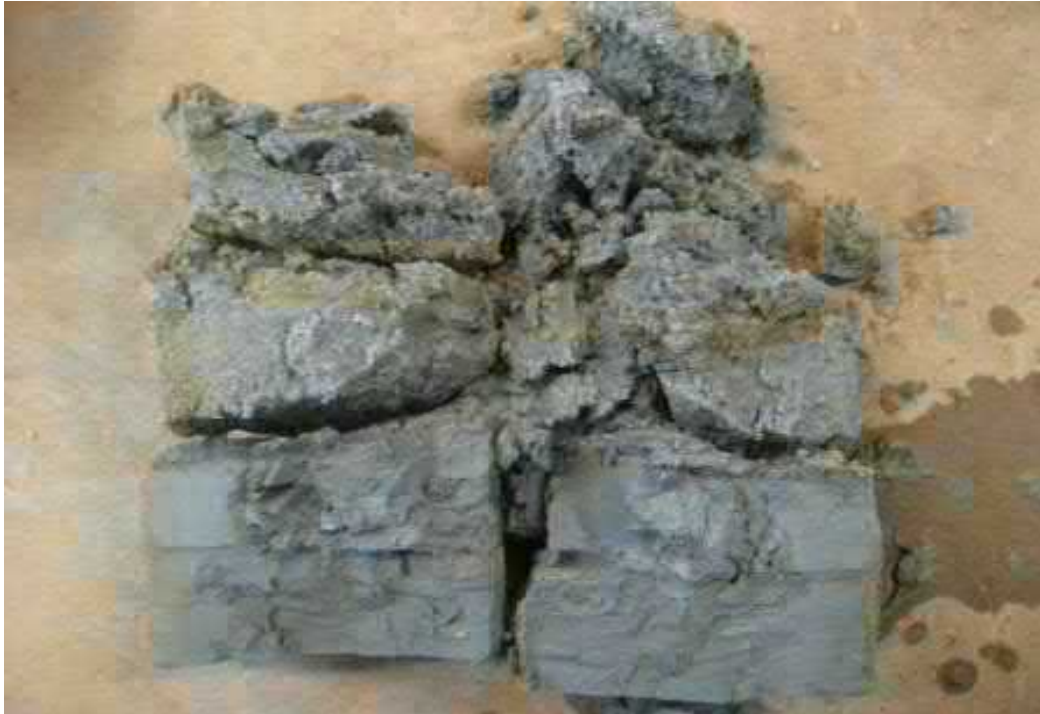
Depth (m) 31.00-31.60

Please note that these photographs are intended to show the failure mode, and do not necessarily show accurately the colouration of the soil.

Sample Condition		Undisturbed		
Height	mm	161.2		
Diameter	mm	102.3		
Moisture Content	%	24		
Bulk Density	Mg/m <sup>3</sup>	2.05		
Dry Density	Mg/m <sup>3</sup>	1.65

Membrane Thickness	mm	0.30		
Membrane Correction	kPa	1.11		
Rate of Axial Displacement	%/min	0.94		
Cell Pressure	kPa	900		
Strain at Failure	%	19.9		
Maximum Deviator Stress	kPa	237		
Shear Strength	kPa	118		
Mode of Failure			Compound

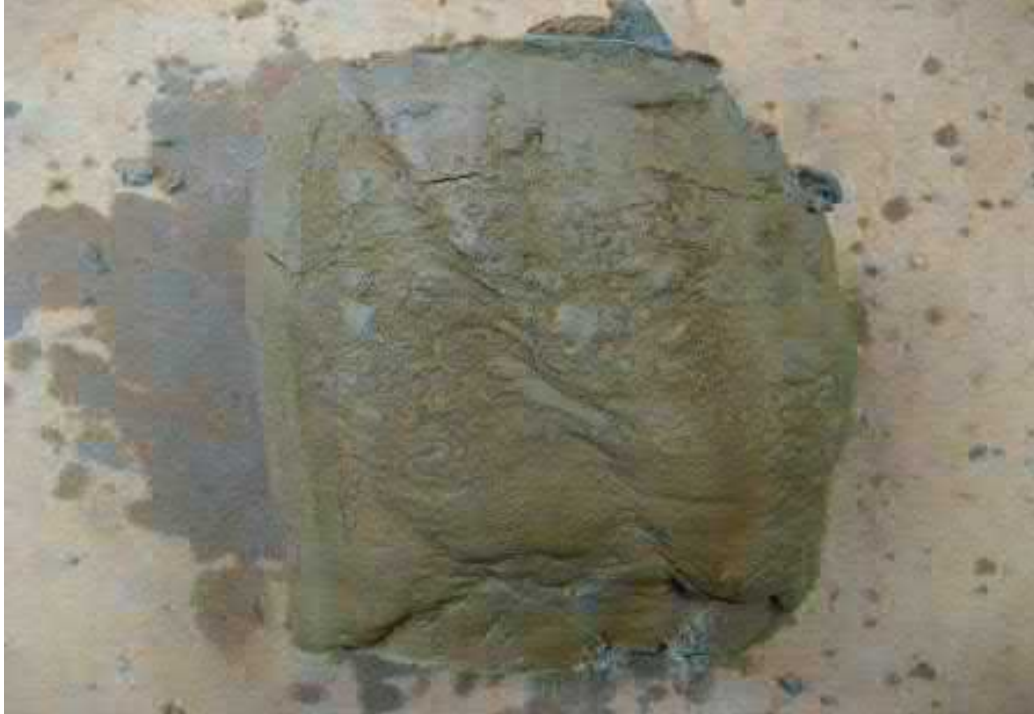
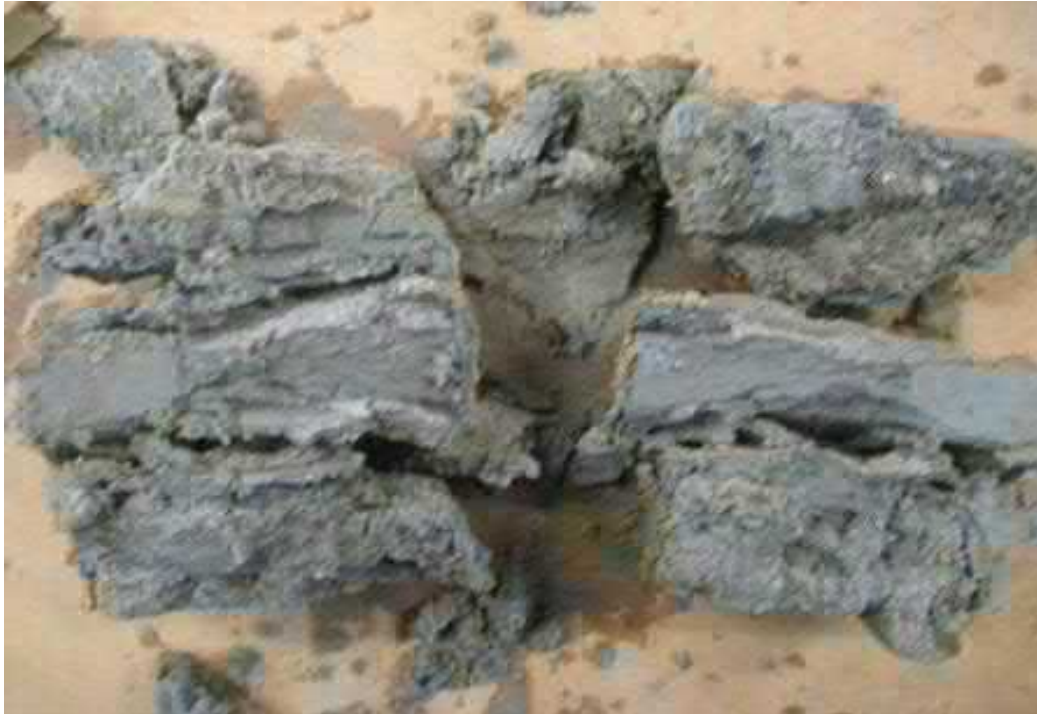
Depth (m) 31.00-31.60

Please note that these photographs are intended to show the failure mode, and do not necessarily show accurately the colouration of the soil.

Sample Condition		Undisturbed		
Height	mm	175.3		
Diameter	mm	103.3		
Moisture Content	%	32		
Bulk Density	Mg/m <sup>3</sup>	1.94		
Dry Density	Mg/m <sup>3</sup>	1.47

Membrane Thickness	mm	0.30		
Membrane Correction	kPa	0.29		
Rate of Axial Displacement	%/min	0.87		
Cell Pressure	kPa	1000		
Strain at Failure	%	3.7		
Maximum Deviator Stress	kPa	479		
Shear Strength	kPa	240		
Mode of Failure			Brittle
