# **Great Yarmouth Third River Crossing**

## **Application for Development Consent Order**

### **Document 6.2: Environmental Statement Volume II: Technical Appendix 16A: Legislation, Policy and Guidance**

Document Reference: 6.2 – Technical Appendix 16A

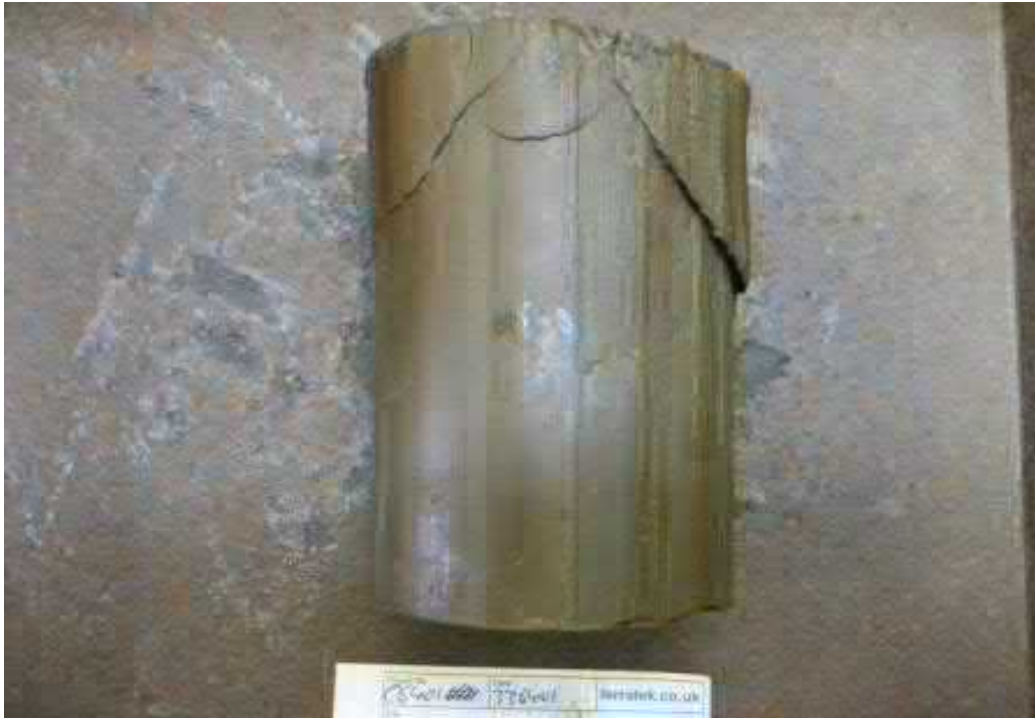
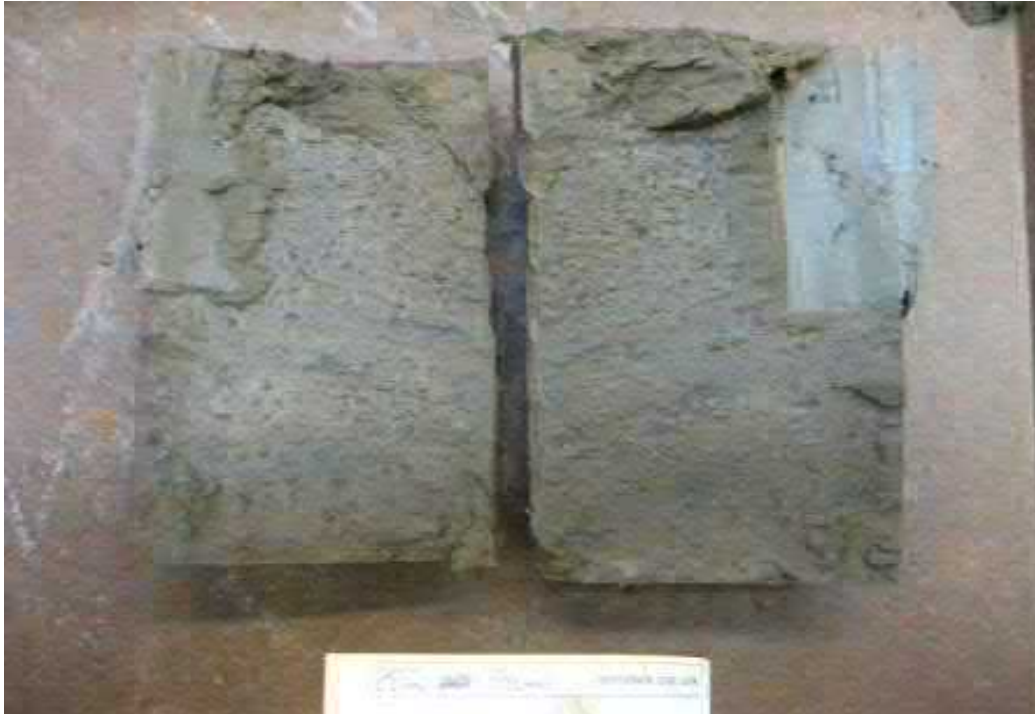
Hole BH10  
Sample Ref 103  
Depth (m) 47.00-47.60  
Sample Type UT

Please note that these photographs are intended to show the failure mode, and do not necessarily show accurately the colouration of the soil.

Sample Condition		Undisturbed		
Height	mm	159.4		
Diameter	mm	103.3		
Moisture Content	%	29		
Bulk Density	Mg/m <sup>3</sup>	1.99		
Dry Density	Mg/m <sup>3</sup>	1.54

Membrane Thickness	mm	0.30		
Membrane Correction	kPa	0.38		
Rate of Axial Displacement	%/min	0.95		
Cell Pressure	kPa	1500		
Strain at Failure	%	5.0		
Maximum Deviator Stress	kPa	477		
Shear Strength	kPa	239		
Mode of Failure			Brittle

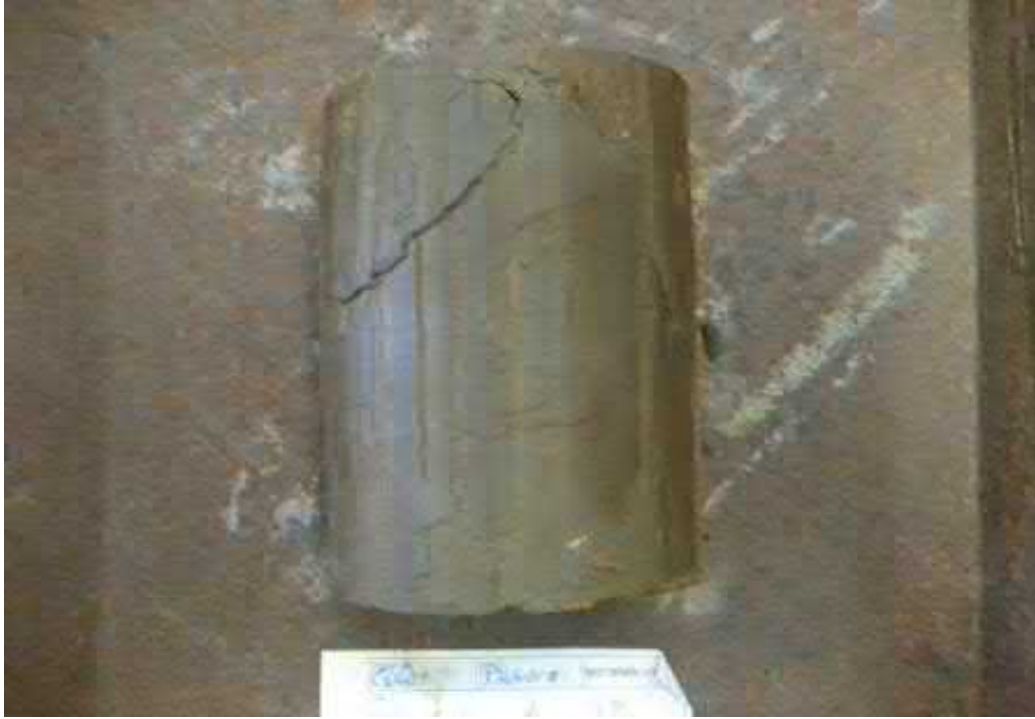
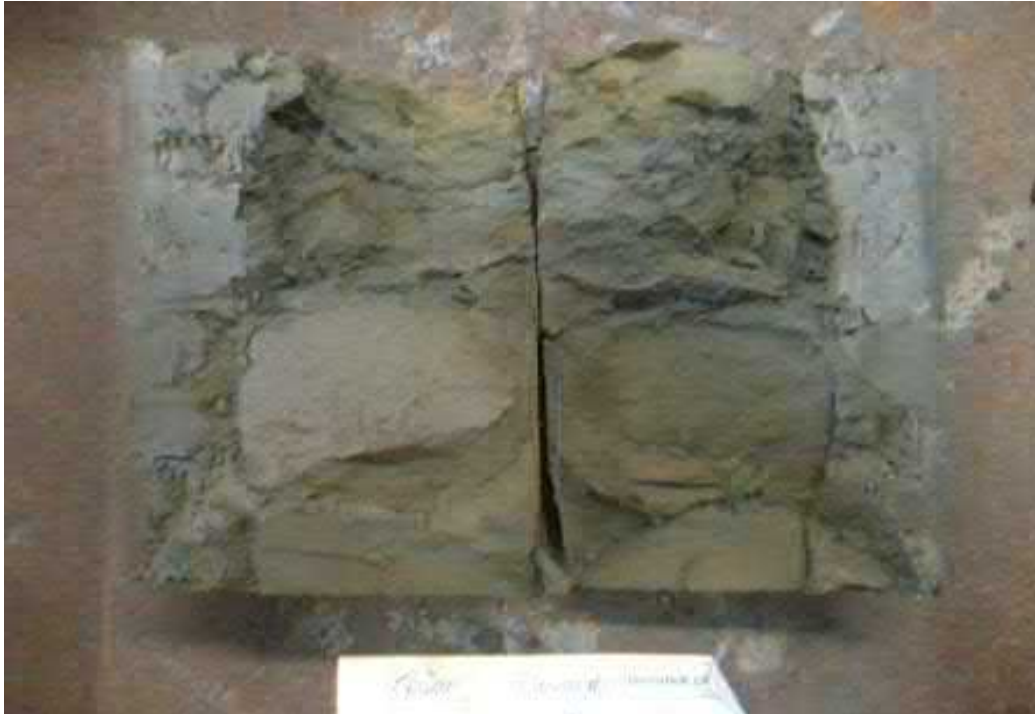
Hole BH10  
Sample Ref 103  
Depth (m) 47.00-47.60  
Sample Type UT

Please note that these photographs are intended to show the failure mode, and do not necessarily show accurately the colouration of the soil.

Sample Condition		Undisturbed		
Height	mm	199.5		
Diameter	mm	103.2		
Moisture Content	%	38		
Bulk Density	Mg/m <sup>3</sup>	1.92		
Dry Density	Mg/m <sup>3</sup>	1.40

Membrane Thickness	mm	0.30		
Membrane Correction	kPa	0.58		
Rate of Axial Displacement	%/min	2.04		
Cell Pressure	kPa	1500		
Strain at Failure	%	8.5		
Maximum Deviator Stress	kPa	305		
Shear Strength	kPa	152		
Mode of Failure			Compound

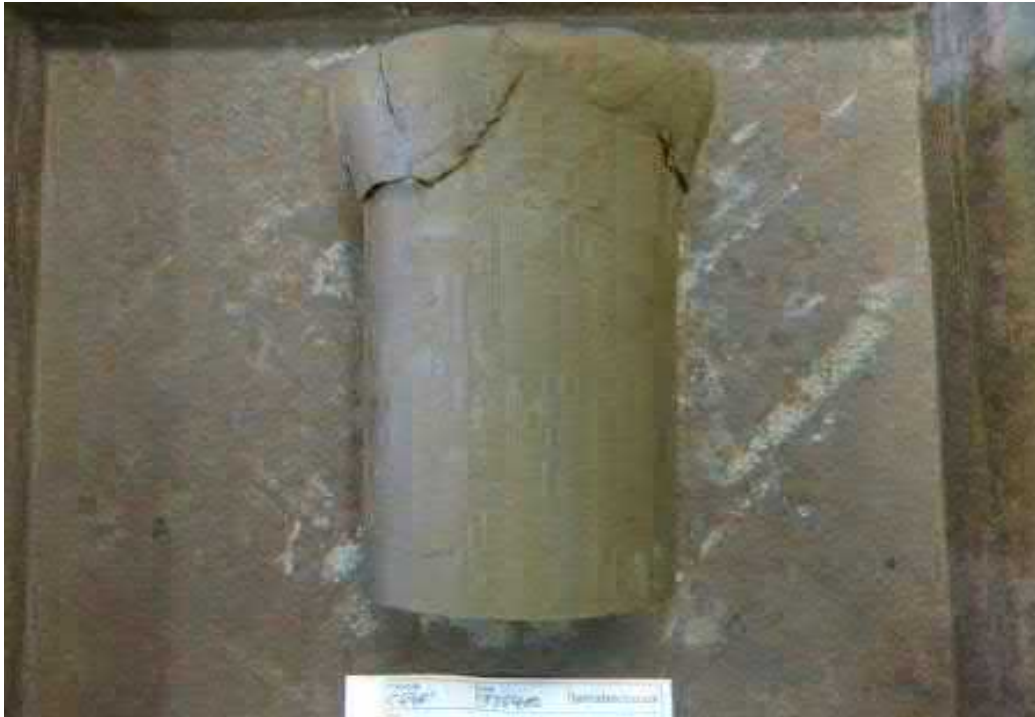
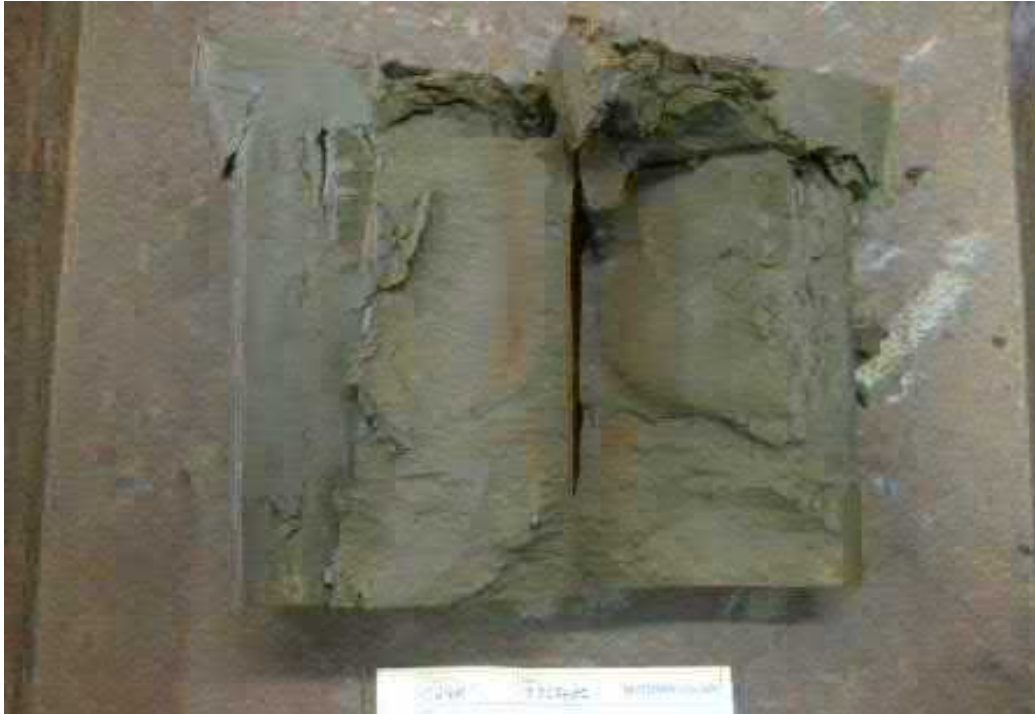
Contract No	<b>PZ1522D1</b>
Hole	BH10
Sample Ref	107
Depth (m)	49.00-49.50
Sample Type	UT

Please note that these photographs are intended to show the failure mode, and do not necessarily show accurately the colouration of the soil.

Sample Condition		Undisturbed		
Height	mm	170.5		
Diameter	mm	104.4		
Moisture Content	%	28		
Bulk Density	Mg/m <sup>3</sup>	2.01		
Dry Density	Mg/m <sup>3</sup>	1.56

Membrane Thickness	mm	0.30		
Membrane Correction	kPa	1.09		
Rate of Axial Displacement	%/min	0.89		
Cell Pressure	kPa	600		
Strain at Failure	%	20.0		
Maximum Deviator Stress	kPa	45		
Shear Strength	kPa	23		
Mode of Failure			Plastic

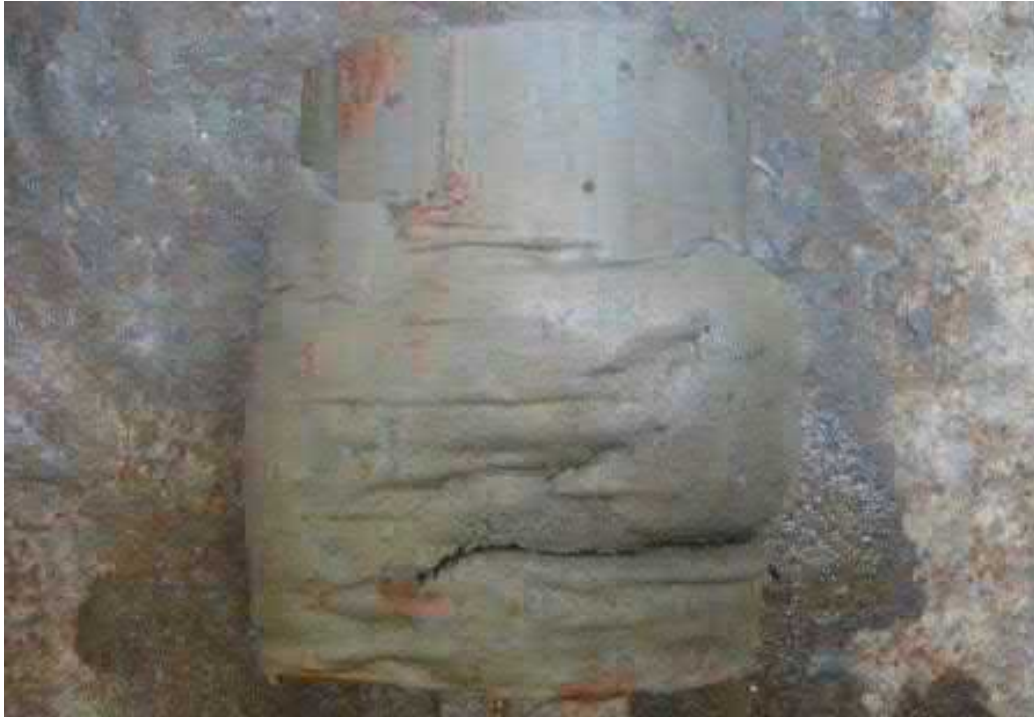
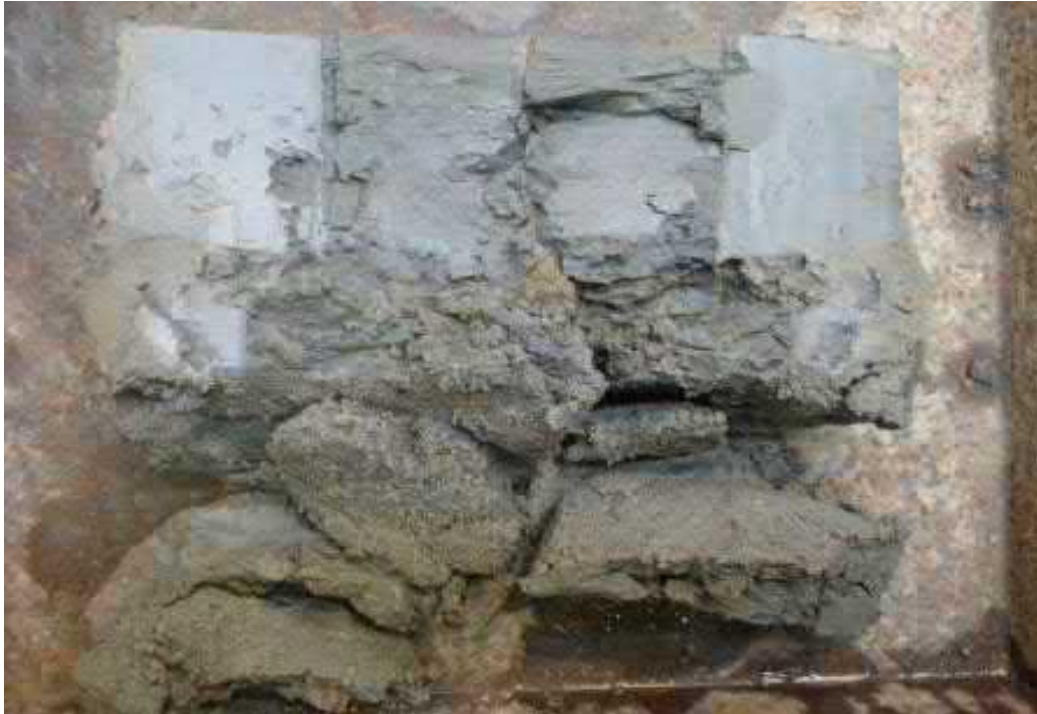
Depth (m) 31.00-31.45

Please note that these photographs are intended to show the failure mode, and do not necessarily show accurately the colouration of the soil.

Sample Condition		Undisturbed		
Height	mm	199.4		
Diameter	mm	103.8		
Moisture Content	%	28		
Bulk Density	Mg/m <sup>3</sup>	2.00		
Dry Density	Mg/m <sup>3</sup>	1.56

Membrane Thickness	mm	0.30		
Membrane Correction	kPa	1.04		
Rate of Axial Displacement	%/min	0.76		
Cell Pressure	kPa	900		
Strain at Failure	%	18.6		
Maximum Deviator Stress	kPa	164		
Shear Strength	kPa	82		
Mode of Failure			Compound

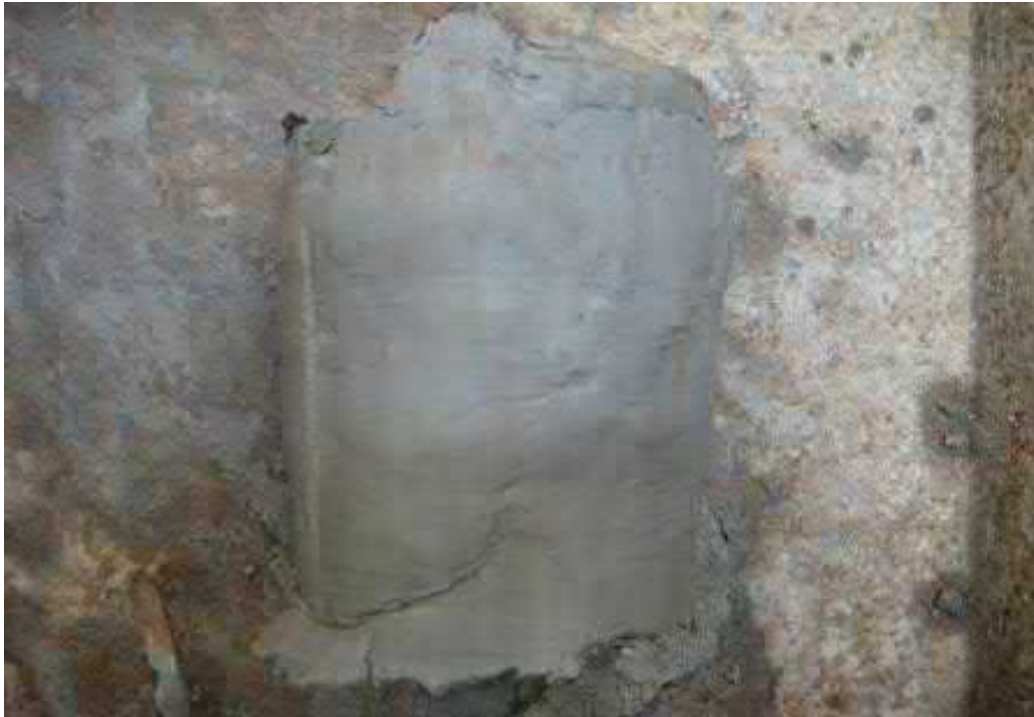
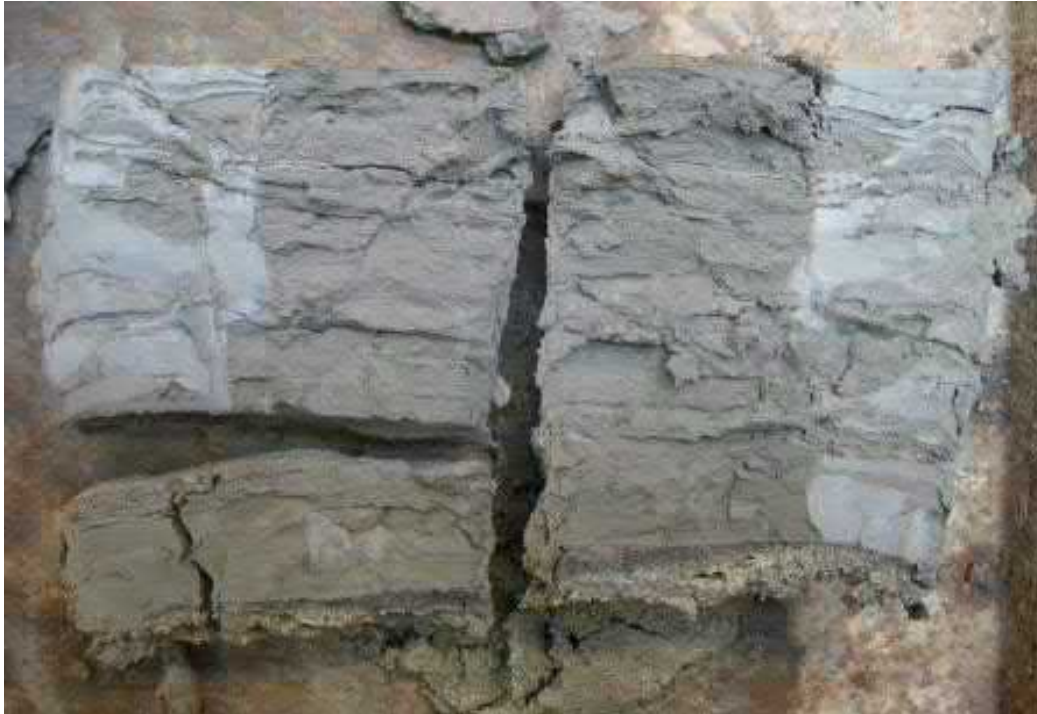
Depth (m) 31.00-31.45

Please note that these photographs are intended to show the failure mode, and do not necessarily show accurately the colouration of the soil.

Sample Condition		Undisturbed		
Height	mm	199.7		
Diameter	mm	101.3		
Moisture Content	%	30		
Bulk Density	Mg/m <sup>3</sup>	1.97		
Dry Density	Mg/m <sup>3</sup>	1.51

Membrane Thickness	mm	0.30		
Membrane Correction	kPa	0.42		
Rate of Axial Displacement	%/min	0.76		
Cell Pressure	kPa	1500		
Strain at Failure	%	5.5		
Maximum Deviator Stress	kPa	478		
Shear Strength	kPa	239		
Mode of Failure			Brittle

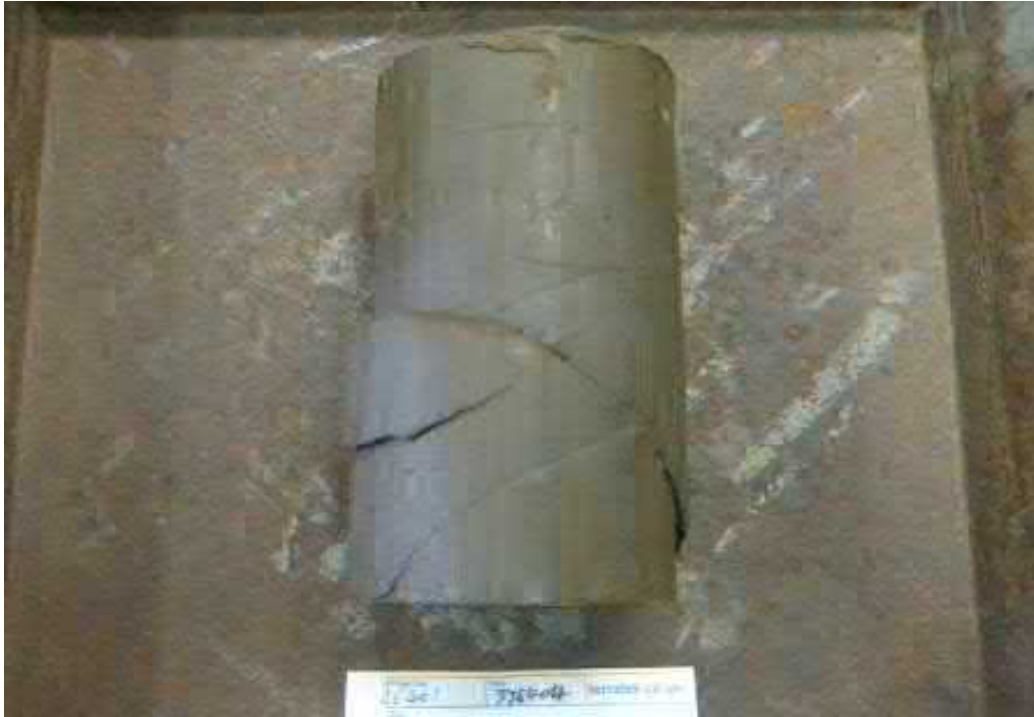
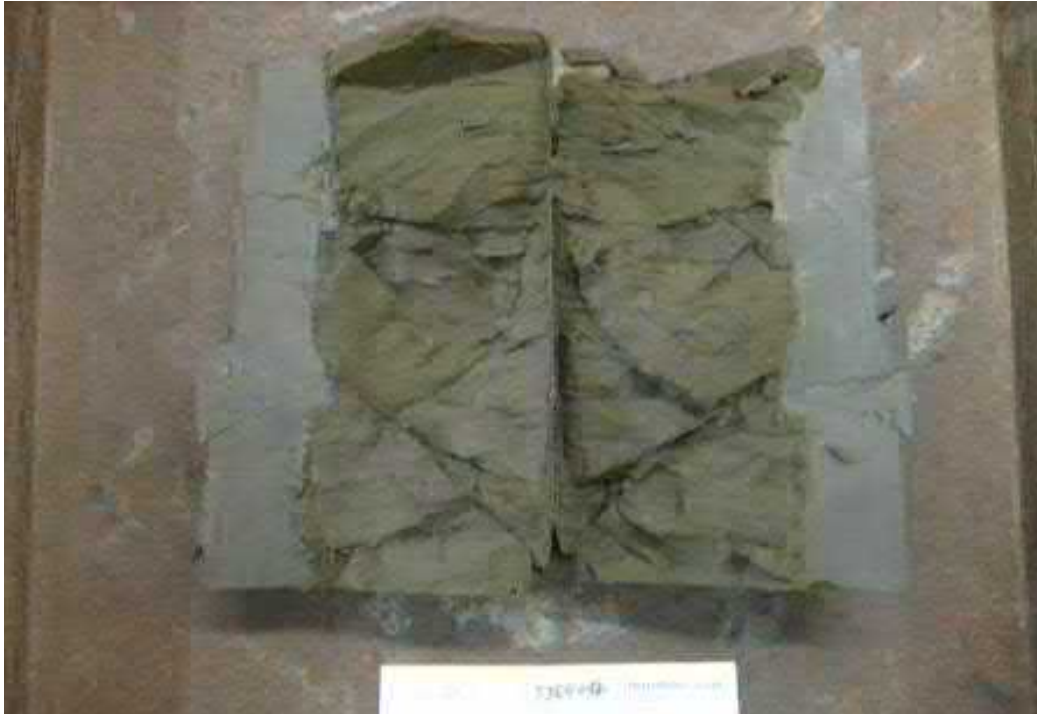
Hole BH10A  
Sample Ref 107  
Depth (m) 47.00-47.45  
Sample Type UT

Please note that these photographs are intended to show the failure mode, and do not necessarily show accurately the colouration of the soil.

Sample Condition		Undisturbed		
Height	mm	159.6		
Diameter	mm	101.1		
Moisture Content	%	37		
Bulk Density	Mg/m <sup>3</sup>	1.87		
Dry Density	Mg/m <sup>3</sup>	1.36

Membrane Thickness	mm	0.30		
Membrane Correction	kPa	0.50		
Rate of Axial Displacement	%/min	2.54		
Cell Pressure	kPa	1000		
Strain at Failure	%	6.9		
Maximum Deviator Stress	kPa	83		
Shear Strength	kPa	41		
Mode of Failure			Brittle

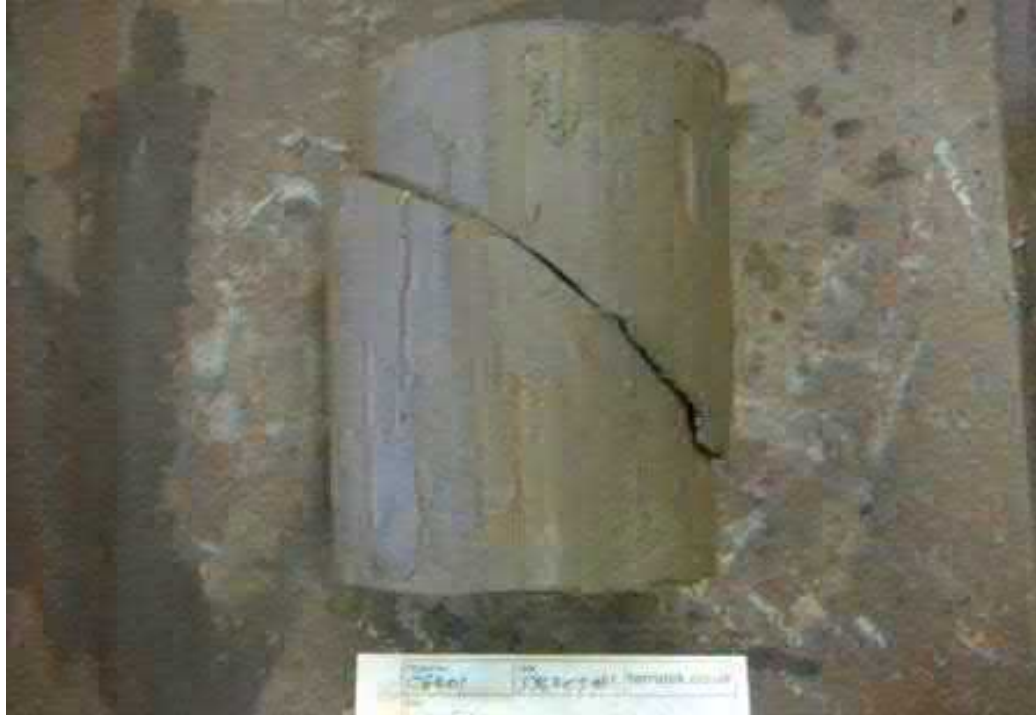
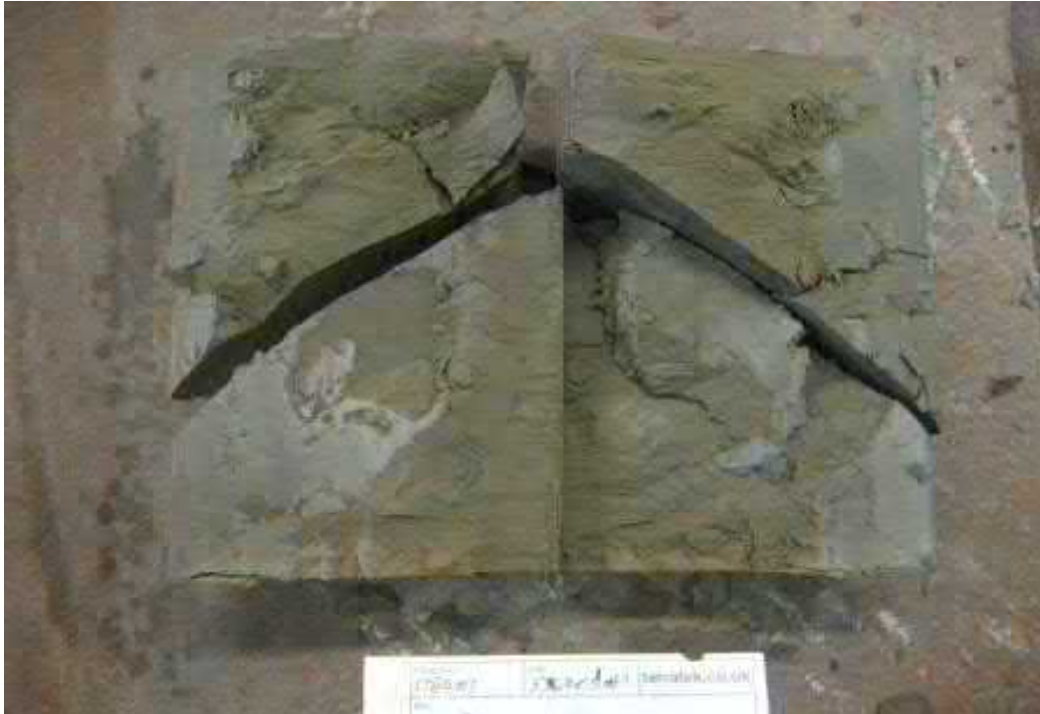
Contract No	<b>PZ1522D1</b>
Hole	BH10A
Sample Ref	111
Depth (m)	49.00-49.45
Sample Type	UT

Please note that these photographs are intended to show the failure mode, and do not necessarily show accurately the colouration of the soil.

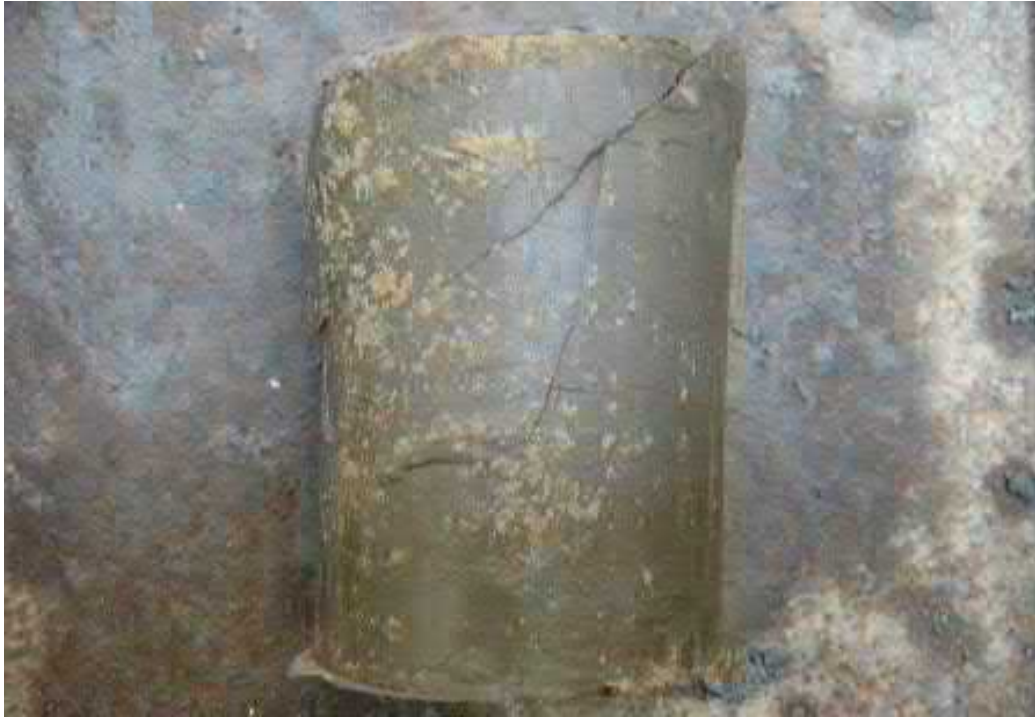
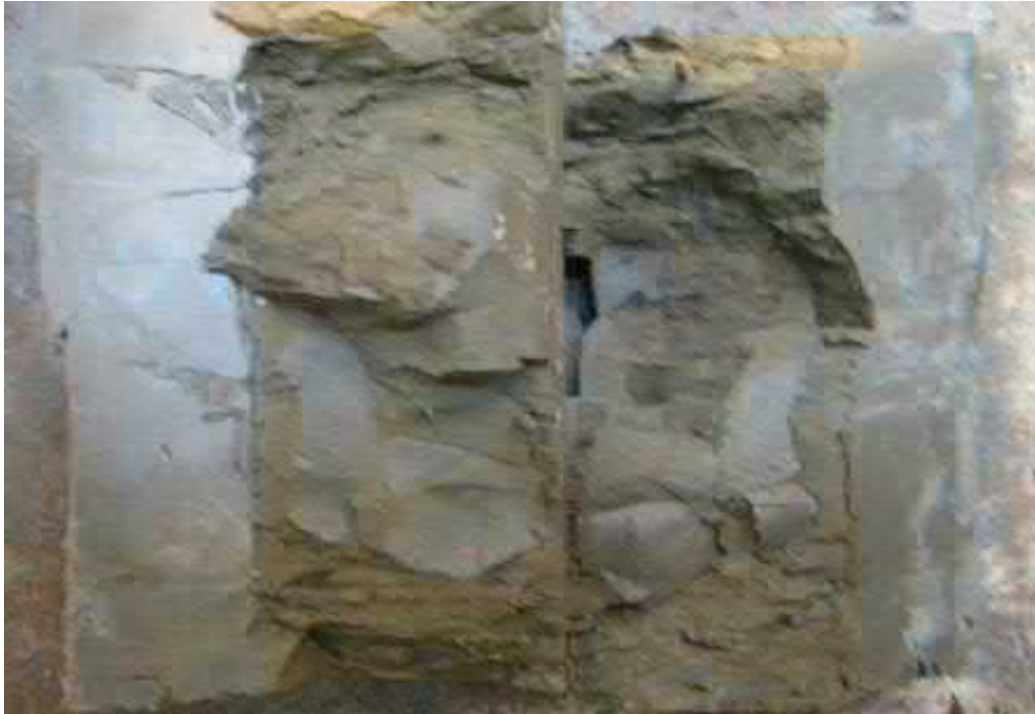
Depth (m) 48.50-48.95

Please note that these photographs are intended to show the failure mode, and do not necessarily show accurately the colouration of the soil.

Sample Condition		Undisturbed		
Height	mm	170.3		
Diameter	mm	103.5		
Moisture Content	%	21		
Bulk Density	Mg/m <sup>3</sup>	2.06		
Dry Density	Mg/m <sup>3</sup>	1.70

Membrane Thickness	mm	0.30		
Membrane Correction	kPa	0.50		
Rate of Axial Displacement	%/min	0.89		
Cell Pressure	kPa	600		
Strain at Failure	%	7.0		
Maximum Deviator Stress	kPa	43		
Shear Strength	kPa	21		
Mode of Failure			Plastic

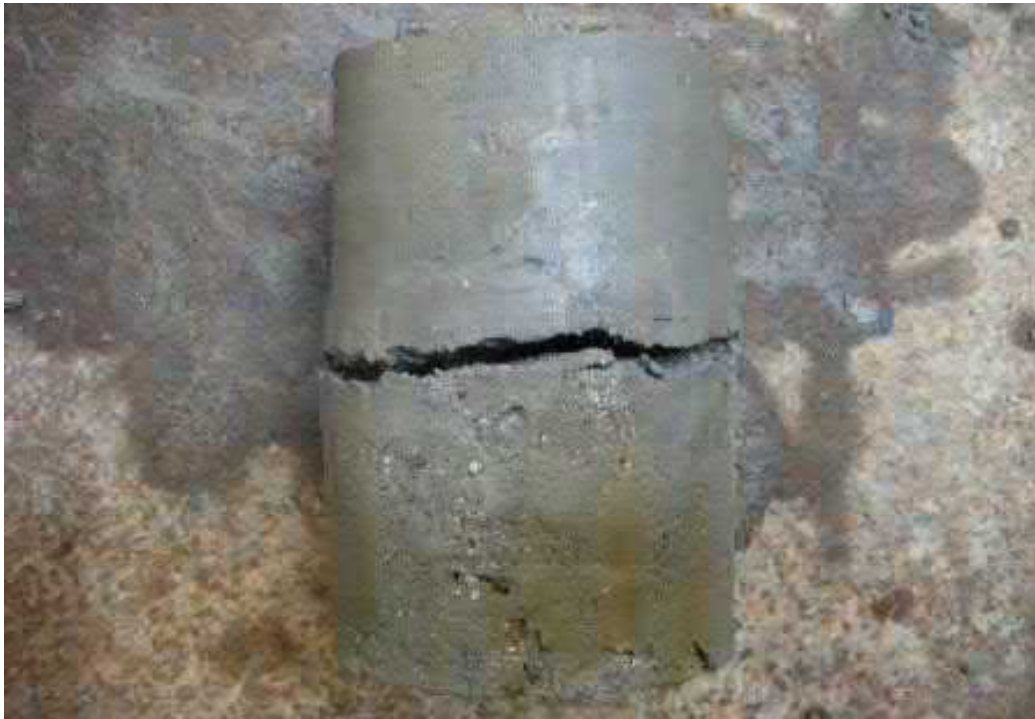
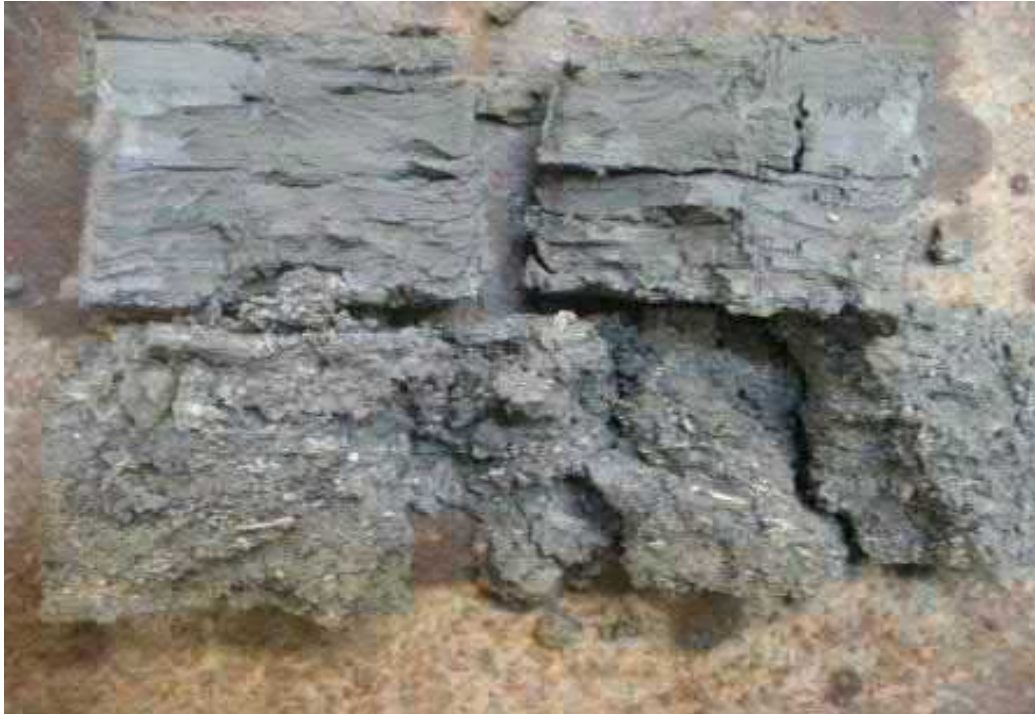
Hole BH11A  
Sample Ref 79  
Depth (m) 28.00-28.45  
Sample Type UT

Please note that these photographs are intended to show the failure mode, and do not necessarily show accurately the colouration of the soil.

Sample Condition		Undisturbed		
Height	mm	194.8		
Diameter	mm	103.9		
Moisture Content	%	24		
Bulk Density	Mg/m <sup>3</sup>	2.08		
Dry Density	Mg/m <sup>3</sup>	1.67

Membrane Thickness	mm	0.30		
Membrane Correction	kPa	0.22		
Rate of Axial Displacement	%/min	0.78		
Cell Pressure	kPa	900		
Strain at Failure	%	2.8		
Maximum Deviator Stress	kPa	32		
Shear Strength	kPa	16		
Mode of Failure			Plastic

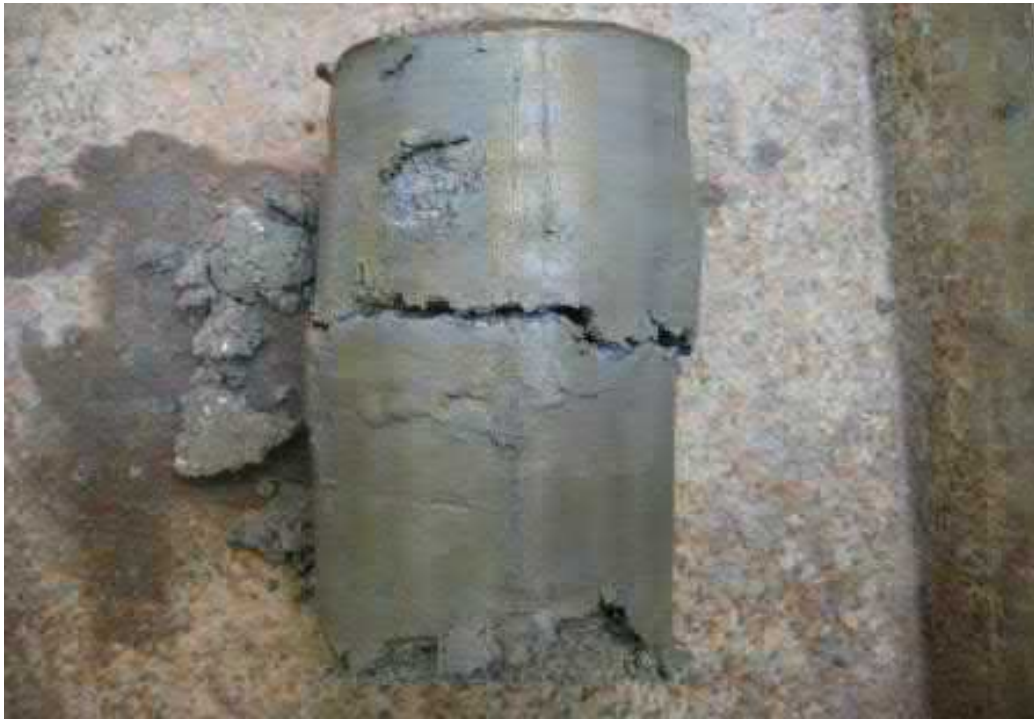
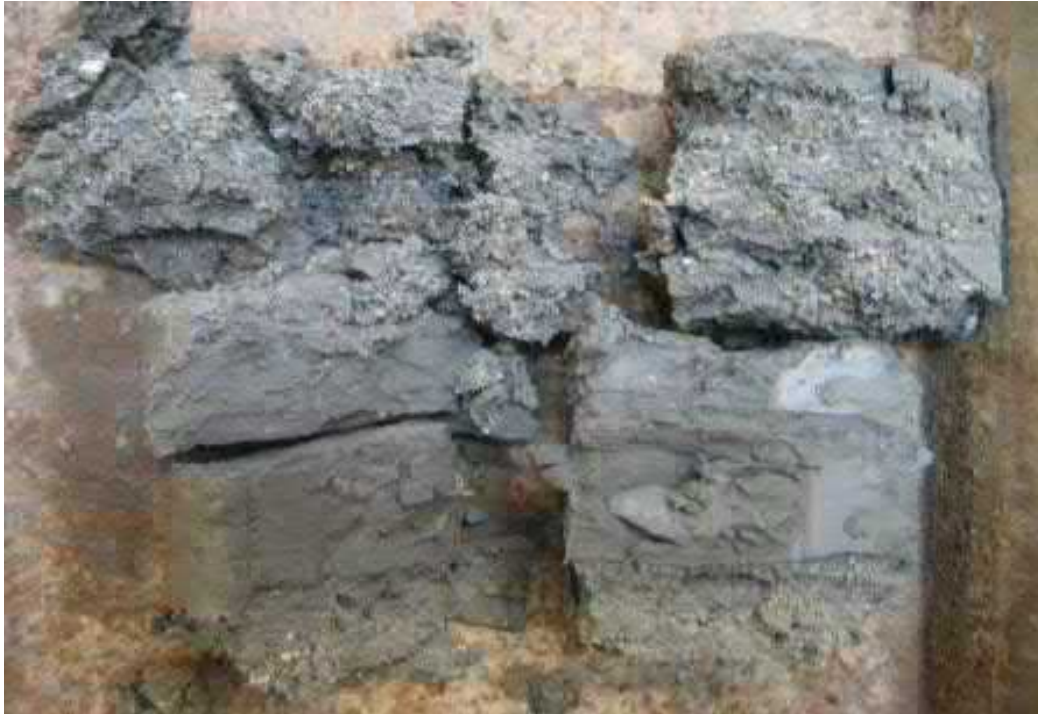
Depth (m) 28.00-28.45

Please note that these photographs are intended to show the failure mode, and do not necessarily show accurately the colouration of the soil.

Sample Condition		Undisturbed		
Height	mm	173.2		
Diameter	mm	103.5		
Moisture Content	%	26		
Bulk Density	Mg/m <sup>3</sup>	1.99		
Dry Density	Mg/m <sup>3</sup>	1.57

Membrane Thickness	mm	0.30		
Membrane Correction	kPa	1.10		
Rate of Axial Displacement	%/min	0.88		
Cell Pressure	kPa	1200		
Strain at Failure	%	20.0		
Maximum Deviator Stress	kPa	358		
Shear Strength	kPa	179		
Mode of Failure			Plastic

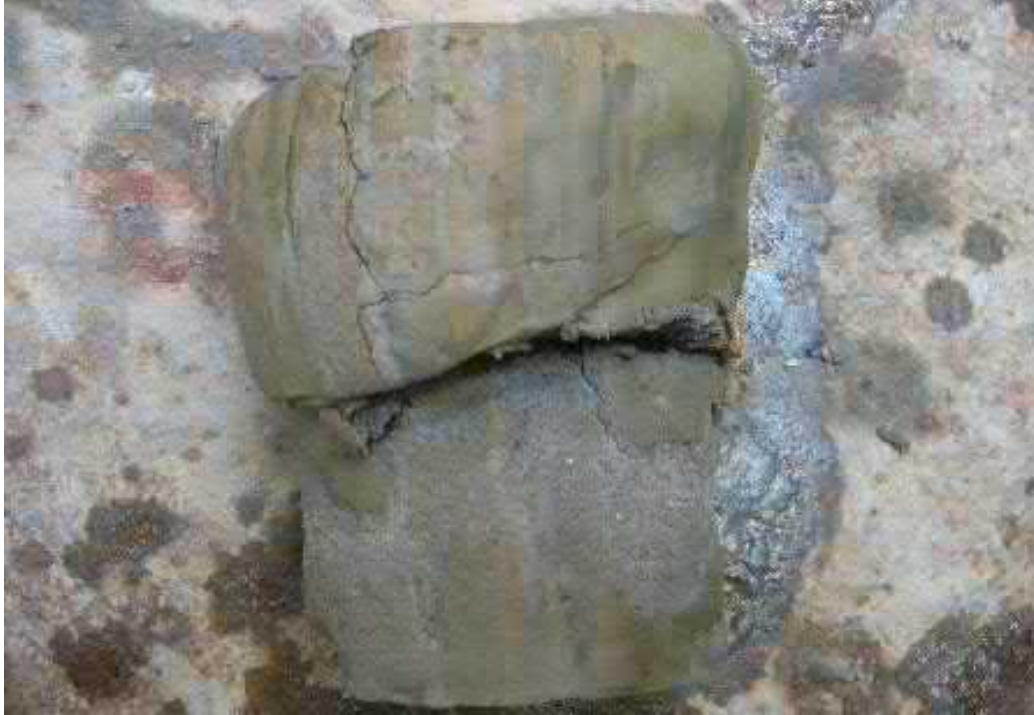
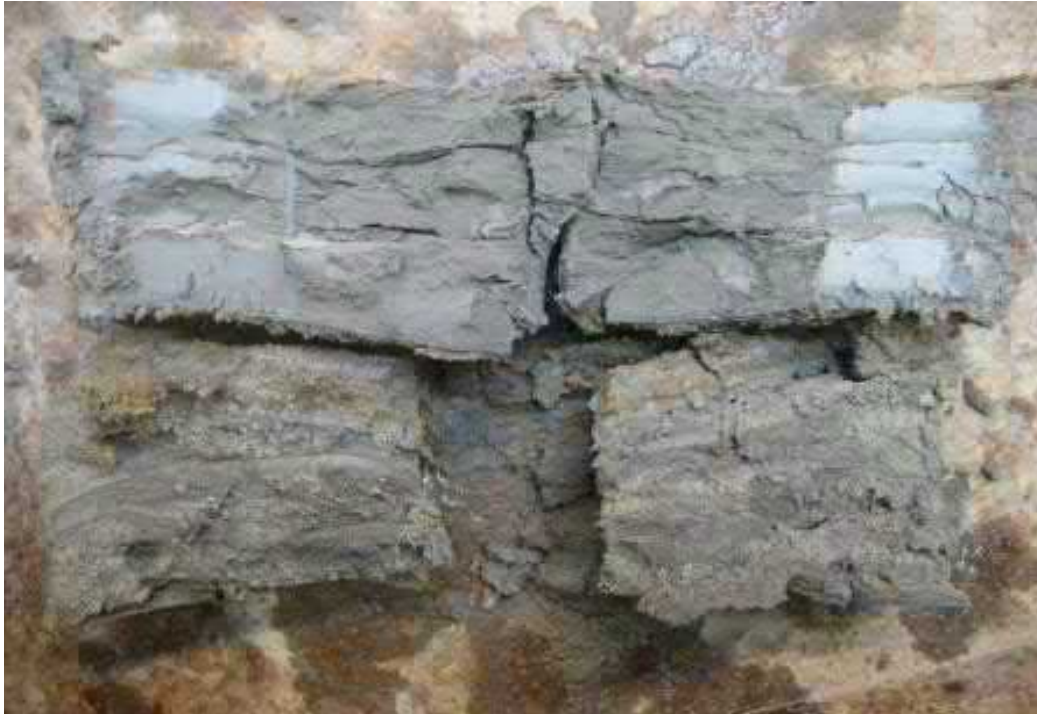
Hole BH11A  
Sample Ref 87  
Depth (m) 31.50-32.10  
Sample Type UT

Please note that these photographs are intended to show the failure mode, and do not necessarily show accurately the colouration of the soil.

Sample Condition		Undisturbed		
Height	mm	173.4		
Diameter	mm	103.4		
Moisture Content	%	24		
Bulk Density	Mg/m <sup>3</sup>	2.05		
Dry Density	Mg/m <sup>3</sup>	1.65

Membrane Thickness	mm	0.30		
Membrane Correction	kPa	0.52		
Rate of Axial Displacement	%/min	0.88		
Cell Pressure	kPa	600		
Strain at Failure	%	7.5		
Maximum Deviator Stress	kPa	132		
Shear Strength	kPa	66		
Mode of Failure			Plastic

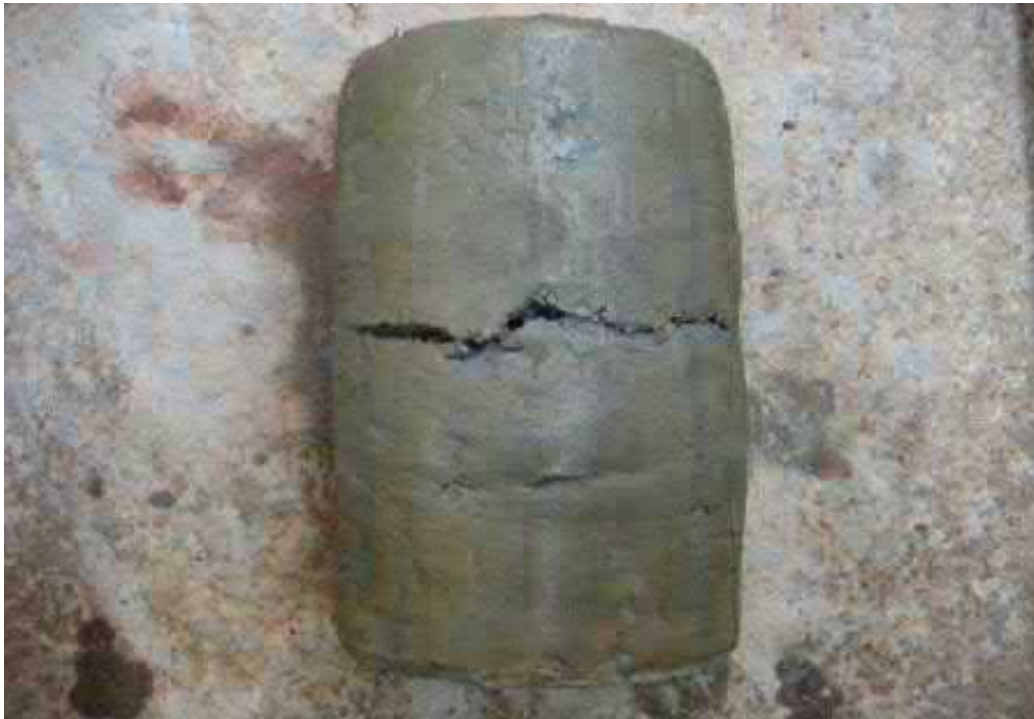
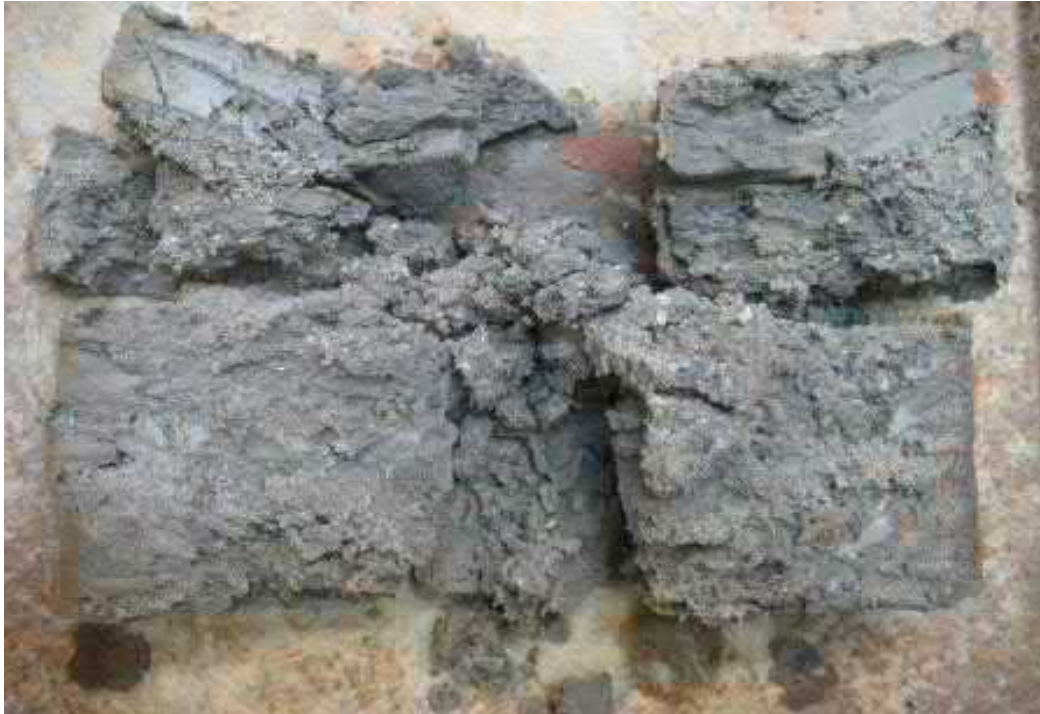
Depth (m) 31.50-32.10

Please note that these photographs are intended to show the failure mode, and do not necessarily show accurately the colouration of the soil.

Sample Condition		Undisturbed		
Height	mm	175.3		
Diameter	mm	102.6		
Moisture Content	%	31		
Bulk Density	Mg/m <sup>3</sup>	1.99		
Dry Density	Mg/m <sup>3</sup>	1.52

Membrane Thickness	mm	0.30		
Membrane Correction	kPa	0.44		
Rate of Axial Displacement	%/min	0.87		
Cell Pressure	kPa	1000		
Strain at Failure	%	6.0		
Maximum Deviator Stress	kPa	470		
Shear Strength	kPa	235		
Mode of Failure			Brittle

Non Engineering Description	Hard fissured dark brown CLAY.
-----------------------------	--------------------------------

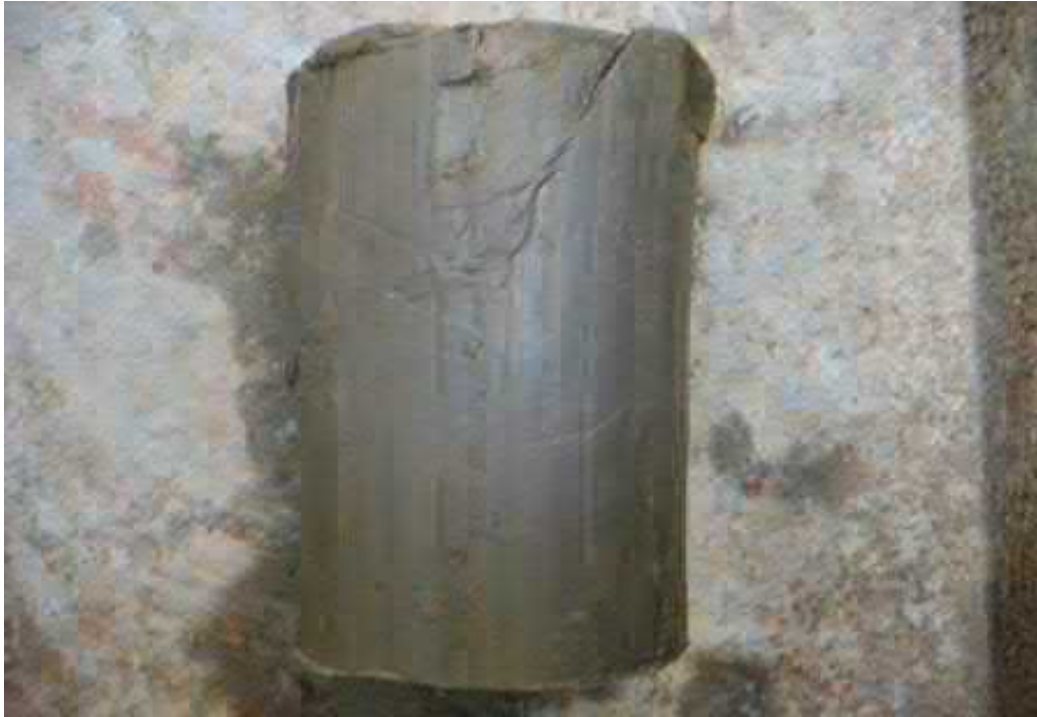
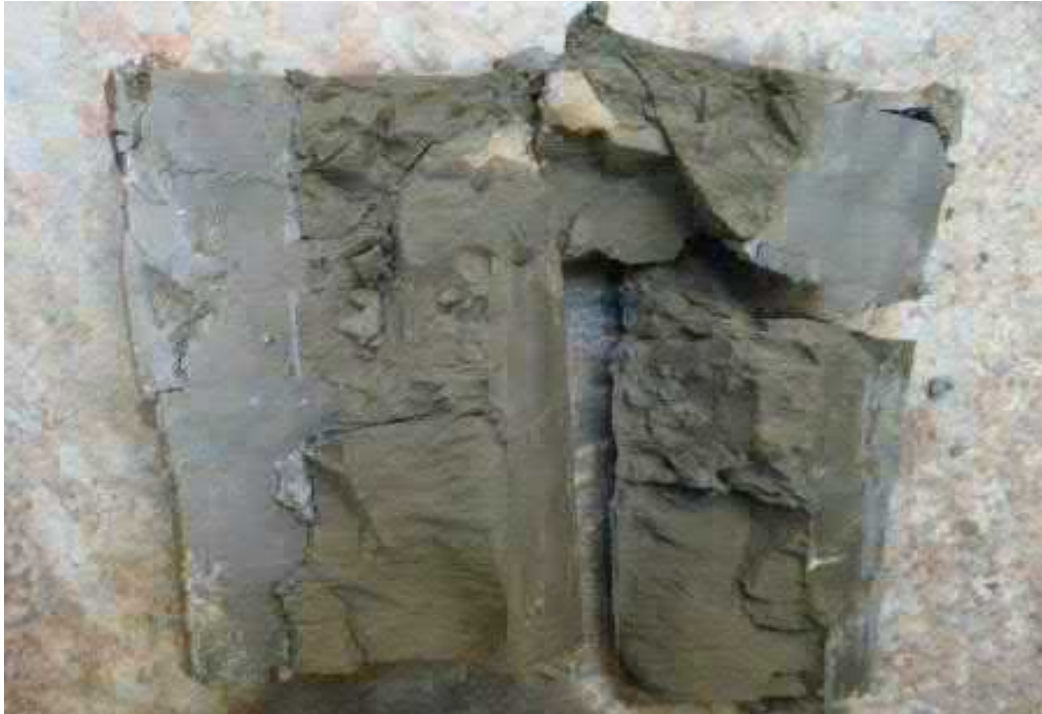
Depth (m) 47.00-47.50

Please note that these photographs are intended to show the failure mode, and do not necessarily show accurately the colouration of the soil.

Sample Condition		Undisturbed		
Height	mm	174.2		
Diameter	mm	102.4		
Moisture Content	%	31		
Bulk Density	Mg/m <sup>3</sup>	1.98		
Dry Density	Mg/m <sup>3</sup>	1.51

Membrane Thickness	mm	0.30		
Membrane Correction	kPa	0.68		
Rate of Axial Displacement	%/min	0.87		
Cell Pressure	kPa	1500		
Strain at Failure	%	10.3		
Maximum Deviator Stress	kPa	392		
Shear Strength	kPa	196		
Mode of Failure			Brittle

Non Engineering Description	Very stiff fissured dark brown CLAY.
-----------------------------	--------------------------------------

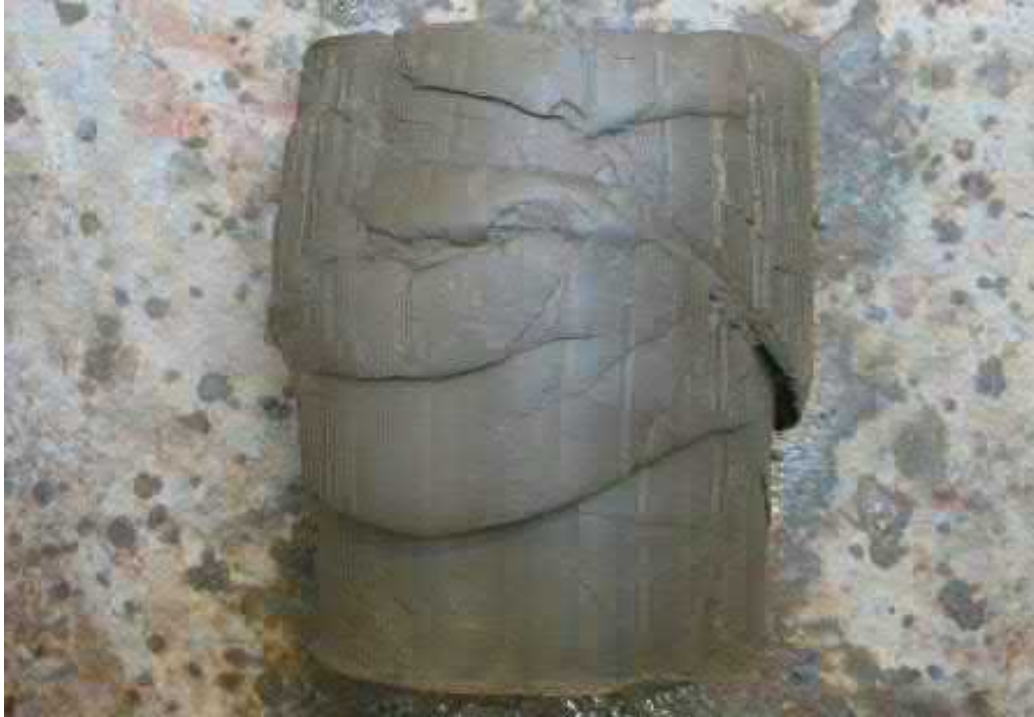
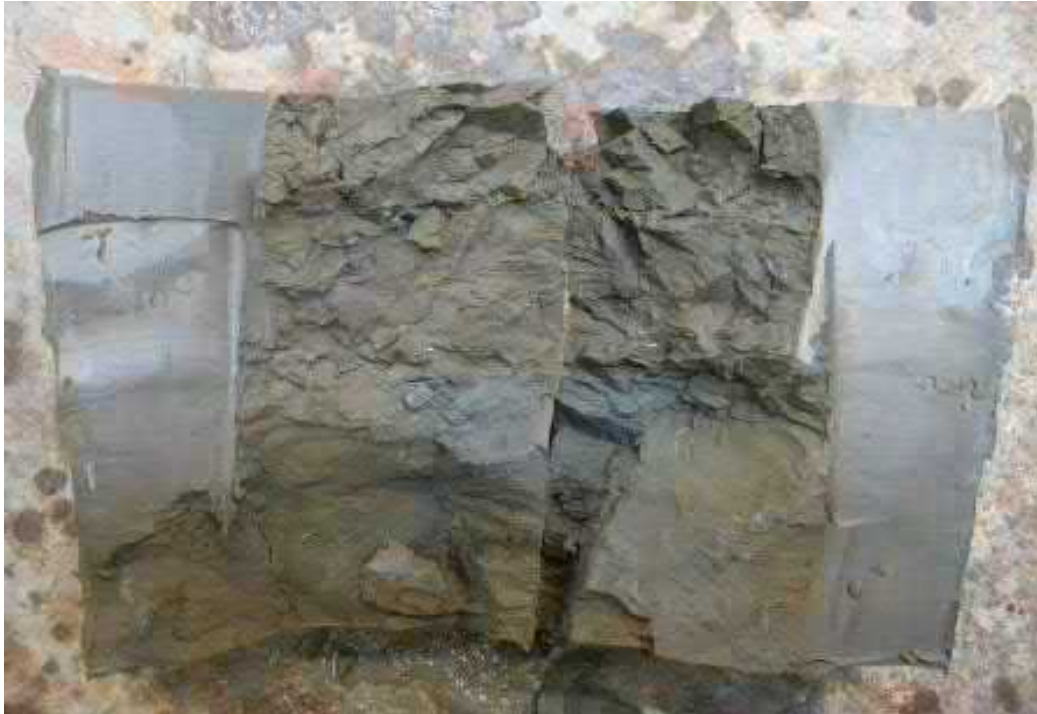
Hole BH11A  
Sample Ref 114  
Depth (m) 47.00-47.50  
Sample Type UT

Please note that these photographs are intended to show the failure mode, and do not necessarily show accurately the colouration of the soil.

<b>Sample Details</b>		Undisturbed		
Sample Condition				
Height	mm	196.8		
Diameter	mm	101.3		
Moisture Content	%	42		
Bulk Density	Mg/m <sup>3</sup>	1.77		
Dry Density	Mg/m <sup>3</sup>	1.25		
<b>Test Details</b>				
Membrane Thickness	mm	0.30		
Membrane Correction	kPa	0.68		
Rate of Axial Displacement	%/min	2.06		
Cell Pressure	kPa	100		
Strain at Failure	%	10.2		
Maximum Deviator Stress	kPa	44		
Shear Strength	kPa	22		
Mode of Failure			Compound	
Non Engineering Description	Soft intact very dark grey slightly sandy CLAY
