# **Great Yarmouth Third River Crossing**

## **Application for Development Consent Order**

### **Document 6.2: Environmental Statement Volume II: Technical Appendix 16A: Legislation, Policy and Guidance**

Document Reference: 6.2 – Technical Appendix 16A

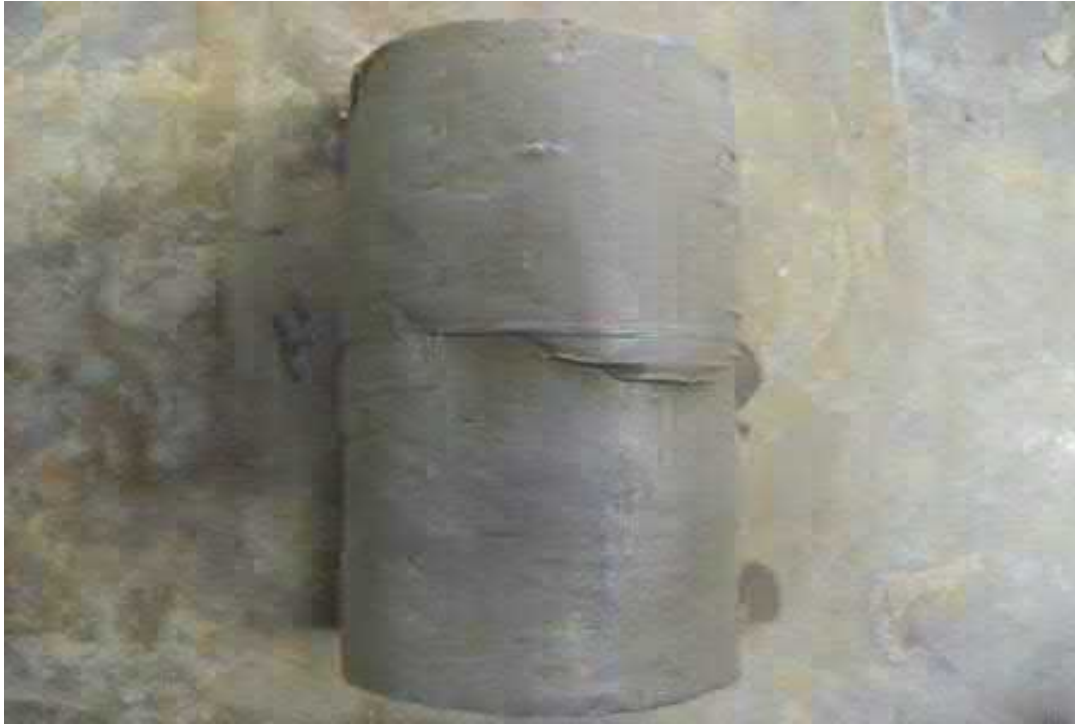
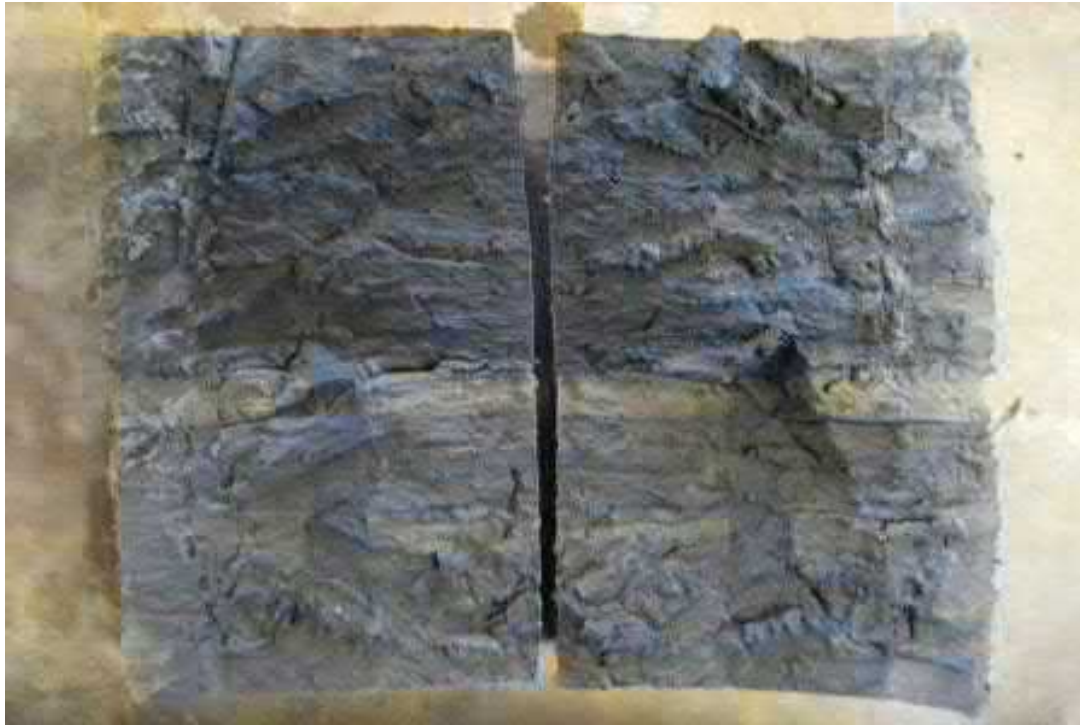
Sample Type P

Originator	Checked & Approved	Please note that these photographs are intended to show the failure mode, and do not necessarily show accurately the colouration of the soil.

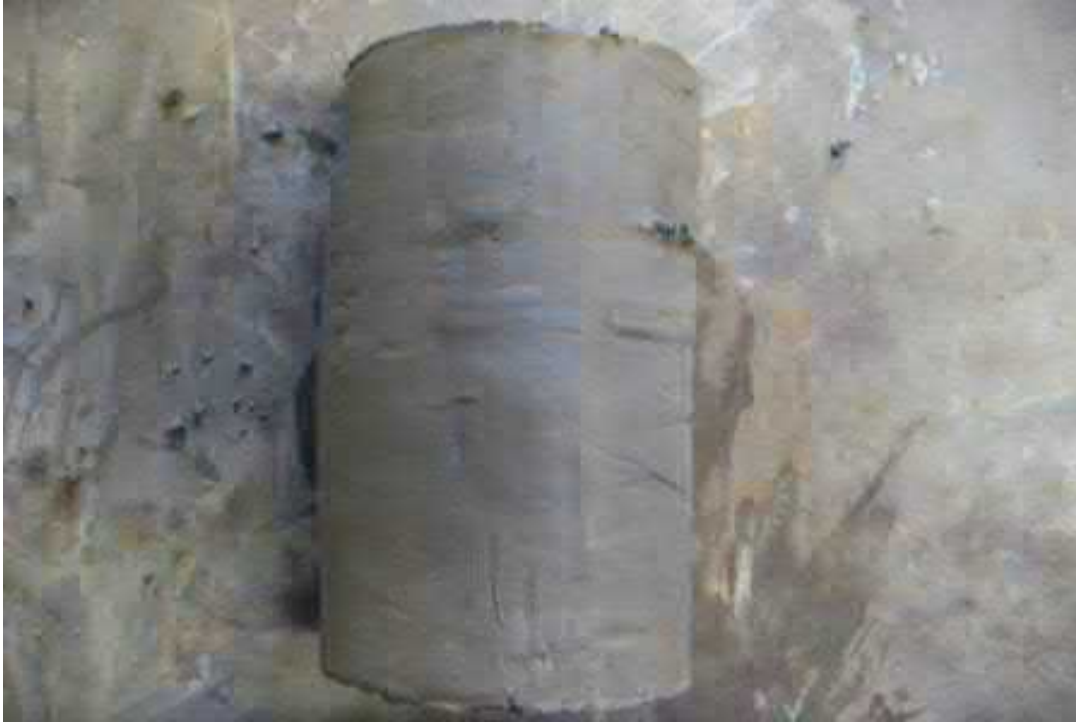
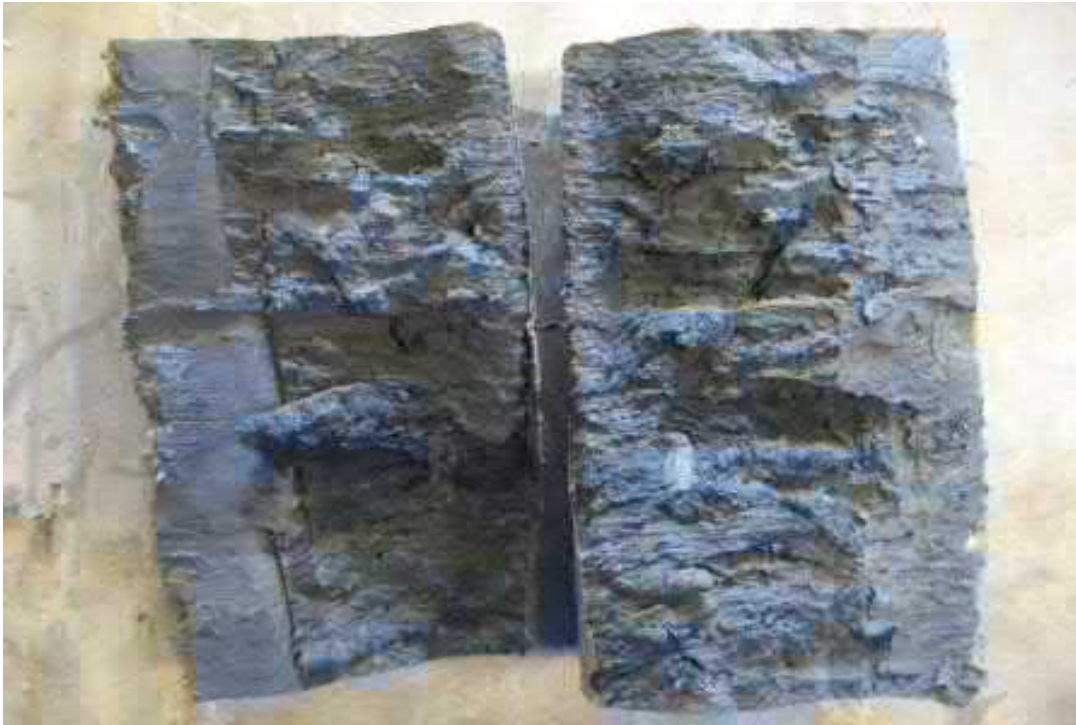
Depth (m) 2.50

Please note that these photographs are intended to show the failure mode, and do not necessarily show accurately the colouration of the soil.

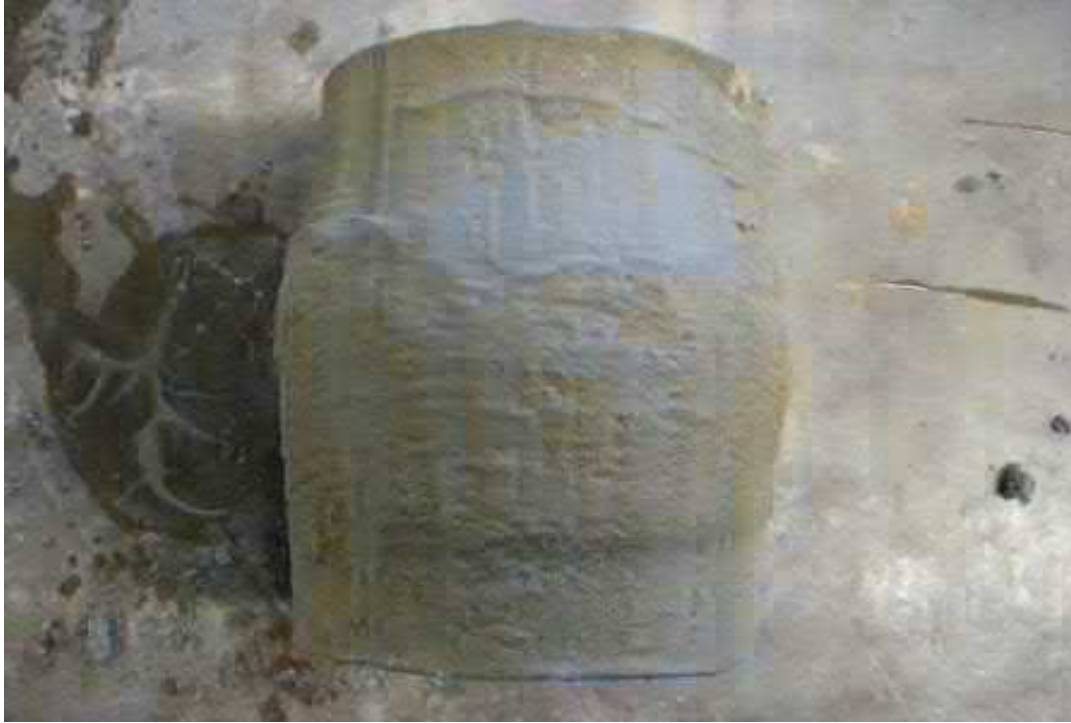
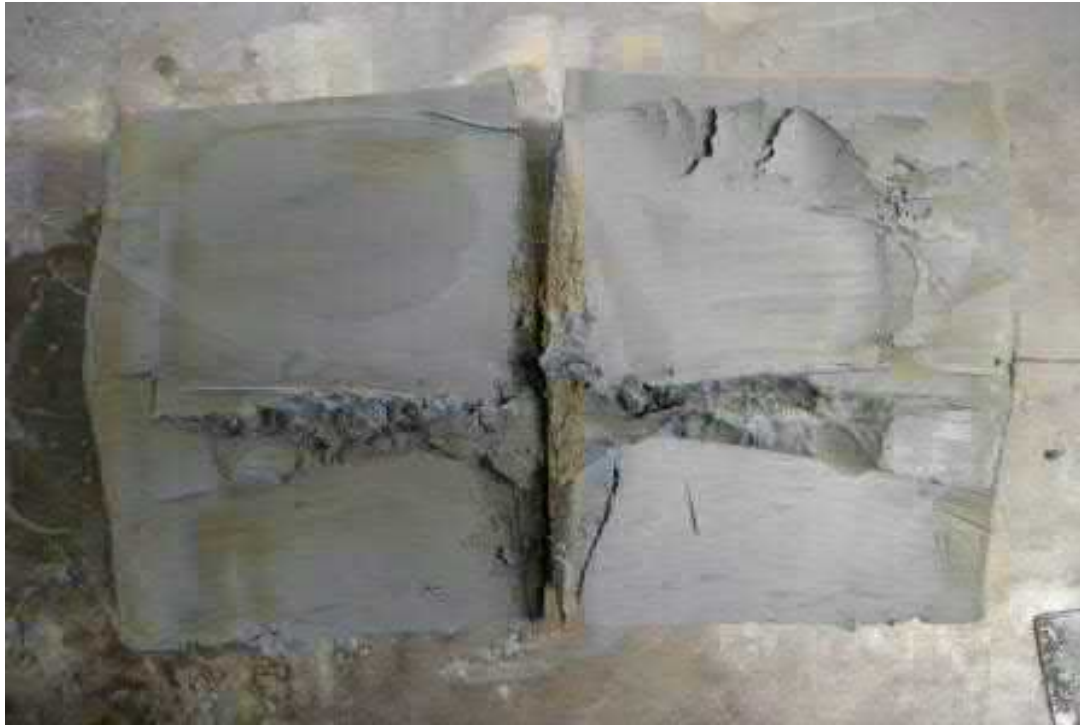
Sample Type U

Originator	Checked & Approved	Please note that these photographs are intended to show the failure mode, and do not necessarily show accurately the colouration of the soil.

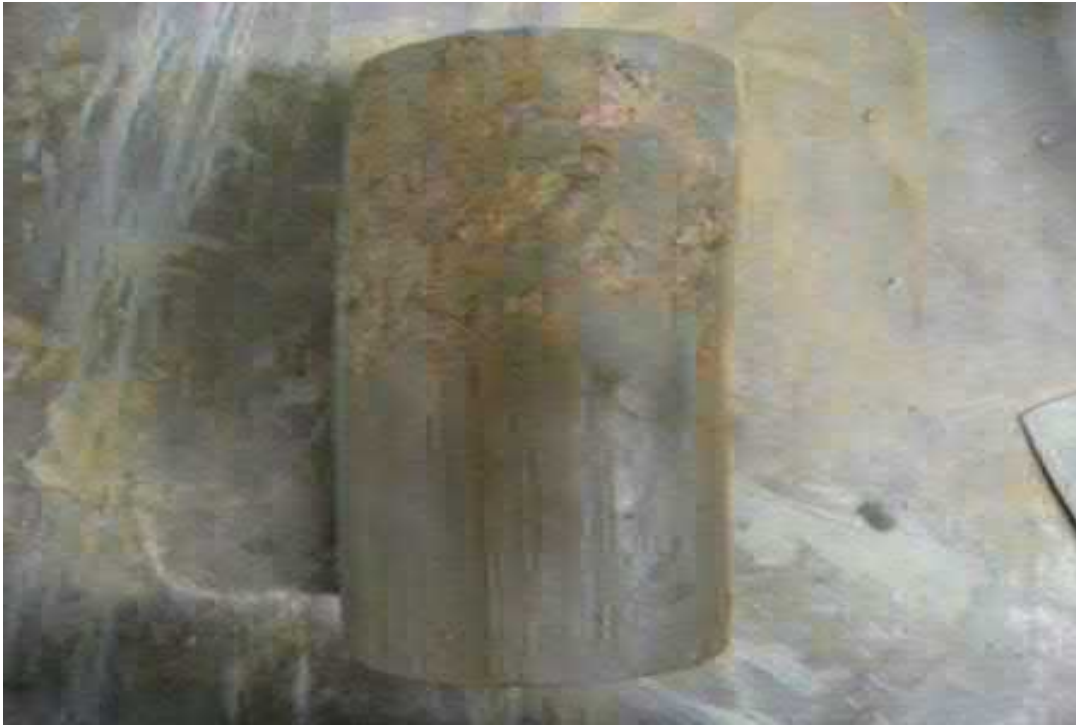
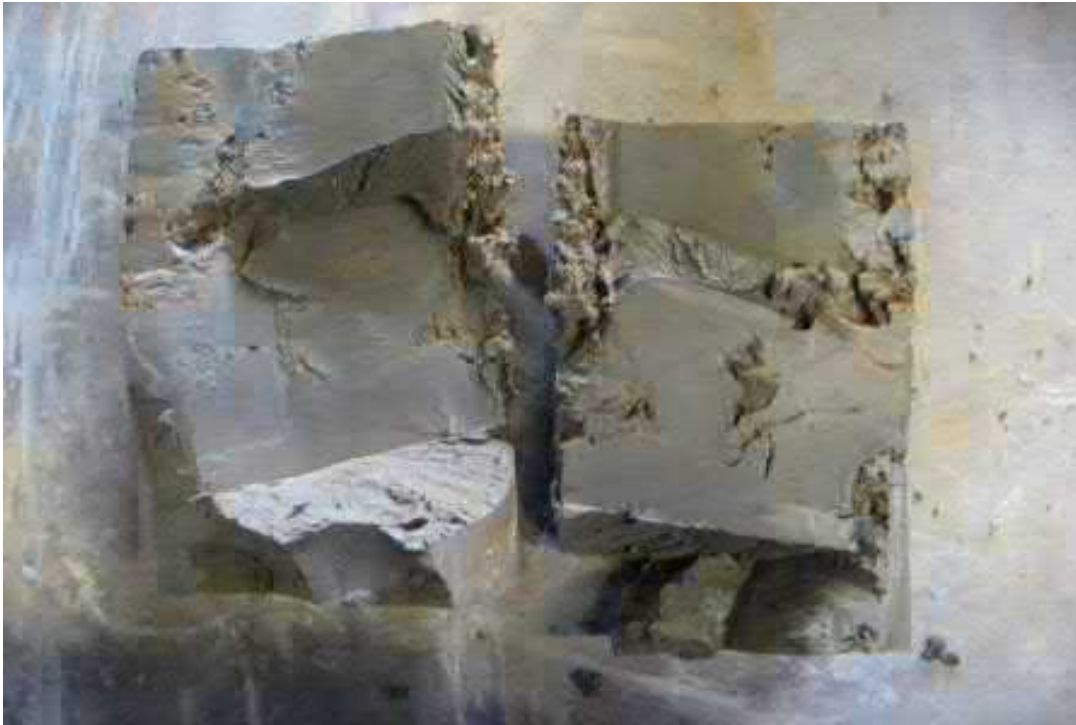
Originator	Checked & Approved	Please note that these photographs are intended to show the failure mode, and do not necessarily show accurately the colouration of the soil.

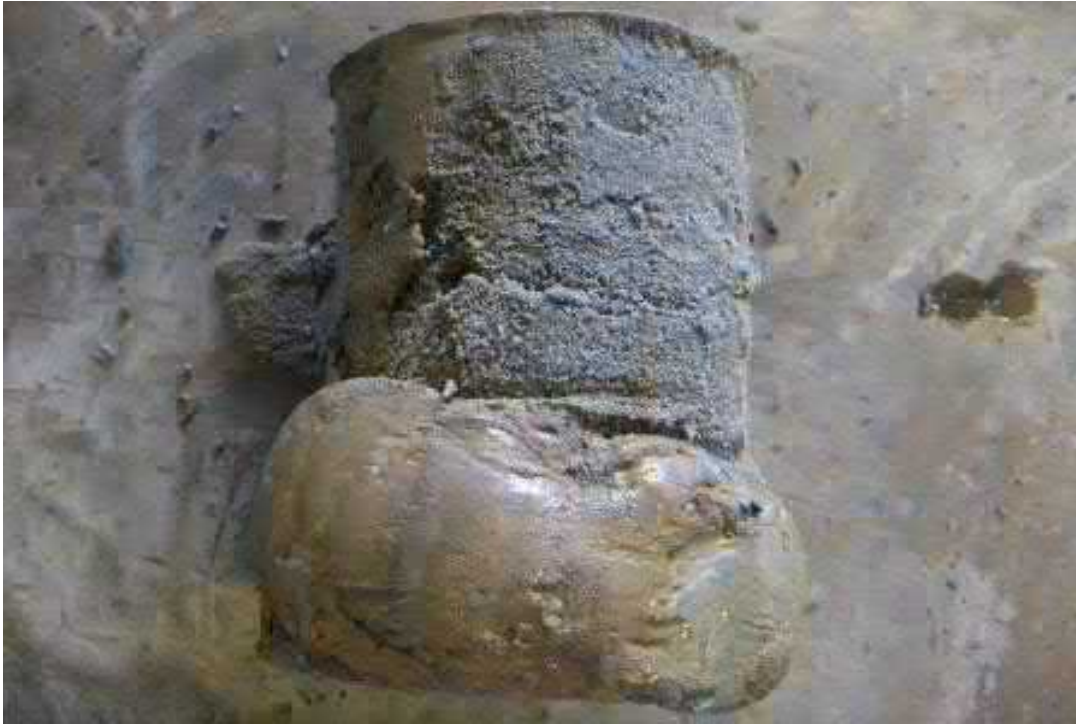
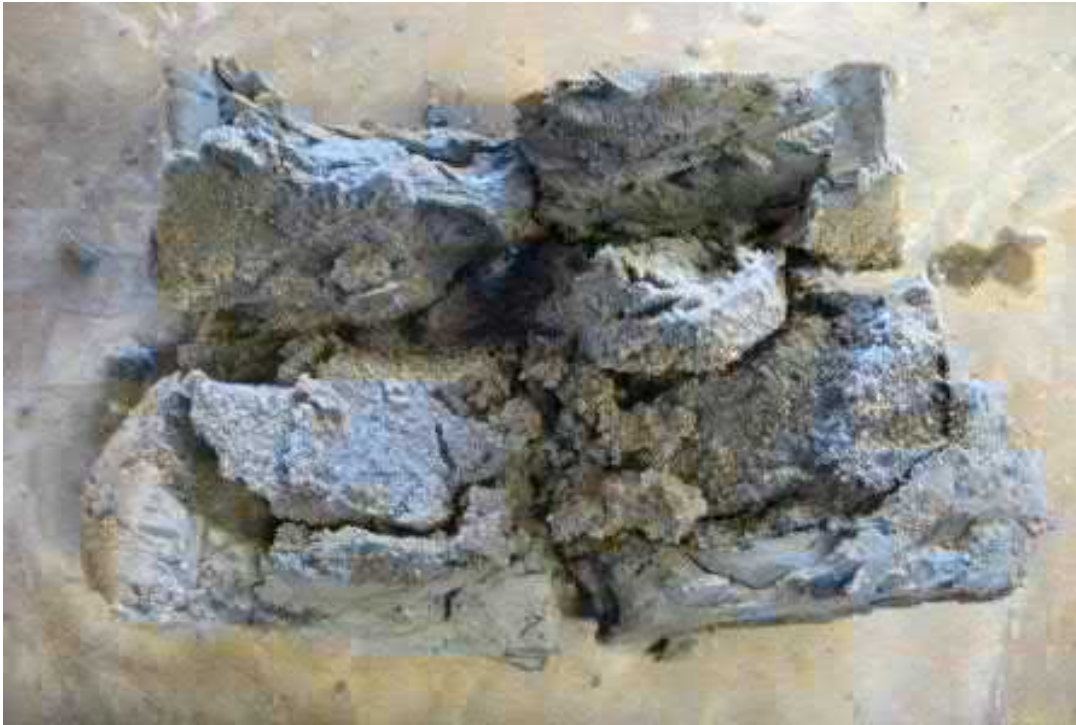
Originator	Checked & Approved	Please note that these photographs are intended to show the failure mode, and do not necessarily show accurately the colouration of the soil.

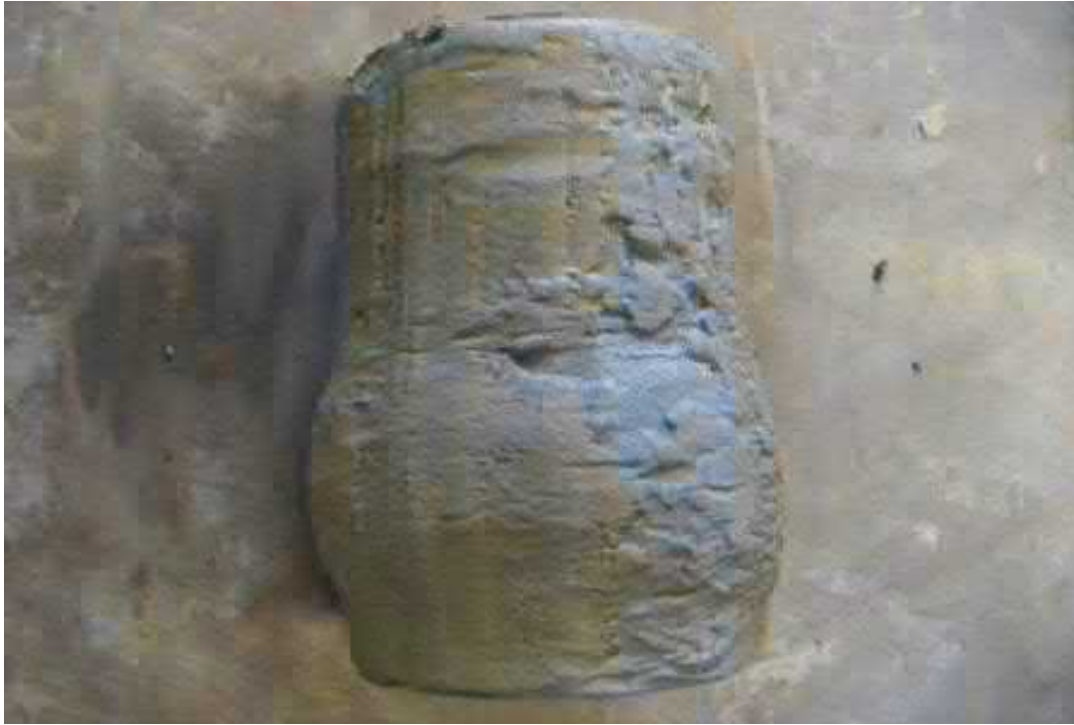
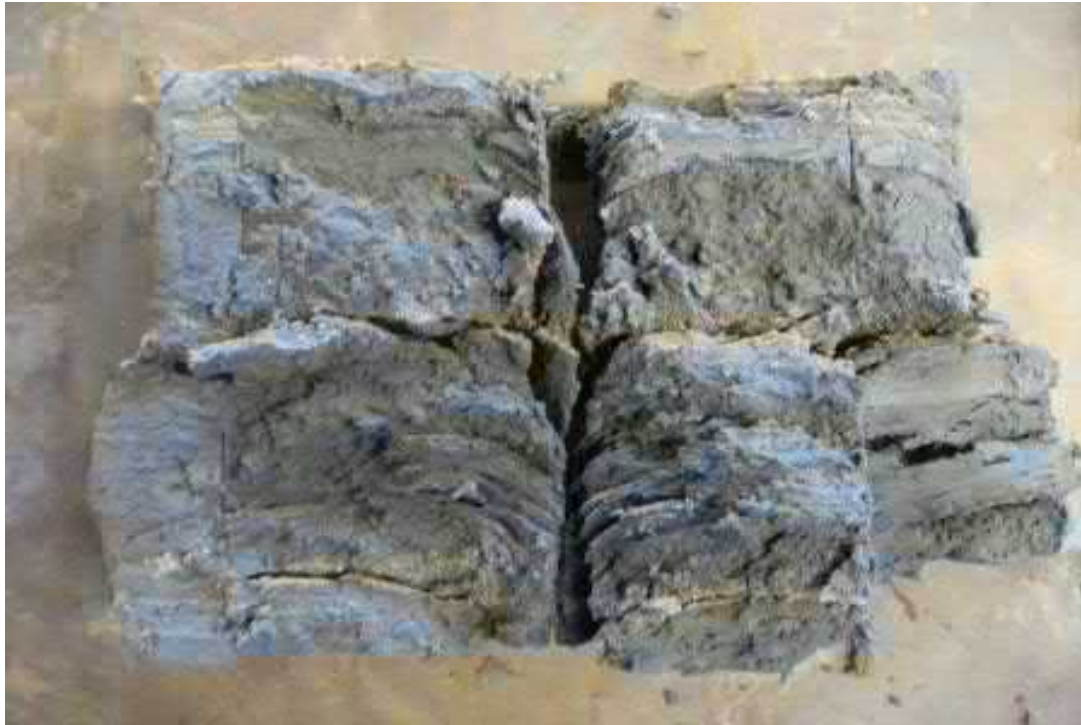
Please note that these photographs are intended to show the failure mode, and do not necessarily show accurately the colouration of the soil.

Membrane Thickness	mm	0.30		
Membrane Correction	kPa	0.53		
Rate of Axial Displacement	%/min	0.86		
Cell Pressure	kPa	1250		
Strain at Failure	%	7.4		
Maximum Deviator Stress	kPa	296		
Shear Strength	kPa	148		
Mode of Failure			Compound

Non Engineering Description: Stiff fissured grey slightly sandy CLAY.

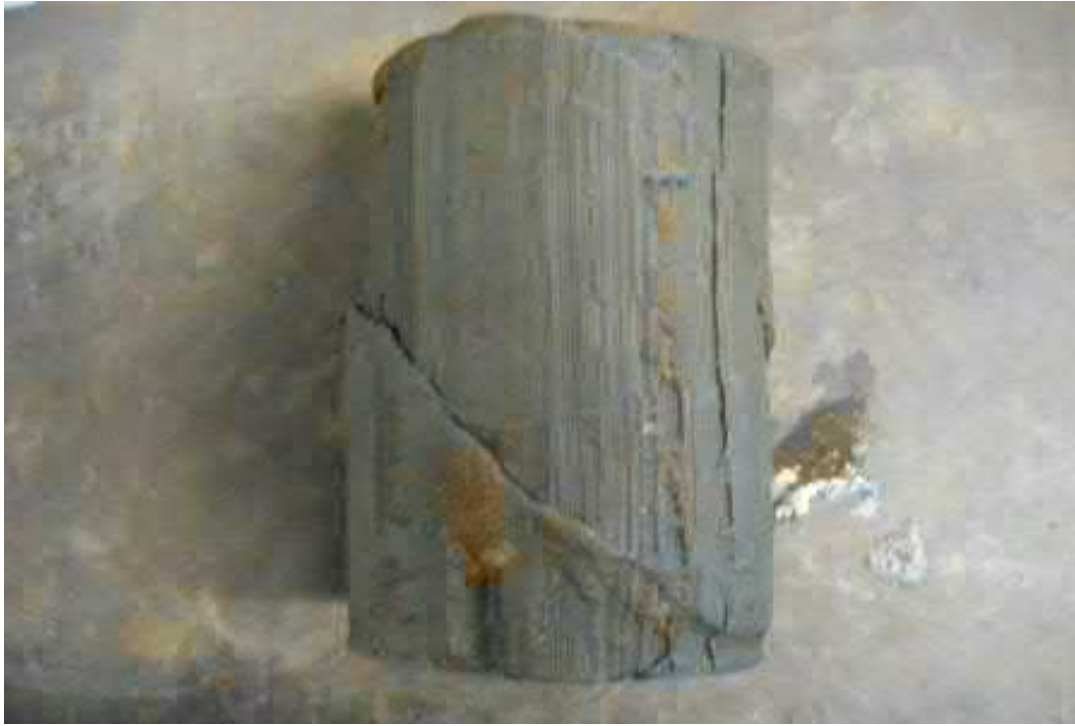
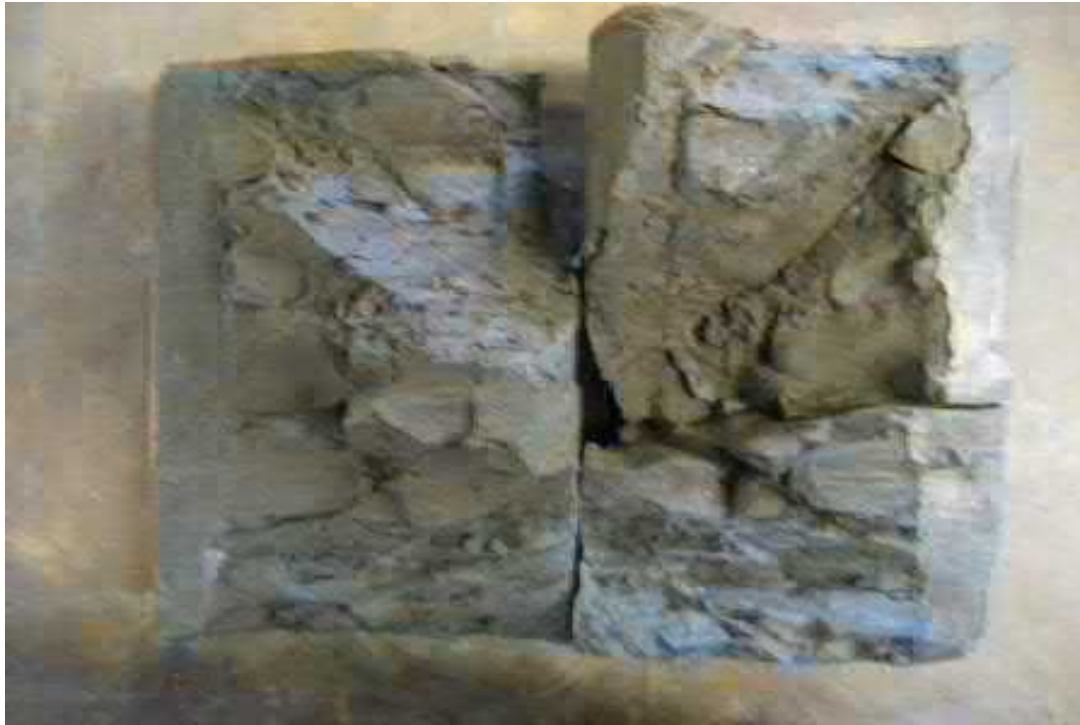
Please note that these photographs are intended to show the failure mode, and do not necessarily show accurately the colouration of the soil.

Membrane Thickness	mm	0.30		
Membrane Correction	kPa	0.63		
Rate of Axial Displacement	%/min	0.93		
Cell Pressure	kPa	1000		
Strain at Failure	%	9.2		
Maximum Deviator Stress	kPa	233		
Shear Strength	kPa	117		
Mode of Failure			Compound

Non Engineering Description: Stiff fissured grey sandy CLAY.

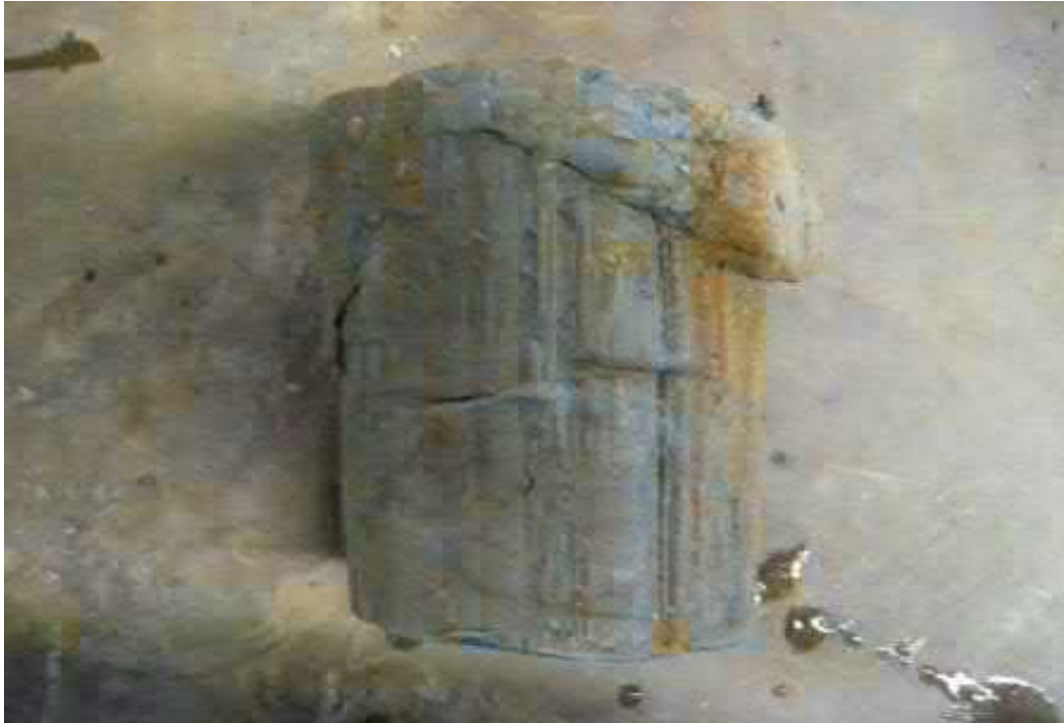
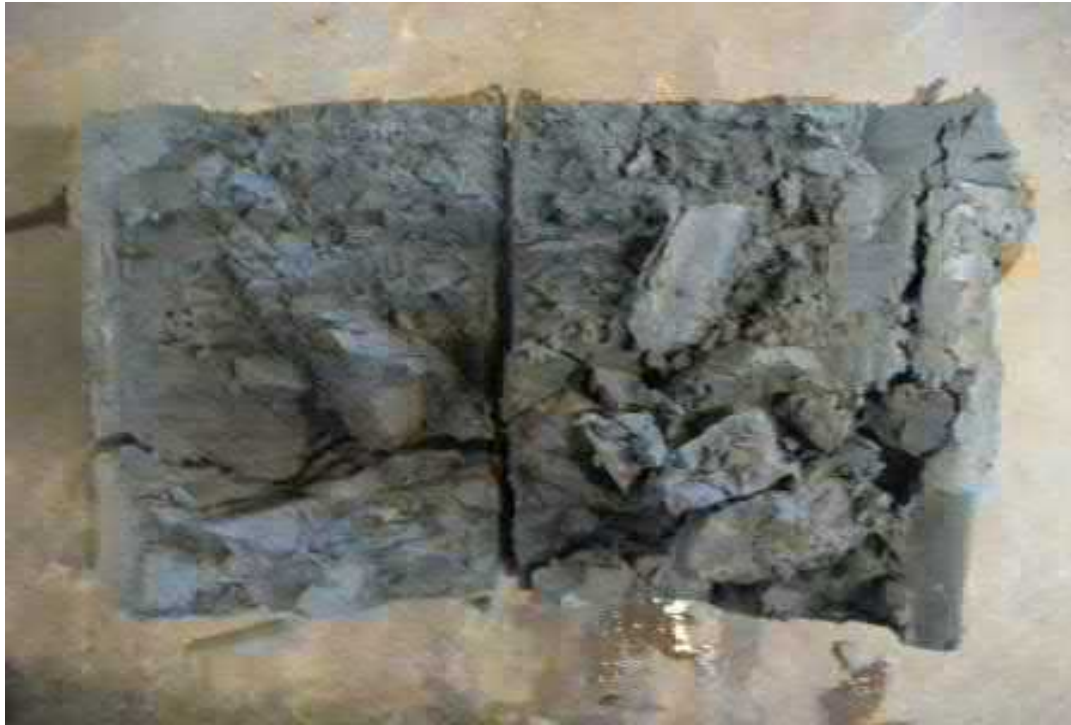
Originator	Checked & Approved	Please note that these photographs are intended to show the failure mode, and do not necessarily show accurately the colouration of the soil.

<b>Sample Details</b>		Undisturbed		
Sample Condition				
Height	mm	177.0		
Diameter	mm	102.8		
Moisture Content	%	34		
Bulk Density	Mg/m <sup>3</sup>	1.92		
Dry Density	Mg/m <sup>3</sup>	1.44		
<b>Test Details</b>				
Membrane Thickness	mm	0.30		
Membrane Correction	kPa	0.75		
Rate of Axial Displacement	%/min	0.86		
Cell Pressure	kPa	1250		
Strain at Failure	%	11.9		
Maximum Deviator Stress	kPa	302		
Shear Strength	kPa	151		
Mode of Failure			Compound	
Non Engineering Description	Very stiff fissured greyish brown slightly sandy CLAY.

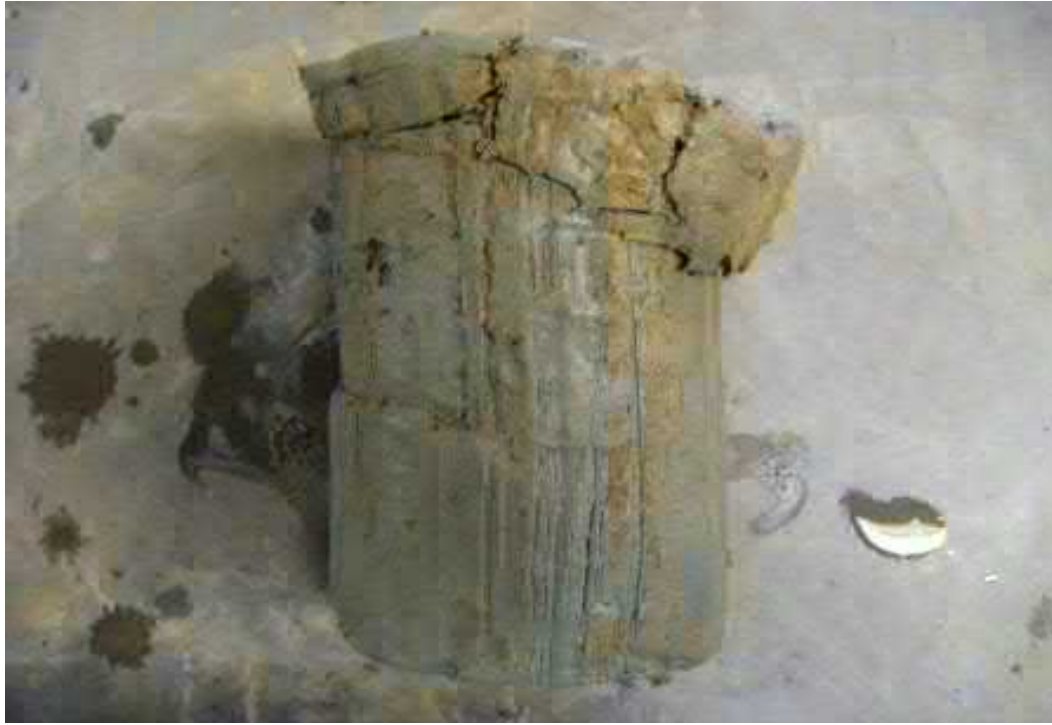
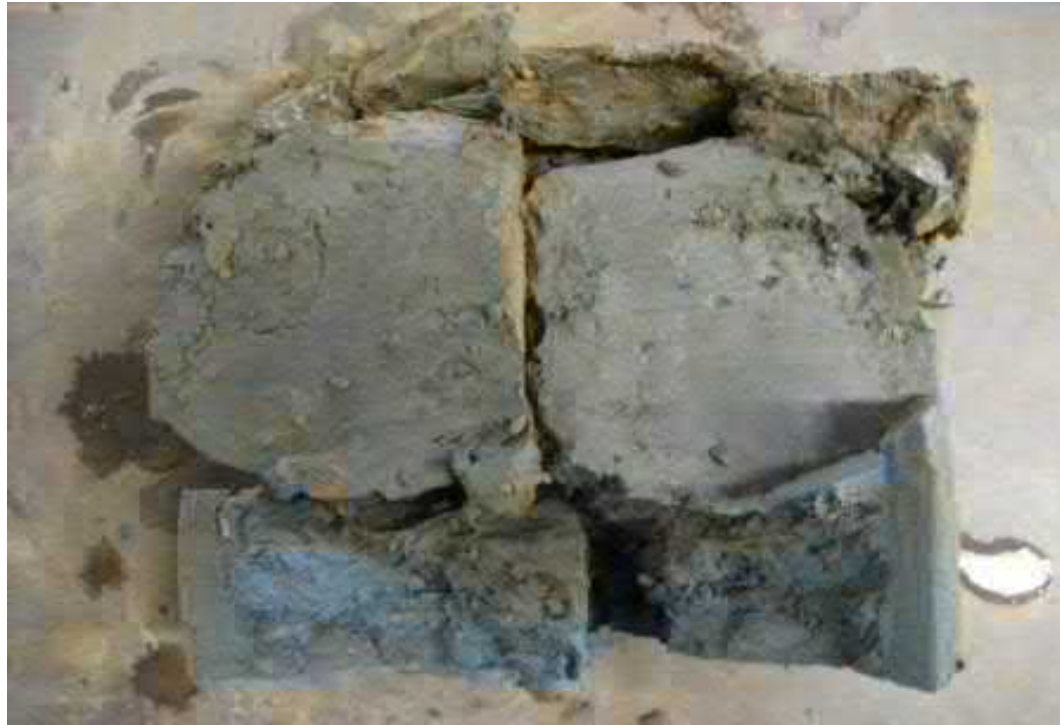
Originator	Checked & Approved	Please note that these photographs are intended to show the failure mode, and do not necessarily show accurately the colouration of the soil.

Membrane Thickness	mm	0.30		
Membrane Correction	kPa	0.41		
Rate of Axial Displacement	%/min	0.77		
Cell Pressure	kPa	1000		
Strain at Failure	%	5.6		
Maximum Deviator Stress	kPa	513		
Shear Strength	kPa	256		
Mode of Failure			Brittle

Non Engineering Description: Very stiff fissured grey slightly sandy CLAY.

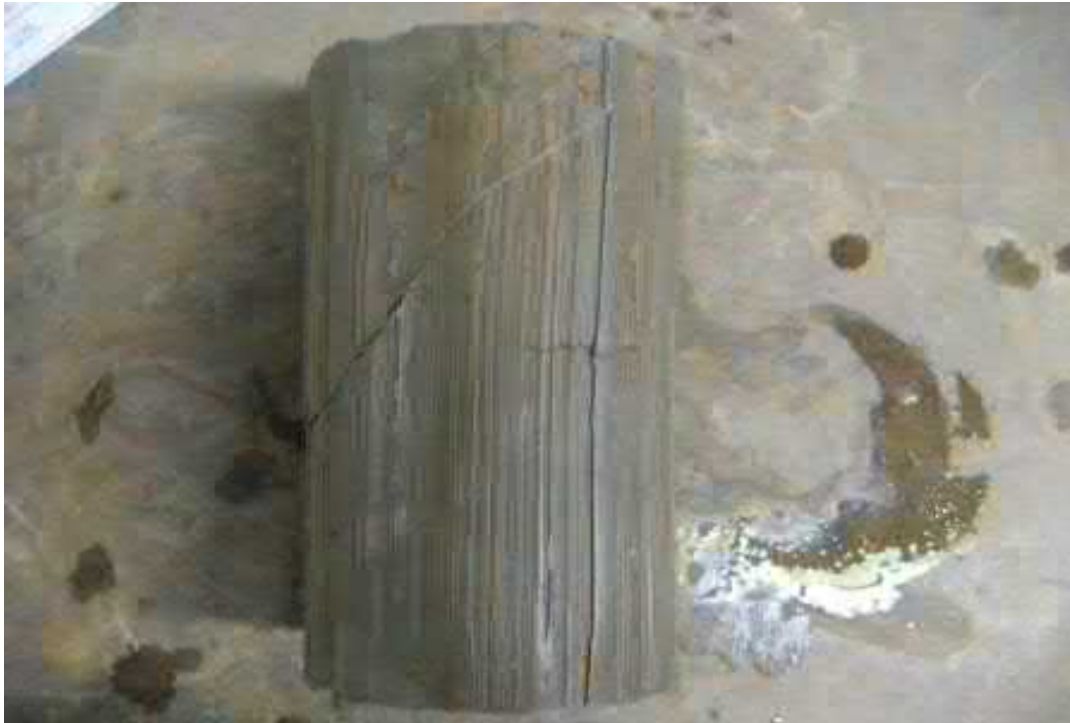
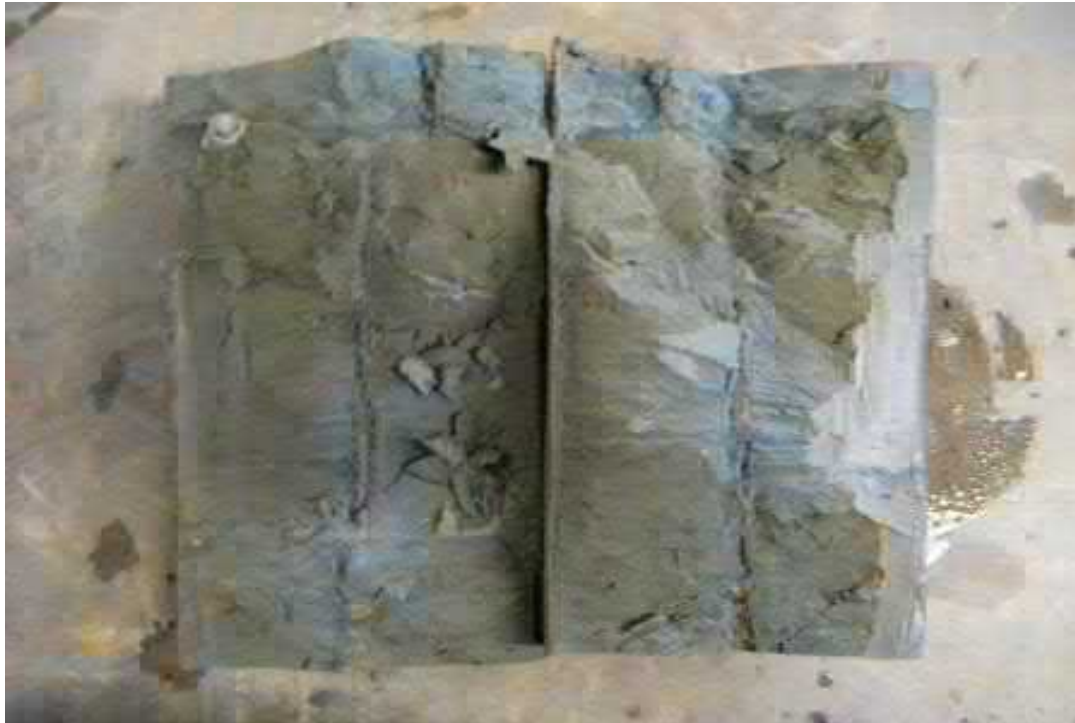
Please note that these photographs are intended to show the failure mode, and do not necessarily show accurately the colouration of the soil.

<b>Sample Details</b>		Undisturbed		
Sample Condition				
Height	mm	177.6		
Diameter	mm	102.4		
Moisture Content	%	28		
Bulk Density	Mg/m <sup>3</sup>	1.97		
Dry Density	Mg/m <sup>3</sup>	1.54		
<b>Test Details</b>				
Membrane Thickness	mm	0.30		
Membrane Correction	kPa	0.38		
Rate of Axial Displacement	%/min	0.86		
Cell Pressure	kPa	1250		
Strain at Failure	%	5.1		
Maximum Deviator Stress	kPa	633		
Shear Strength	kPa	316		
Mode of Failure			Brittle	
Non Engineering Description	Hard fissured greyish brown slightly sandy CLAY

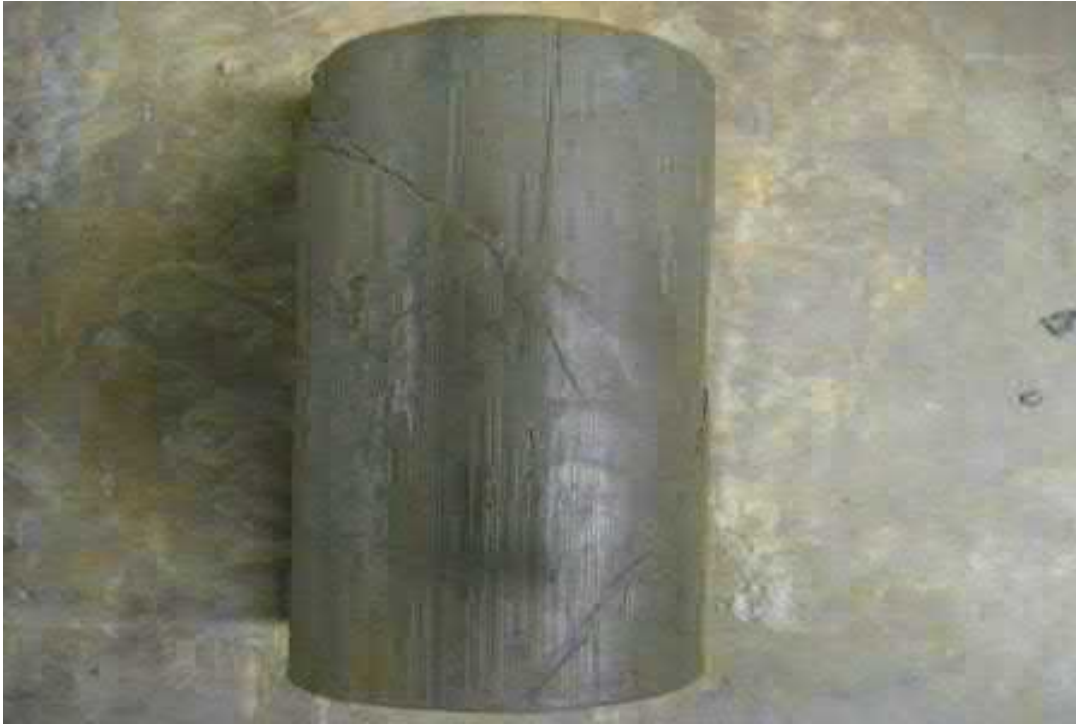
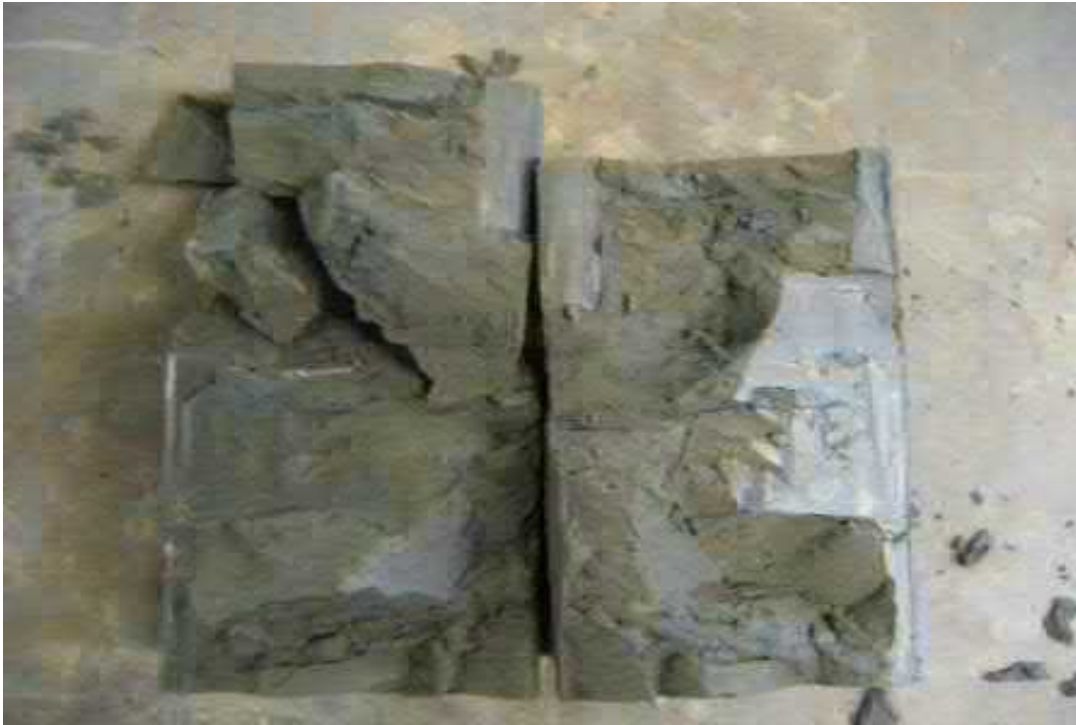
Originator	Checked & Approved	Please note that these photographs are intended to show the failure mode, and do not necessarily show accurately the colouration of the soil.

Sample Details		Undisturbed		
Sample Condition		Undisturbed		
Height	mm	165.8		
Diameter	mm	102.7		
Moisture Content	%	35		
Bulk Density	Mg/m <sup>3</sup>	1.94		
Dry Density	Mg/m <sup>3</sup>	1.44		
Test Details				
Membrane Thickness	mm	0.30		
Membrane Correction	kPa	0.70		
Rate of Axial Displacement	%/min	0.92		
Cell Pressure	kPa	1000		
Strain at Failure	%	10.9		
Maximum Deviator Stress	kPa	367		
Shear Strength	kPa	183		
Mode of Failure			Plastic	
Non Engineering Description		Very stiff fissured greyish brown slightly sandy CLAY.

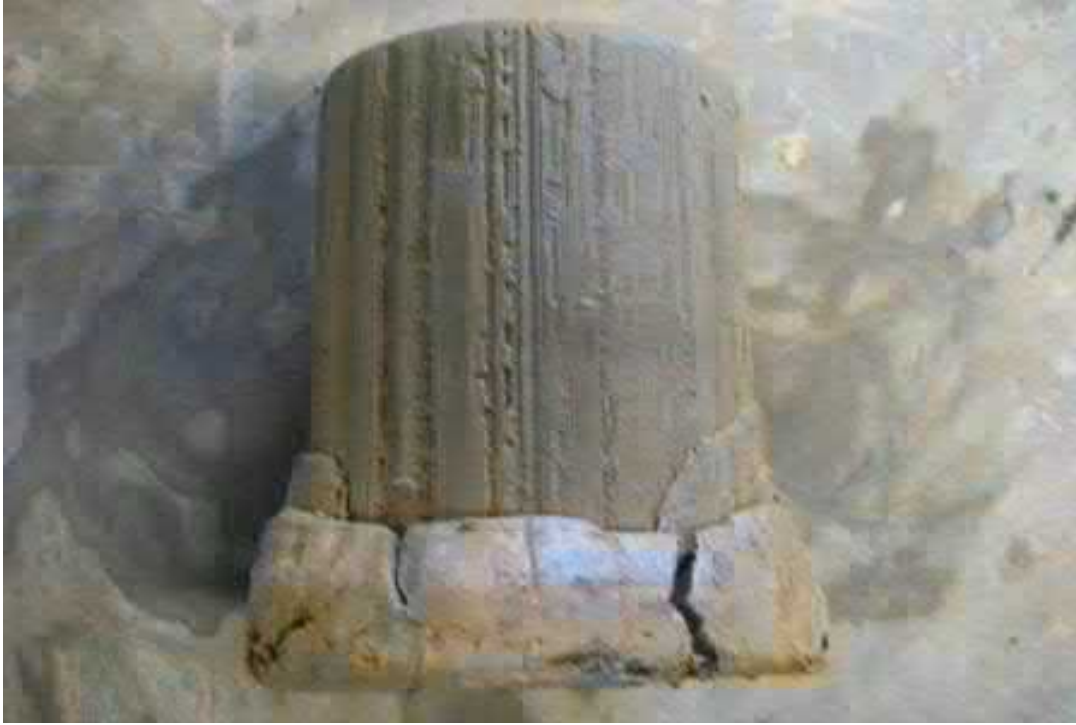
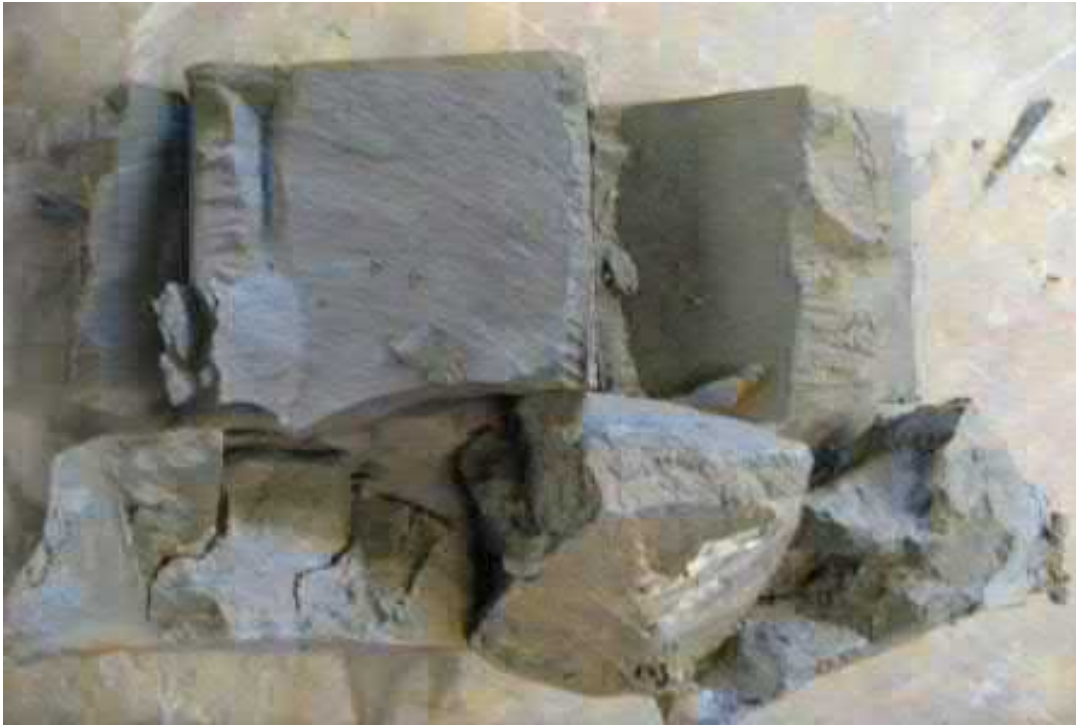
Please note that these photographs are intended to show the failure mode, and do not necessarily show accurately the colouration of the soil.

<b>Sample Details</b>		Undisturbed		
Sample Condition				
Height	mm	200.0		
Diameter	mm	103.8		
Moisture Content	%	18		
Bulk Density	Mg/m <sup>3</sup>	2.15		
Dry Density	Mg/m <sup>3</sup>	1.82		
<b>Test Details</b>				
Membrane Thickness	mm	0.30		
Membrane Correction	kPa	0.34		
Rate of Axial Displacement	%/min	0.76		
Cell Pressure	kPa	600		
Strain at Failure	%	4.5		
Maximum Deviator Stress	kPa	93		
Shear Strength	kPa	47		
Mode of Failure			Plastic	
Non Engineering Description	Firm intact grey silty SAND.

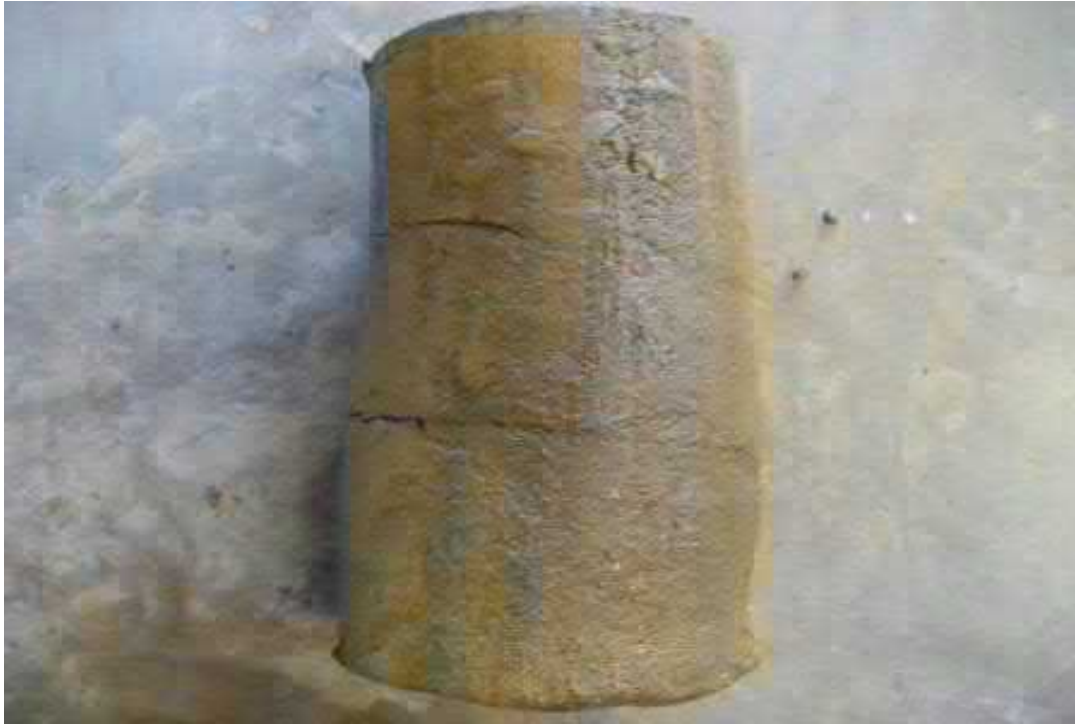
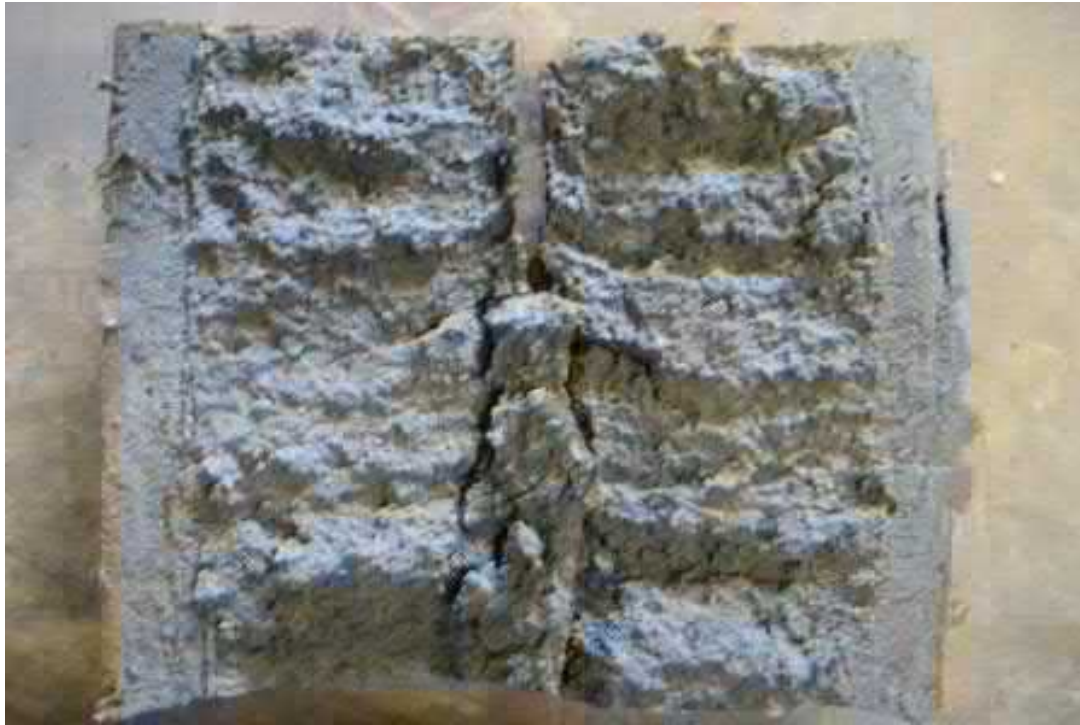
Originator	Checked & Approved	Please note that these photographs are intended to show the failure mode, and do not necessarily show accurately the colouration of the soil.

<b>Sample Details</b>		Undisturbed		
Sample Condition				
Height	mm	175.3		
Diameter	mm	103.8		
Moisture Content	%	26		
Bulk Density	Mg/m <sup>3</sup>	2.04		
Dry Density	Mg/m <sup>3</sup>	1.62		
<b>Test Details</b>				
Membrane Thickness	mm	0.30		
Membrane Correction	kPa	0.35		
Rate of Axial Displacement	%/min	0.87		
Cell Pressure	kPa	600		
Strain at Failure	%	4.6		
Maximum Deviator Stress	kPa	29		
Shear Strength	kPa	15		
Mode of Failure			Plastic	
Non Engineering Description		Very soft intact sandy CLAY.
