# **Great Yarmouth Third River Crossing**

## **Application for Development Consent Order**

### **Document 6.2: Environmental Statement Volume II: Technical Appendix 16A: Legislation, Policy and Guidance**

Document Reference: 6.2 – Technical Appendix 16A

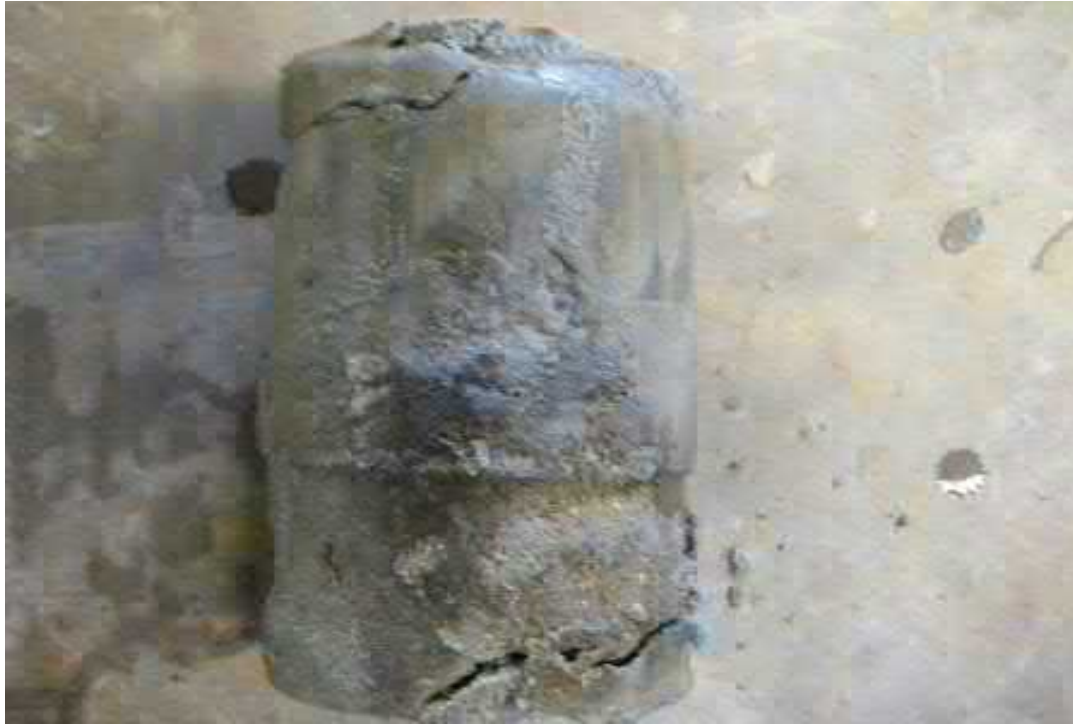
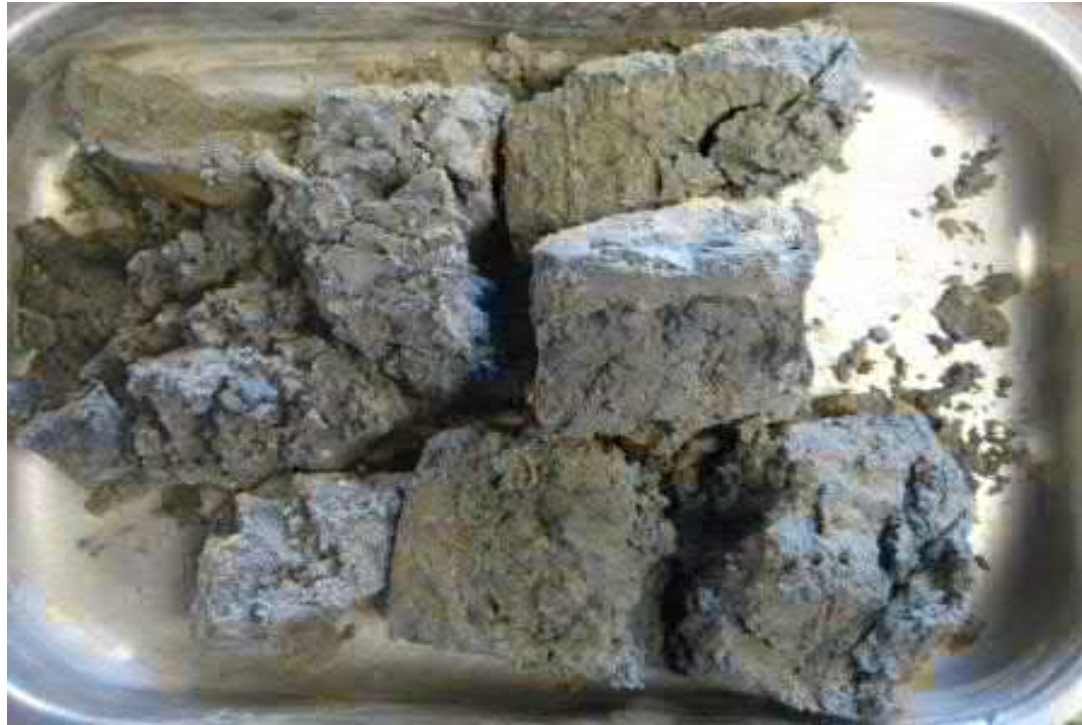
Please note that these photographs are intended to show the failure mode, and do not necessarily show accurately the colouration of the soil.

<b>Sample Details</b>		Undisturbed		
Sample Condition				
Height	mm	165.3		
Diameter	mm	103.5		
Moisture Content	%	33		
Bulk Density	Mg/m <sup>3</sup>	1.94		
Dry Density	Mg/m <sup>3</sup>	1.46		
<b>Test Details</b>				
Membrane Thickness	mm	0.30		
Membrane Correction	kPa	0.44		
Rate of Axial Displacement	%/min	0.92		
Cell Pressure	kPa	1250		
Strain at Failure	%	6.1		
Maximum Deviator Stress	kPa	430		
Shear Strength	kPa	215		
Mode of Failure			Compound	
Non Engineering Description	Very stiff fissured grey mottled brown slightly sandy CLAY.

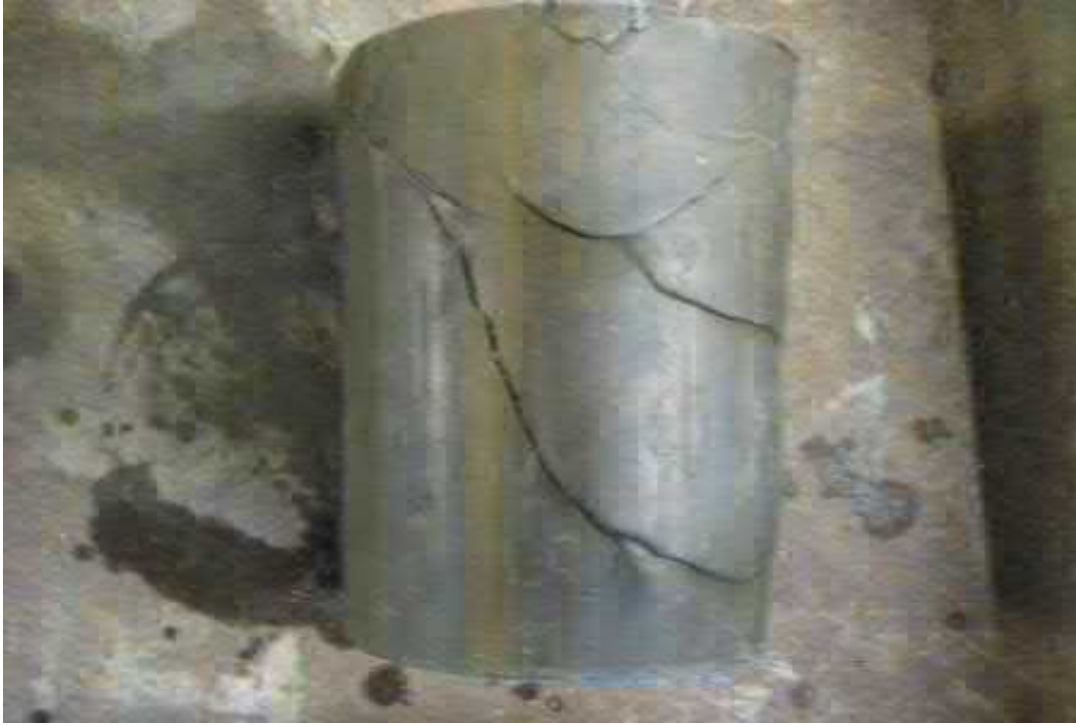
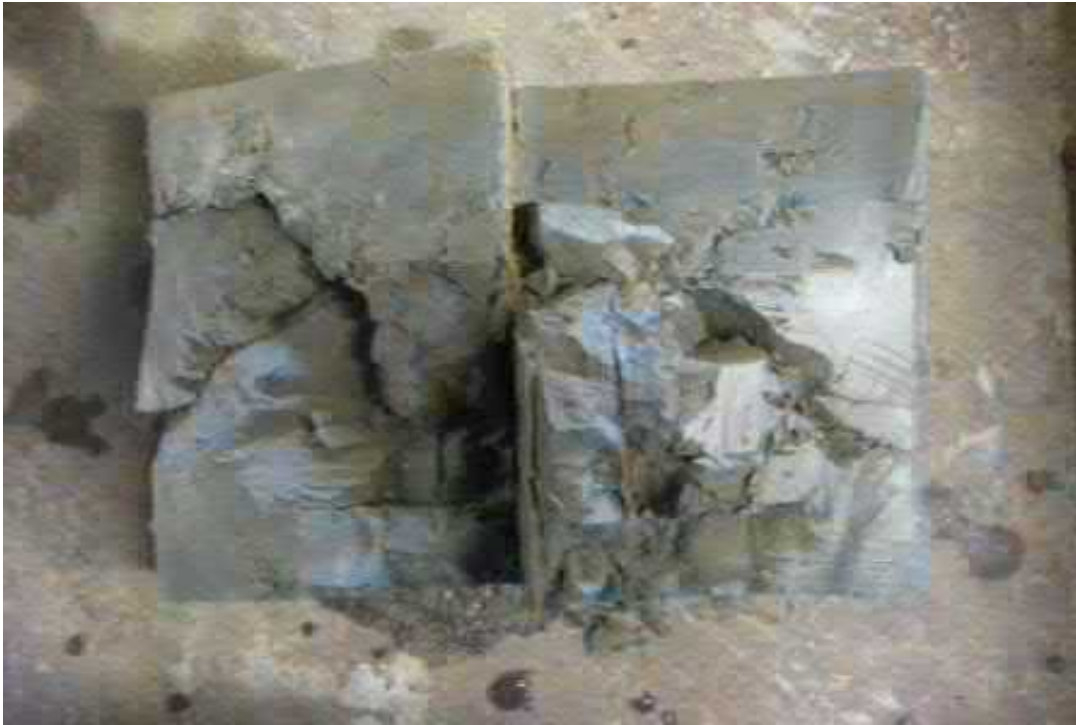
Please note that these photographs are intended to show the failure mode, and do not necessarily show accurately the colouration of the soil.

Membrane Thickness	mm	0.30		
Membrane Correction	kPa	1.12		
Rate of Axial Displacement	%/min	0.86		
Cell Pressure	kPa	1000		
Strain at Failure	%	20.5		
Maximum Deviator Stress	kPa	222		
Shear Strength	kPa	111		
Mode of Failure			Compound

Non Engineering Description: Stiff fissured grey mottled brown slightly sandy CLAY.

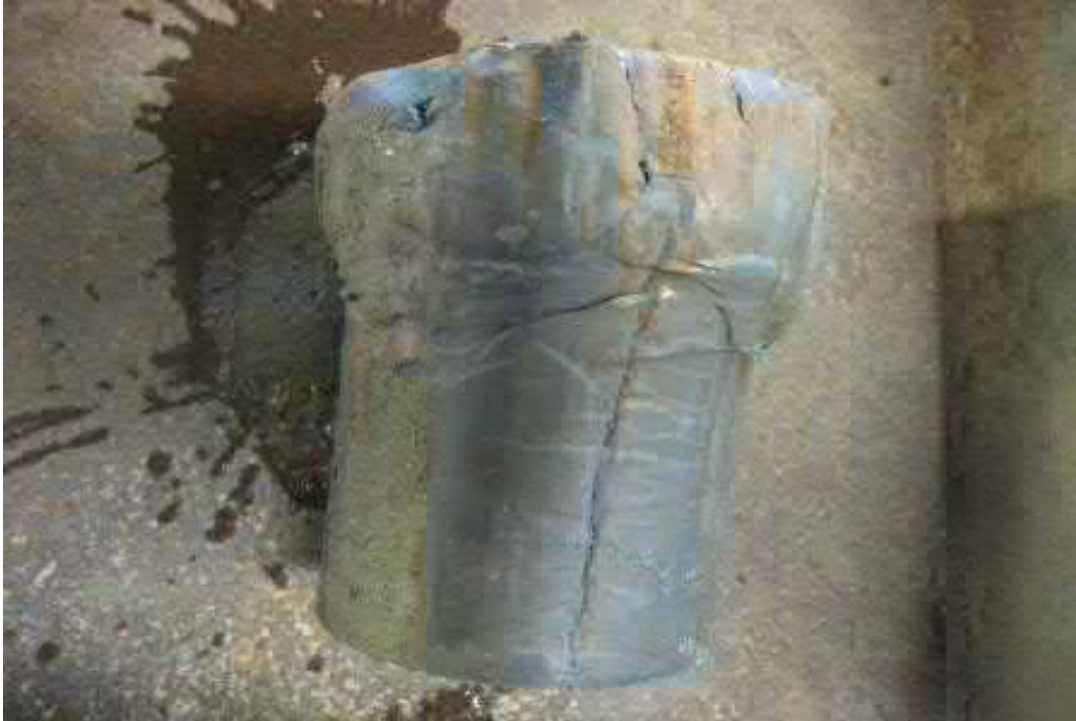
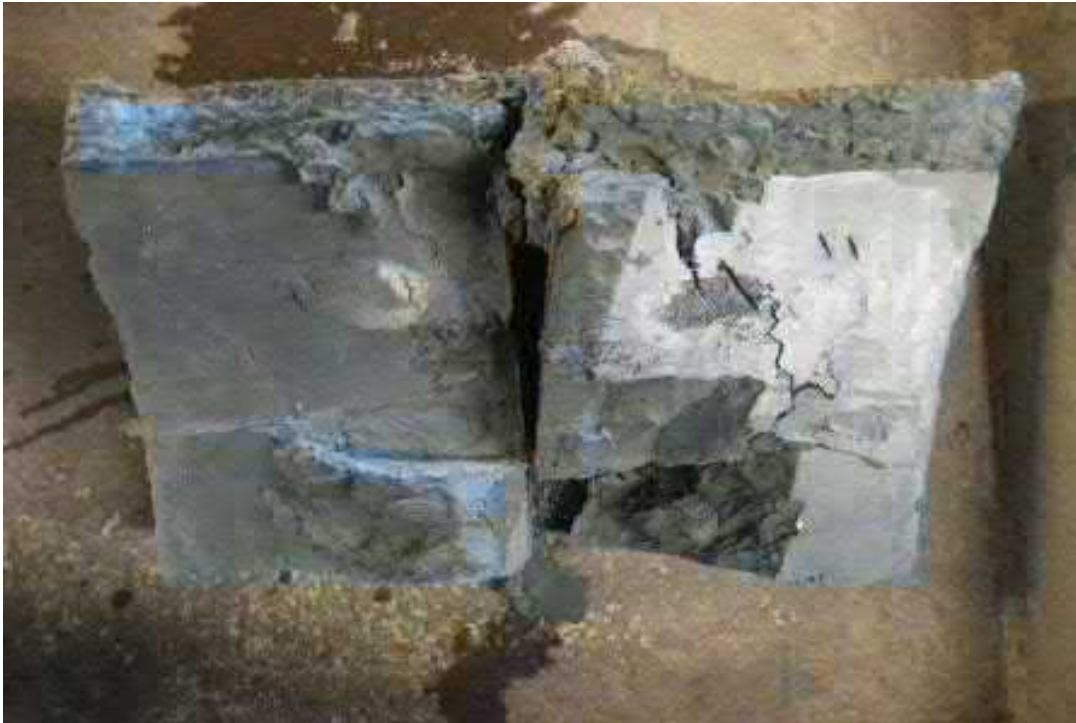
Please note that these photographs are intended to show the failure mode, and do not necessarily show accurately the colouration of the soil.

<b>Sample Details</b>		Undisturbed		
Sample Condition				
Height	mm	176.6		
Diameter	mm	103.6		
Moisture Content	%	22		
Bulk Density	Mg/m <sup>3</sup>	1.85		
Dry Density	Mg/m <sup>3</sup>	1.51		
<b>Test Details</b>				
Membrane Thickness	mm	0.30		
Membrane Correction	kPa	0.55		
Rate of Axial Displacement	%/min	0.86		
Cell Pressure	kPa	1250		
Strain at Failure	%	7.9		
Maximum Deviator Stress	kPa	206		
Shear Strength	kPa	103		
Mode of Failure			Compound	
Non Engineering Description	Stiff fissured brown slightly sandy CLAY.

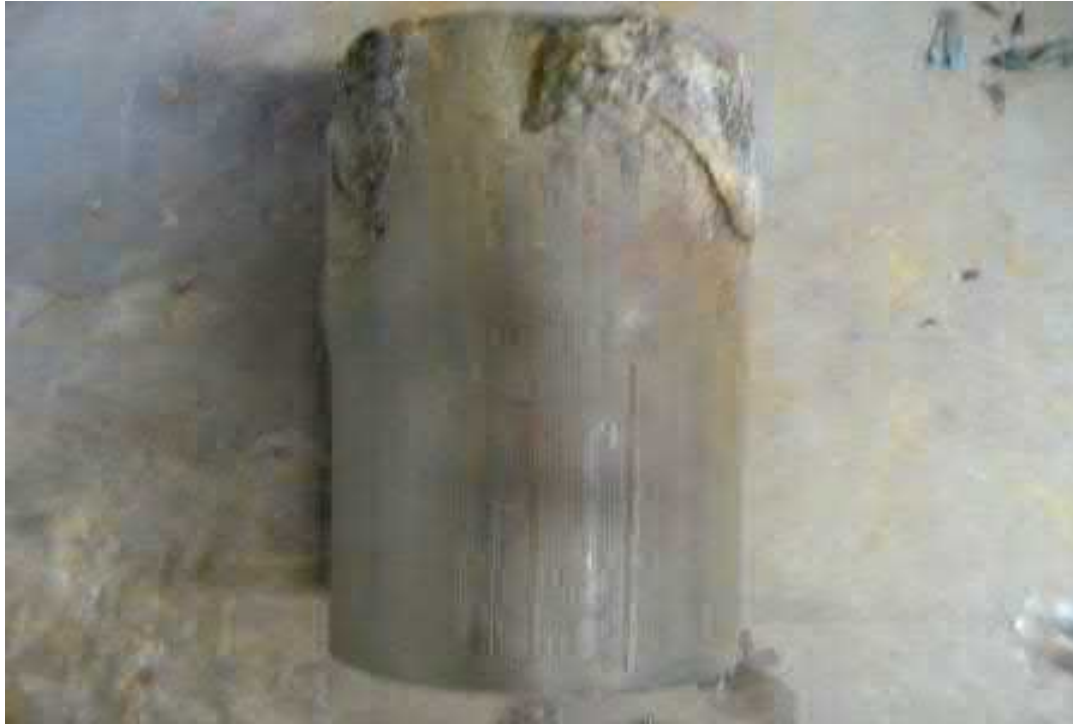
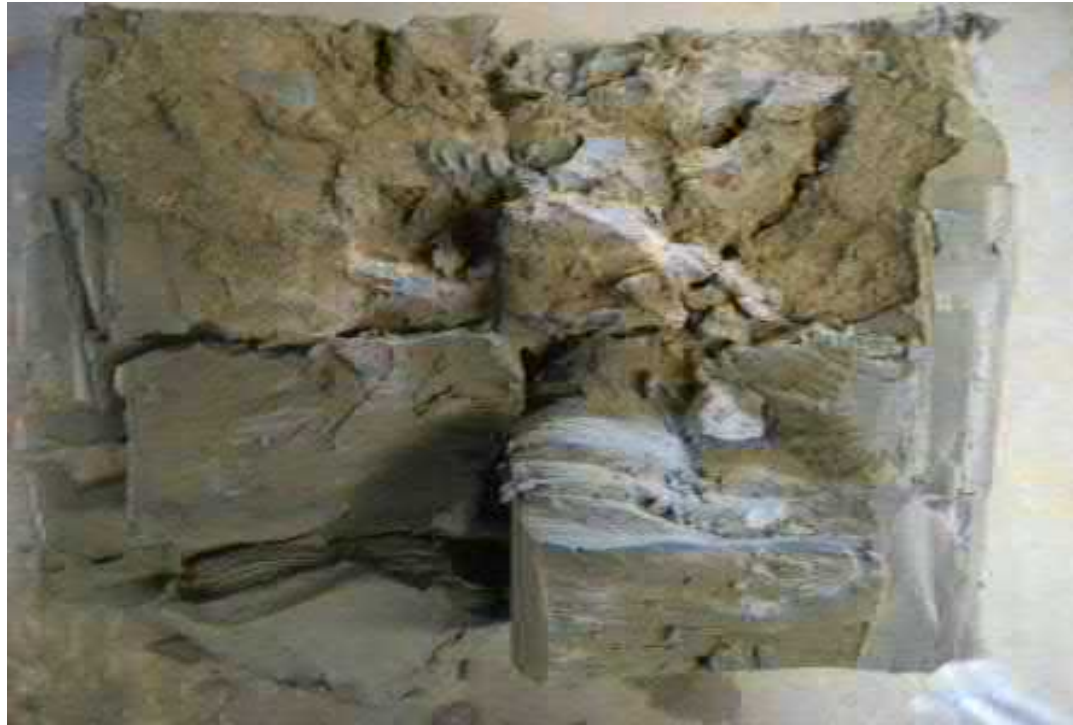
Please note that these photographs are intended to show the failure mode, and do not necessarily show accurately the colouration of the soil.

Membrane Thickness	mm	0.30		
Membrane Correction	kPa	0.29		
Rate of Axial Displacement	%/min	0.76		
Cell Pressure	kPa	1000		
Strain at Failure	%	3.8		
Maximum Deviator Stress	kPa	516		
Shear Strength	kPa	258		
Mode of Failure			Brittle

Non Engineering Description: Very stiff fissured brown slightly sandy CLAY.

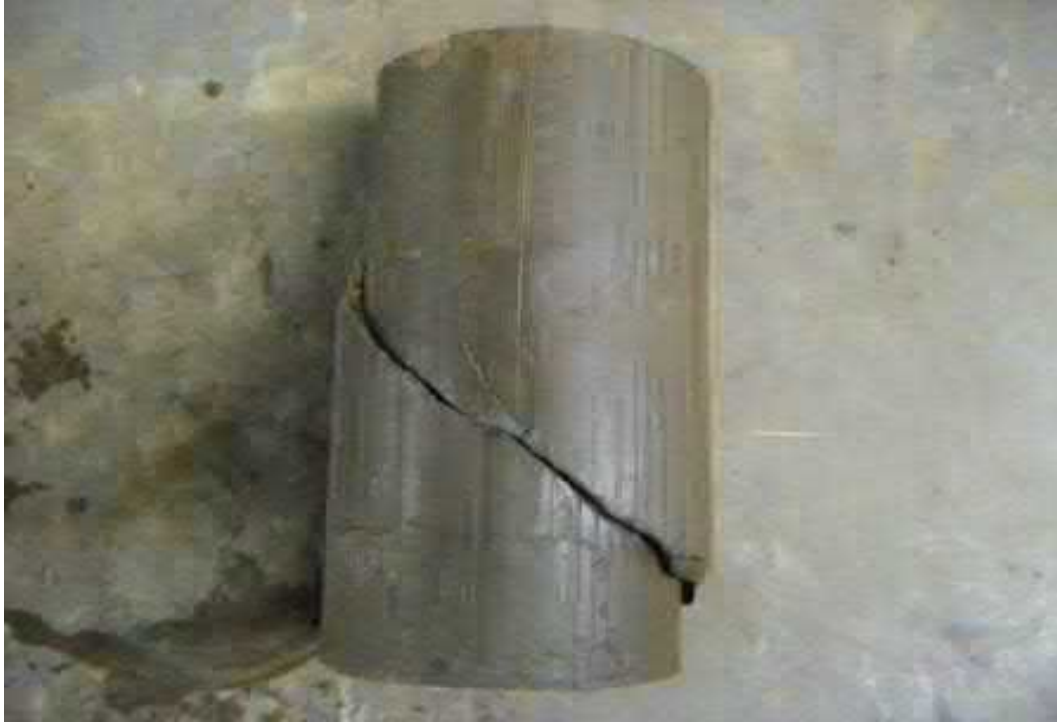
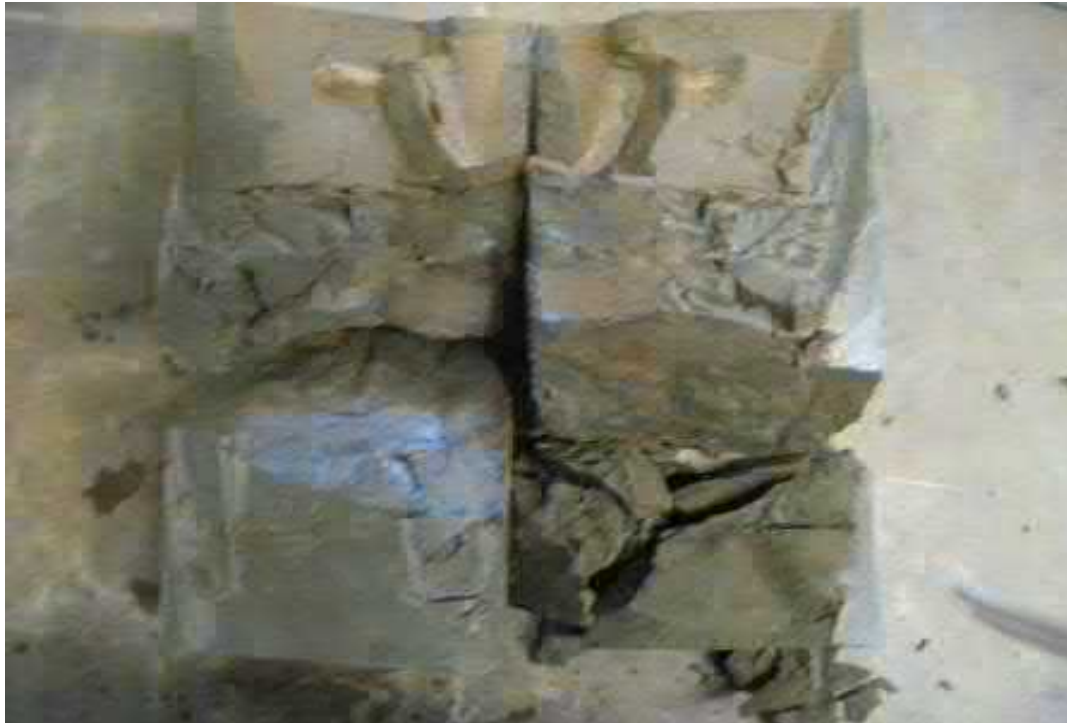
Please note that these photographs are intended to show the failure mode, and do not necessarily show accurately the colouration of the soil.

Non Engineering Description: Hard fissured dark brown slightly sandy CLAY.

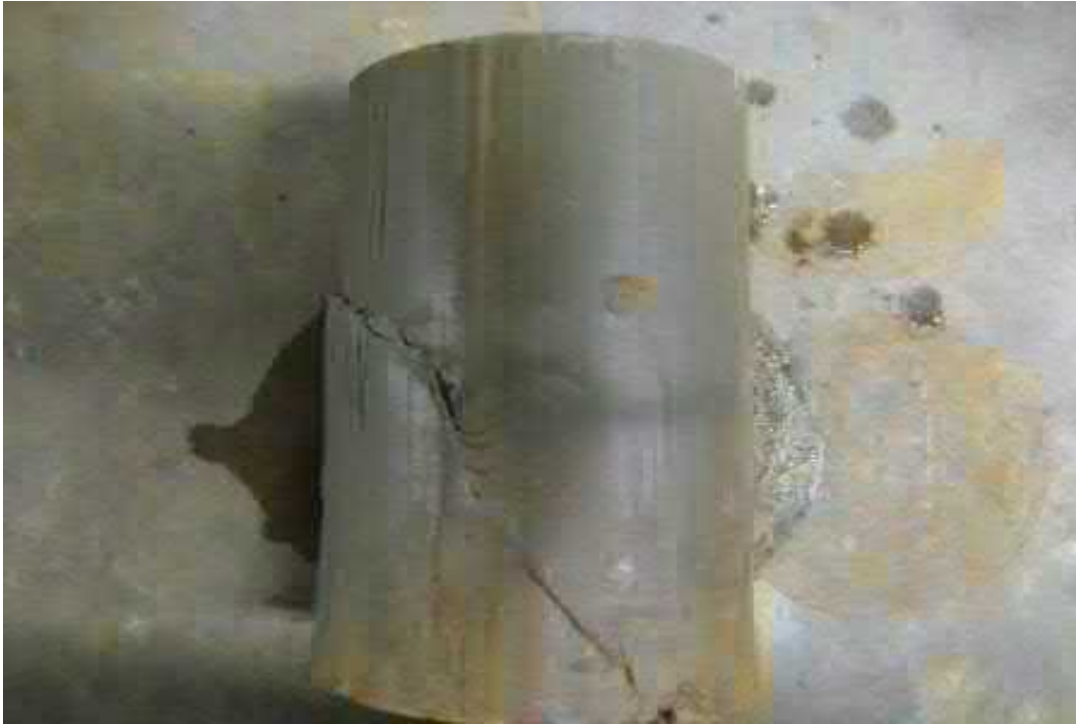
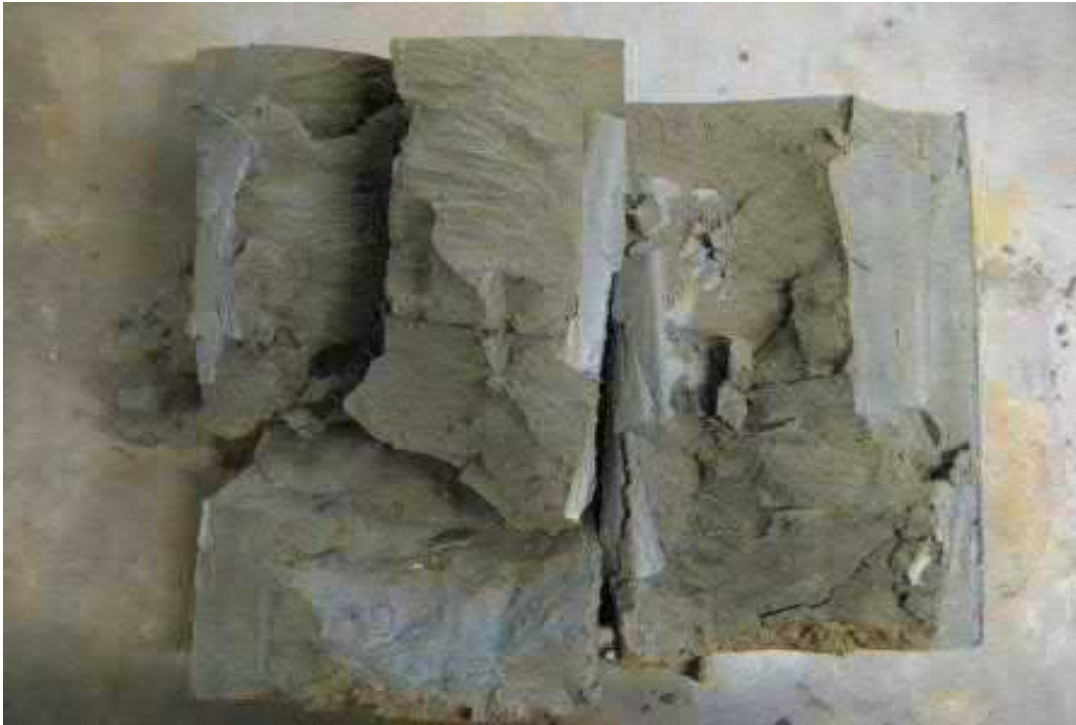
Originator	Checked & Approved	Please note that these photographs are intended to show the failure mode, and do not necessarily show accurately the colouration of the soil.

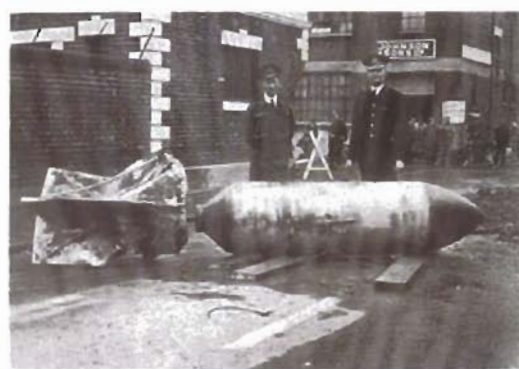
*Admiralty Road, June 5th, 1941*

**An unexploded high explosive bomb recovered in Admiralty Road.  
This bomb was the only one dropped in a raid on 5<sup>th</sup> June 1941.**

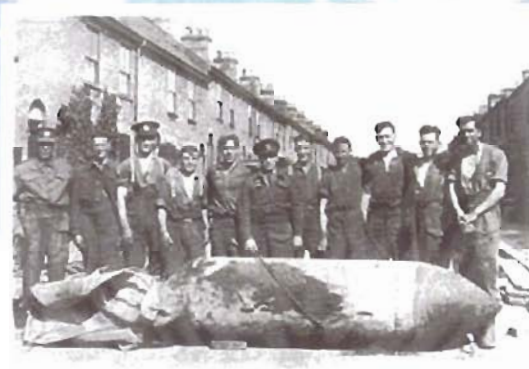
*Fredrick Road, Gorleston, June 12th, 1941*

**A 4,000lb bomb which failed to explode in Fredrick Road, Gorleston.  
This was one of three bombs dropped on 12<sup>th</sup> June 1941.**

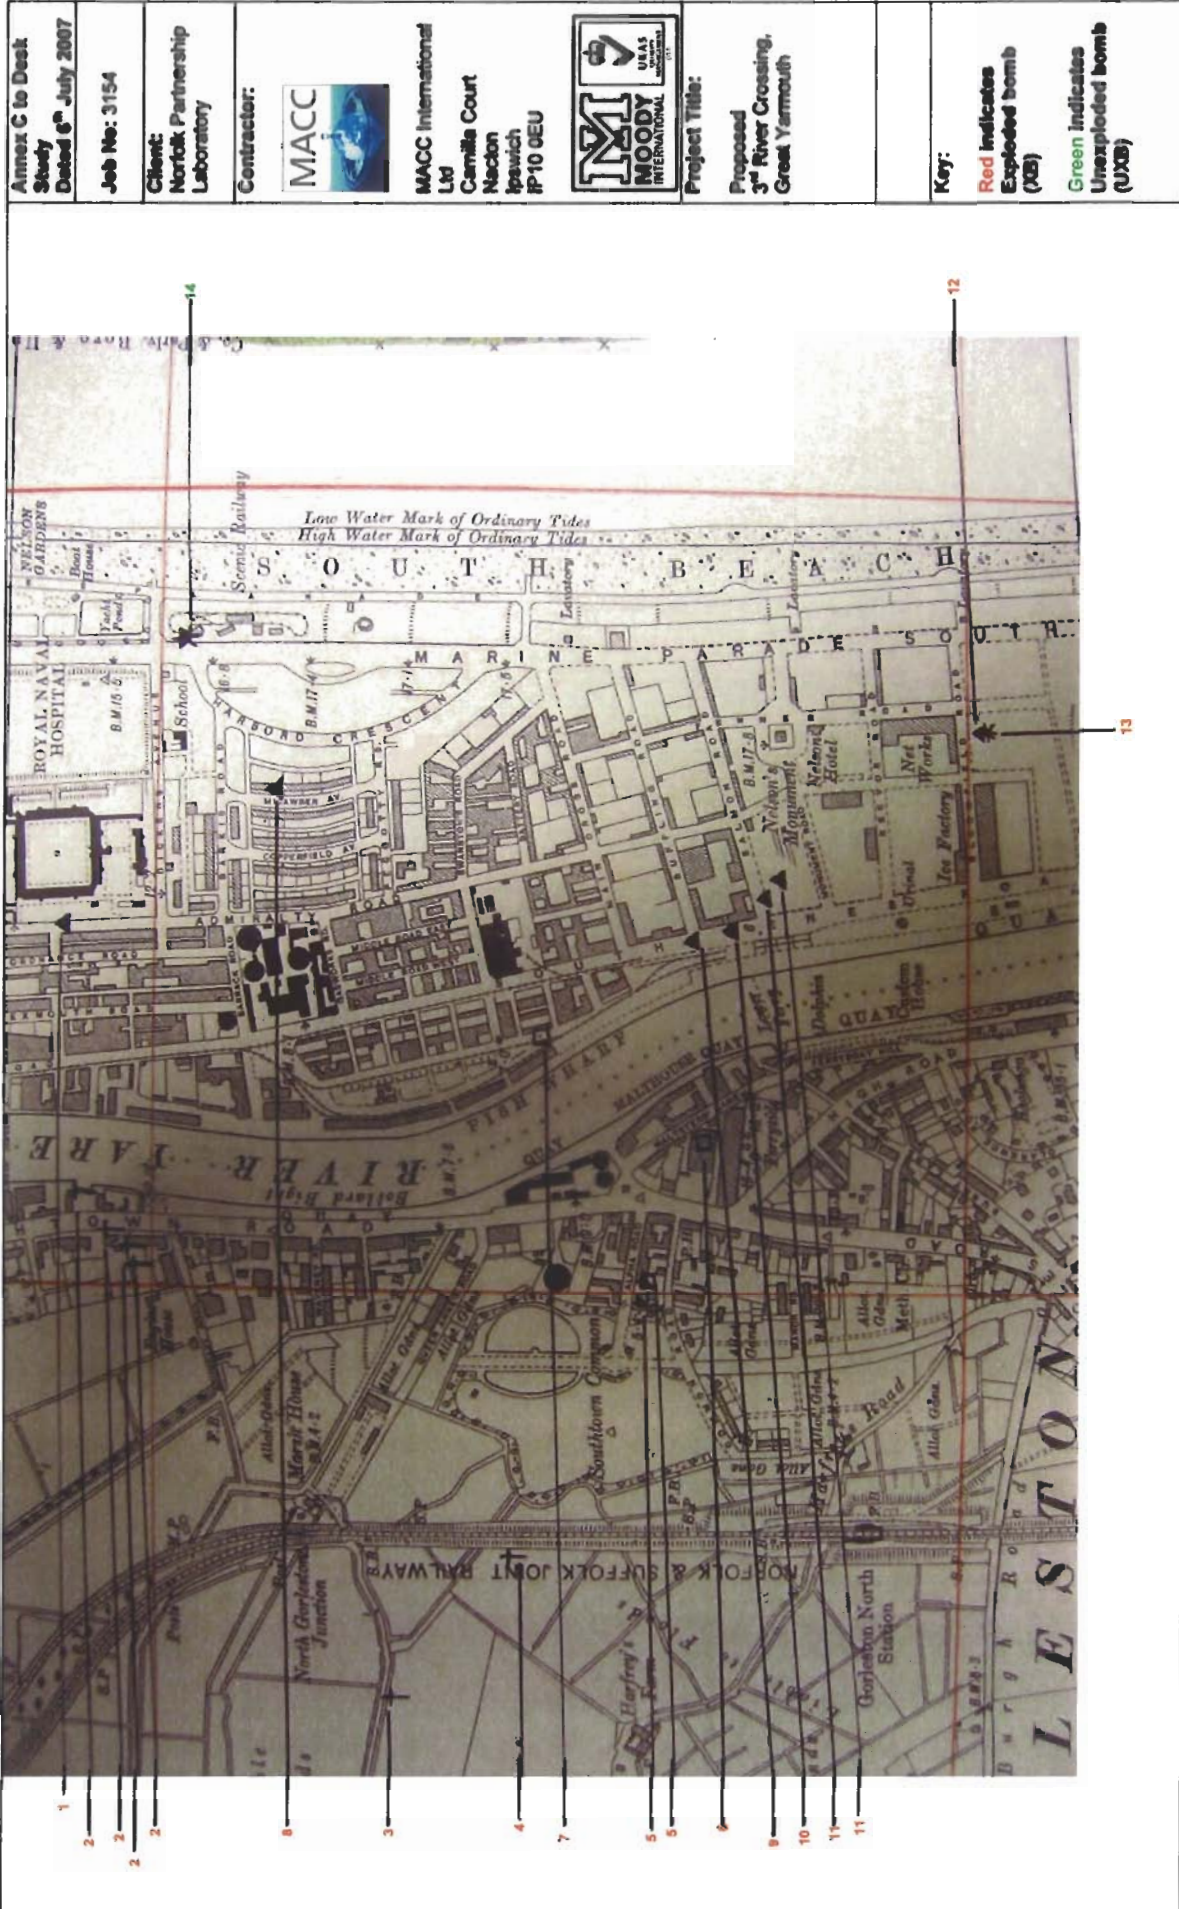
**BOMB PLOT MAP 1**

Note: Bomb numbers refer to locations in Annexes C, D and E.

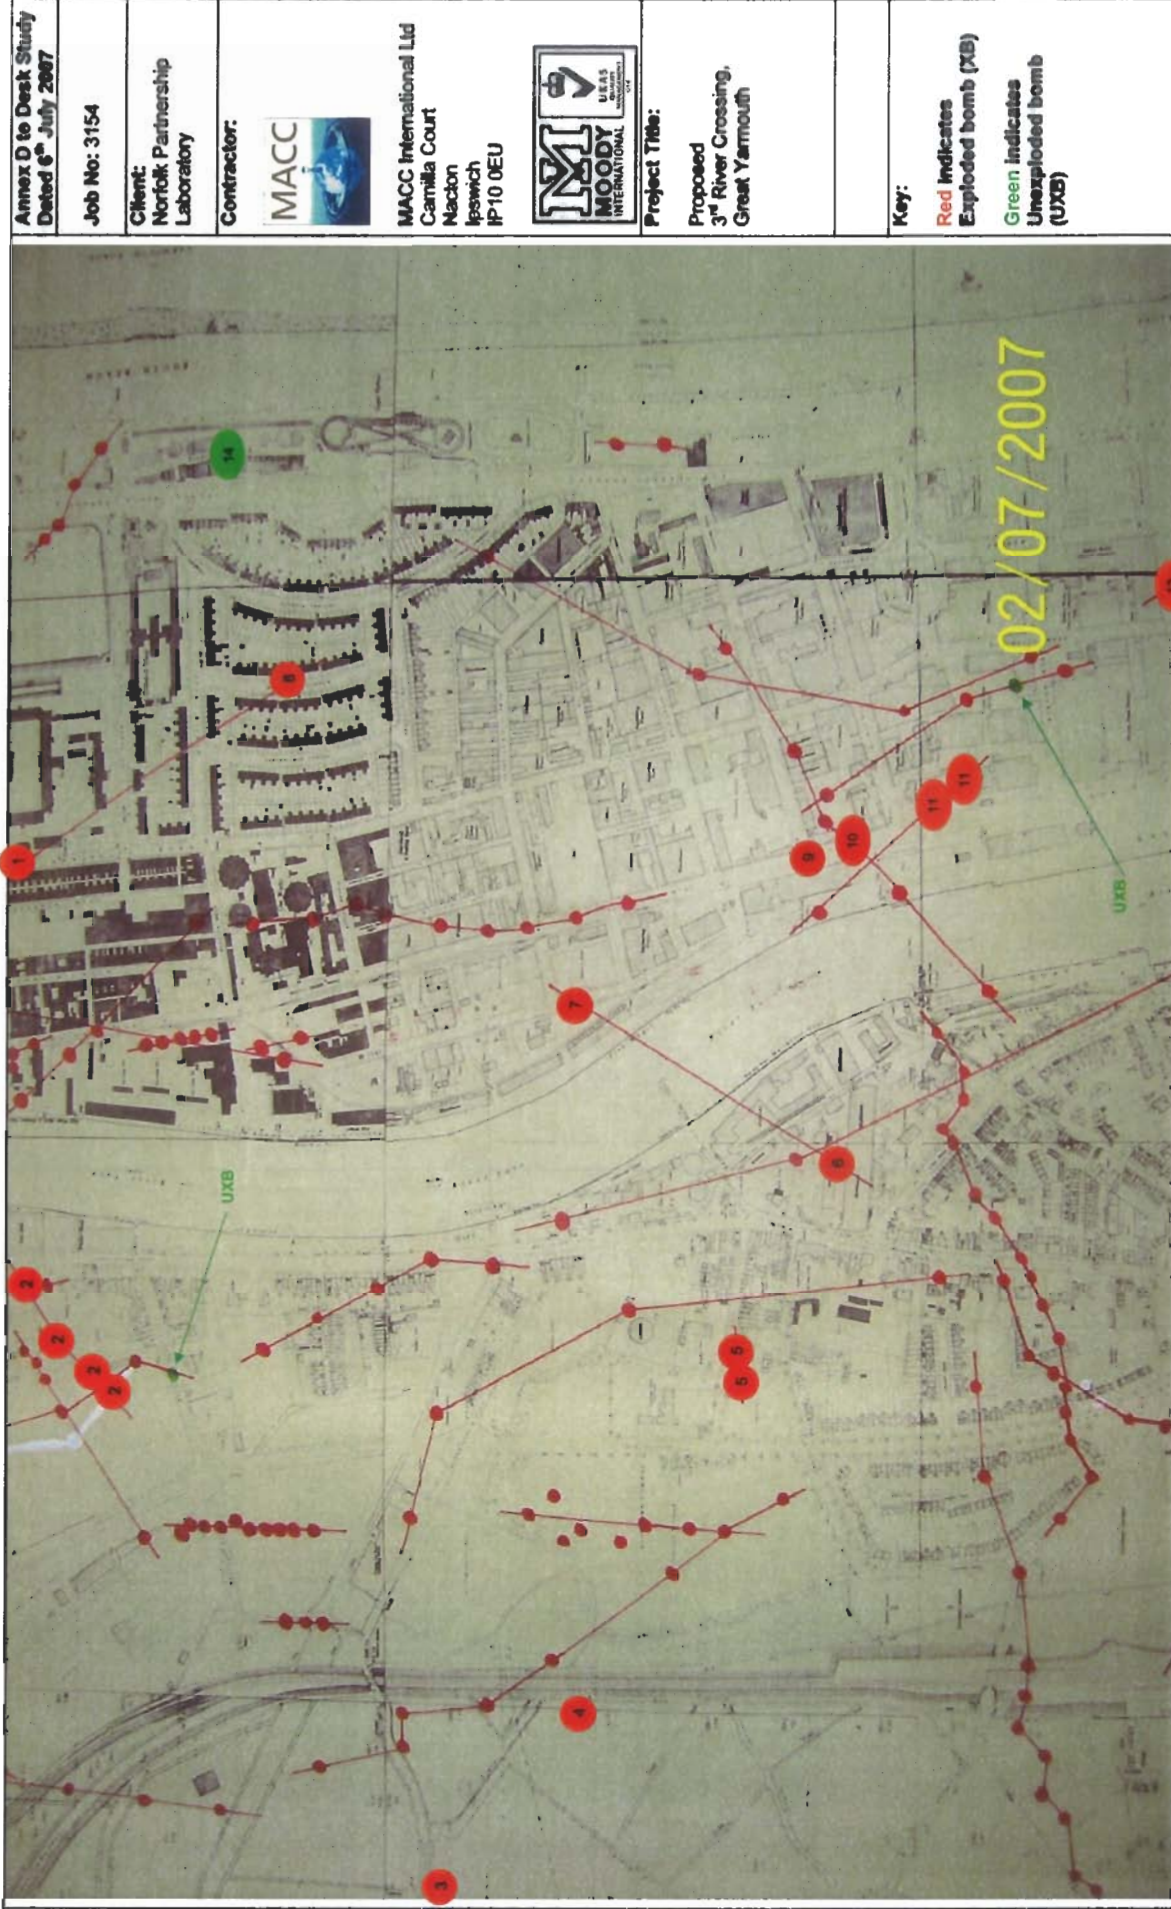
**BOMB PLOT MAP 2**

<b>Annex D to Desk Study</b> Dated 6 <sup>th</sup> July 2007	<b>Job No:</b> 3154
<b>Client:</b> Norfolk Partnership Laboratory	<b>Contractor:</b>   MACC International Ltd Carnilla Court Nacton Ipswich IP10 0EU
<b>Project Title:</b> Proposed 3 <sup>rd</sup> River Crossing, Great Yarmouth	  MOODY INTERNATIONAL UKAS INTERNATIONAL CERT
<b>Key:</b> Red indicates Exploded bomb (XB) Green indicates Unexploded bomb (UXB)

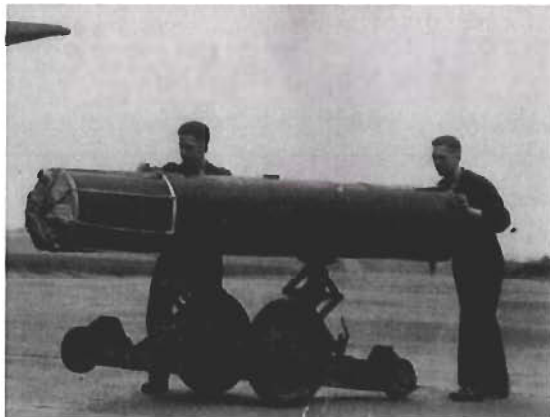
PARACHUTE MINE

**Type 'C'** – 8ft 8in long weighing 1000kg with parachute.

**Type 'D'** – 5ft 8in long weighing 500kg with parachute.

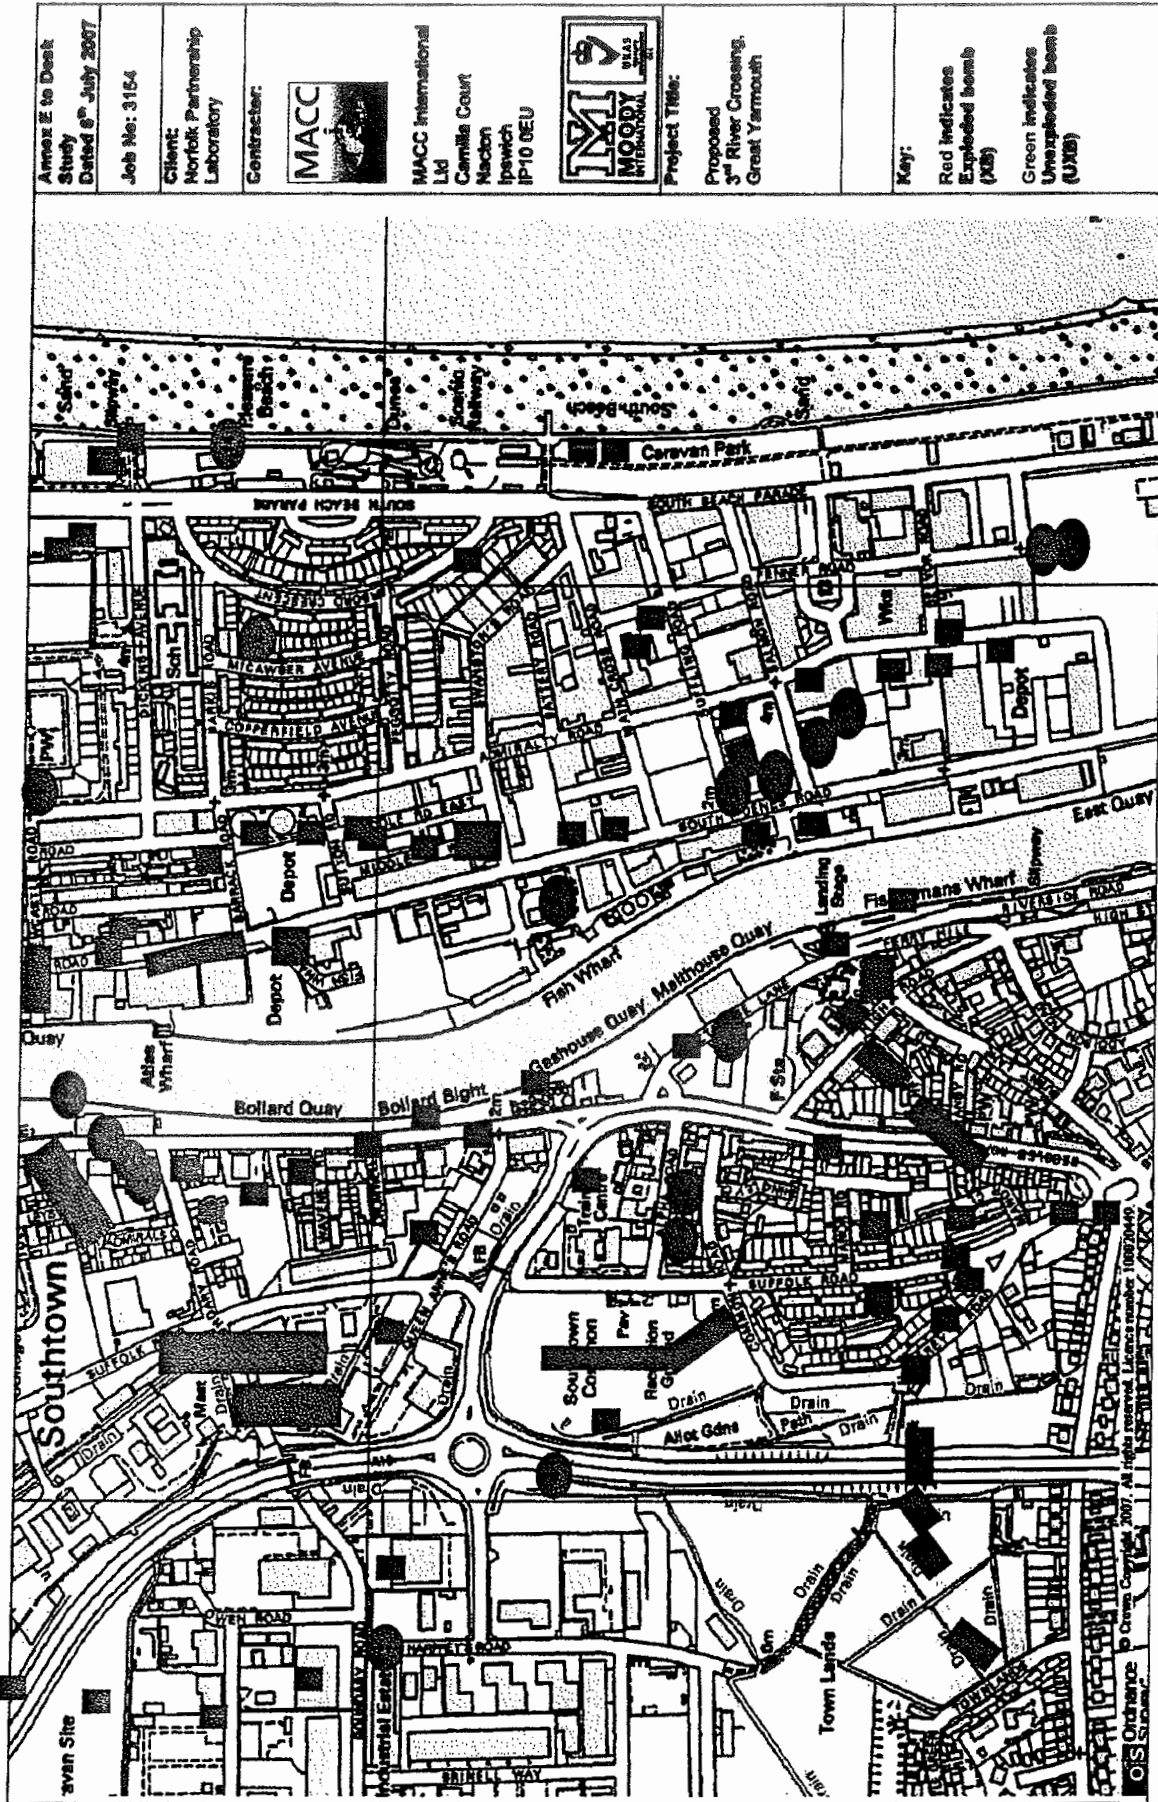
LOCATION AND RISK MAP

Annex E to Desk Study Dated 6 <sup>th</sup> July 2007	Client: Norfolk Partnership Laboratory	Contractor: <b>MACC</b> MACC International Ltd Camilla Court Necton Ipswich IP10 0EU	<b>MOODY</b> INTERNATIONAL	Project Title: Proposed 3 <sup>rd</sup> River Crossing, Great Yarmouth	Key: Red indicates Exploded bombs (XEB) Green indicates Unexploded bombs (UXB)
--	---	--	-------------------------------	---	--

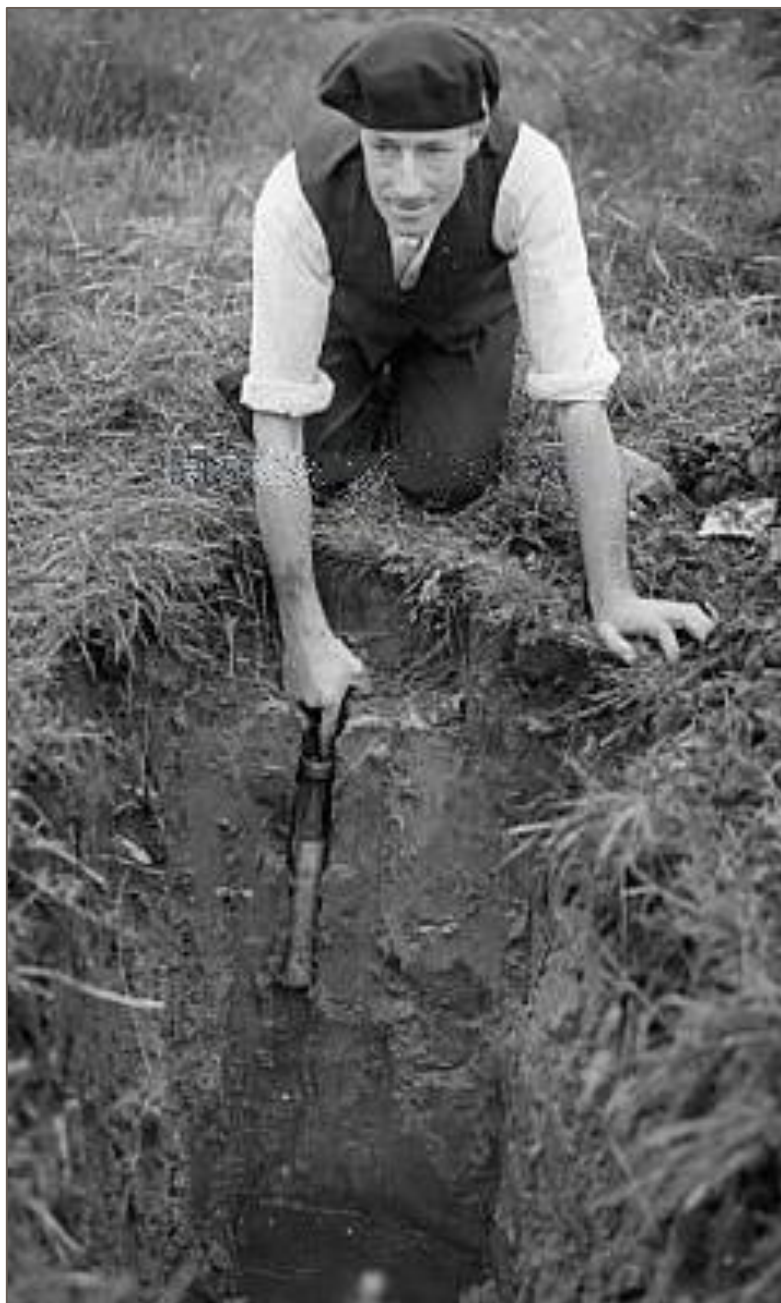
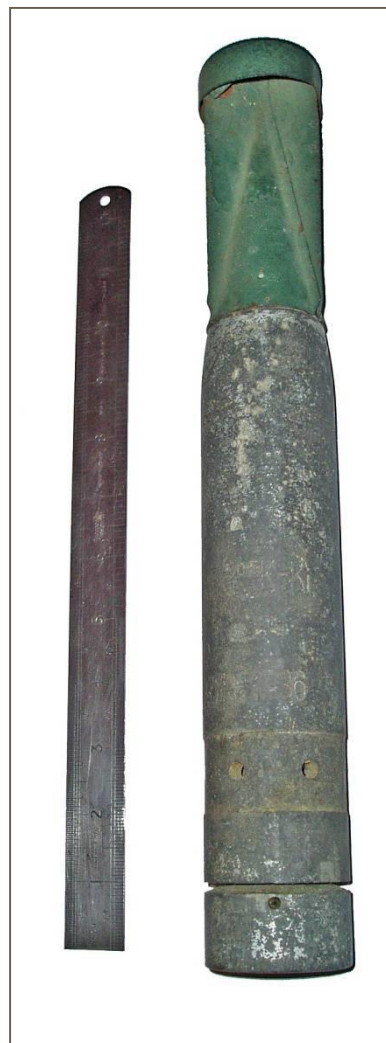
1kg German Incendiary Bomb next to a 30cm ruler

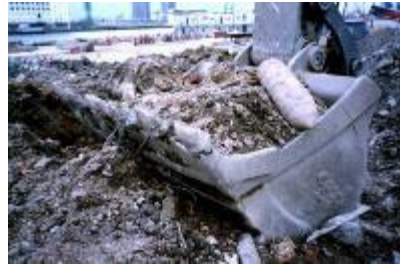
**SC 50**

**Bomb Weight:** 40-54kg (110-119lb)  
**Explosive Weight:** c25kg (55lb)  
**Fuze Type:** Impact fuze/electro-mechanical time delay fuze  
**Bomb Dimensions:** 1,090 x 280mm (42.9 x 11.0in)  
**Body Diameter:** 200mm (7.87in)  
**Use:** Against lightly damageable materials, hangars, railway rolling stock, ammunition depots, light bridges and buildings up to three stories.  
**Remarks:** The smallest and most common conventional German bomb. Nearly 70% of bombs dropped on the UK were 50kg.

50kg bomb, London Docklands

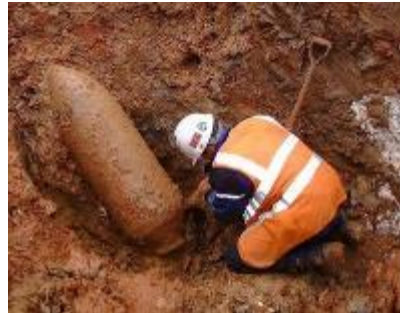
**SC 250**

**Bomb weight:** 245-256kg (540-564lb)  
**Explosive weight:** 125-130kg (276-287lb)  
**Fuze type:** Electrical impact/mechanical time delay fuze.  
**Bomb dimensions:** 1640 x 512mm (64.57 x 20.16in)  
**Body diameter:** 368mm (14.5in)  
**Use:** Against railway installations, embankments, flyovers, underpasses, large buildings and below-ground installations.

250kg bomb, Hawkinge

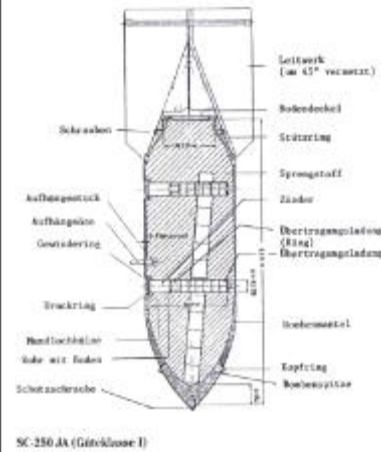
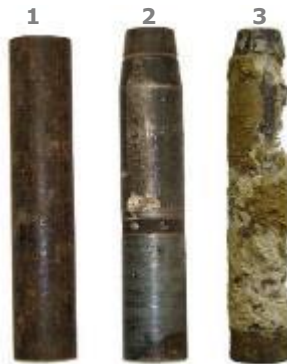
**1kg Incendiary Bomb**

**Bomb weight:** 1.0 and 1.3kg (2.2 and 2.87lb)  
**Filling:** 680gm (1.3lb) Thermite  
**Fuze type:** Impact fuze  
**Bomb dimensions:** 350 x 50mm (13.8 x 1.97in)  
**Body diameter:** 50mm (1.97in)  
**Use:** As incendiary – dropped in clusters against towns and industrial complexes  
**Remarks:** Jettisoned from air-dropped containers. Magnesium alloy case. Sometimes fitted with high explosive charge

1. Scaffold pipe
2. Incendiary 1kg bomb
3. Incendiary bomb recently found on site in UK

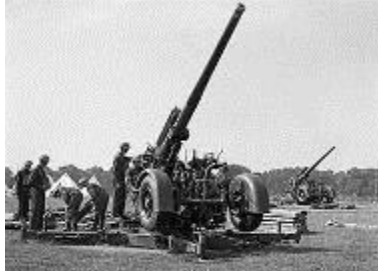
Hyde Park 1939 3.7 Inch QF gun on mobile mounting

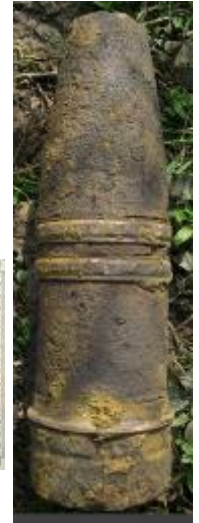
3.7 inch AA Projectile Minus Fuze

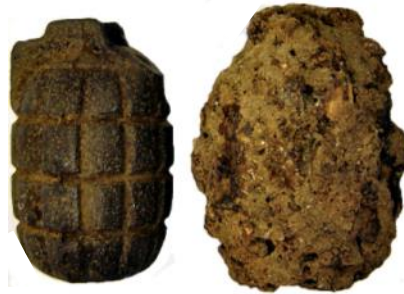
**No. 36 'Mills' Grenade**

Weight: 0.7kg filled (1lb 6oz)  
 Type: Hand or discharger, fragmentation  
 Dimensions: 95 x 61mm (3.7 x 2.4in)  
 Filling: Alumatol, Amatol 2 or TNT  
 Remarks: 4 second hand-throwing fuse with approximate 30m range. First introduced May 1918.

Grenade, .303 inch rifle, No. 36M, Mark I.

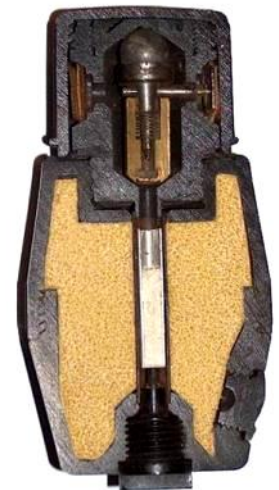
**No. 69 Grenade**

Weight: 0.38kg filled (0.8lb)  
 Type: Percussion/Blast  
 Date Introduced: December 1940  
 Remarks: Black Bakelite body. Blast rather than fragmentation type. After unscrewing the safety cap, a tape is held when throwing the grenade releasing the safety bolt in the throwing motion. Detection is problematic due to its very low metal content.

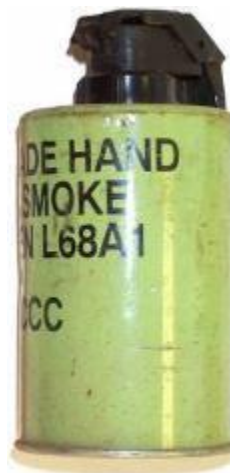
**Typical Smoke Grenade**

Dimensions: Approx. 65 x 115mm (2.5 x 4.5in)  
 Type: Smoke  
 Date Introduced: Current MoD issue  
 Remarks: Smoke grenades are used as ground-to-ground or ground-to-air signalling devices, target or landing zone marking devices, and screening devices for unit movement.

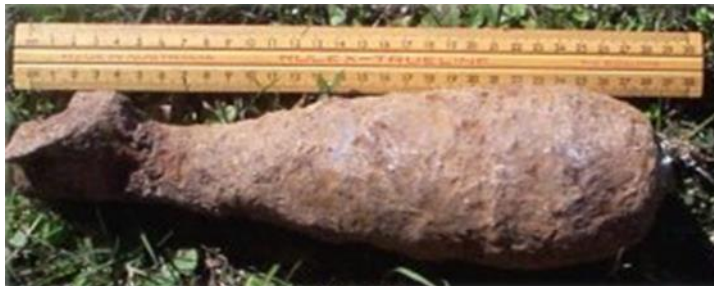
### Typical 3 inch Smoke Mortar

- Type: Smoke
- Dimensions: c490 x 76mm (19.3in x 3in)
- Filling: Typically white phosphorous
- Maximum Range: 2515m (2,750yds)
- Remarks: On impact, the fuze functions and initiates the bursting charge. The bursting charge ruptures the mortar bomb body and disperses the white phosphorous filler. The white phosphorous produces smoke upon exposure to the air.

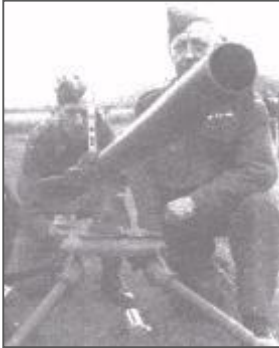
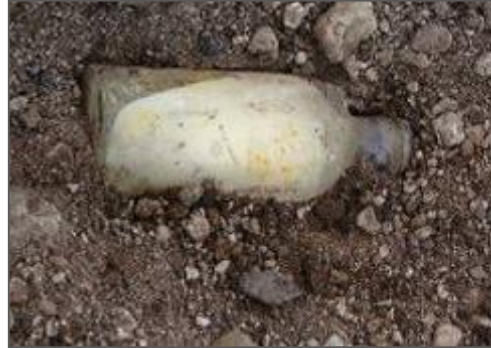
### Self Igniting Phosphorous (SIP) Grenades

**Filling:** White Phosphorous and Benzene  
**Remarks:** The grenade comprised a glass bottle with a total volume of approximately one pint. It was filled with White Phosphorus, benzene, a piece of rubber and water. Over time the rubber dissolved to create a sticky fluid which would self ignite when the bottle broke. Fired by hand or Northover Projector. Sometimes called the "A & W" (Albright & Wilson) grenade.

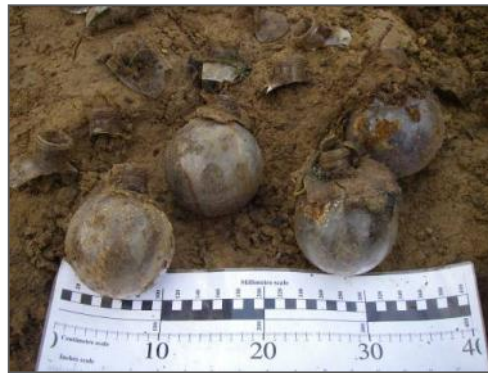
### No 74 Grenade (Sticky Bomb)

**Remarks:** Designed as an anti-tank grenade and used by the Home Guard. The grenade consisted of a glass ball on the end of a Bakelite (plastic) handle. Inside the glass ball was an explosive filling whilst on the outside was a very sticky adhesive covering. Until used, this adhesive covering was encased in a metal outer casing.

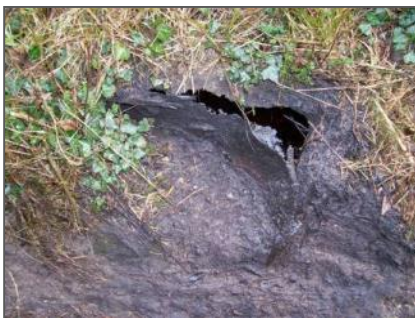
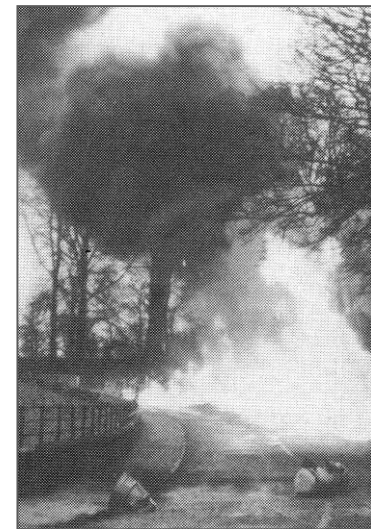
### Flame Fougasse Bomb

**Remarks:** A Flame Fougasse was a weapon in which the projectile was a flammable liquid, typically a mixture of petrol and oil. It was usually constructed from a 40-gallon drum dug into the roadside and camouflaged. Ammonal provided the propellant charge which, when triggered, caused the weapon to shoot a flame 3m (10ft) wide and 27m (30 yards) long. Initially a mixture of 40% petrol and 60% gas oil was used, this was later replaced by an adhesive gel of tar, lime and petrol known as 5B.

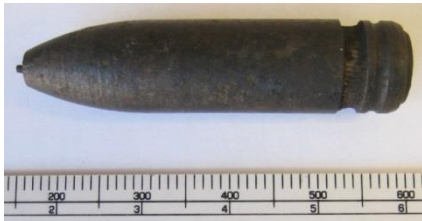
### 20mm Hispano HEI Ammunition

Type: Live canon round  
 Markings: Upper half of projectile painted 'buff' colour, lower half is red.  
 Cartridge Weight: 256 grams  
 Dimensions: Total cartridge / projectile length - 182mm  
 Fuzed: Contact fuze – No.253, No.254 or No.917  
 Filling: 108 grains of contact explosive + 68 grains of SR.379 incendiary composition.  
 Threat: Explosives within unspent cartridge as well as the projectile.  
 Deployment: Royal Navy, RAF and British Army Light Anti-Aircraft guns. Also RAF aircraft canons.  
 Remarks: Cartridges are belted or supplied lose in cartons.
