# **Great Yarmouth Third River Crossing**

## **Application for Development Consent Order**

### **Document 6.2: Environmental Statement Volume II: Technical Appendix 16A: Legislation, Policy and Guidance**

Document Reference: 6.2 – Technical Appendix 16A

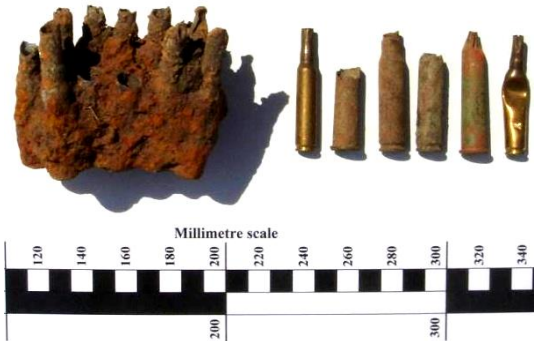
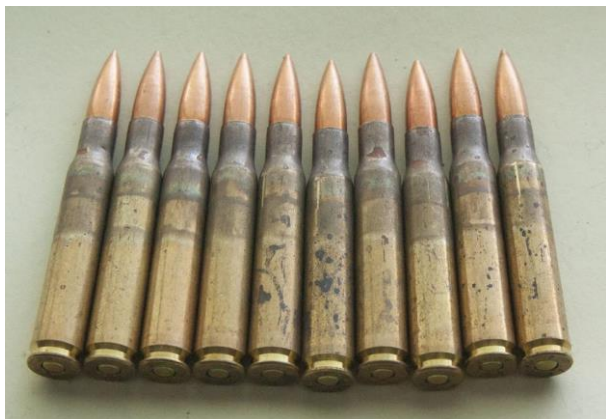
### .303" Ammunition

Type: Rifle / machine gun round  
 Markings: Regular round - none. Tracer round – red Primer  
 Bullet Weight: 150 - 180 grams  
 Dimensions: Total cartridge /projectile length - 78mm  
 Filling: Regular round – none. Tracer round - small incendiary fill  
 Threat: Explosive cordite within unspent cartridge  
 Deployment: Royal Navy, RAF and British Army Light Anti-Aircraft guns, machine guns and rifles. Standard British and Commonwealth military cartridge from 1889 until the 1950s.  
 Remarks: Cartridges are belted or supplied lose in cartons.

TYPES OF SMALL ARMS AMMUNITION  
 Fig. 1. Four types of ammunition used by modern infantry. 1 and 2 are ball cartridges, 3 is an armour-piercing bullet, and 4 a tracer bullet which burns and makes its flight visible.

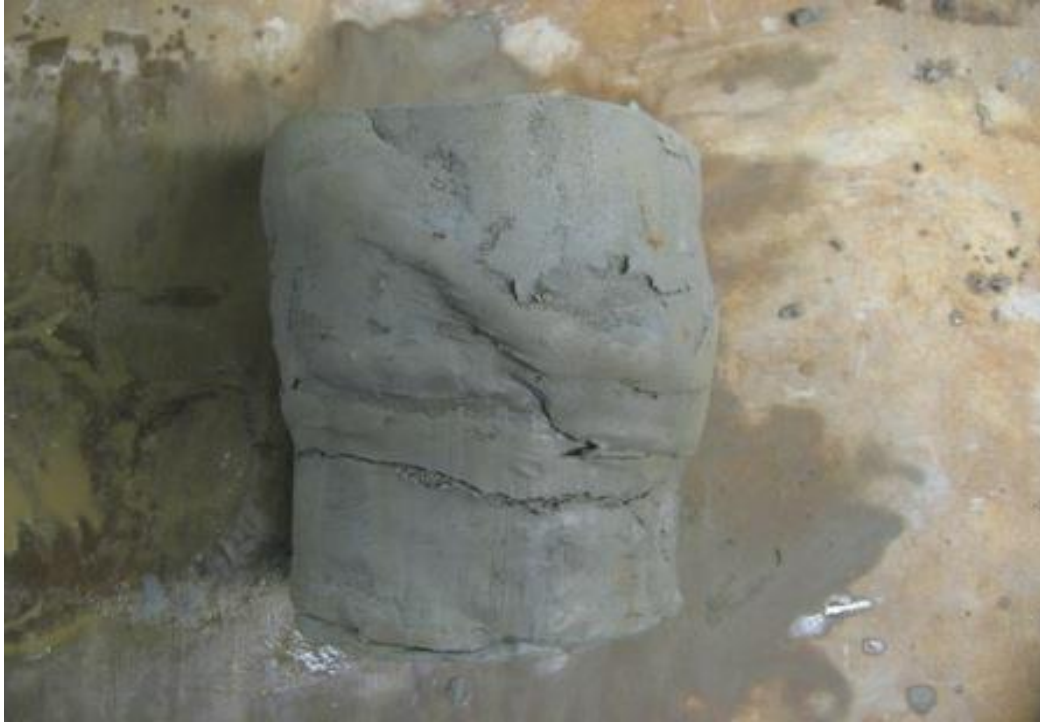
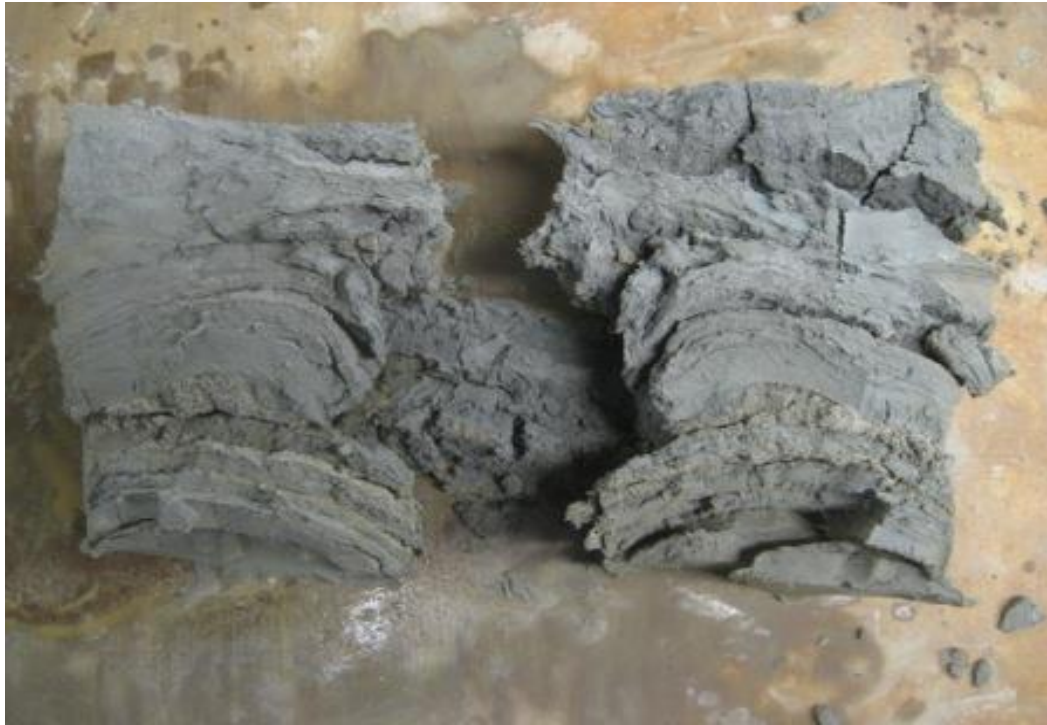
Depth (m) 23.00-23.45

Originator	Checked & Approved	Please note that these photographs are intended to show the failure mode, and do not necessarily show accurately the colouration of the soil.

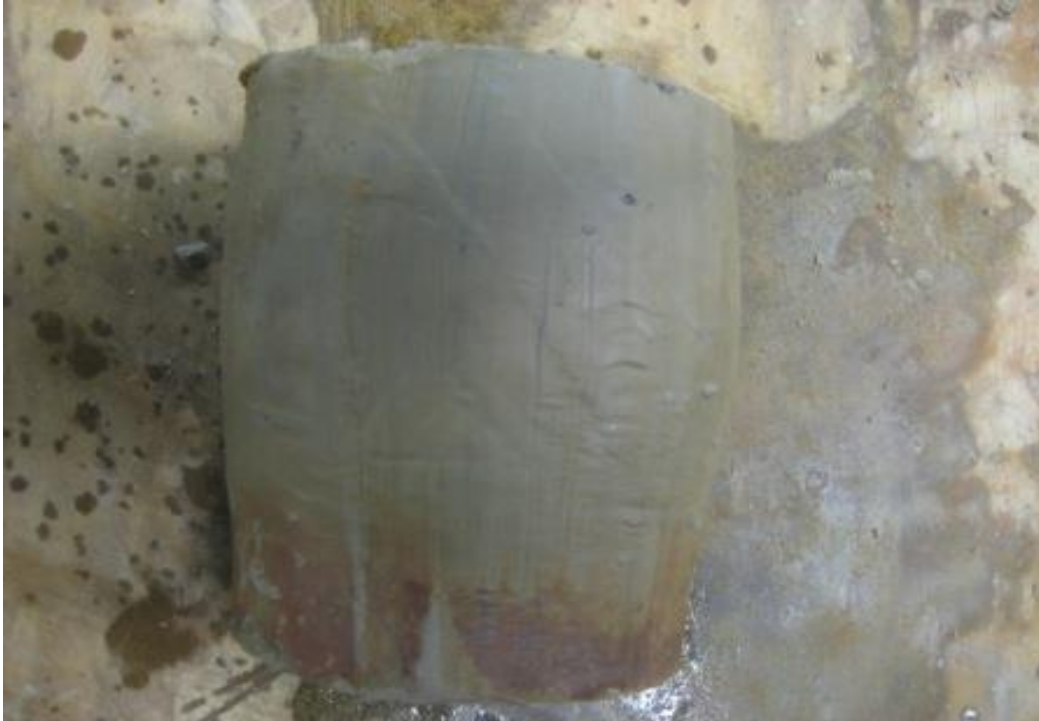
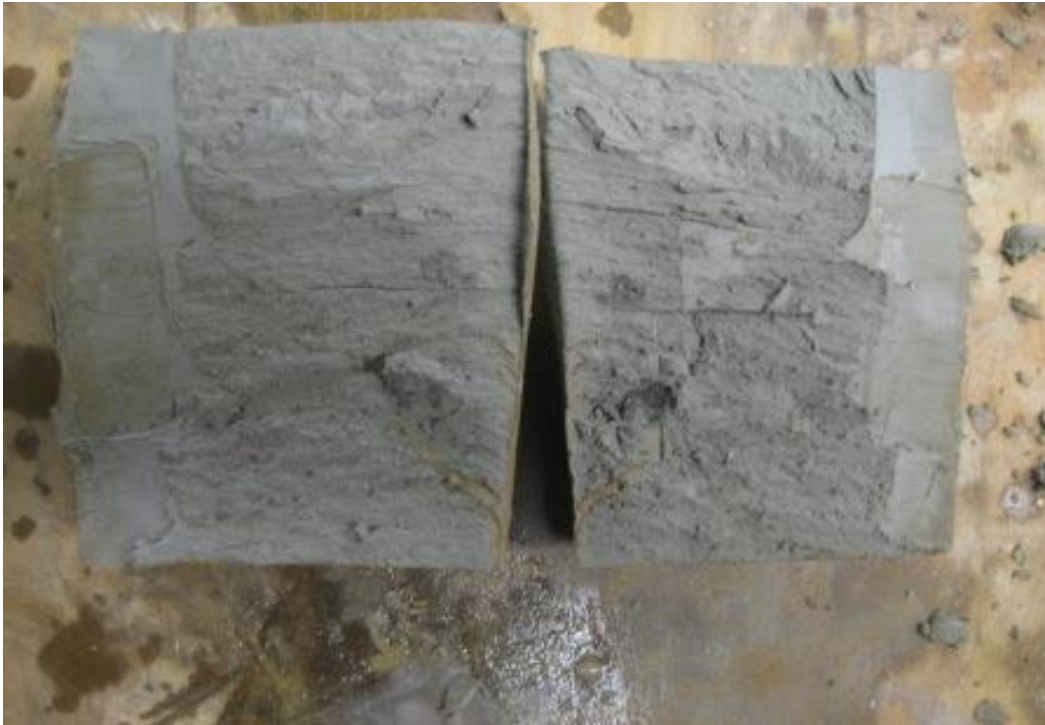
Depth (m) 23.00-23.45

Please note that these photographs are intended to show the failure mode, and do not necessarily show accurately the colouration of the soil.

<b>Sample Details</b>		Undisturbed		
Sample Condition				
Height	mm	172.7		
Diameter	mm	103.4		
Moisture Content	%	27		
Bulk Density	Mg/m <sup>3</sup>	2.02		
Dry Density	Mg/m <sup>3</sup>	1.59		
<b>Test Details</b>				
Membrane Thickness	mm	0.30		
Membrane Correction	kPa	0.65		
Rate of Axial Displacement	%/min	0.88		
Cell Pressure	kPa	750		
Strain at Failure	%	9.8		
Maximum Deviator Stress	kPa	206		
Shear Strength	kPa	103		
Mode of Failure			Compound	
Non Engineering Description		Stiff layered light grey sandy CLAY.

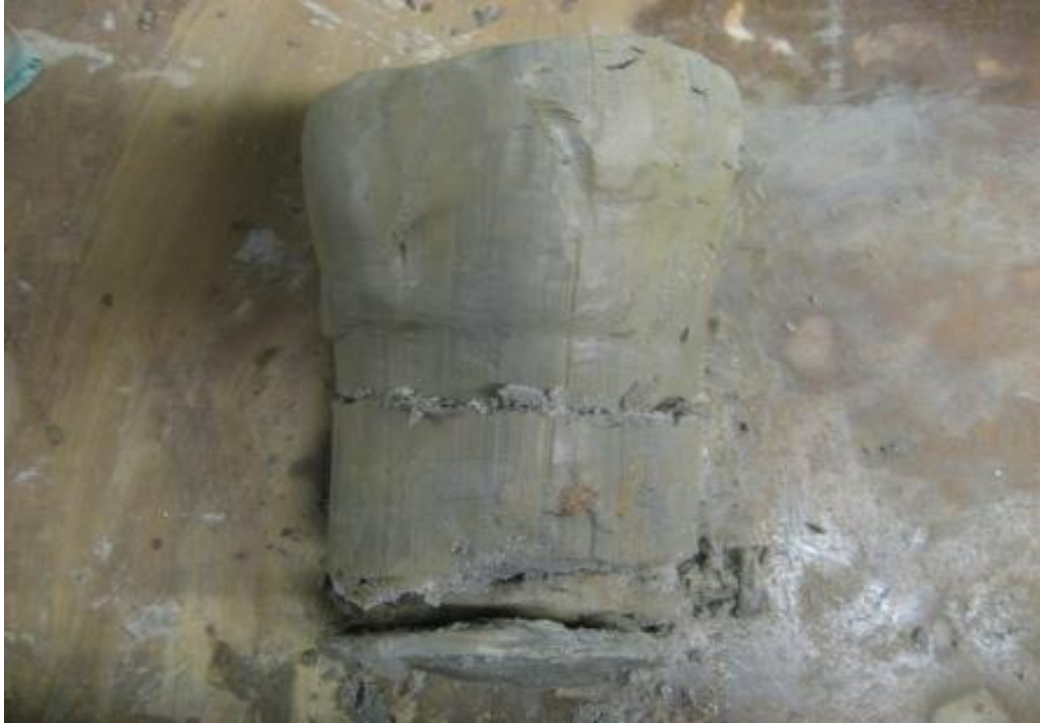
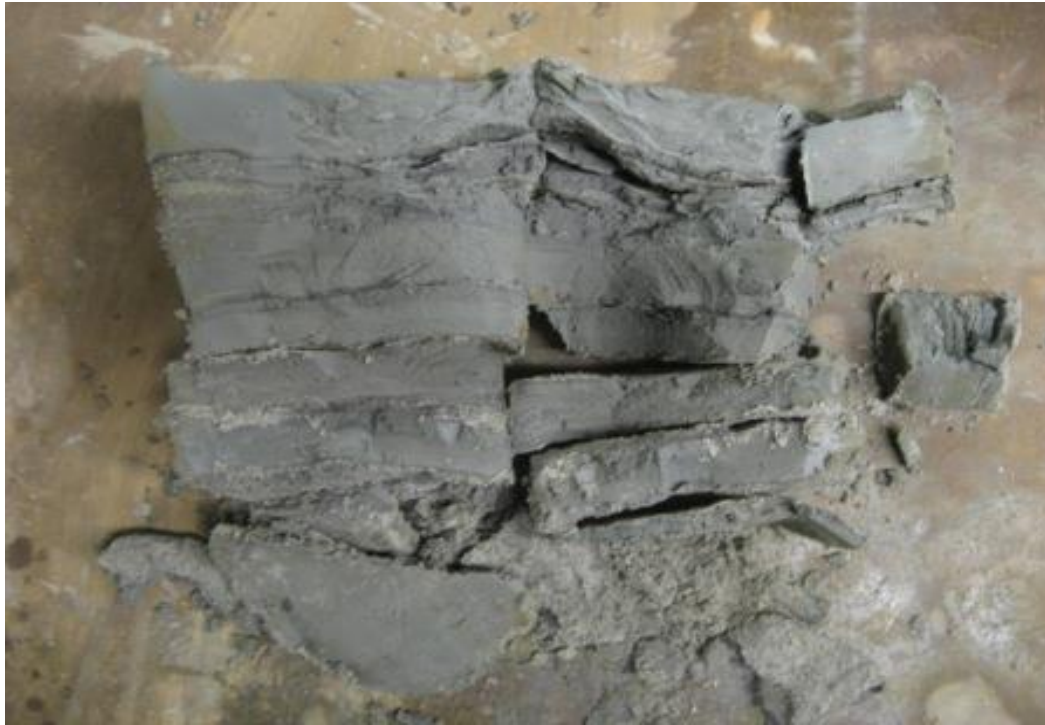
Depth (m) 25.00-25.45

Please note that these photographs are intended to show the failure mode, and do not necessarily show accurately the colouration of the soil.

<b>Sample Details</b>		Undisturbed		
Sample Condition				
Height	mm	173.5		
Diameter	mm	103.5		
Moisture Content	%	26		
Bulk Density	Mg/m <sup>3</sup>	1.96		
Dry Density	Mg/m <sup>3</sup>	1.55		
<b>Test Details</b>				
Membrane Thickness	mm	0.30		
Membrane Correction	kPa	0.67		
Rate of Axial Displacement	%/min	2.34		
Cell Pressure	kPa	400		
Strain at Failure	%	10.4		
Maximum Deviator Stress	kPa	71		
Shear Strength	kPa	35		
Mode of Failure			Plastic	
Non Engineering Description		Soft layered light grey very sandy CLAY.

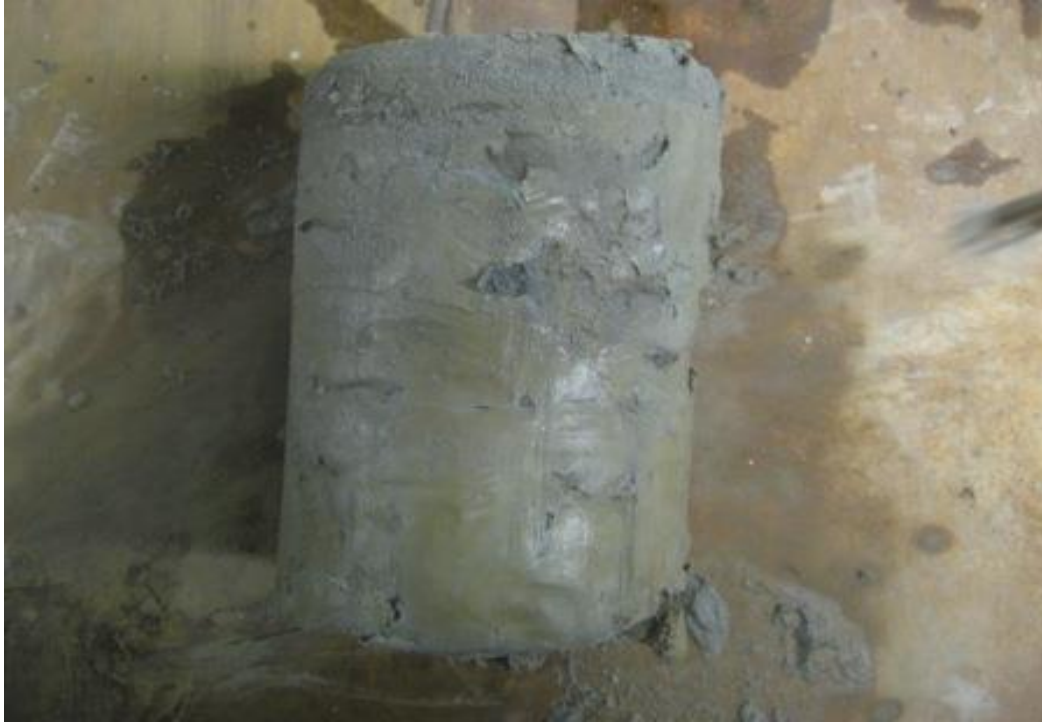
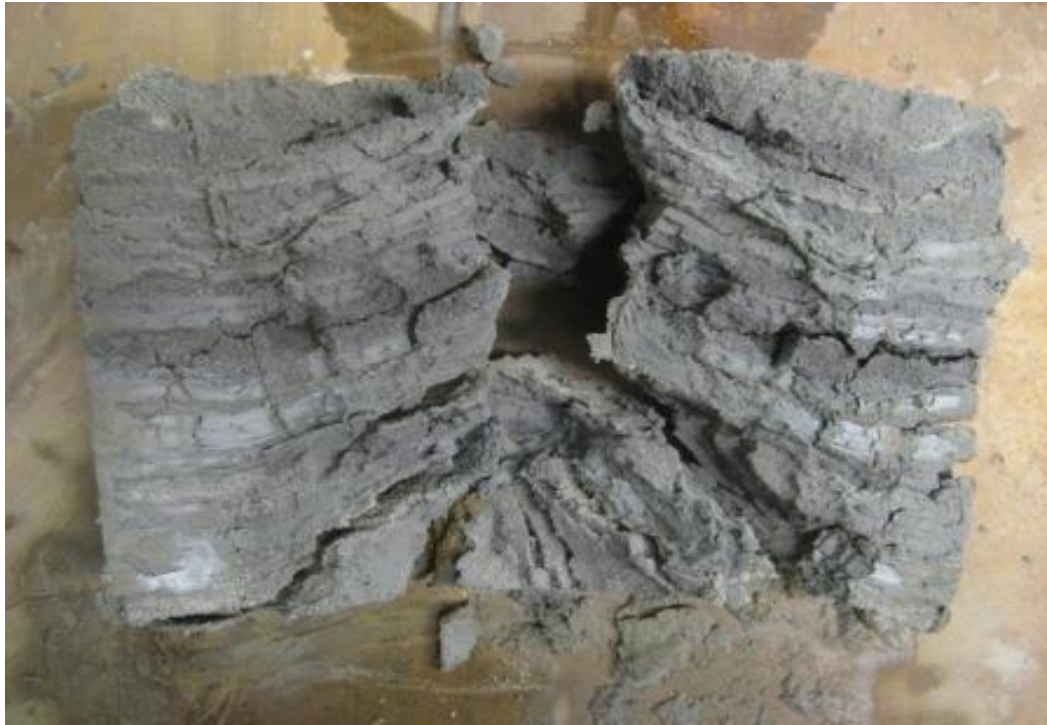
Depth (m) 20.00-20.45

Please note that these photographs are intended to show the failure mode, and do not necessarily show accurately the colouration of the soil.

Sample Details		Undisturbed		
Sample Condition		Undisturbed		
Height	mm	198.0		
Diameter	mm	103.9		
Moisture Content	%	30		
Bulk Density	Mg/m <sup>3</sup>	1.98		
Dry Density	Mg/m <sup>3</sup>	1.52		
Test Details				
Membrane Thickness	mm	0.30		
Membrane Correction	kPa	1.10		
Rate of Axial Displacement	%/min	2.05		
Cell Pressure	kPa	500		
Strain at Failure	%	20.2		
Maximum Deviator Stress	kPa	27		
Shear Strength	kPa	14		
Mode of Failure			Plastic	
Non Engineering Description		Very soft intact light grey very sandy CLAY.

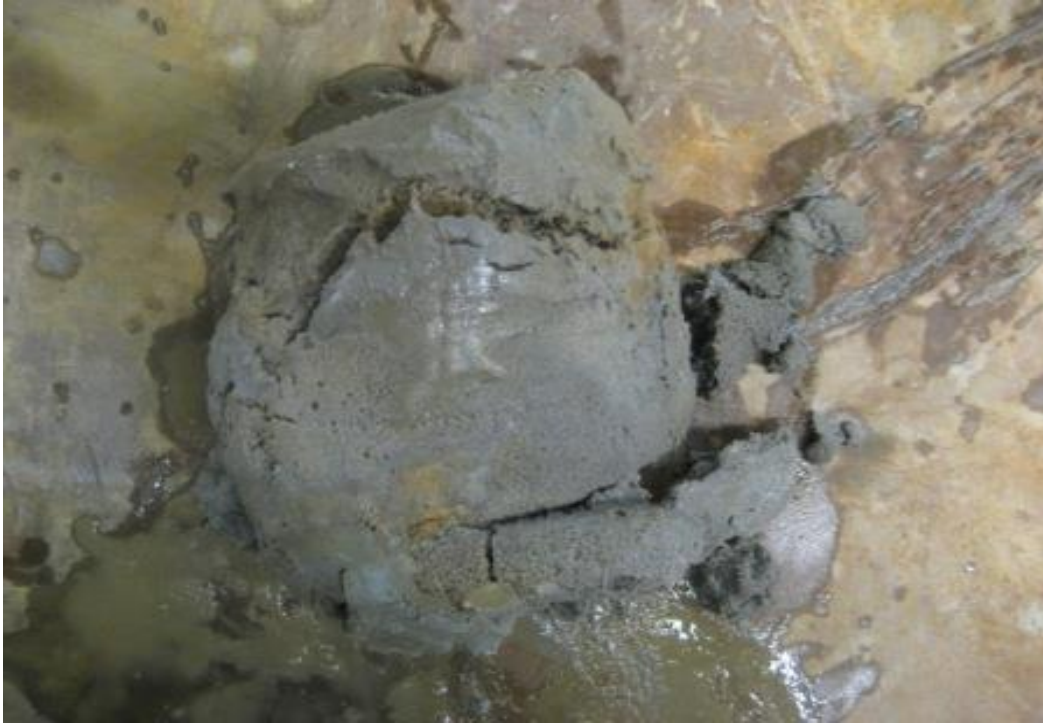
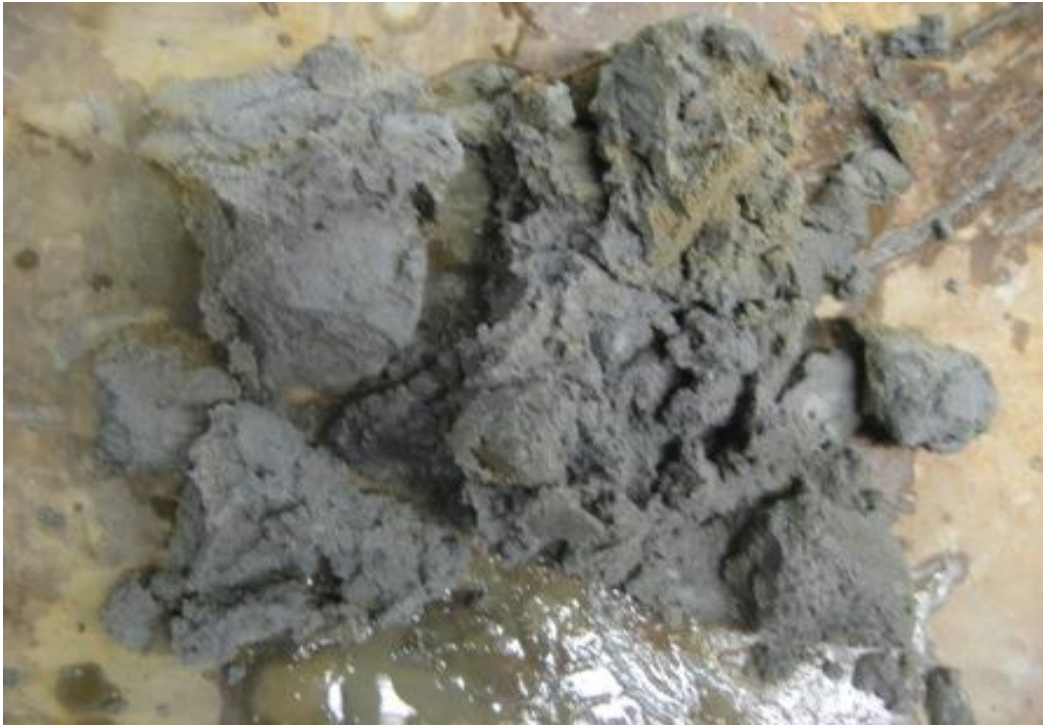
Depth (m) 22.00-22.45

Please note that these photographs are intended to show the failure mode, and do not necessarily show accurately the colouration of the soil.

Sample Condition		Undisturbed		
Height	mm	173.3		
Diameter	mm	103.3		
Moisture Content	%	29		
Bulk Density	Mg/m <sup>3</sup>	1.95		
Dry Density	Mg/m <sup>3</sup>	1.52

Membrane Thickness	mm	0.30		
Membrane Correction	kPa	0.73		
Rate of Axial Displacement	%/min	2.34		
Cell Pressure	kPa	750		
Strain at Failure	%	11.5		
Maximum Deviator Stress	kPa	158		
Shear Strength	kPa	79		
Mode of Failure			Compound

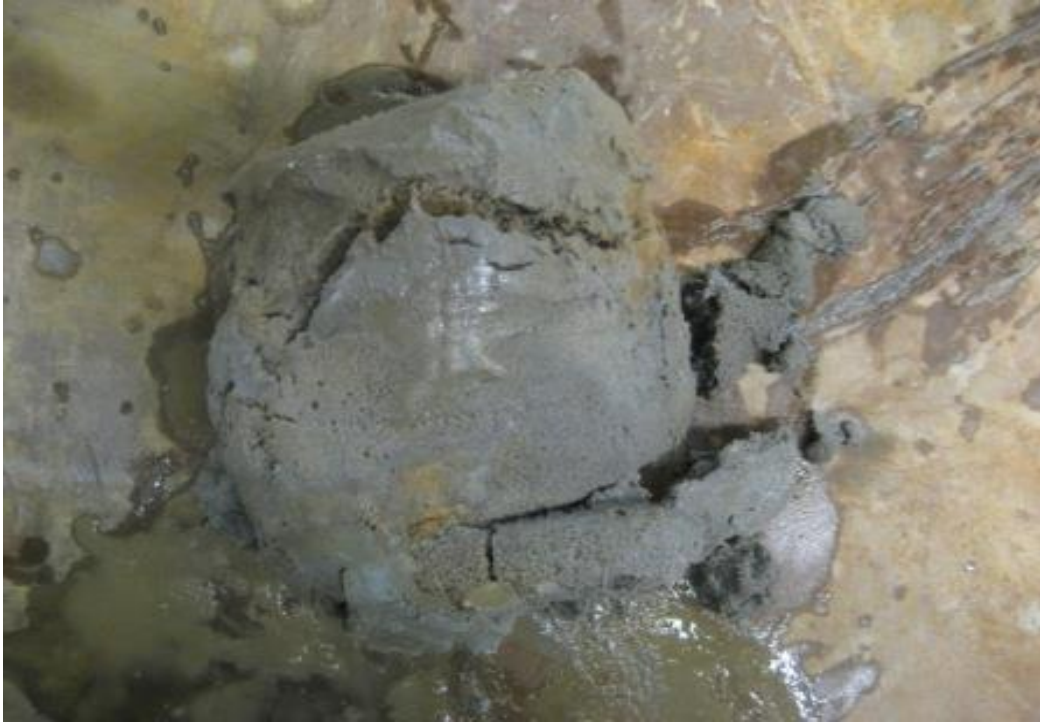
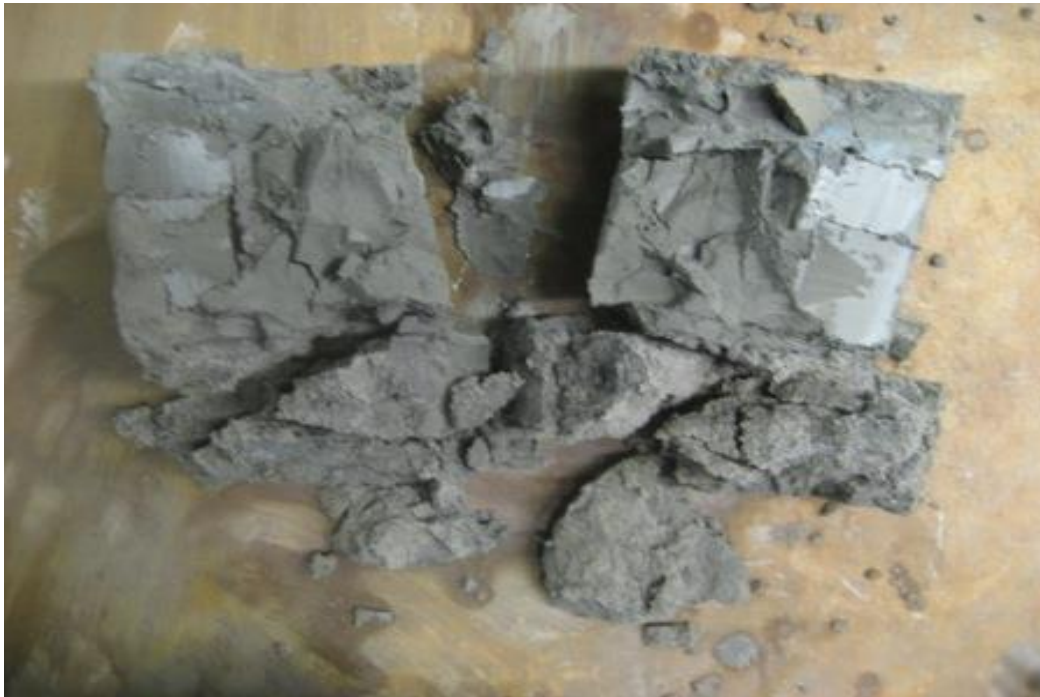
Depth (m) 22.00-22.45

Originator	Checked & Approved	Please note that these photographs are intended to show the failure mode, and do not necessarily show accurately the colouration of the soil.

Sample Condition		Undisturbed		
Height	mm	171.3		
Diameter	mm	103.6		
Moisture Content	%	26		
Bulk Density	Mg/m <sup>3</sup>	1.98		
Dry Density	Mg/m <sup>3</sup>	1.57

Membrane Thickness	mm	0.30		
Membrane Correction	kPa	0.79		
Rate of Axial Displacement	%/min	2.37		
Cell Pressure	kPa	750		
Strain at Failure	%	12.8		
Maximum Deviator Stress	kPa	341		
Shear Strength	kPa	170		
Mode of Failure			Compound

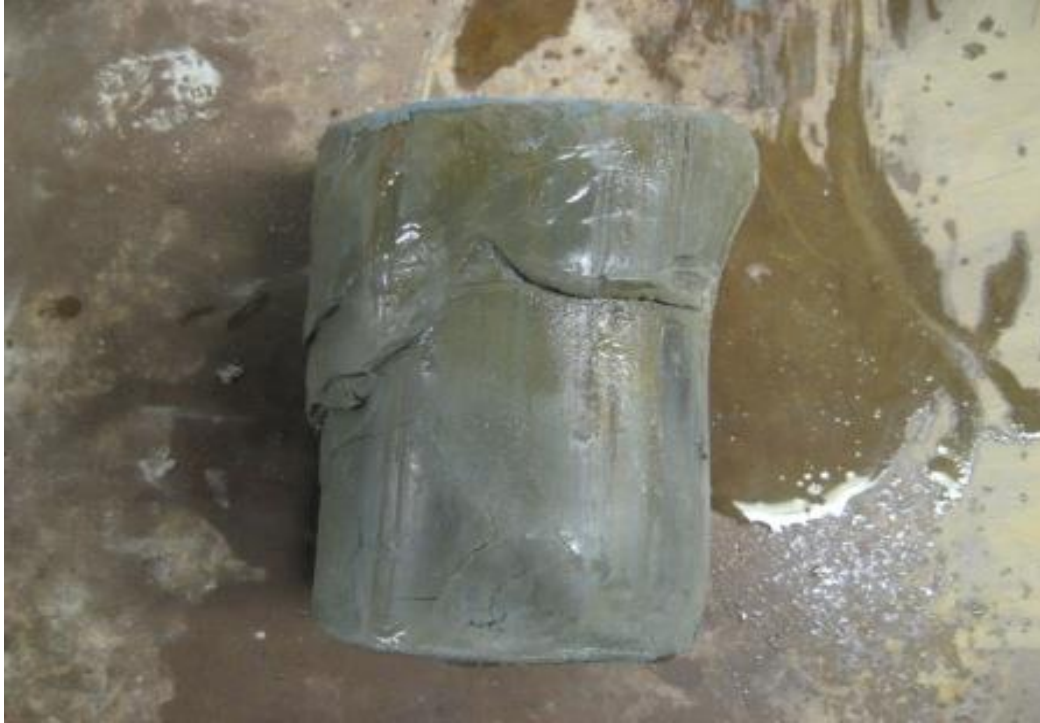
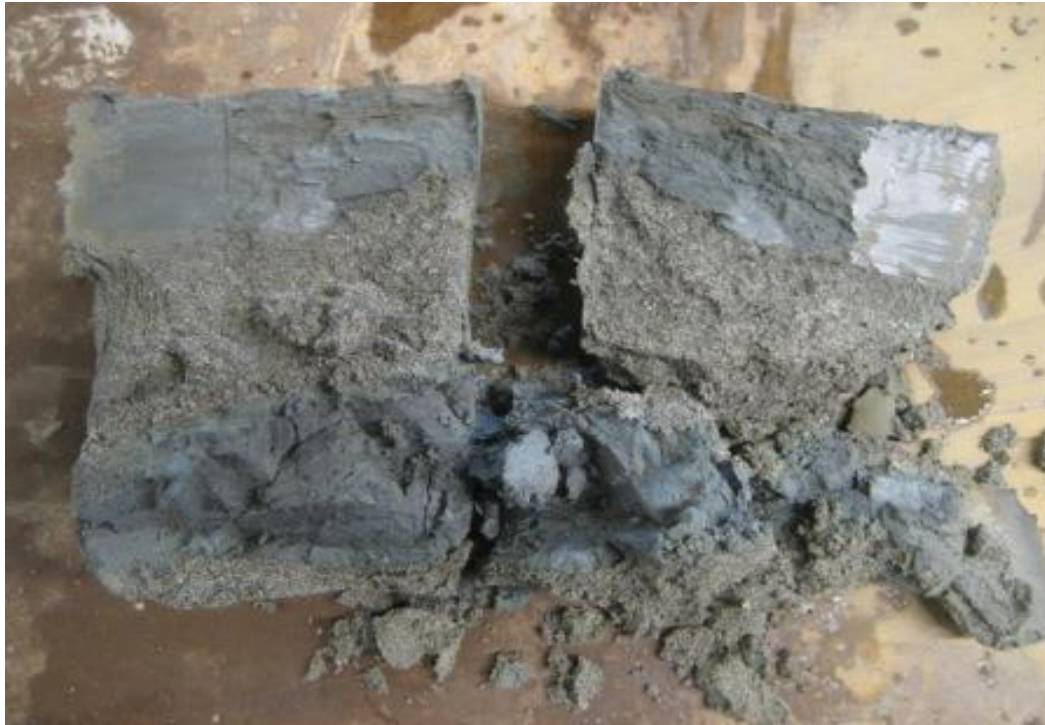
Depth (m) 38.00-38.45

Please note that these photographs are intended to show the failure mode, and do not necessarily show accurately the colouration of the soil.

<b>Sample Details</b>		Undisturbed		
Sample Condition				
Height	mm	171.4		
Diameter	mm	103.6		
Moisture Content	%	30		
Bulk Density	Mg/m <sup>3</sup>	1.97		
Dry Density	Mg/m <sup>3</sup>	1.52		
<b>Test Details</b>				
Membrane Thickness	mm	0.30		
Membrane Correction	kPa	0.43		
Rate of Axial Displacement	%/min	0.89		
Cell Pressure	kPa	1000		
Strain at Failure	%	5.8		
Maximum Deviator Stress	kPa	517		
Shear Strength	kPa	259		
Mode of Failure			Compound	
Non Engineering Description	Very stiff fissured brownish grey slightly sandy CLAY.

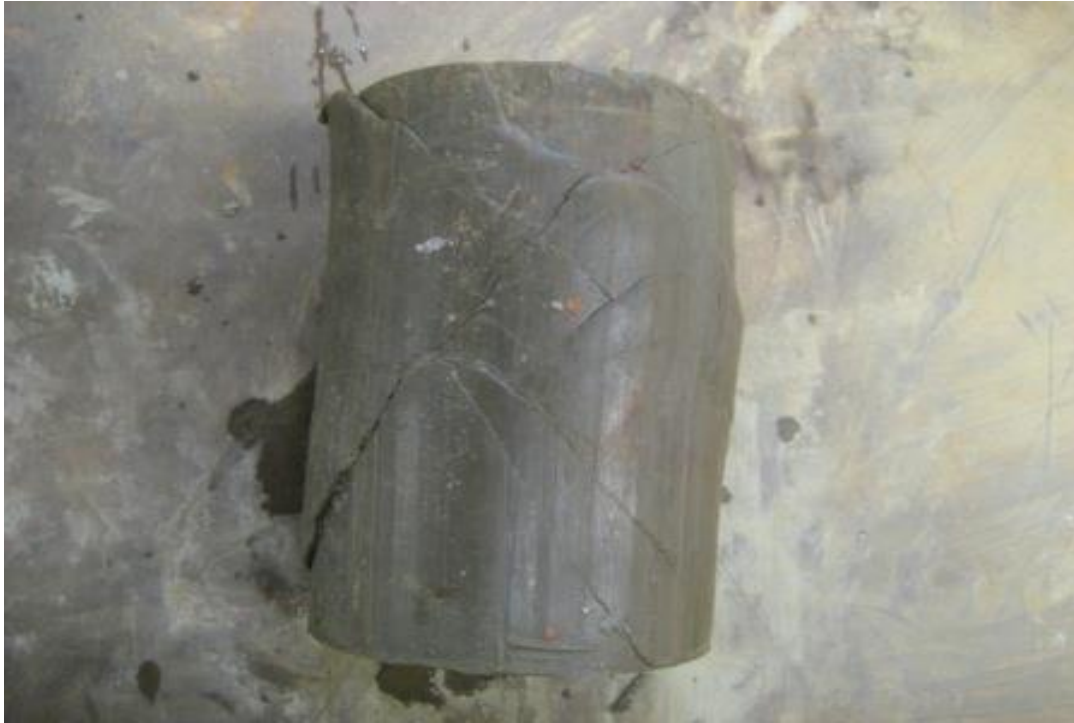
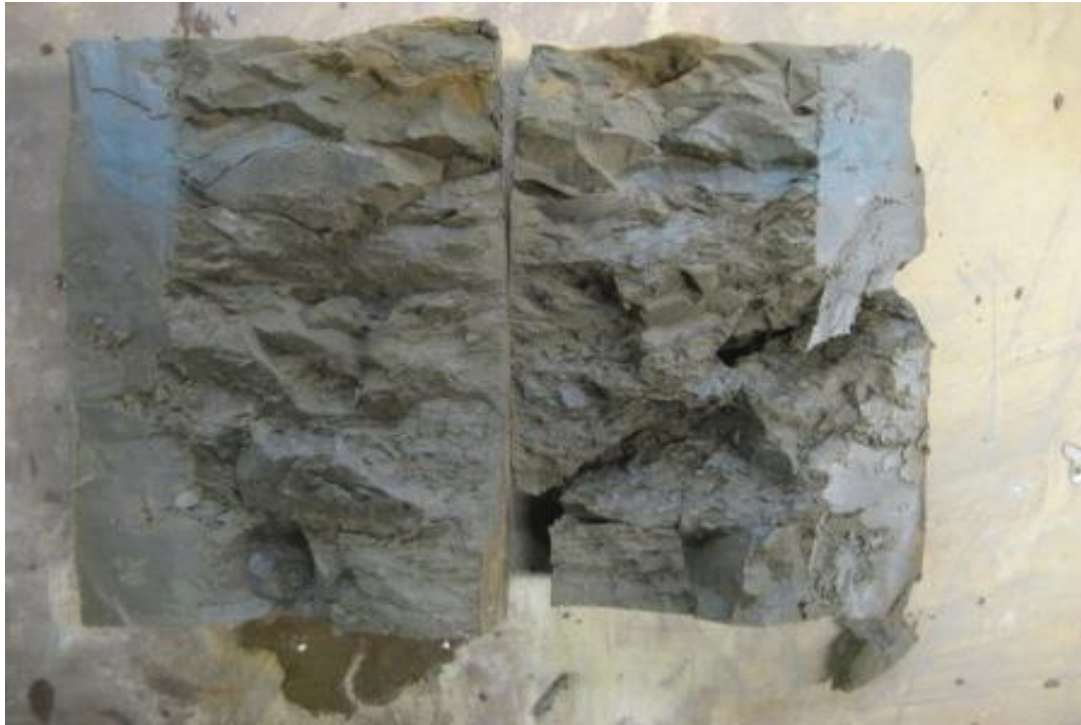
Originator	Checked & Approved	Please note that these photographs are intended to show the failure mode, and do not necessarily show accurately the colouration of the soil.

Sample Condition		Undisturbed		
Height	mm	172.3		
Diameter	mm	103.2		
Moisture Content	%	26		
Bulk Density	Mg/m <sup>3</sup>	2.00		
Dry Density	Mg/m <sup>3</sup>	1.59

Membrane Thickness	mm	0.30		
Membrane Correction	kPa	1.10		
Rate of Axial Displacement	%/min	0.91		
Cell Pressure	kPa	750		
Strain at Failure	%	20.0		
Maximum Deviator Stress	kPa	406		
Shear Strength	kPa	203		
Mode of Failure			Compound

Non Engineering Description: Very stiff fissured dark greenish grey slightly sandy CLAY.

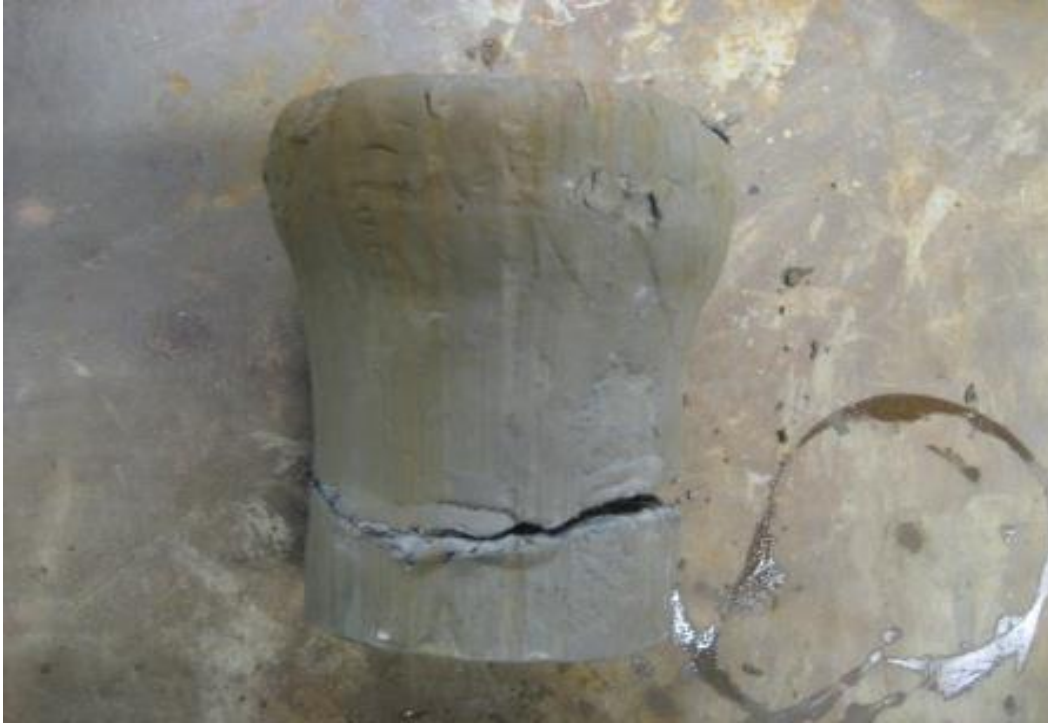
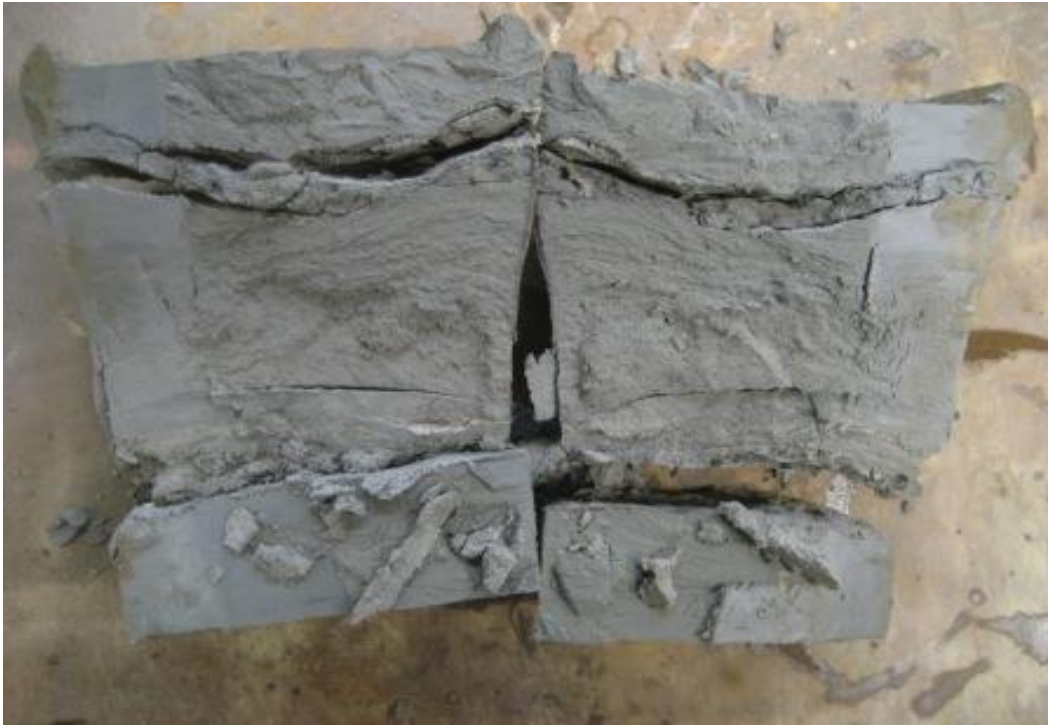
Depth (m) 22.00-22.45

Please note that these photographs are intended to show the failure mode, and do not necessarily show accurately the colouration of the soil.

Sample Condition		Undisturbed		
Height	mm	172.2		
Diameter	mm	102.1		
Moisture Content	%	25		
Bulk Density	Mg/m <sup>3</sup>	2.17		
Dry Density	Mg/m <sup>3</sup>	1.74
