Norfolk County Council

Investigation Report into the flooding in Acle in 10th-13th June 2016

Report Reference: FIR026

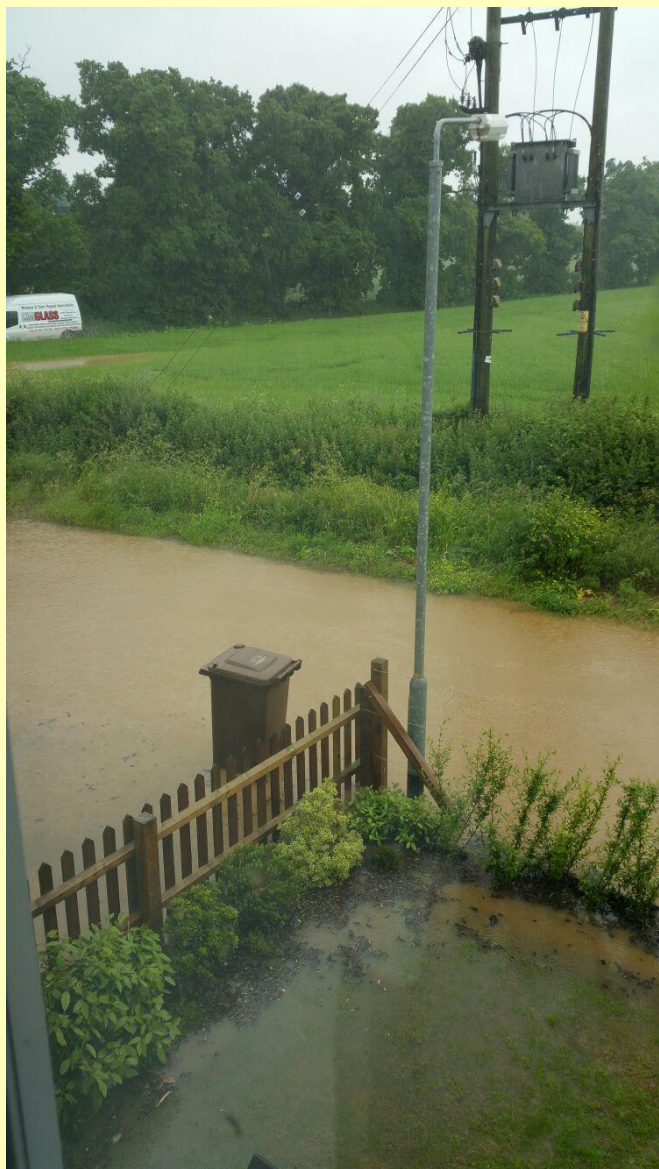
Beighton Road – internal and external flooding experienced 13th June 2016.

Run-off causing pooling at low points in the catchment.

Surface run-off from the highway was directed towards the houses and exacerbated by vehicles which created a wash and pushed more water towards the houses.

Run-off from the rainfall was directed towards the surface water drainage network which was already at full capacity and caused it to be overloaded.

One of the properties had structural issues which was susceptible to the heavy rainfall.

Recommendations - Norfolk County Council will look for funding for individual property level protection and advise residents on appropriate measures. Meanwhile, property owners should protect their buildings where funding is not forthcoming.

Norfolk County Council will determine if other measures to reduce flow such as Natural Flood Management would be appropriate and /or routing flood water on the highway away from affected properties to alternative points of discharge.
