Investigation Report into the flooding in Breckland Various in 2017/18

Report Reference: 38

Draft Report prepared by Nathan Harris on 18 March 2019

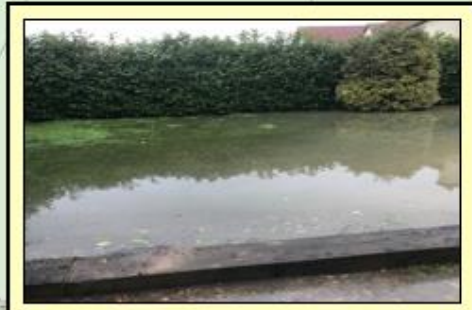
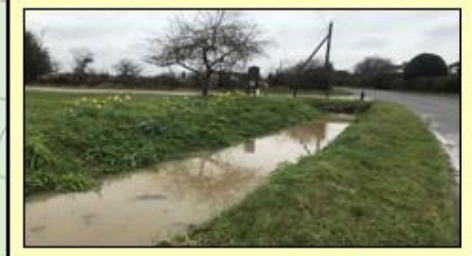
Causes – Surface run-off from rainfall that had made its way onto the highway flowed along the road network and overland flowpaths, on which the affected property is adjacent to, and onto the accesses of affected properties via dropped kerbs. Run-off from rainfall was concentrated. Rainfall was directed into the surface water system causing it to surcharge elsewhere, the flood water entered the property through low thresholds at entrances.

Recommendations – NCC will investigate with third parties the potential to fund small scale improvement schemes to mitigate the risk experienced at this location. NCC will consider opportunities to manage the amount or rate of surface water entering their drainage system as well as options to route flood water on the highway away from affected properties to alternative points of discharge. Property owners should protect their buildings through flood protection measures where appropriate.

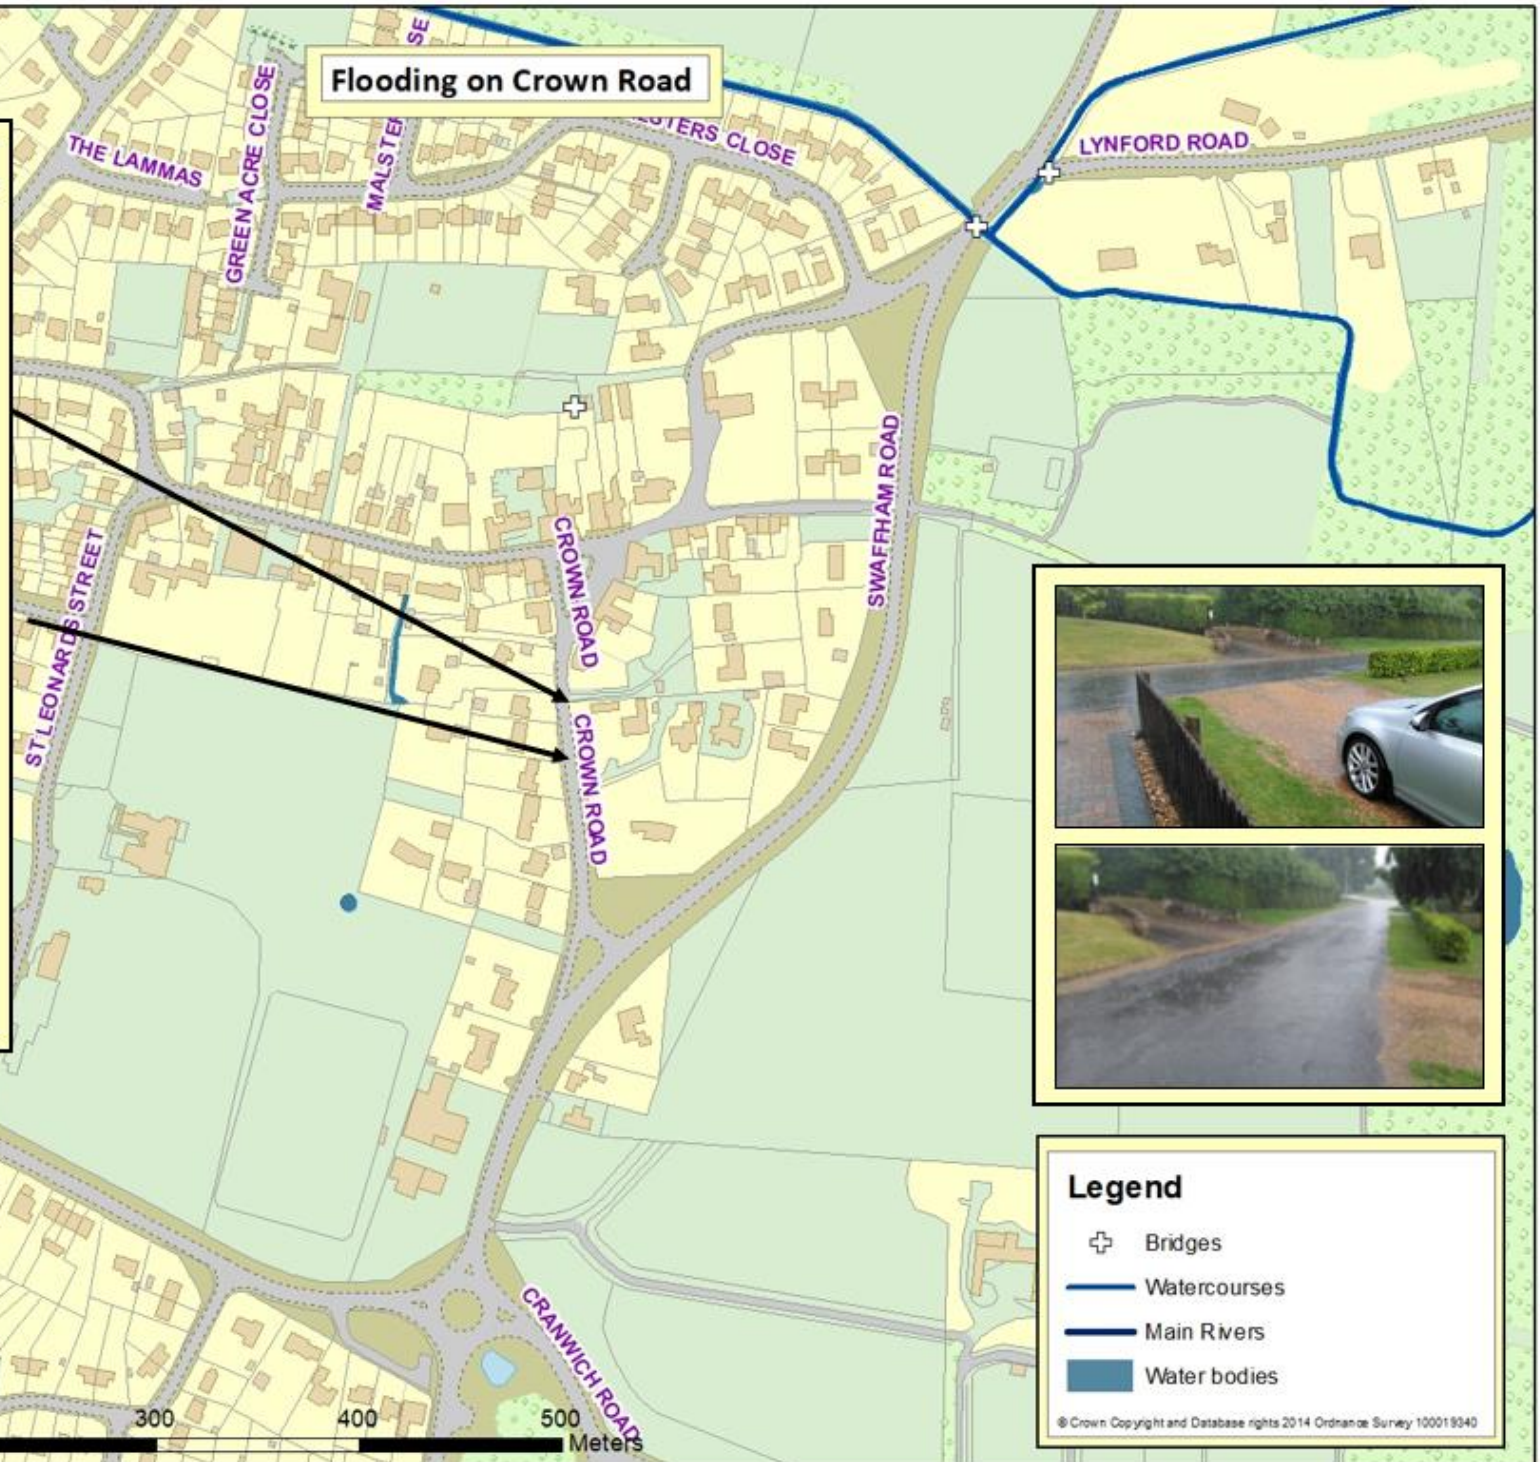
Causes – Surface run-off from rainfall and that directed from neighbouring property access drives made its way onto the highway, flowed along the road network and via dropped kerbs onto the accesses of affected properties that were situated lower than these features. The flood water entered the properties through low thresholds at entrances.

Recommendations – NCC will consider opportunities to route flood water on the highway away from affected properties to alternative points of discharge, consider options that would ensure water does not pool on the highway and also amendments to neighbouring properties to ensure water is not directed to other properties. NCC will investigate with property owners and third parties the potential for retro-fitting permeable areas and other methods of small scale sustainable drainage systems. Property owners should protect their buildings through flood protection measures where appropriate.
