Investigation Report into the flooding in Breckland in 2016

Report Reference: FIR028

Draft Report prepared by Robert Webster on June 2019

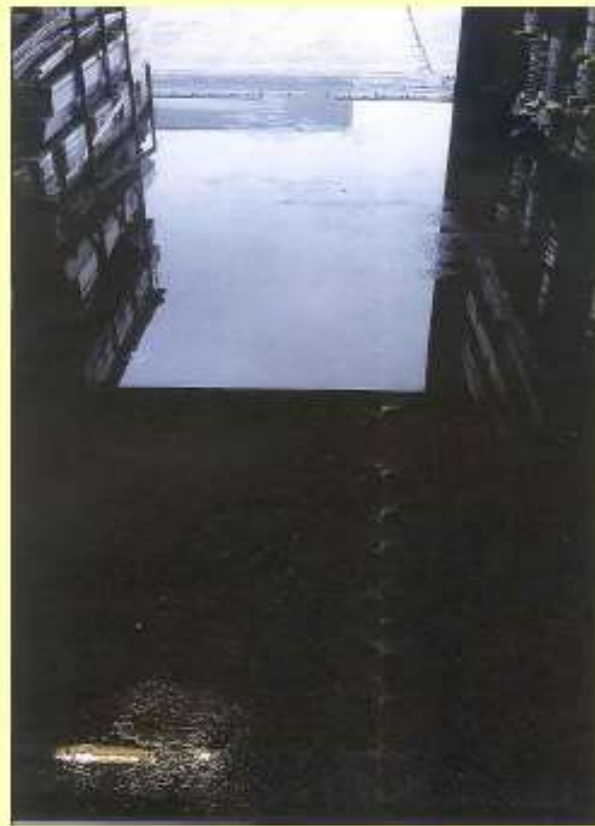
Drawing:
Map 3 - Flood and Drainage Details

Causes – Runoff from rainfall that made its way onto the adjacent highway and flowed along the road into the access of an affected property on Burrell Way

Recommendations – Highway improvement works have recently been undertaken on Burrell Way – Norfolk County Council to monitor area and reassess if flooding occurs again

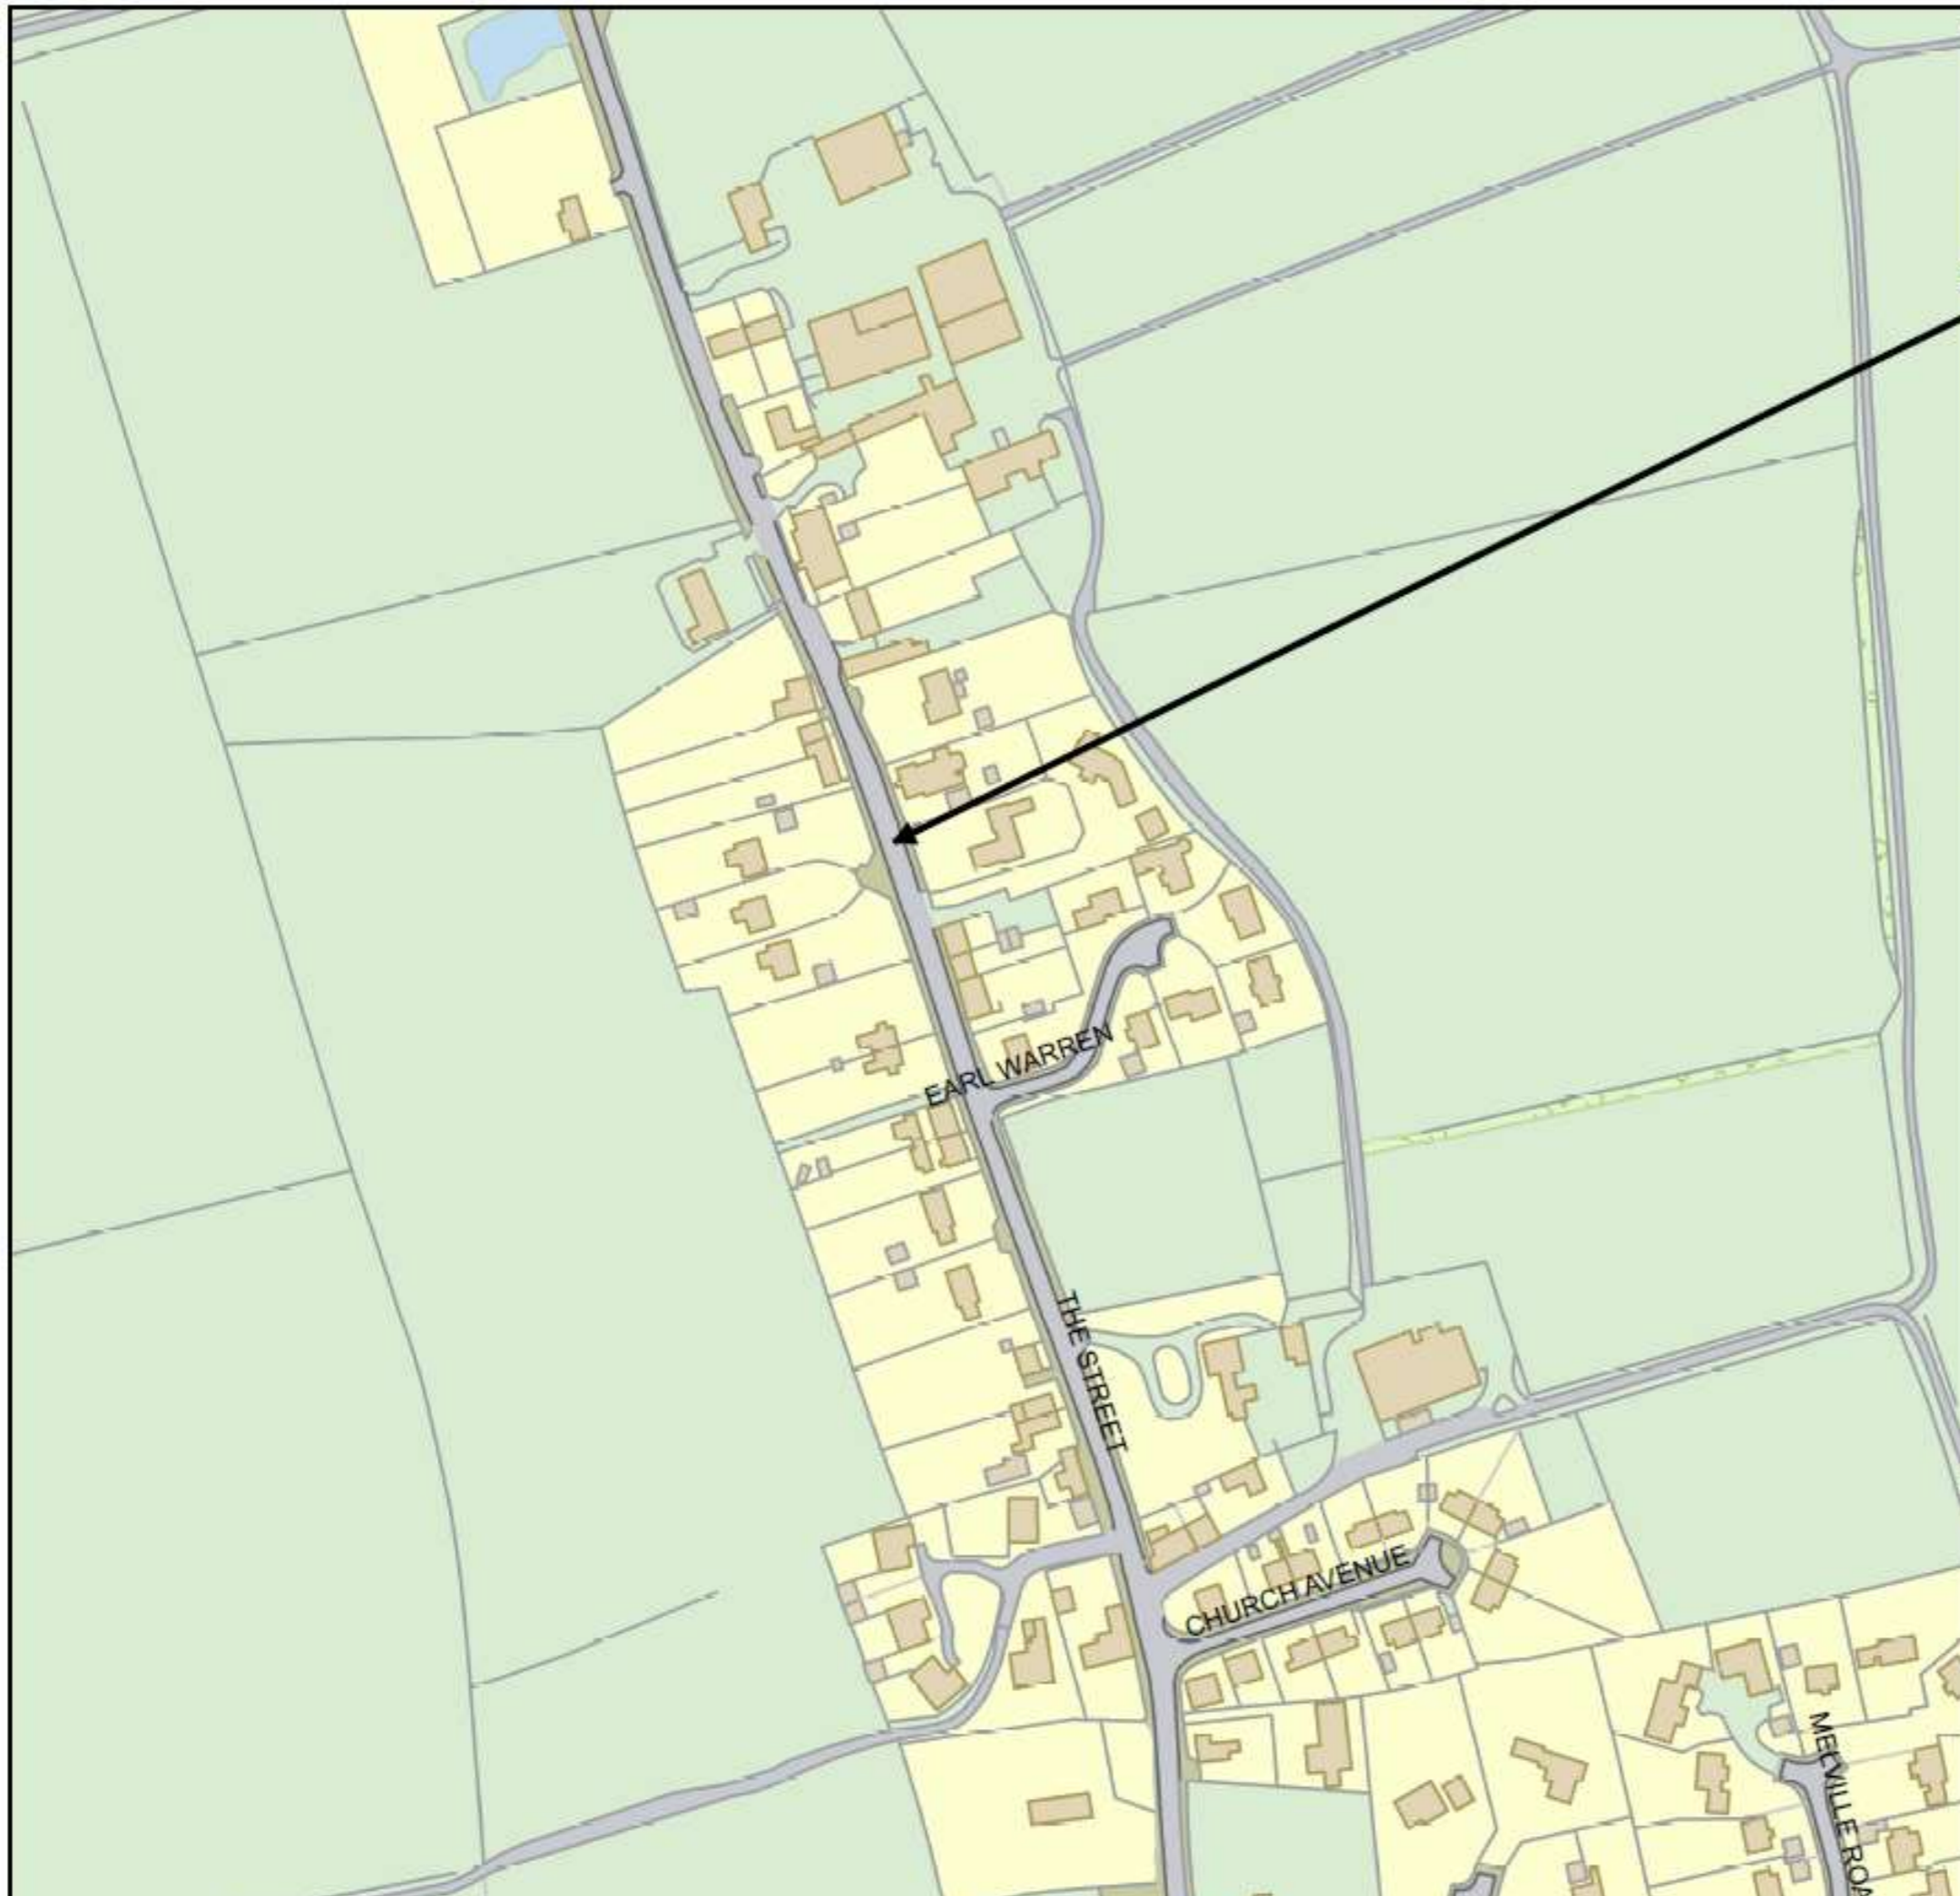
Drawing:
Map 7 - Flood and Drainage Details

Causes – Significant runoff from adjacent highway affected a property on The Street. It is believed that this was caused by the drainage system within the footway being obstructed

Recommendations – Norfolk County Council will investigate into the potential obstruction within the footway drainage system and consider opportunities to route highway water away from affected property

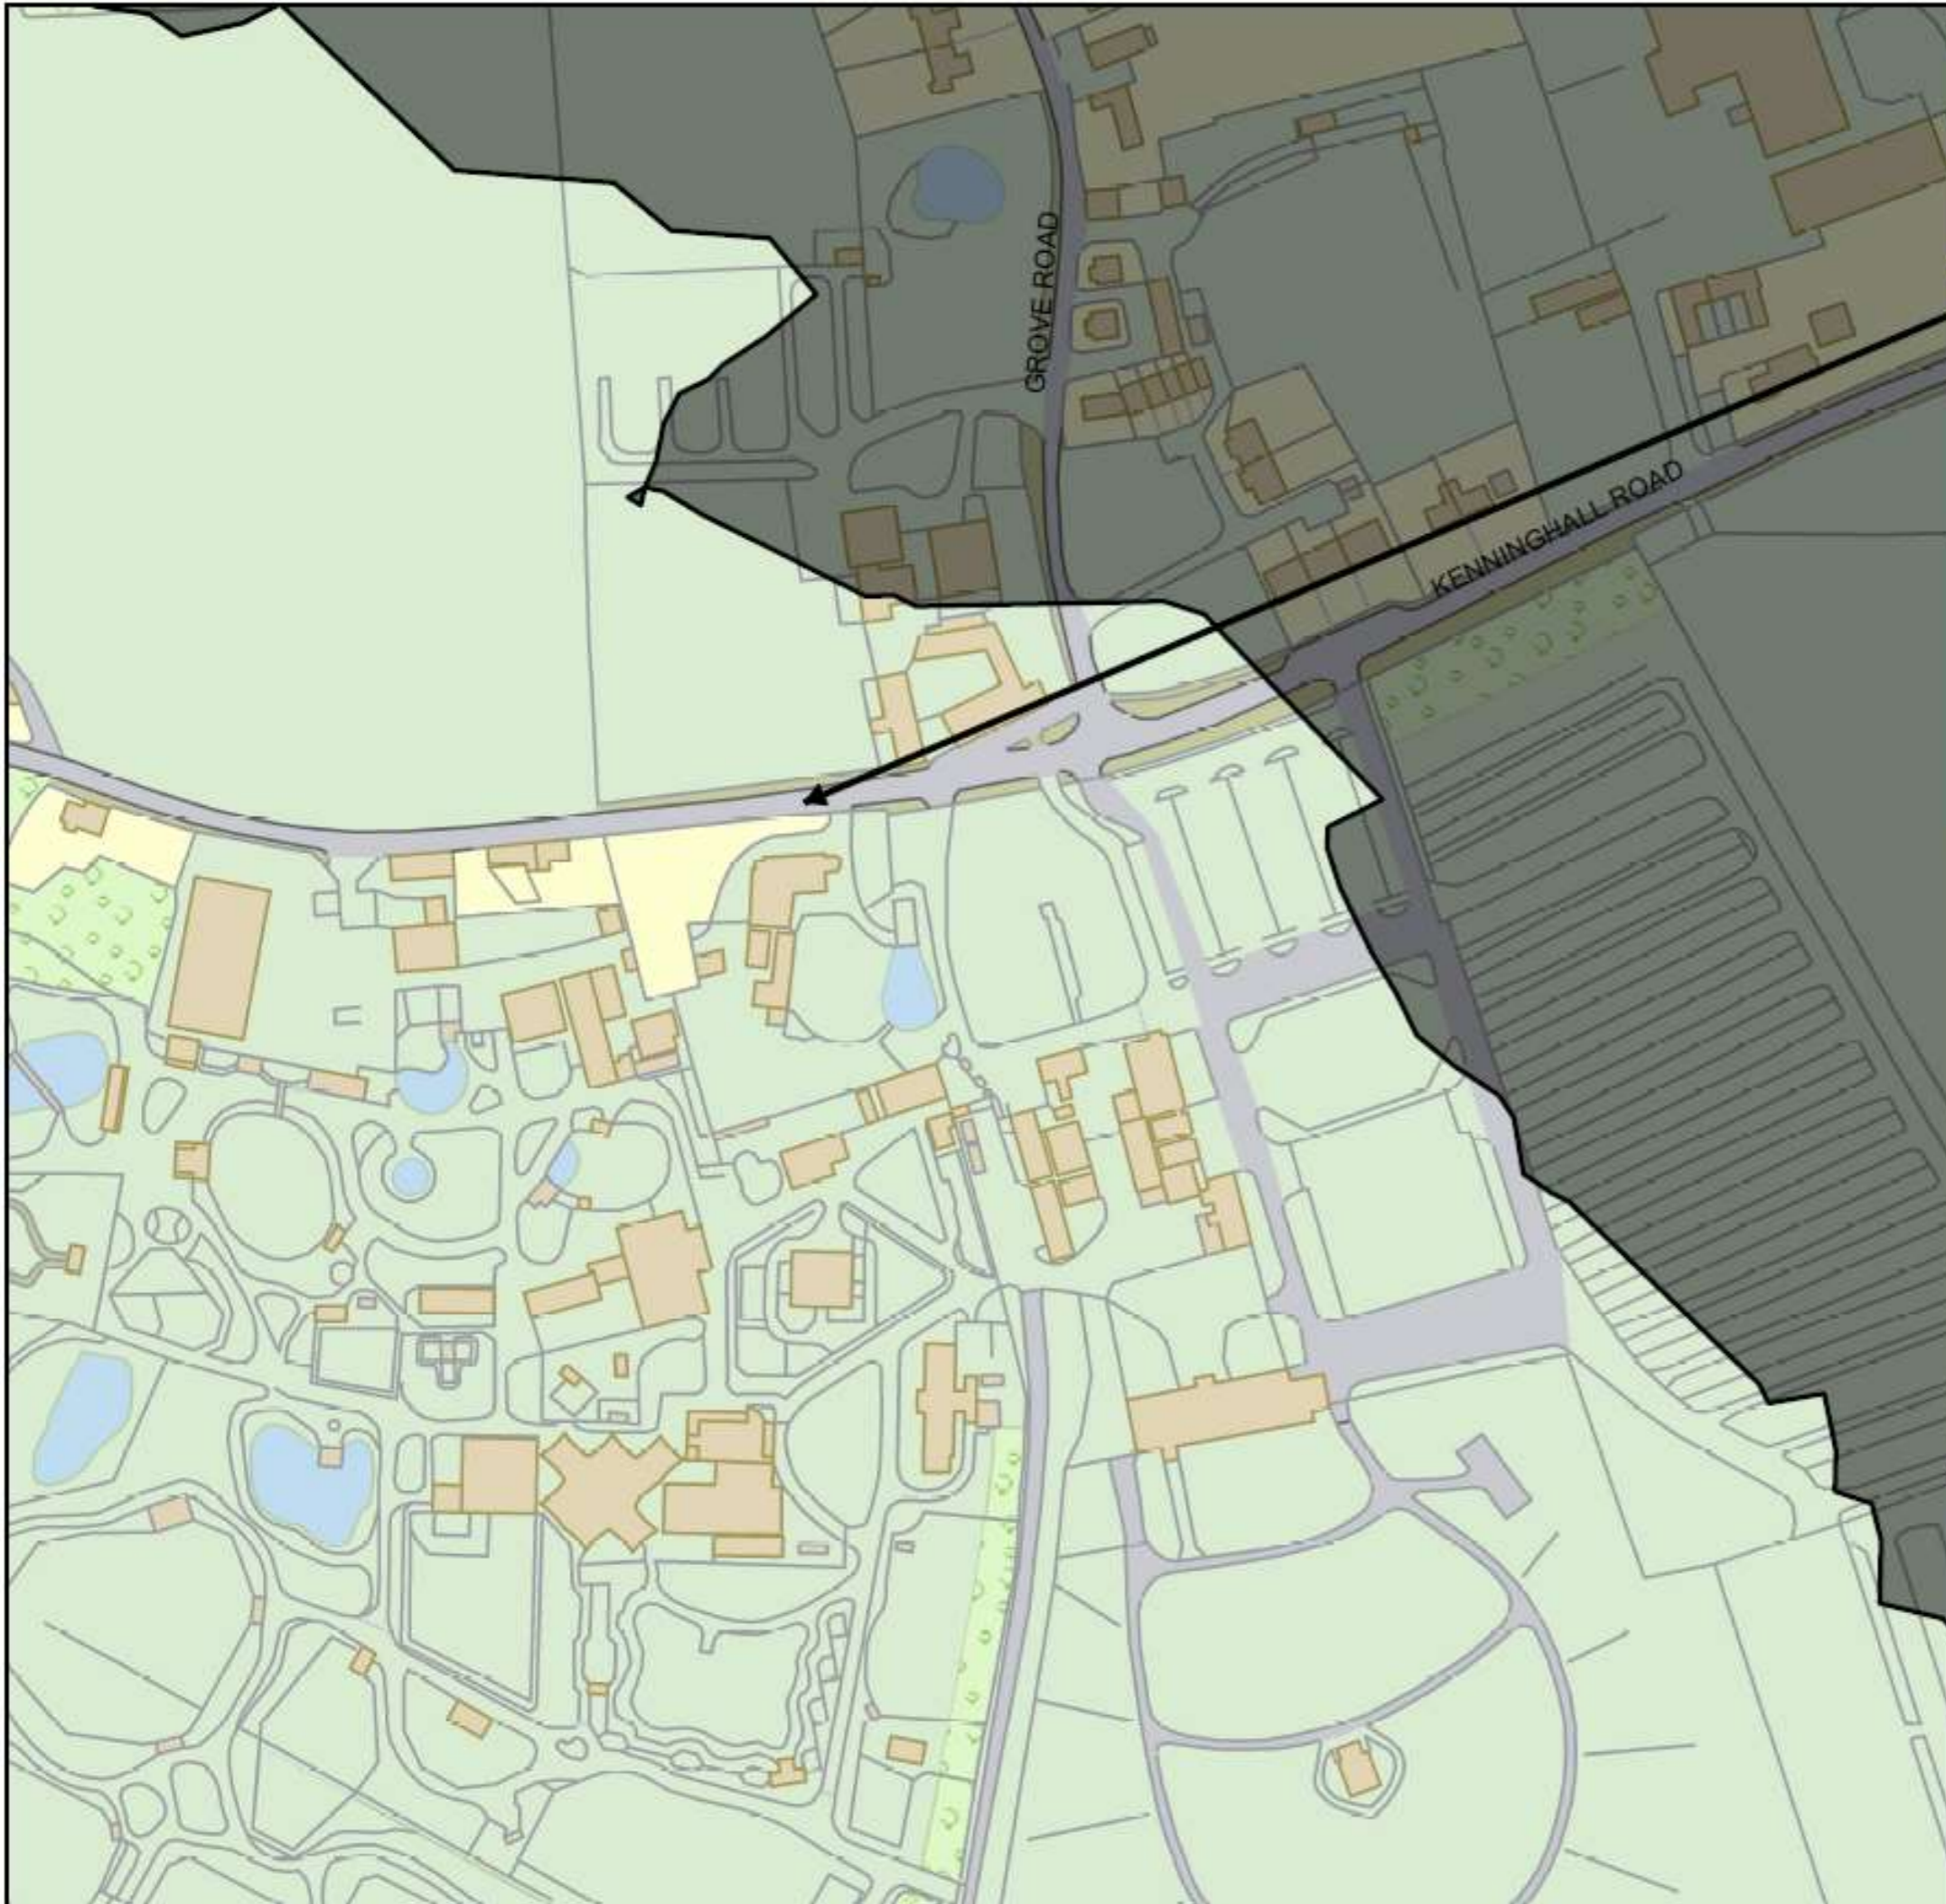
Drawing:
Map 9 - Flood and Drainage Details

Causes – Runoff from adjacent highway affected a property on Kenninghall Road. Also reports of the highway system being collapsed and a gully being blocked

Recommendations – Norfolk County Council will consider opportunities to route highway water away from affected properties to alternative points of discharge. The Property Owner should investigate into the effectiveness of any existing drainage in front of the affected property

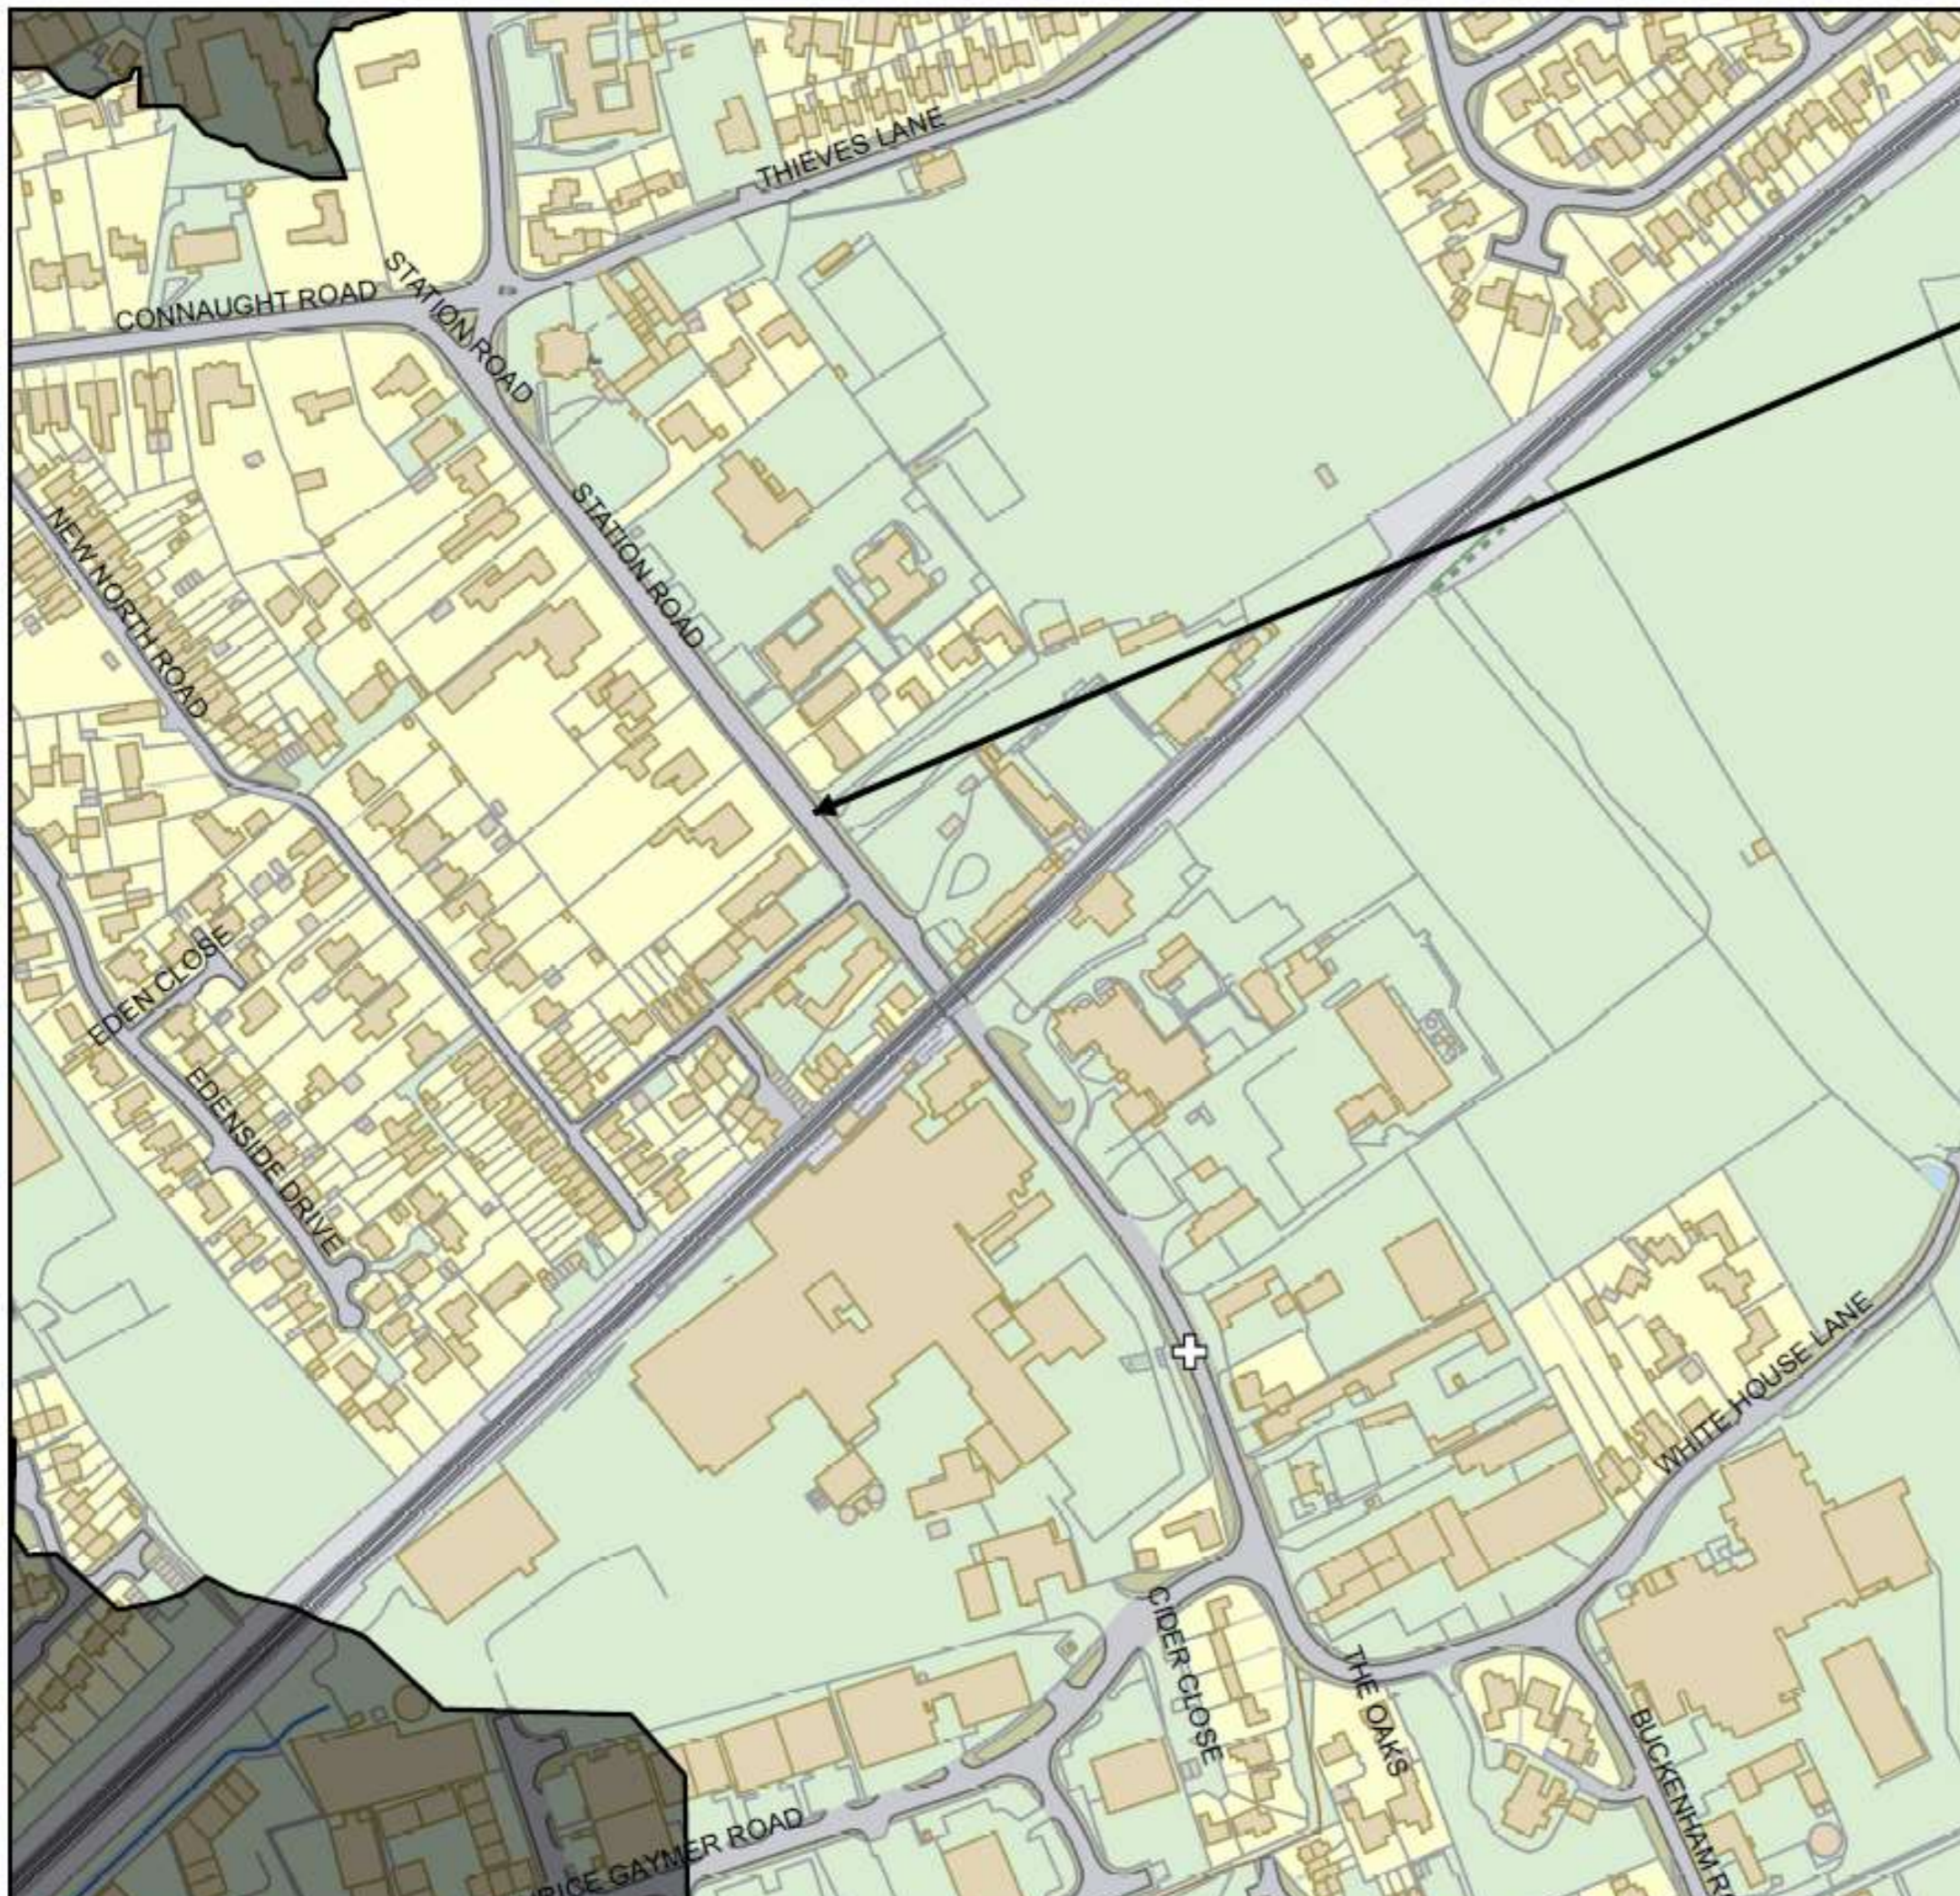
Drawing:
Map 10 - Flood and Drainage Details

Causes – Significant runoff from adjacent properties and highway affected a property on Station Road. Also reports of combined sewer flooding

Recommendations – Norfolk County Council will liaise with local landowners to discuss runoff prevention methods and consider opportunities to route highway water away from affected properties. NCC will also work with Anglian Water to manage the surface water entering their system. Anglian Water to investigate into the report of combined sewer flooding

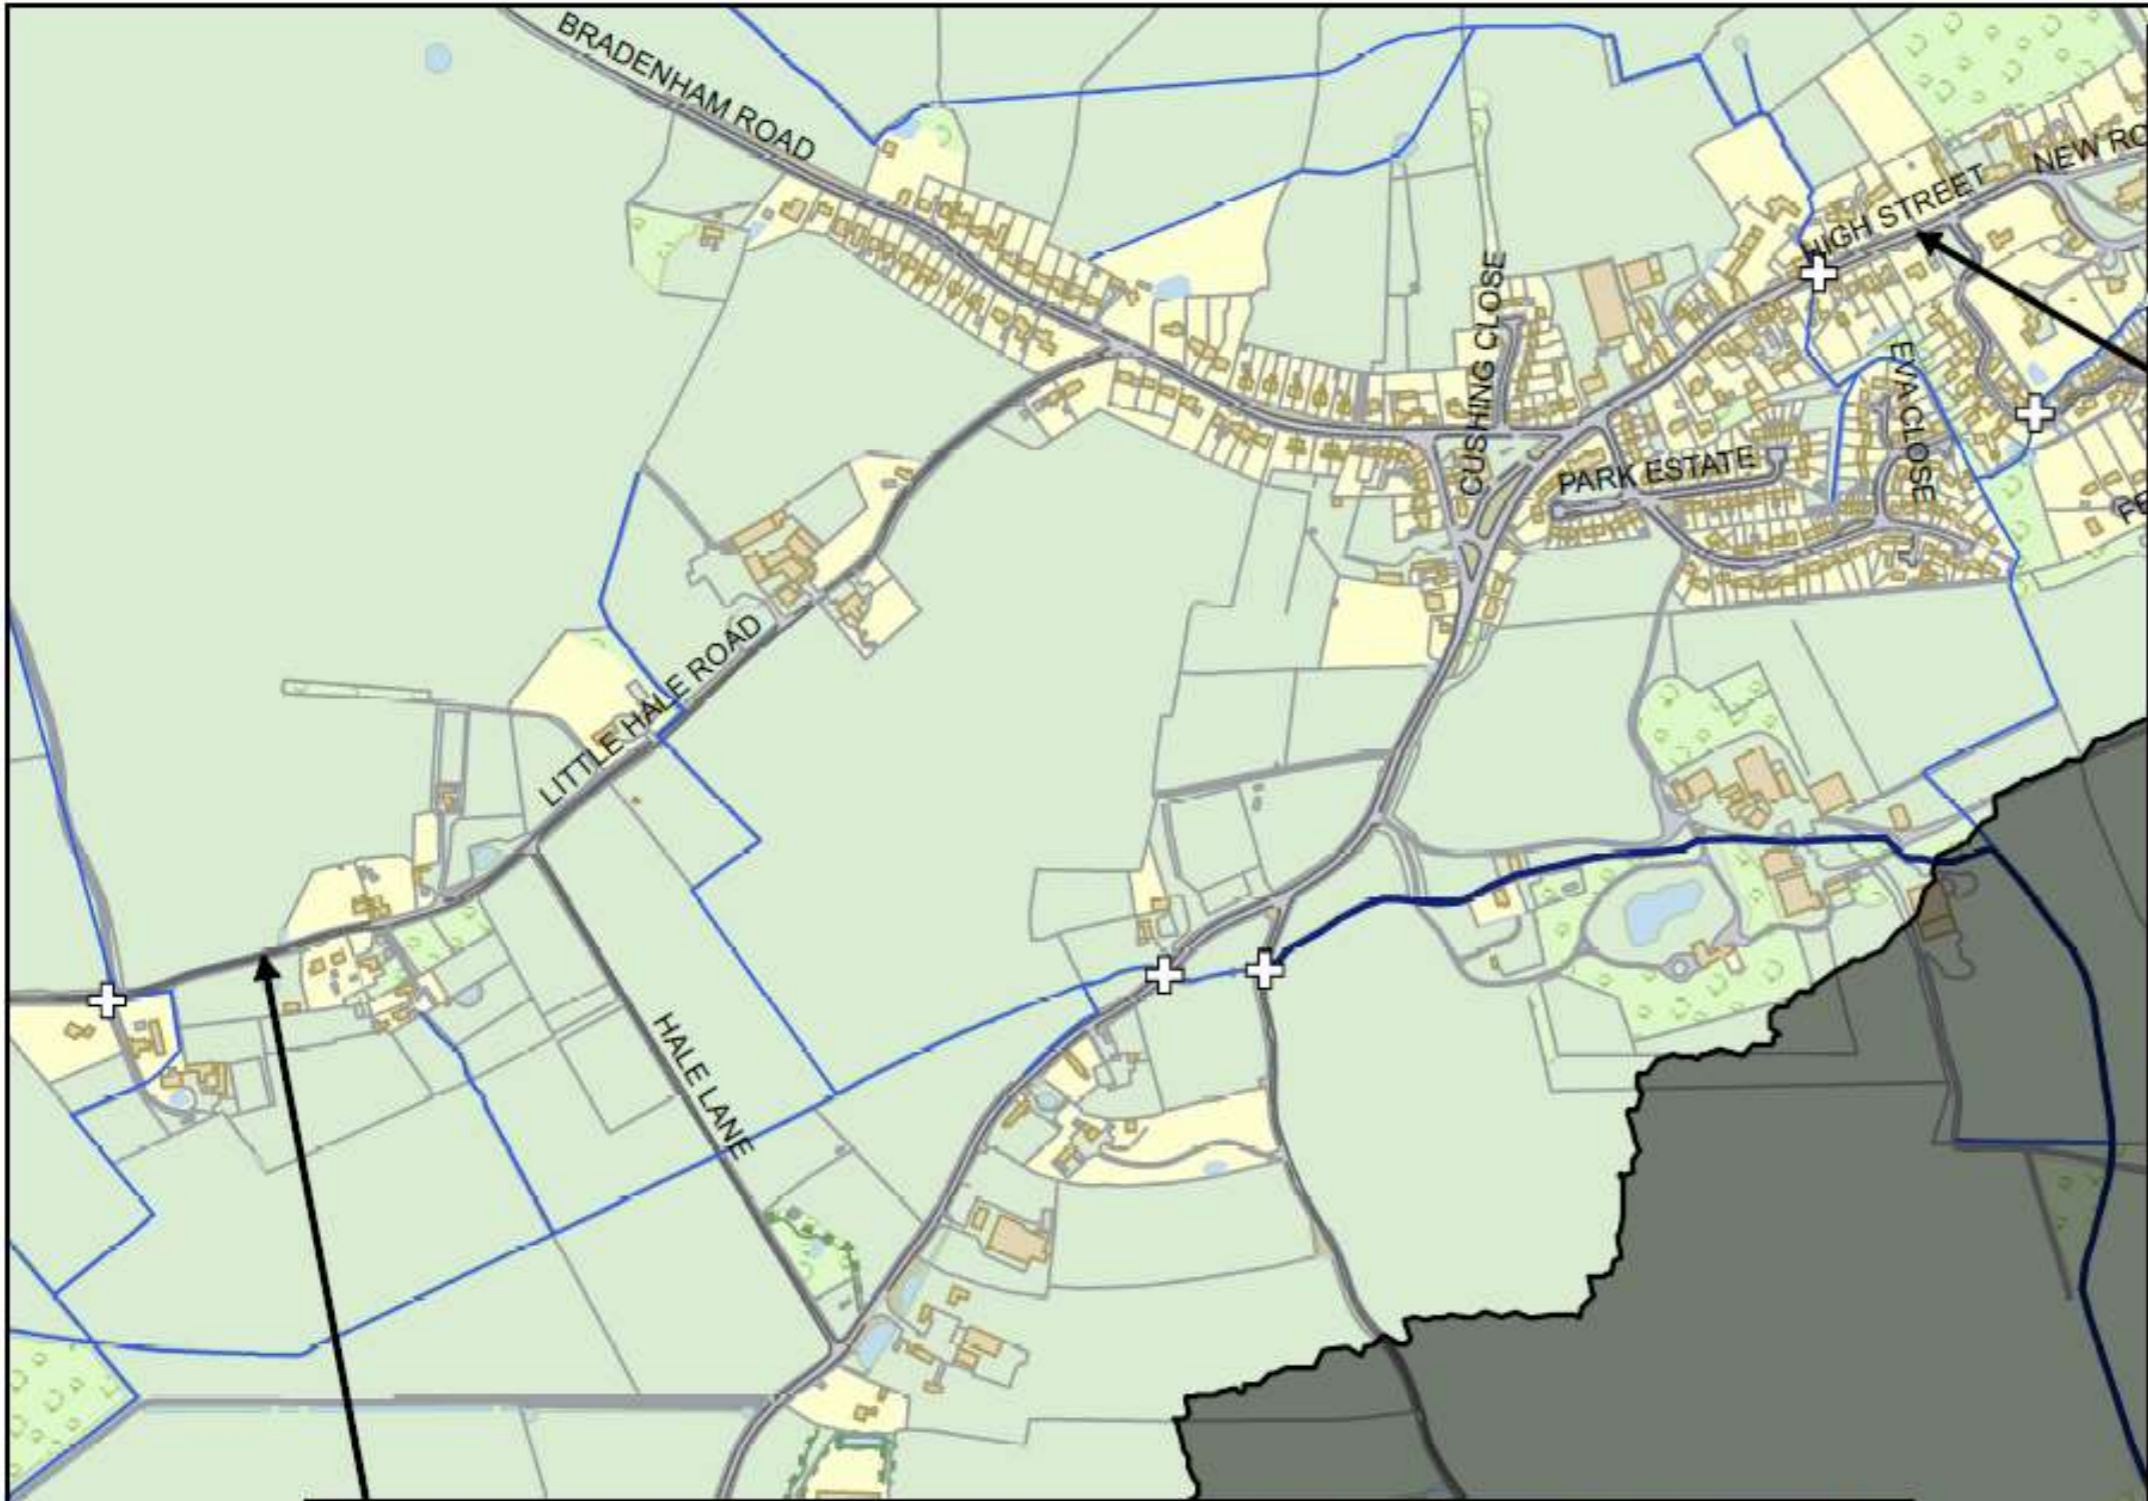
Drawing:
Map 17 - Flood and Drainage Details

Causes – Significant runoff from adjacent fields and runoff from rainfall that made its way onto the adjacent highway and flowed along the road into the access of an affected property on High Street. Also reports of ordinary watercourse bursting its banks and foul system surcharging

Recommendations – Norfolk County Council will liaise with local landowners to discuss runoff prevention methods and consider opportunities to re-route highway runoff away from affected properties. NCC to investigate into the condition of the bridges, watercourses and associated culverts. Anglian Water to investigate into the report of foul sewer flooding. NCC will also work with partner organisations to

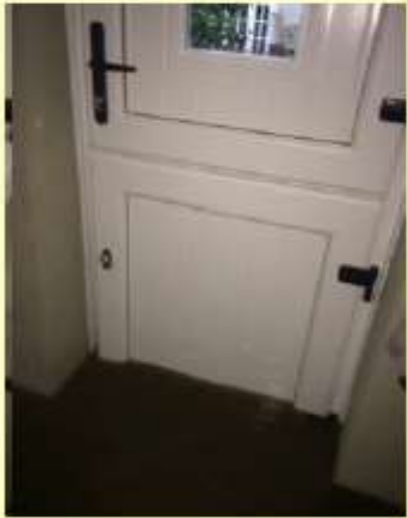
Little Hale Road – Internal flooding experienced on 23 June 2016

Causes – Significant runoff from adjacent fields and runoff from rainfall that made its way onto the adjacent highway and flowed along the road into the access of an affected property on Little Hale Road

Recommendations – Norfolk County Council will liaise with local landowners to discuss runoff prevention methods and investigate into the effectiveness of the ordinary watercourses and associated culverts. NCC will also look into potential options for re-routing highway runoff away from the affected property

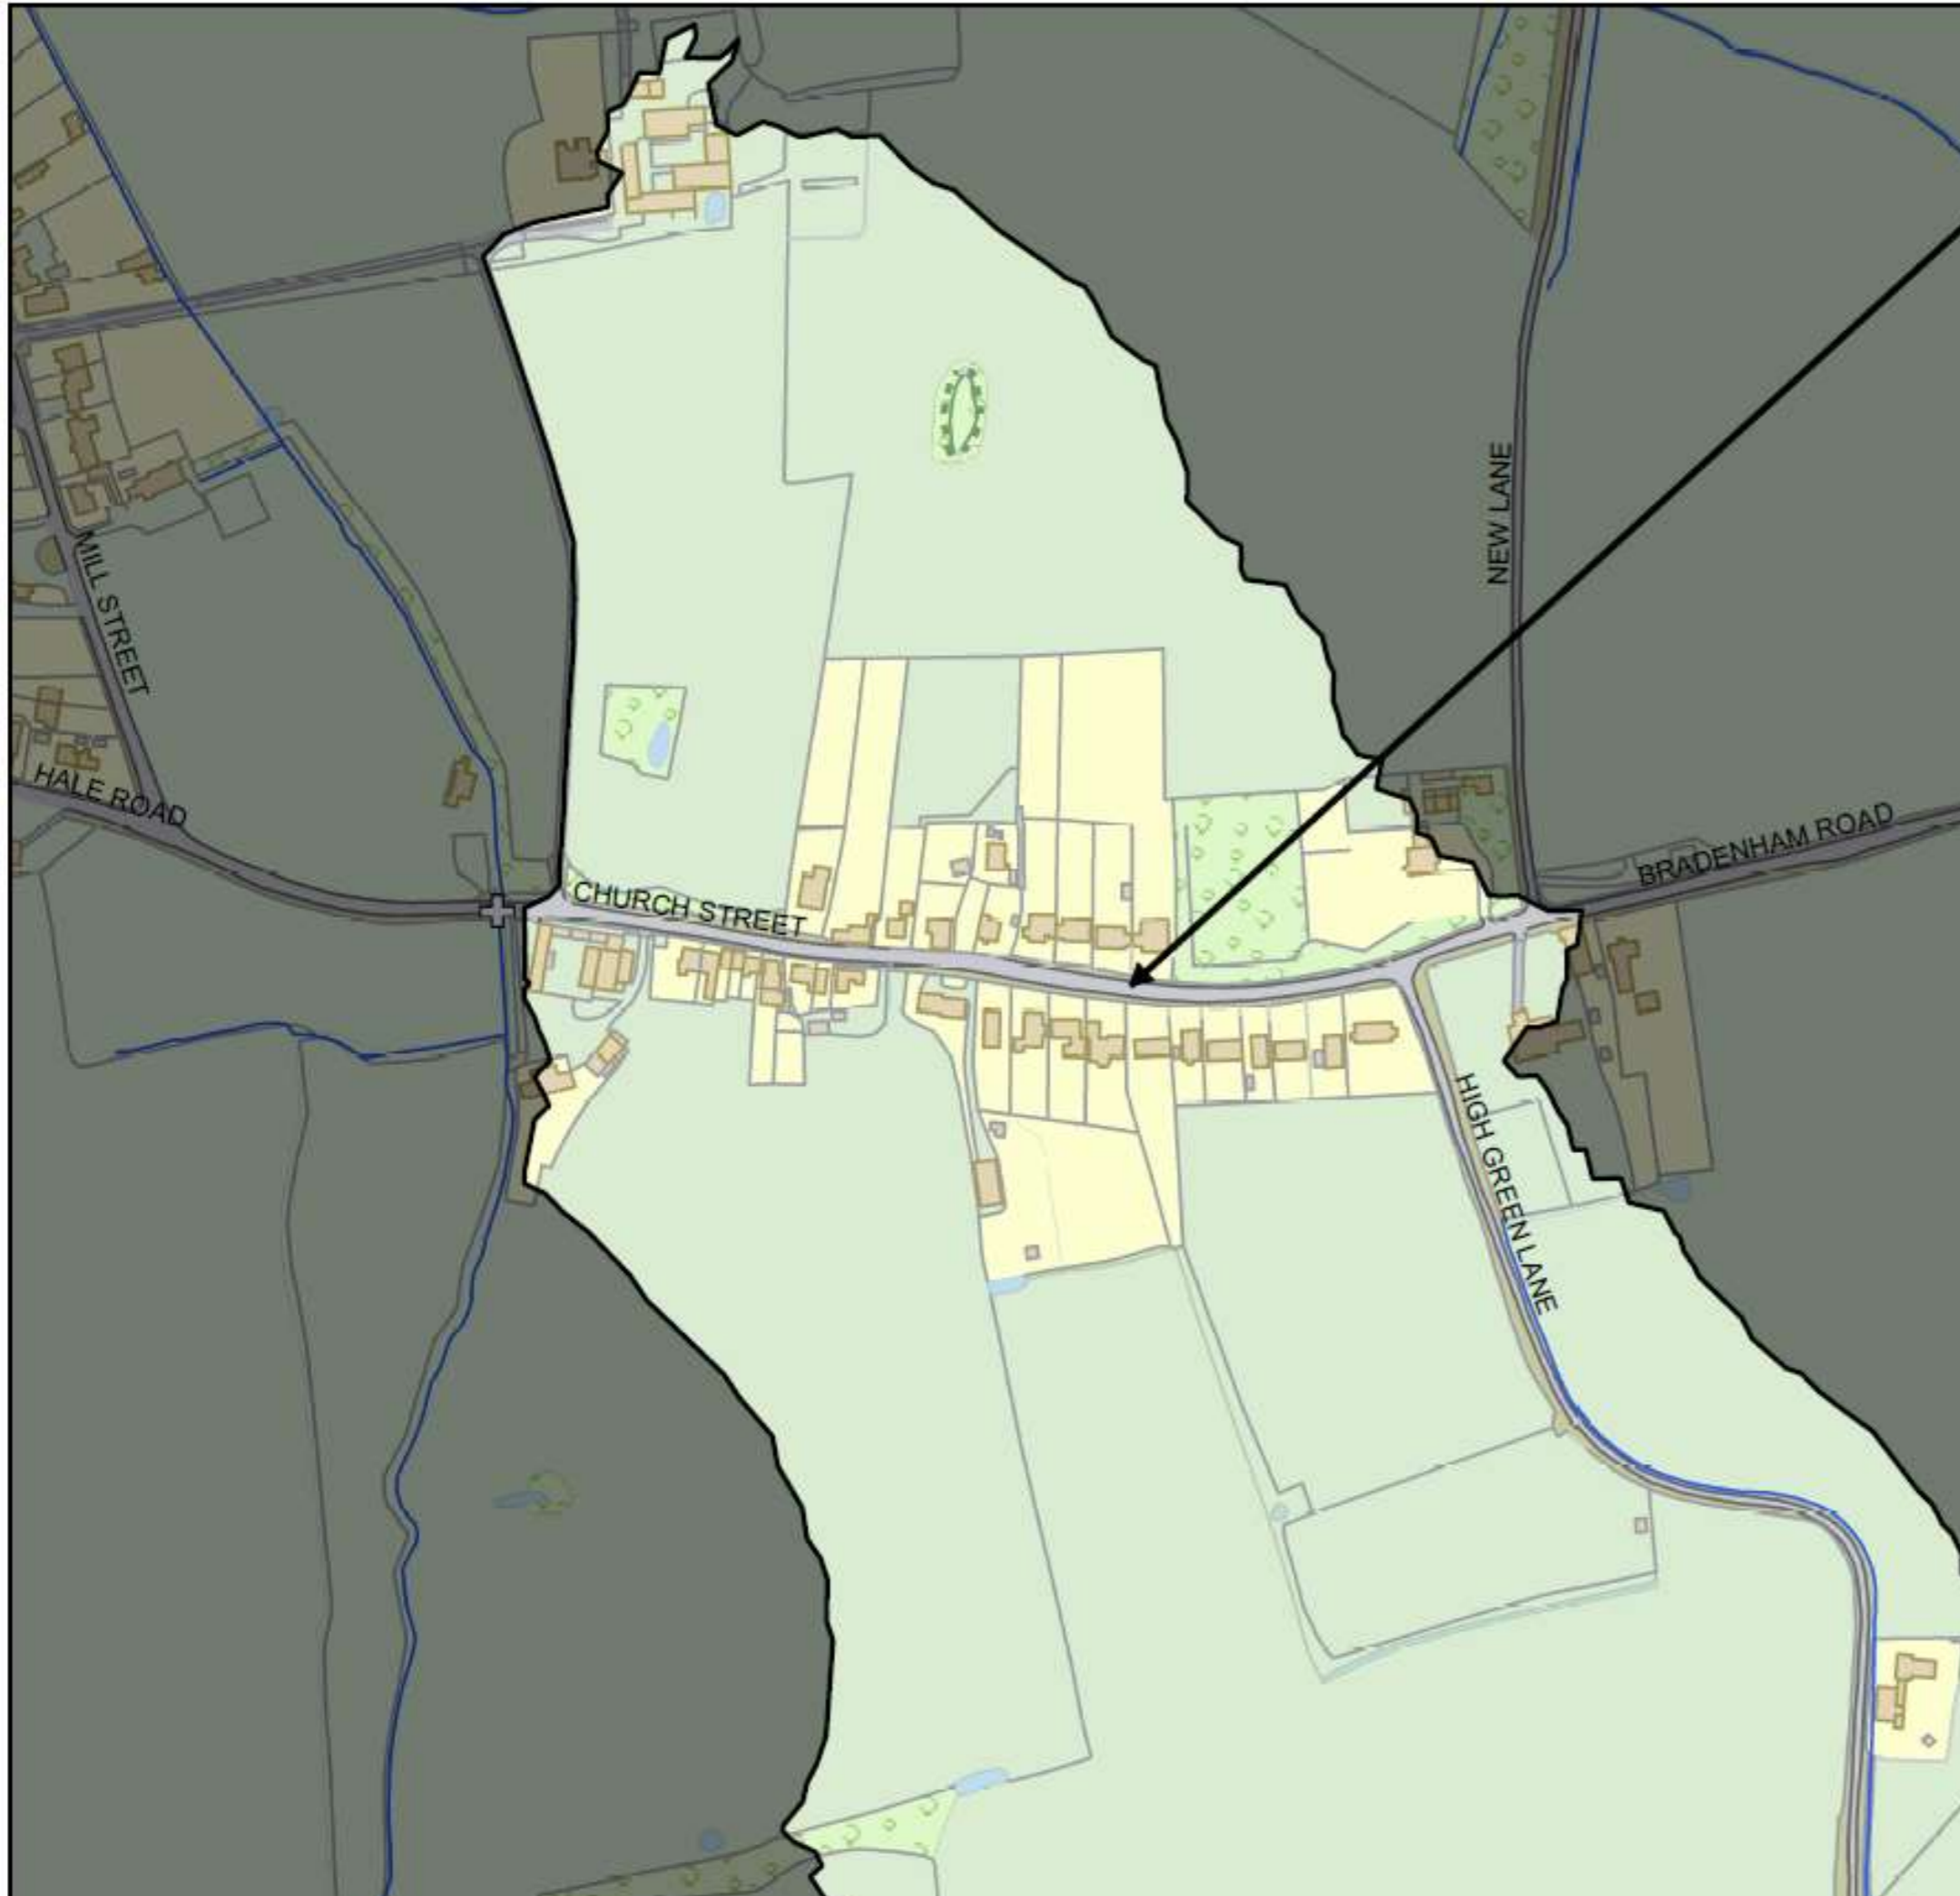
Drawing: **Map 19 - Flood and Drainage Details**

Causes – Significant runoff from adjacent fields and highway affected a property on Church Street. Also reports of ordinary watercourse bursting its banks

Recommendations – Norfolk County Council will liaise with local landowners to discuss runoff prevention methods and investigate into the effectiveness of the watercourses and associated culverts. NCC will also work with partner organisations to identify funding for flood mitigation and consider opportunities to re-route highway runoff away from affected properties
