Norfolk County Council

Investigation Report into the flooding in Breckland District in Winter 2020-2021

Report Reference: FIR066

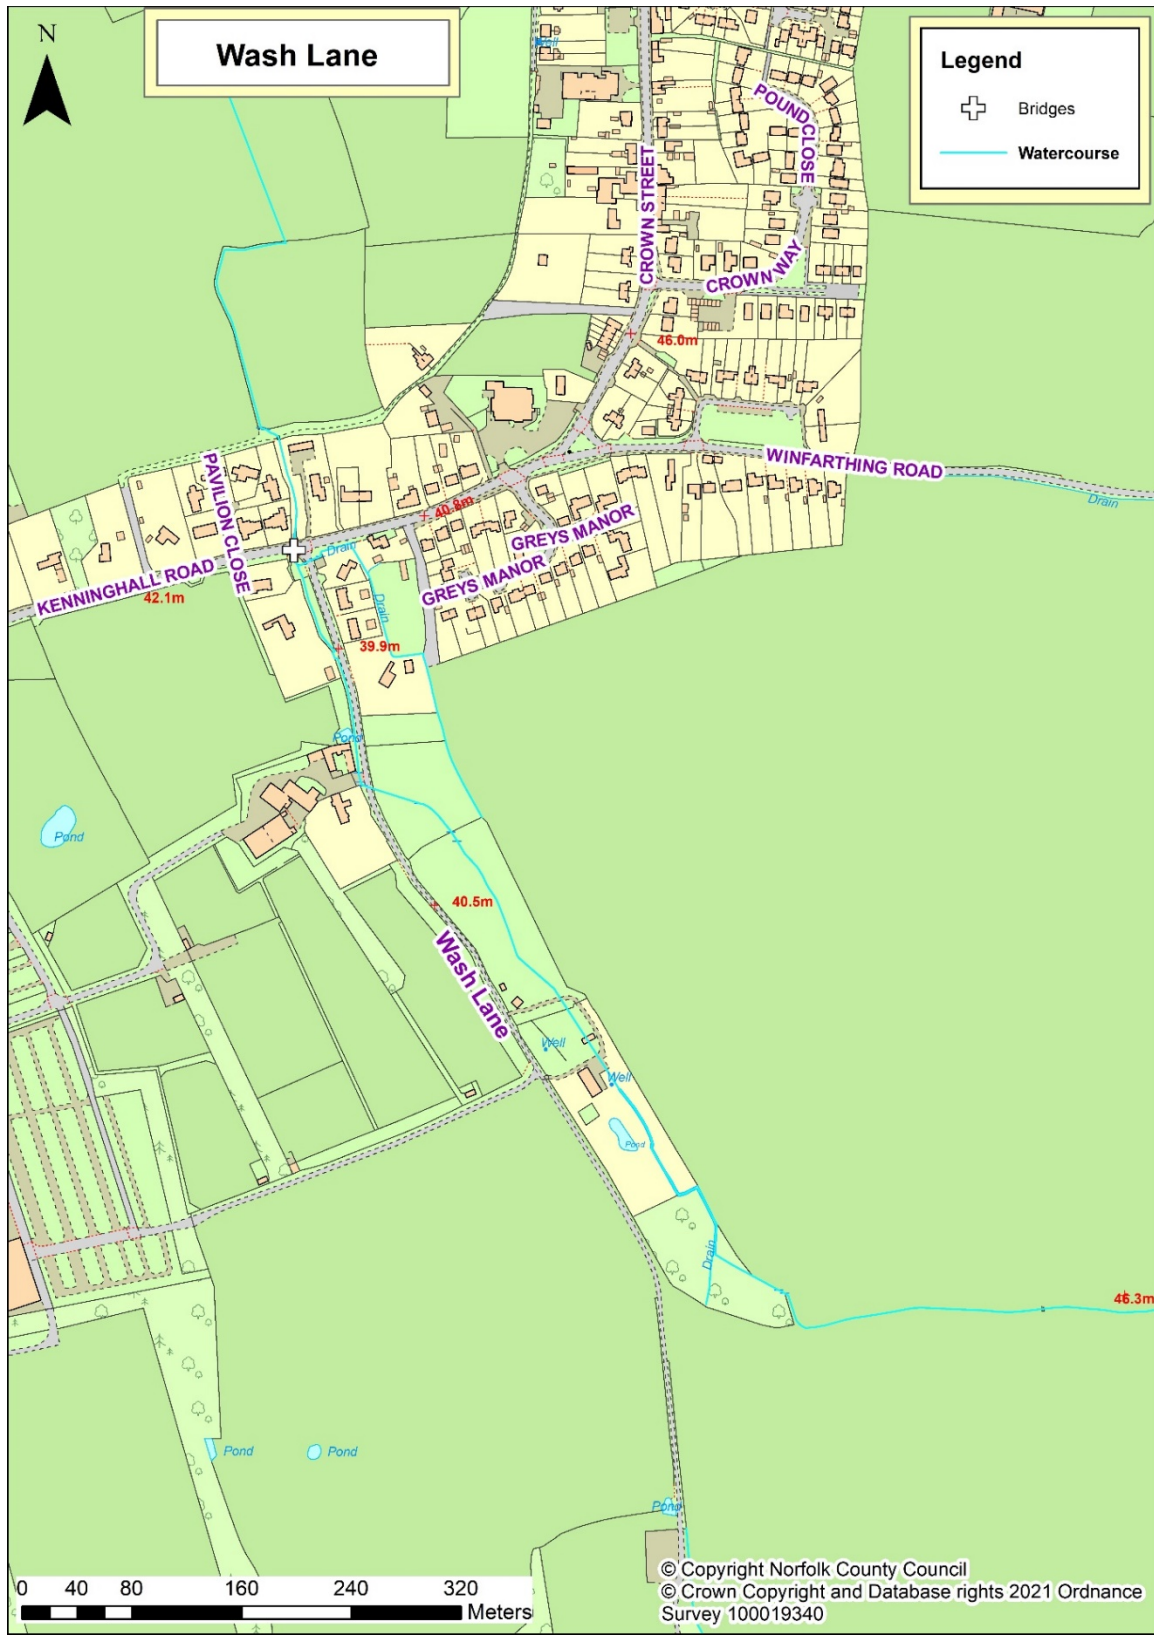
Wash Lane and Kenninghall Road, Banham - 23/12/2020

Causes of flooding	Risk Management Authority with Relevant Flood Risk Function
<p>A substantial amount of rainfall fell on the 23rd Dec onto a catchment with preceding high saturation levels (See Figure 1, page 4 of the report for the catchment area)</p> <p>Wash Lane watercourse and adjacent ditches consequently overtopped their bank(s) adjacent to properties on the eastern side of Wash Lane due to the flashy runoff from the upstream catchment. Two main flow paths were observed:-</p> <ul style="list-style-type: none"> • Breach onto Wash Lane itself from where the main watercourse crosses Wash Lane about half-way up the track to run on the west side. Resulting in major flood flow down Wash Lane itself. This was constricted by Kenninghall Rd culvert. • Another flow path on eastern side of Wash Lane where a much smaller watercourse is evident, this was likely conveying runoff from the upstream catchment too. This is obstructed by a 90° left hand bend towards AW's pump station at Wash Lane Junction. Likely that flow exceeded the pipe and overtopped adjacent banks into Kenninghall Rd and continued north where it would re-join the main watercourse. <p>Flood water entered the properties through low thresholds at entrances / the air bricks / the electricity conduits.</p> <p>Wreck marks on structures such as culvert and footbridges indicate head losses downstream linked to afflux (surcharging). Noted especially at Kenninghall Rd culvert where utility ducting also crosses the D/S face of the road culvert and Back Lane Footbridge.</p> <p>Constrictions and blockages were identified at several locations along all watercourses associated with structures trapping debris. Excessive vegetation is noted within the Wash Lane channel likely contributing to blockages especially on the section downstream of Kenninghall Rd.</p> <p>Surface water runoff across Kenninghall Rd towards the low spot at Wash Lane junction also added to the problem. Accumulation of fluvial/pluvial flows exceeded</p>	<p>Norfolk County Council (LLFA): Regulatory body for ordinary watercourses/surface water</p> <p>Norfolk County Council (Highways): Public highway maintenance, land & asset owner</p> <p>Breckland District Council: Planning Authority + public open space maintenance.</p>

the design capacity of the surface water drainage systems within Kenninghall Rd.

Recommendations	Who has responsibility to follow up the recommendation?	Timescales
Review maintenance responsibilities for the Wash Lane Stream(s) and its associated drainage infrastructure and implement to a wider action plan.	NCC (LLFA)	6 months
Review the inspection and maintenance schedule of all surface water drainage assets within the adopted Highway.	NCC (Highways)	6 months
Review access arrangements for inspection and maintenance. A two-stage channel would improve ease of access, some reduction in flood risk due to additional storage.	NCC (LLFA)	6 months
Riparian owners to clear watercourses (open and/or piped) through areas of concern particularly downstream of Kenninghall Rd. Ensures sufficient capacity and reduction of blockage potential likely to cause reduced conveyance and breaches.	Homeowners	6 months
<p>Advise residents of Property Level Resilience measures and funding opportunities.</p> <p>Property owners could also carry out their own measures where funding is not forthcoming, or residents are unwilling to wait / Property Owners should consider the potential to retrofit permeable areas and other methods of small-scale sustainable drainage systems.</p>	NCC (LLFA)	Ongoing

<p>Riparian owners to consider increasing size of piped watercourses and/or providing additional surface water storage that may currently act as a constriction.</p>		
<p>RMA's to investigate and seek opportunities for partnership funding to deliver a capital scheme which aims to increase standard of protection in Wash Lane and Kenninghall Rd. Works recommended include: -</p> <ol style="list-style-type: none"> 1) Natural Flood Management Scheme on agricultural land to the South of Kenninghall Rd. Two landowners have been identified. 2) Improve conveyance of channels through widening, straightening and regrading – section downstream of Kenninghall Rd culvert needs attention. 	<p>NCC (LLFA) NCC (Highways)</p>	<p>12- 24 months</p>

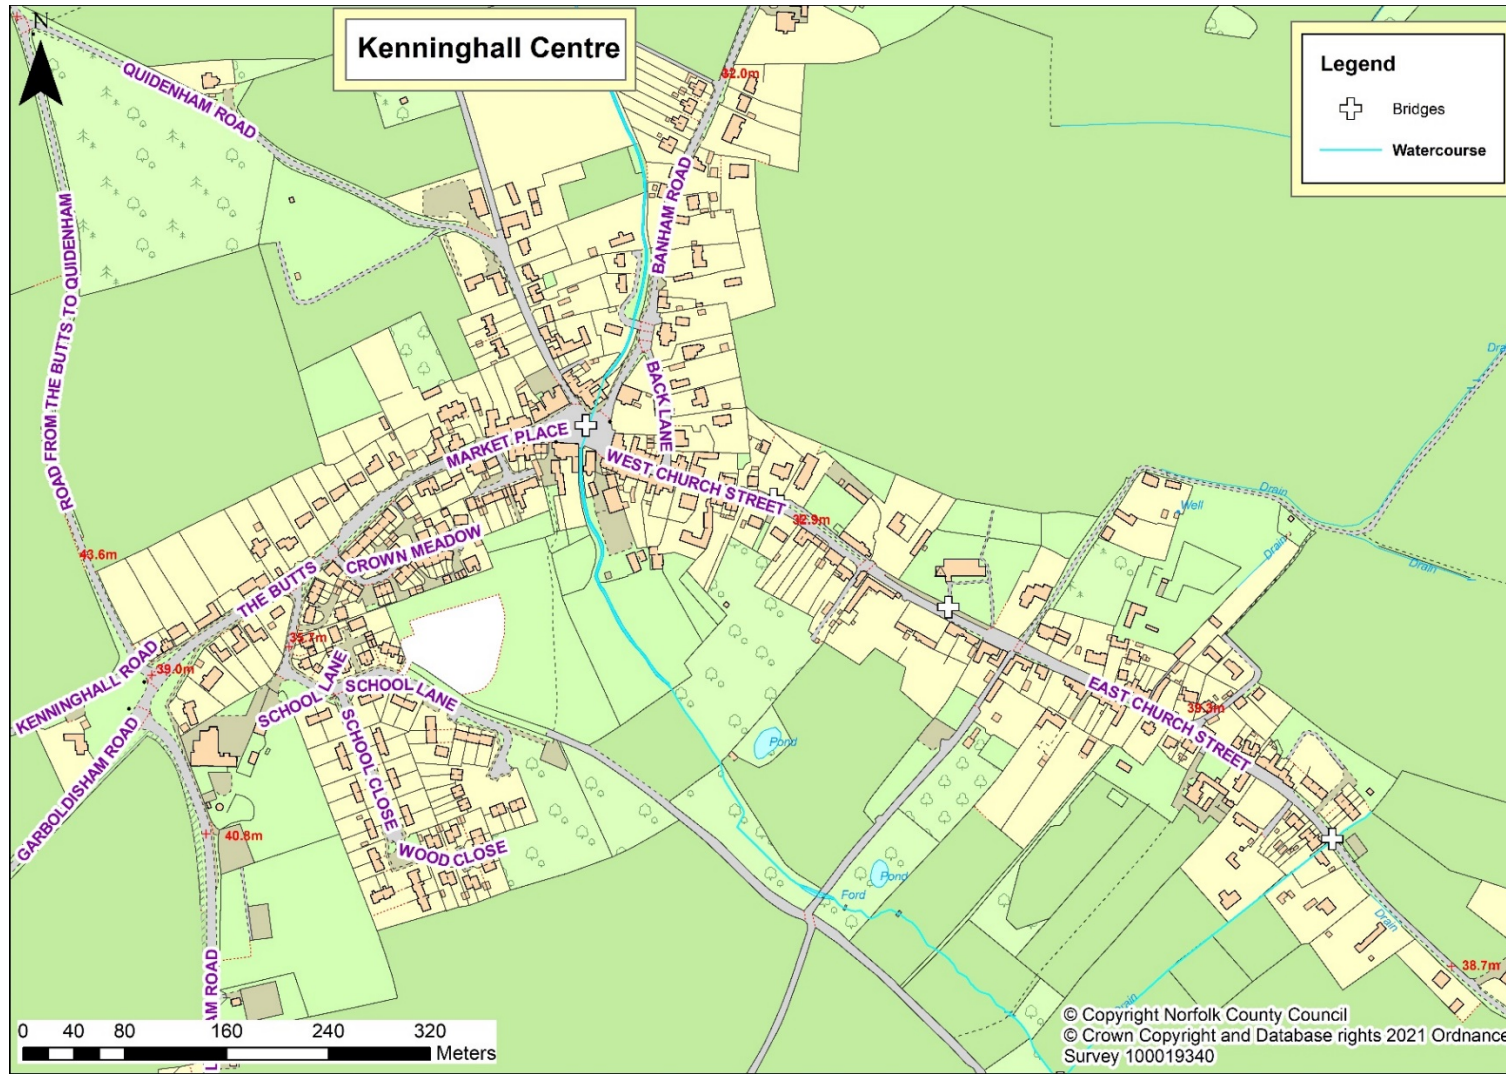
Market Place/ West Church Street/ Banham Rd/ The Beck/ Back Lane/ Crown Courtyard/ Quidenham Road, Kenninghall,
23/12/2020

Causes of flooding	Risk Management Authority with Relevant Flood Risk Function
<p>A substantial amount of rain fell on the 23rd Dec onto a catchment with prior high saturation levels. The catchment is 9.6km² upstream of Kenninghall generating a flashy response to which local watercourses and drainage infrastructure could not cope.</p>	<p>Norfolk County Council: Highways - Public highway maintenance & asset owner</p> <p>Norfolk County Council: LLFA – Land Drainage Powers</p>
<p>Within the centre of Kenninghall the floodplain is naturally constrained by a valley bounded by high ground near to the Community Centre and West Church Street. The inability of the river to spread out over a wider floodplain led to the severe depths witnessed in the centre of the village (1.2m deep reading on village shop) and of which are similar to flood levels witnessed in the Great Flood of 1968. The flood water entered the properties through low thresholds at entrances / the air bricks / the electricity conduits.</p> <p>A tributary, within East Church Street was also heavily constrained by road crossings but was also backed by the high levels in the Beck.</p> <p>Overall, it appears the Beck was overtopping its bank(s) upstream of Kenninghall as far as Dam Green and conveyance of floodwater within the constrained floodplain inundated Kenninghall rather than localised overtopping within the centre of the village itself.</p>	<p>Norfolk County Council: Highways - Public highway maintenance & asset owner</p> <p>Norfolk County Council: LLFA – Land Drainage Powers</p>

<p>Locals witnessed a torrent of overland flow from the west off East Harling Rd adding to the main problems in the Market Square. Possibly surface water runoff from fields.</p>	<p>Norfolk County Council: Highways - Public highway maintenance & asset owner</p> <p>Norfolk County Council: LLFA – Land Drainage Powers</p>
<p>Blockages were identified at several locations along the watercourse post-event, associated with large in-channel trees. Two major blockages were evident in the downstream section along Banham Rd.</p>	<p>Norfolk County Council: Highways - Public highway maintenance & asset owner</p>

Recommendations	Who has responsibility to follow up the recommendation?	Timescales
surface water storage that may currently act as a constriction.		
Riparian owners to clear watercourses (open and/or piped) through areas of upstream hydraulic structures such as culverts/bridges. Ensures sufficient capacity and reduction of blockage potential which is likely to cause reduced conveyance and breaches.	Homeowners	6 months
<p>RMA's to investigate partnership funding to deliver a capital scheme which aims to increase standard of protection in Kenninghall. Works recommended include: -</p> <p>6) Feasibility Study / hydraulic assessment to understand baseline flood risk and potential alleviation options for Kenninghall. This will assess the full catchment and identify areas for storage as material changes to the market square culvert are highly unlikely in terms of improving conveyance at this pinch point</p> <p>7) A community led Natural Flood Management Scheme by the community on agricultural land to the South of Kenninghall. One landowner has been identified to date.</p> <p>8) Pending feasibility study outputs deliver a capital scheme to raise Standard of Protection for properties near the Beck.</p>	NCC (LLFA), NCC (Highways) and Parish Council	12- 24 months

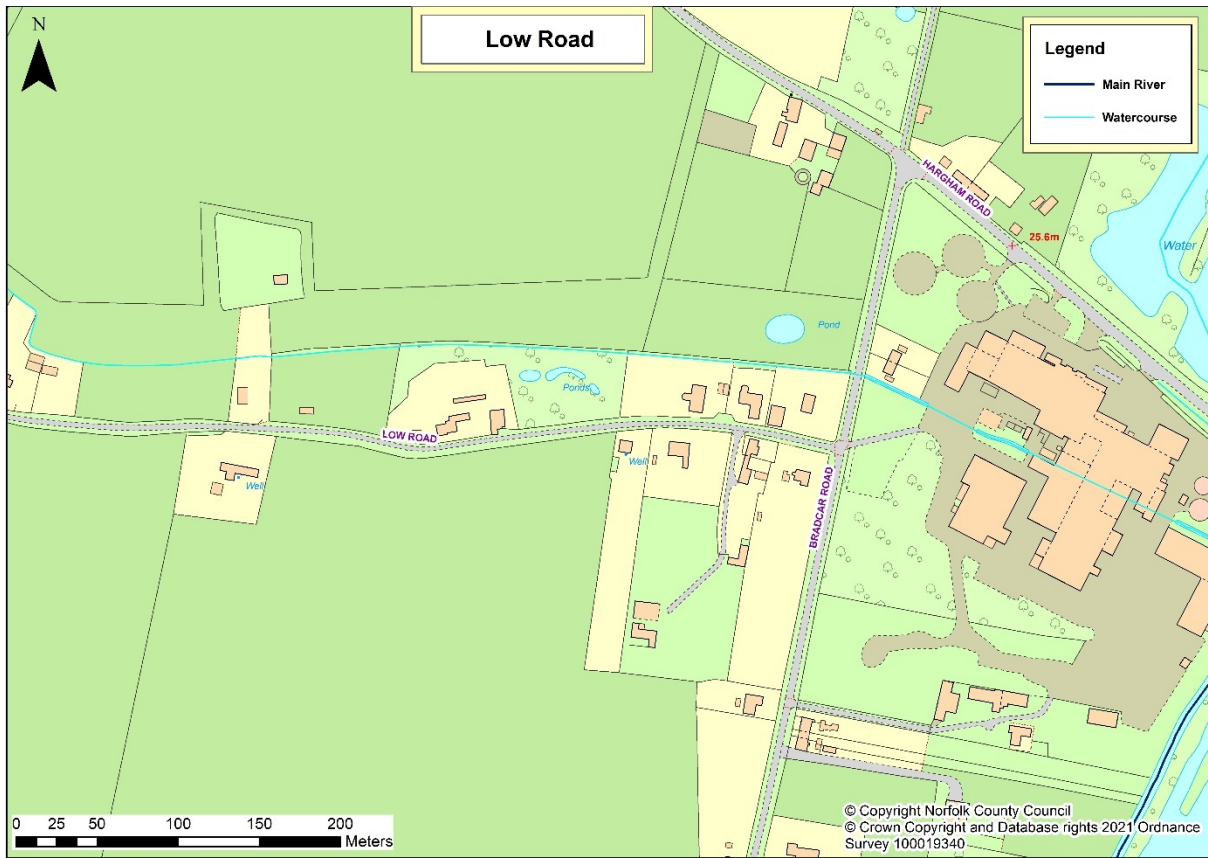
Low Road, Shropham, 27/01/2021

Causes of flooding	Who has responsibilities to manage the cause(s) of the flood?
Run-off from significant rainfall was concentrated along overland flowpaths on which the affected properties are positioned on/adjacent to.	Norfolk County Council (LLFA): Regulatory body for ordinary watercourses/ surface water Norfolk County Council (Highways): Public highway maintenance, land & asset owner
The highway drainage system network was fully obstructed by debris or silt. This caused the failure of the upstream drainage system contributing to flooding at the affected properties. The volume of flooding in Low Rd and surrounding areas may have been exacerbated by all gullies being blocked in the low spot road restricting flow getting off the highway to local ditches.	Norfolk County Council (Highways): Public highway maintenance, land & asset owner
The flood water entered the properties through low thresholds at entrances/the air bricks.

Partial blockages were identified at several locations along Watercourse, especially opposite Low Road on the northern side of properties. Large in-channel trees were trapping debris leading to reduced flow capacity. This reduced the efficiency of the upstream drainage system contributing to flooding at the affected properties.	NCC (LLFA) Riparian Landowners
