Norfolk County Council

Investigation Report into the flooding in Broadland Various in 2013-2016

Report Reference: FIR037

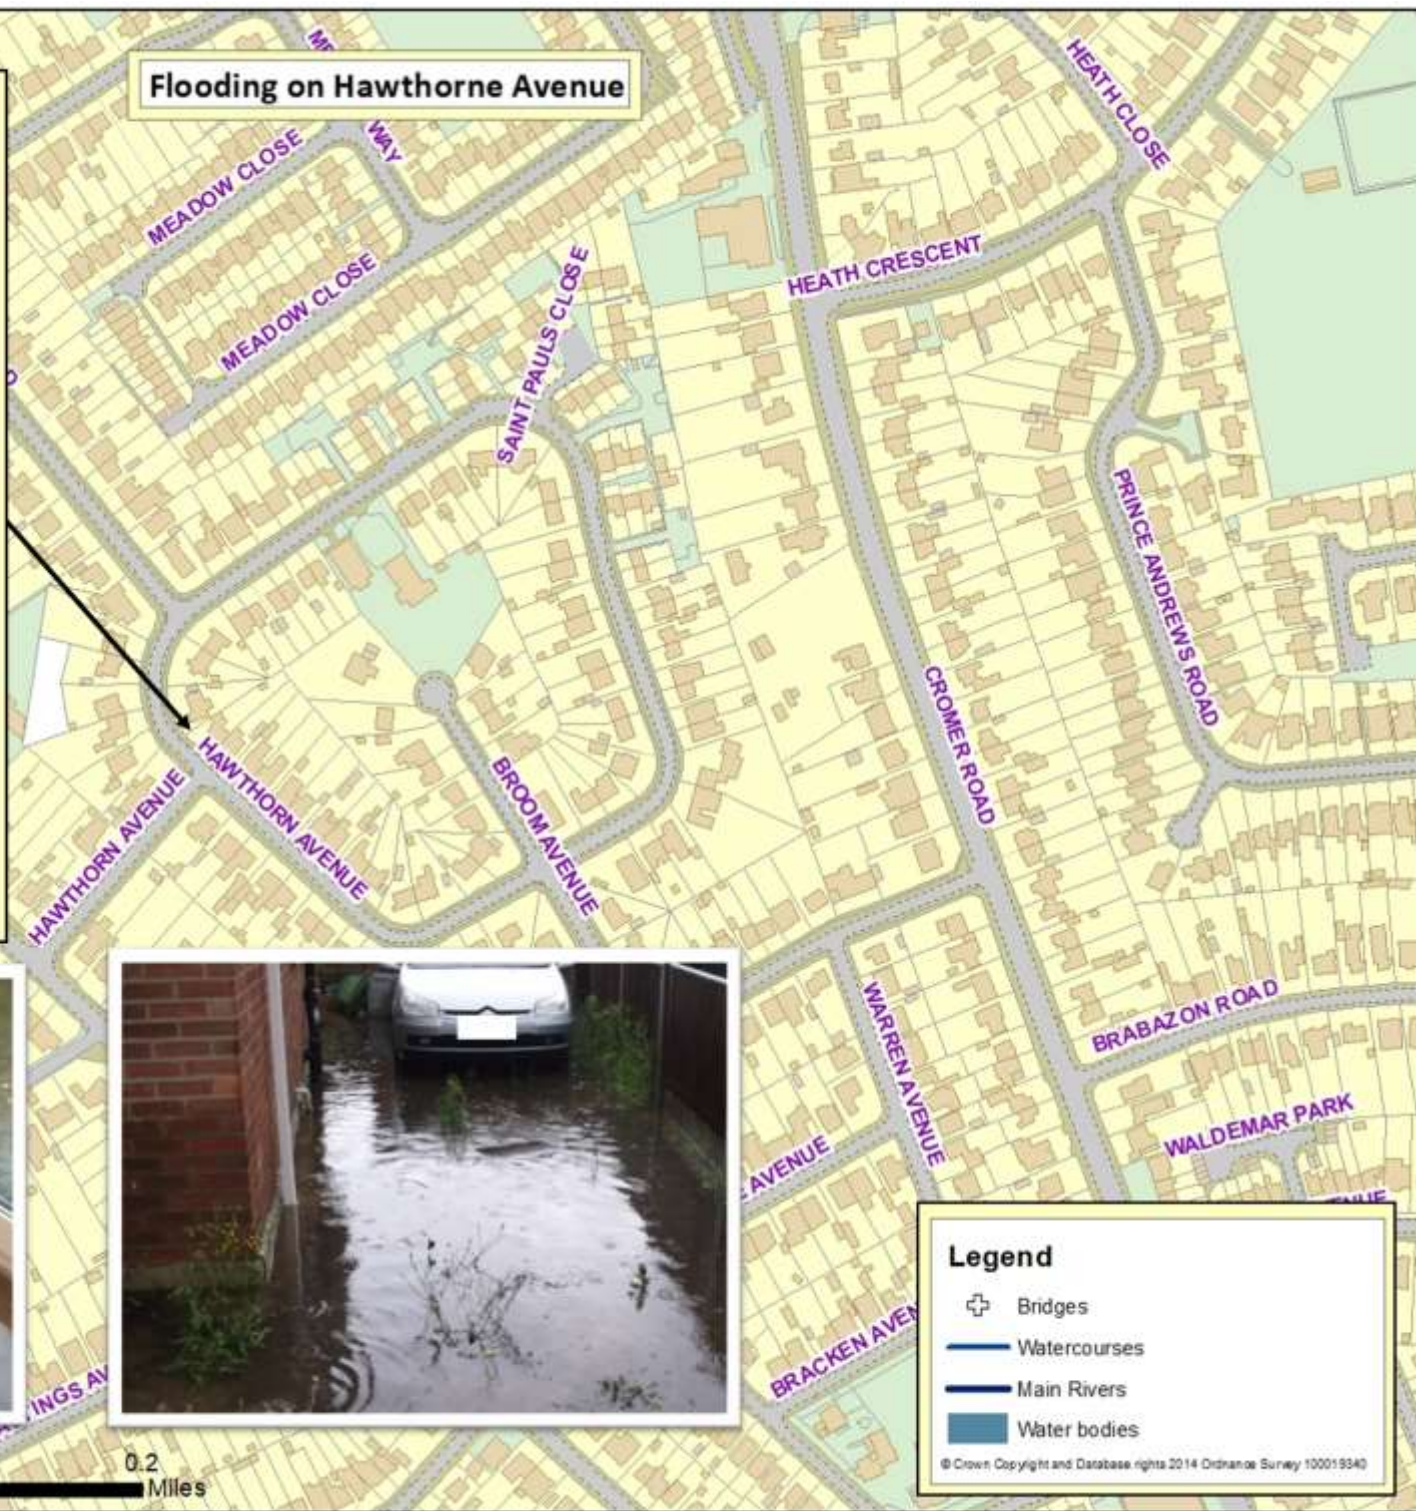
Flooding on Middletons Lane

Location: Middletons Lane- 6 reports of internal flooding on 23rd June 2016

Causes –

Recommendations –

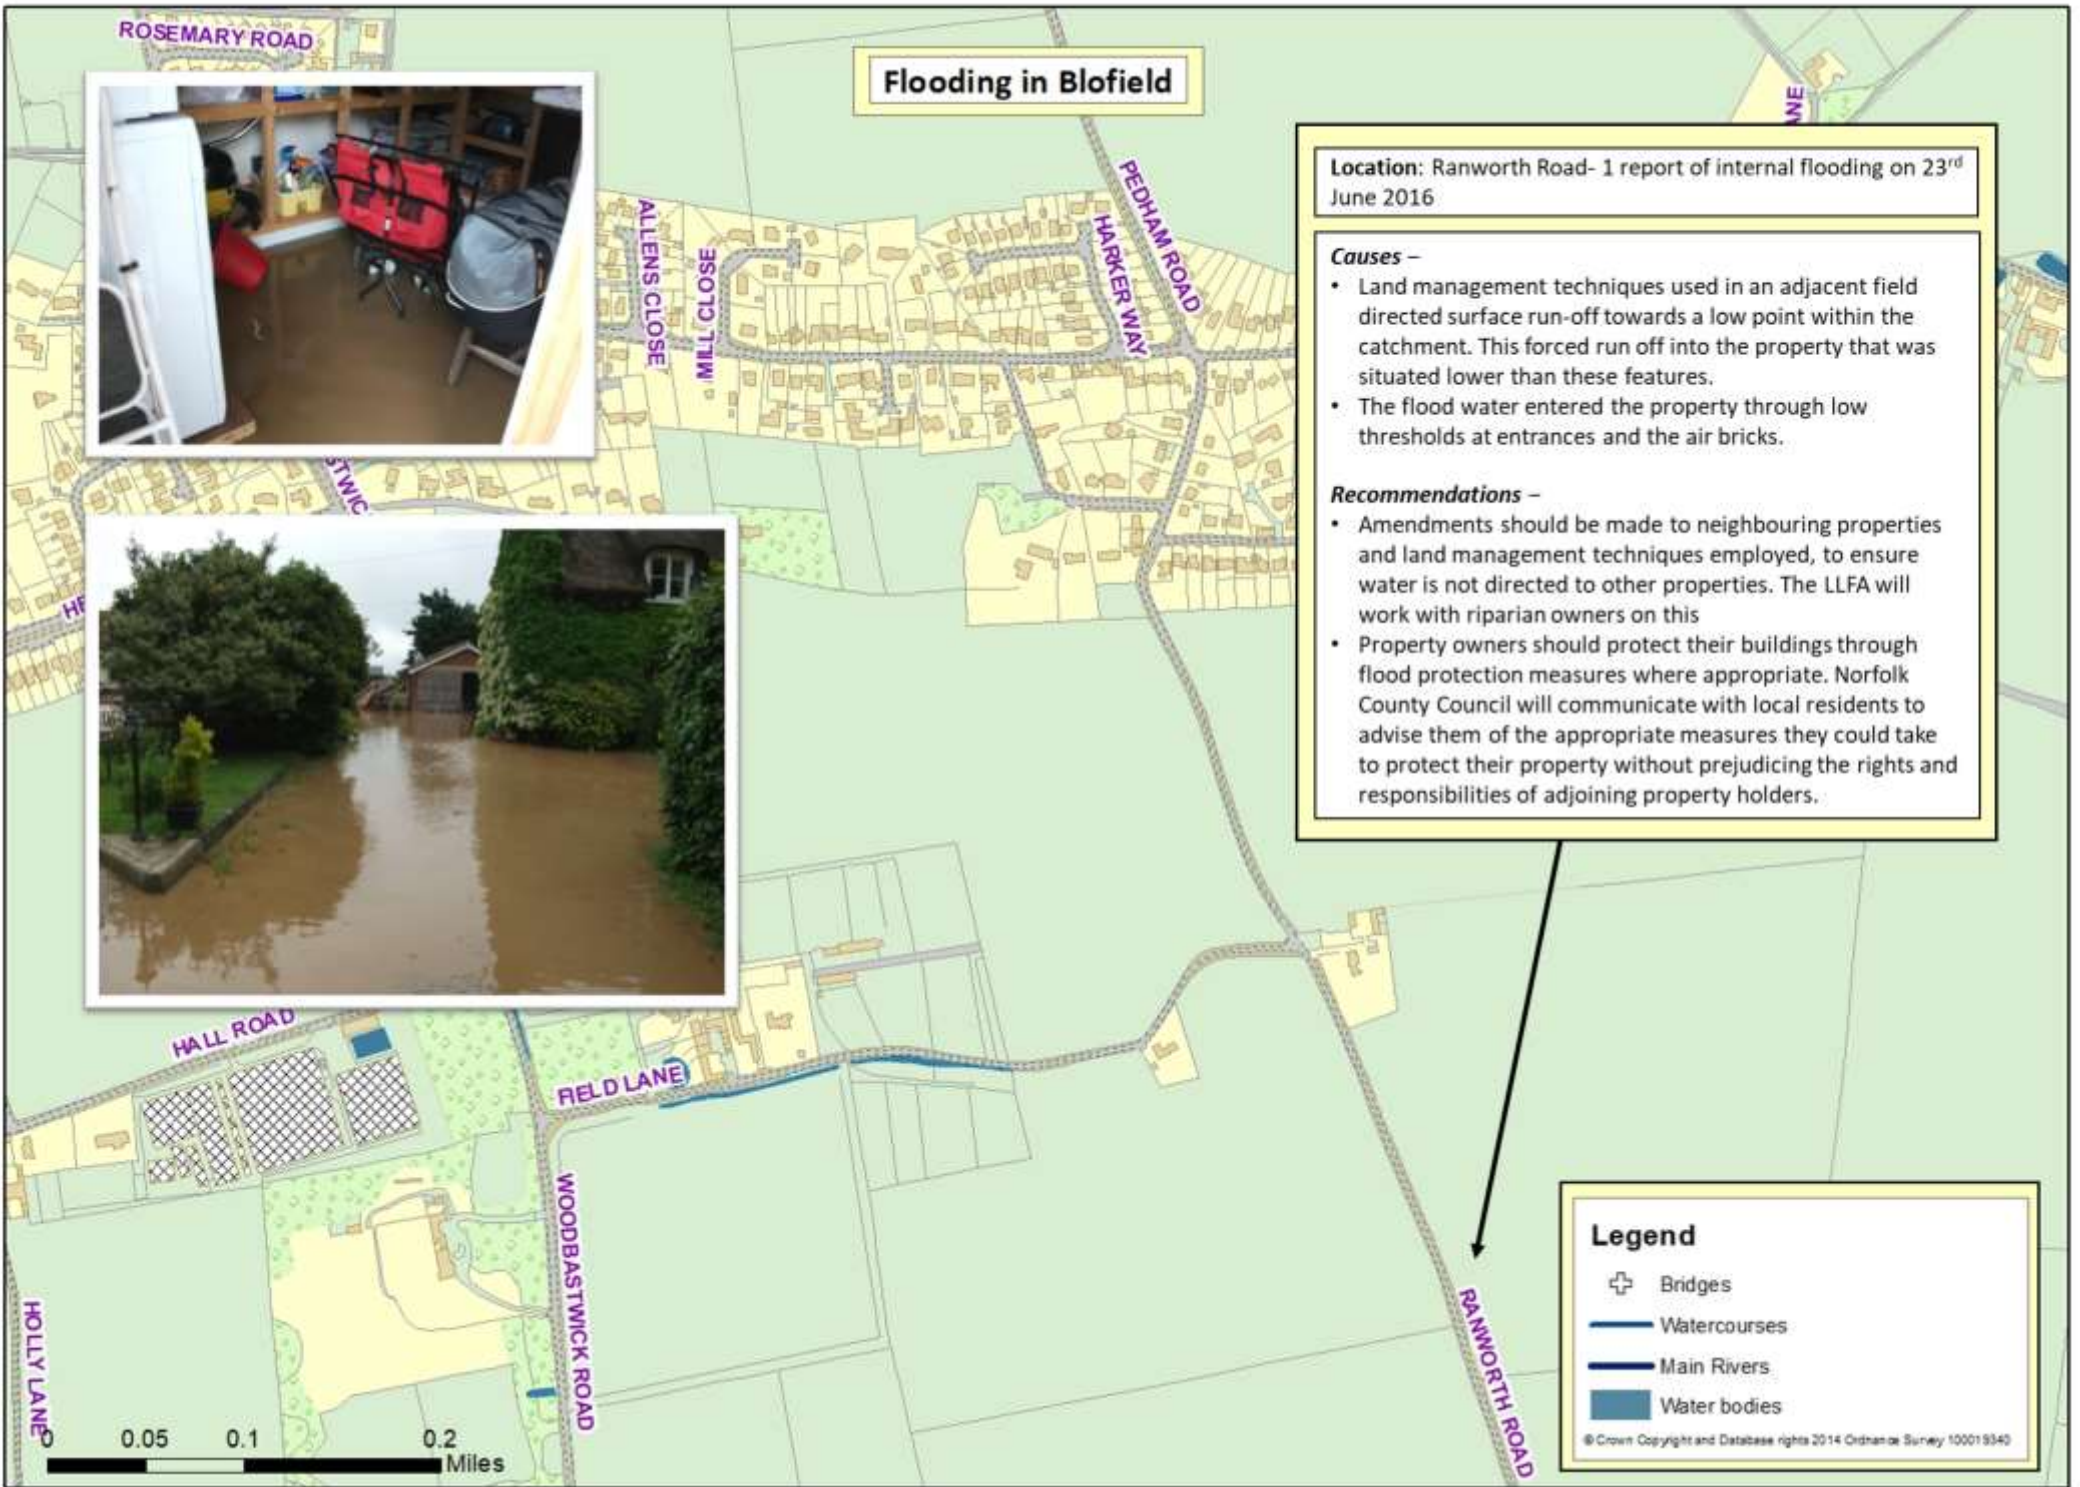
Flooding in Blofield

Location: Ranworth Road- 1 report of internal flooding on 23rd June 2016

- Causes –**
- Land management techniques used in an adjacent field directed surface run-off towards a low point within the catchment. This forced run off into the property that was situated lower than these features.
 - The flood water entered the property through low thresholds at entrances and the air bricks.
- Recommendations –**
- Amendments should be made to neighbouring properties and land management techniques employed, to ensure water is not directed to other properties. The LLFA will work with riparian owners on this
 - Property owners should protect their buildings through flood protection measures where appropriate. Norfolk County Council will communicate with local residents to advise them of the appropriate measures they could take to protect their property without prejudicing the rights and responsibilities of adjoining property holders.

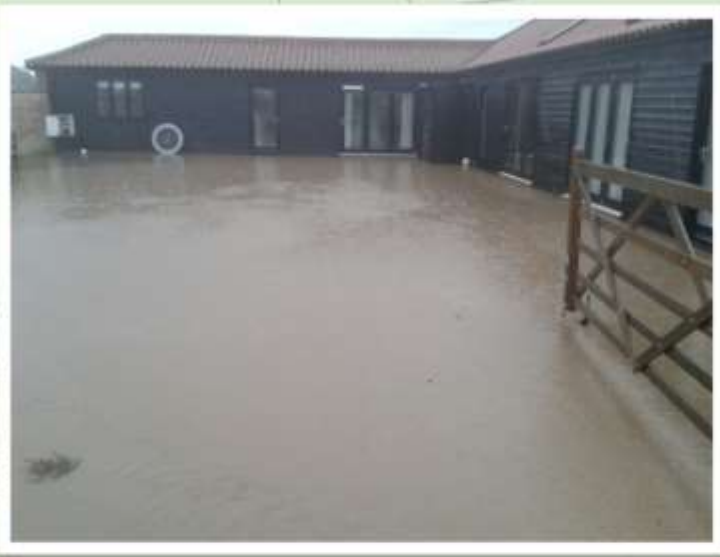
Flooding in Buxton with Lammas

Location – Elizabeth Lane- 1 report of internal flooding on 24th August 2015

- Causes** –
- Surface run-off from significant rainfall was concentrated along overland flowpaths and made its way onto the road from a neighbouring field.
 - The surface run- off pooled at a low point within the catchment and onto the access of the affected property that was lower than these features.
 - The flood water entered the property through low thresholds at entrances.

- Recommendations** –
- Amendments should be made to neighbouring properties to ensure water is not directed to other properties.
 - Property owners should protect their buildings through flood protection measures where appropriate. Norfolk County Council will communicate with local residents to advise them of the appropriate measures they could take to protect their property without prejudicing the rights and responsibilities of adjoining property holders.

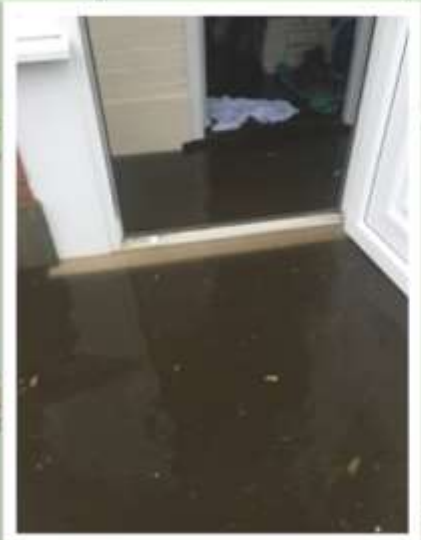
Flooding in Horsford

Location: Harts Hill- 1 report of internal flooding on 23rd June 2016

- The land owner should determine the adequacy of the on-site drainage and where appropriate increase on-site storage capacity and system efficiency.
- The property owner could confirm, where possible, the existence of any connections to a wider drainage network. This work should seek to confirm where the drainage network conveys flows to.
- Property owners should protect their buildings through flood protection measures where appropriate. Norfolk County Council will communicate with local residents to advise them of the appropriate measures they could take to protect their property without prejudicing the rights and responsibilities of adjoining property holders.
