Flood Investigation Report

Flooding in Cringleford on 23 June 2016

Report Reference: FIR025

Final, prepared by Robert Webster on 27 November 2018

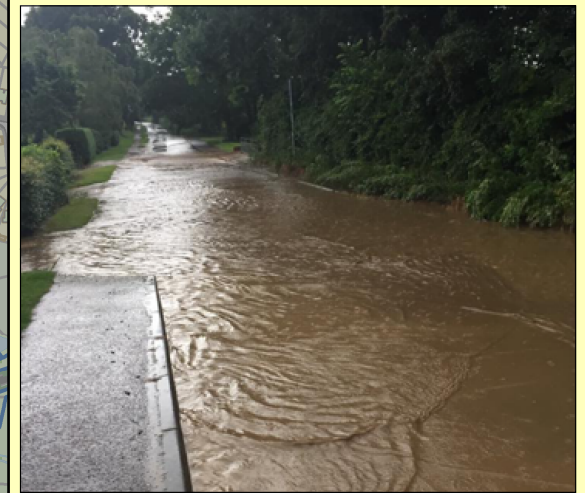
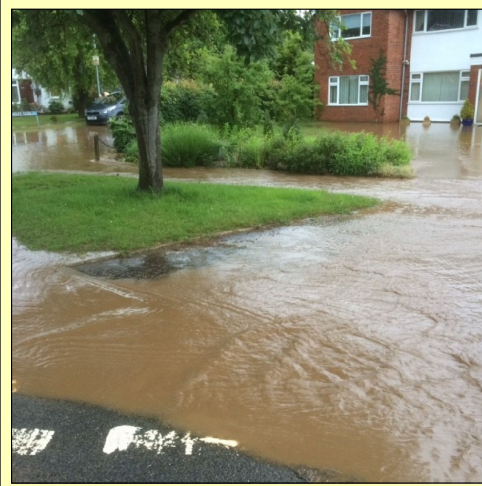
Drawing:
Map 3 - Flood and Drainage Details

Cantley Lane – Internal and external flooding experienced on 23 June 2016

Causes – Significant runoff from adjacent fields and the highway affected properties on Cantley Lane.

Langley Close and Brettingham Avenue – Internal and external flooding experienced on 23 June 2016

Causes – The field and highway runoff that occurred on Cantley Lane during a significant rainfall event was channelled down the footpath linking Cantley Lane and Langley Close and affected the properties on Langley Close and Brettingham Avenue.

Recommendations – Norfolk County Council will work with partner organisations to identify funding for flood mitigation. This would include assessing the potential to install property level protection measures, reduce runoff and increase the attenuation of flood water to reduce the impacts of flooding. NCC will also liaise with local landowners to discuss riparian responsibilities and runoff prevention methods.

Recommendations – Since flooding to properties on Langley Close and Brettingham Avenue is caused from flooding on Cantley Lane, any recommendations undertaken on Cantley Lane will mitigate flooding to properties downstream. Norfolk County Council will also work with partner organisations to identify funding for property level protection flood mitigation.

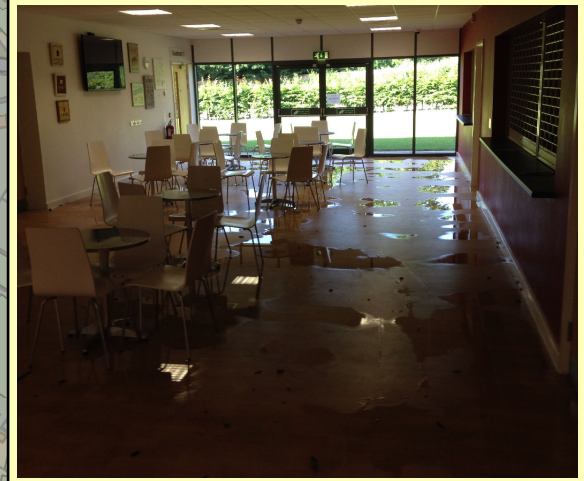
Causes – Significant runoff from adjacent fields affected a commercial property on Willowcroft Way. Surcharging from a surface water drain also contributed towards the flooding.

Recommendations – Norfolk County Council will work with partner organisations to identify funding for flood mitigation. This would include assessing the potential to install property level protection measures, reduce runoff and increase the attenuation of flood water to reduce the impacts of flooding. Investigation into the surcharging water drain should also be carried out so that recommendations can be presented.

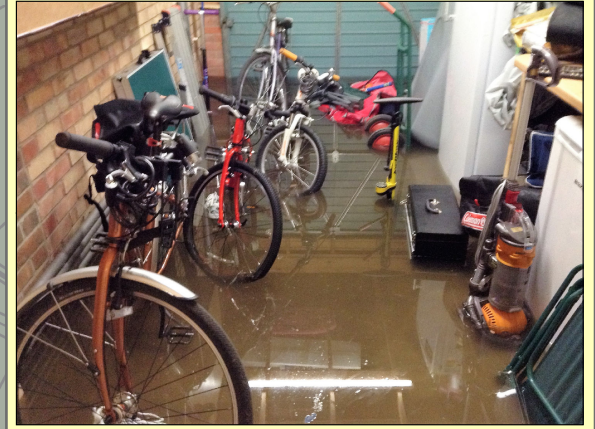
Causes – During a significant rainfall event highway runoff from Newmarket Road channelled through the external of a property which has an access lower than the carriageway, through garages and gardens and into the affected property.

Recommendations – Norfolk County Council will work with partner organisations to identify funding for flood mitigation. This would include assessing the potential to install property level protection measures, reduce runoff and increase the attenuation of flood water to reduce the impacts of flooding.
