Flood Investigation Report

Flooding in Dereham on 23 June 2016

Report Reference: FIR017
Draft Report, Version 3, prepared by Mark Ogden on 2 October 2017

Norfolk County Council

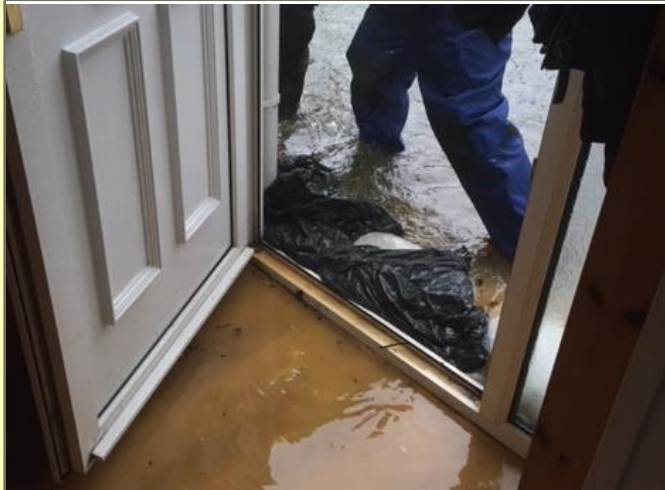
Map 4: Flood and drainage details

South Green Gardens – Internal and external flooding experienced on 23 June 2016

Causes – Significant rainfall was directed into the surface water and foul drainage networks. This caused the network to surcharge. Flows that exceeded the system’s capacity contributed to the flooding.

Recommendations – Norfolk County Council and relevant RMAs to explore funding for flood mitigation, attenuation and flood routing. Property owners should protect their buildings through flood protection measures where appropriate.

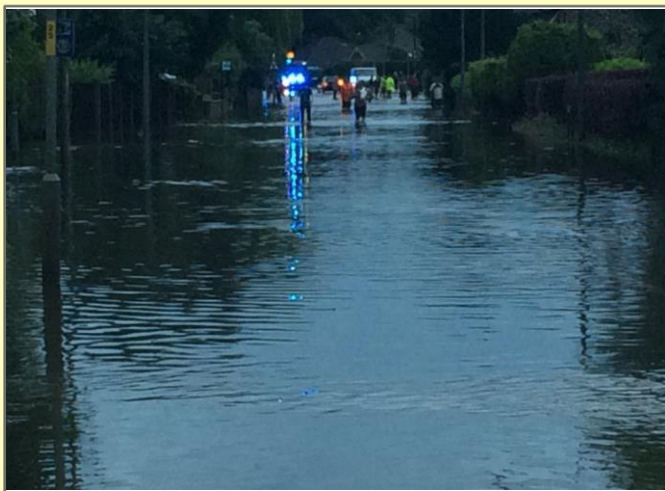
Causes – Flows entering the ditches and watercourse could not be accommodated. This caused water to exceed the channel capacity and overtop its banks. These flood flows then made their way into the affected properties and egressed onto the road.

Recommendations – Norfolk County Council will determine if works are needed to remove the risk posed by structures that form obstructions to watercourse flows and communicate with affected parties and riparian owners.

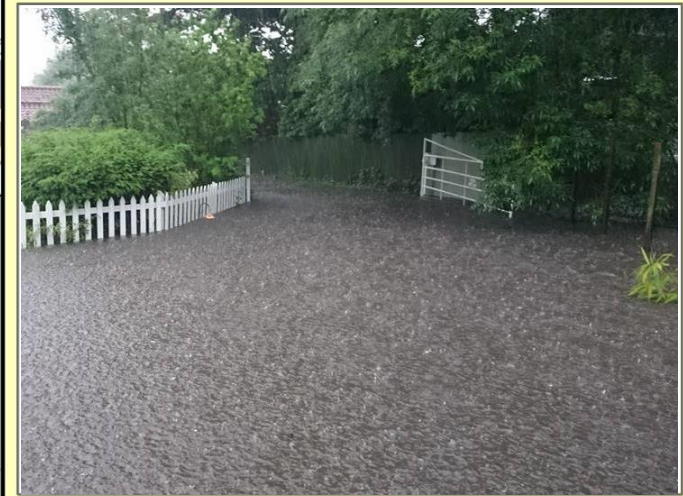
Location: **Upper Dereham Stream, above A47 culvert**

Norwich Road – Internal and external flooding experienced on 23 June 2016

Causes – Surface run-off from significant rainfall that had made its way onto roads and the highway flowed along the road network and onto the accesses of affected properties that were situated lower than these features.

Recommendations – Norfolk County Council could assess whether opportunities exist to route flood water on the highway away from the affected properties to alternative points of discharge.

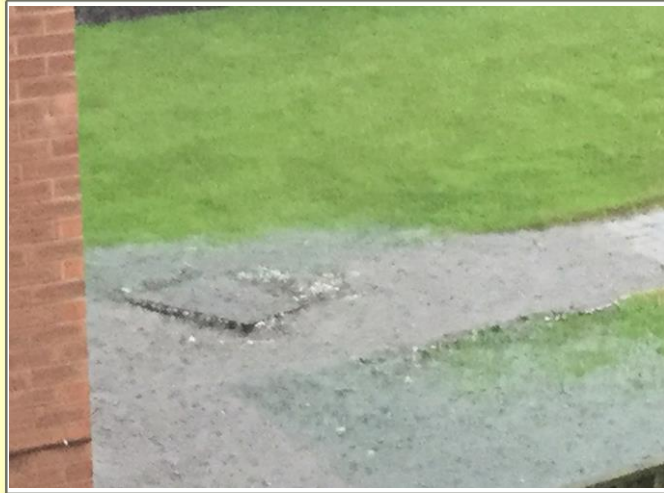
Map 6: Flood and drainage details

Lineside – Internal and external flooding experienced on 23 June 2016

Causes – Surface run-off from significant rainfall that had made its way onto the highway flowed onto the accesses of affected properties that were situated lower than these features.

Recommendations – Norfolk County Council will consider opportunities to route flood water on the highway away from affected properties to alternative points of discharge, or other solutions as practicable.

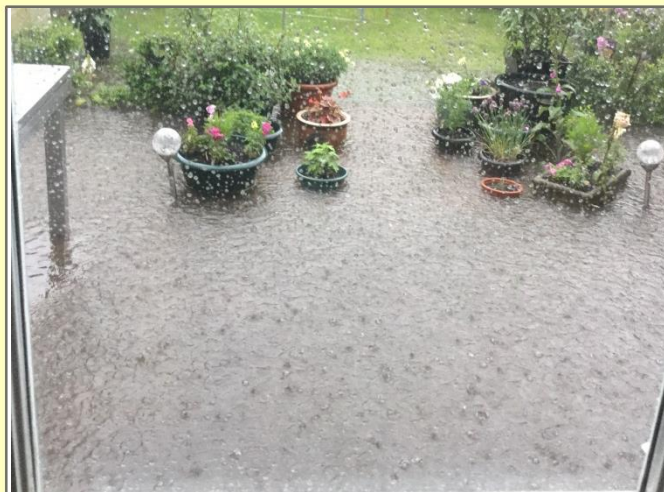
Location: **Lower Dereham Stream**

Washbridge – Internal flooding experienced on 23 June 2016

Causes – Run-off from significant rainfall was directed into Dereham Stream. These flows could not be contained within the watercourse channel and flooded the affected property. Properties have been built in areas prone to natural flooding e.g. the functional flood plain of Dereham Stream.

Recommendations – The Internal Drainage Board should determine if works are needed to remove the risk posed by structures that form obstructions to watercourse flows and communicate with affected parties and riparian owners.

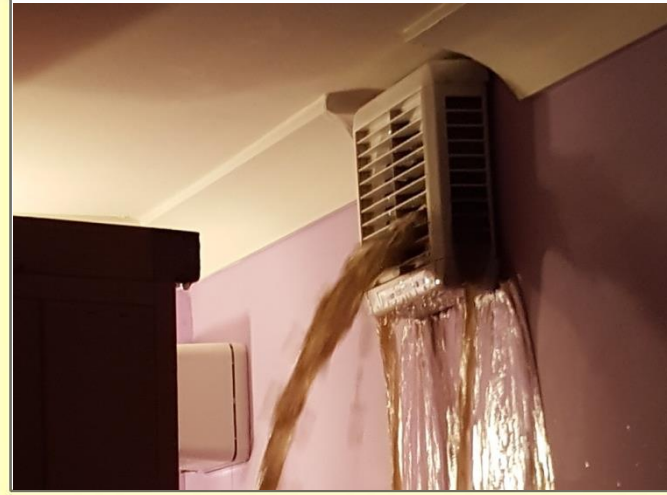
Causes – The flood water entered many of the properties through the unprotected structure of the building. This included via features such as low thresholds at entrances, unprotected air bricks and services conduits (including ventilation systems).

Recommendations – Property owners should protect their buildings through flood protection measures where appropriate.

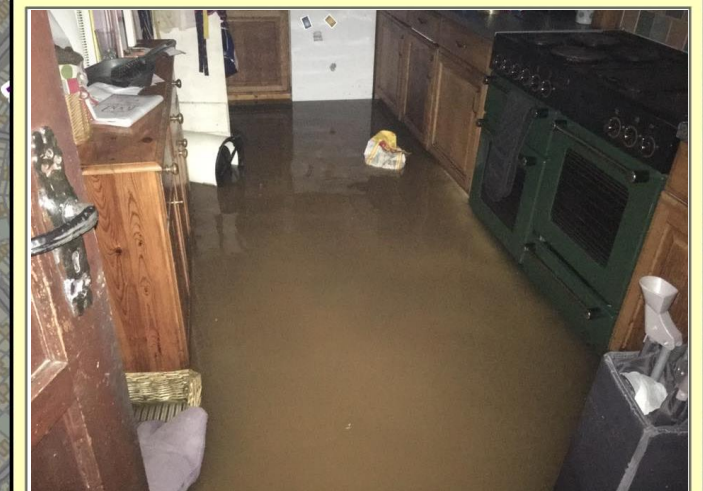
Location: **Fen Road Watercourse**

Fen Road – Internal and external flooding experienced on 23 June 2016

Causes – Run-off from significant rainfall across the catchment was directed along flow paths towards the drainage network and watercourse. These flows could not be accommodated by the receiving watercourse. This caused flood water to enter properties through the unprotected structure of the building.

Recommendations – Norfolk County Council will determine the influence on the watercourse of channel capacity, structures and maintenance. Property owners should protect their buildings through flood protection measures where appropriate.

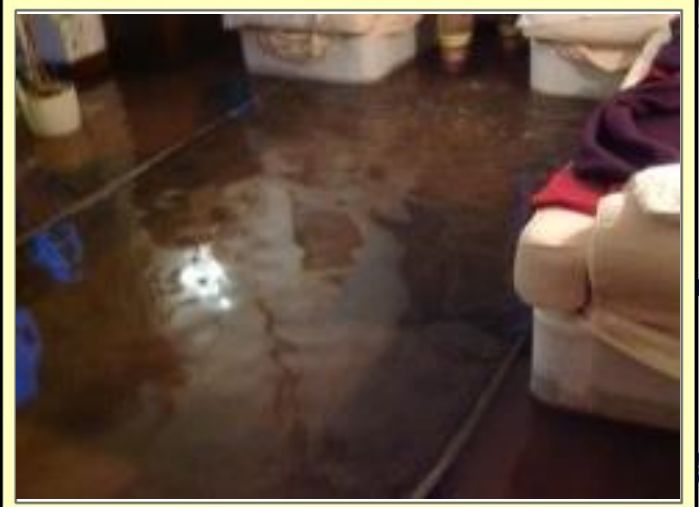
Location: Upper River Tud

Shipdham Road and Yaxham Road – Internal flooding experienced on 23 June 2016

Causes – Run-off from significant rainfall entered surface water drainage and watercourse. These flows exceeded the capacity of the watercourse flooding properties. The flood water entered many of the properties through the unprotected structure of the building at **all locations** in this catchment.

Recommendations – Norfolk County Council will determine the influence on the watercourse of channel capacity, structures and maintenance. Property owners should protect their buildings through flood protection measures where appropriate.
