Investigation Report into flooding across Great Yarmouth Borough during the summer of 2014

Report Reference: FWF/14/6/0672

Investigation Report into flooding across Great Yarmouth Borough during the summer of 2014.

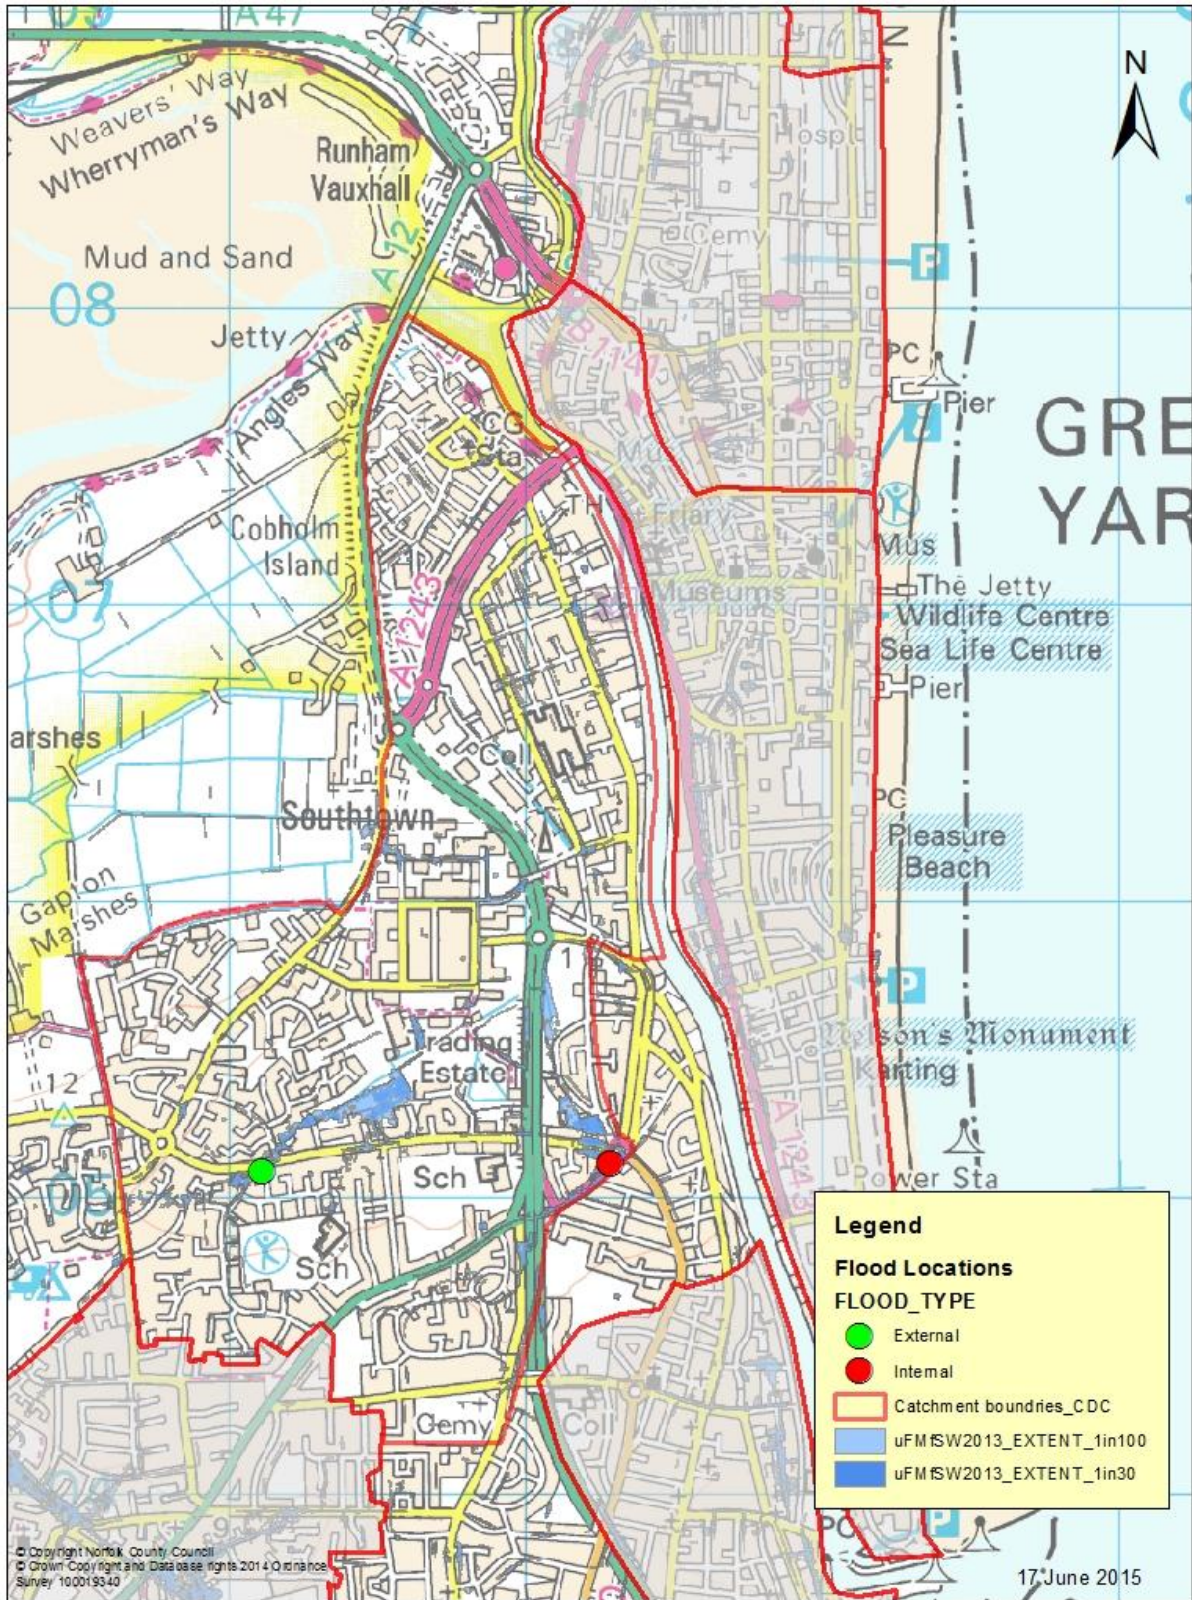
Map 8

Claydon, Southtown and Cobham Catchment
