## Investigation Report into the Flooding in the Borough of King's Lynn and West Norfolk in 2014-2018

Report Reference: FIR033

Draft Report prepared by John Mellows on 25/07/2019

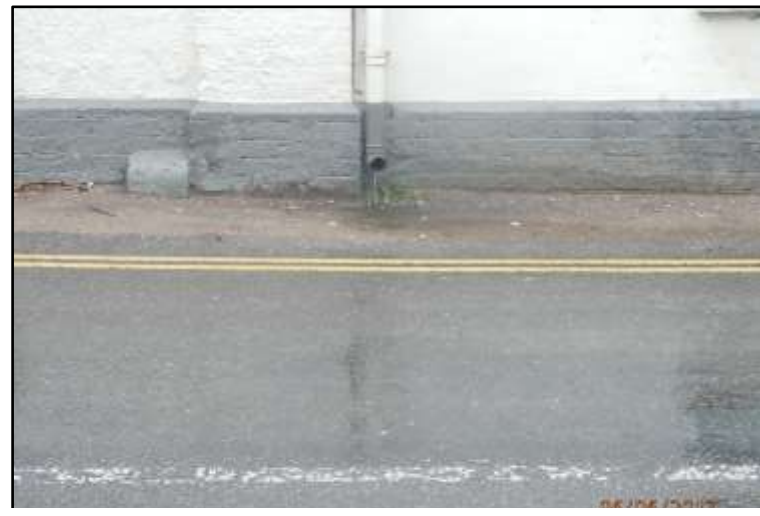
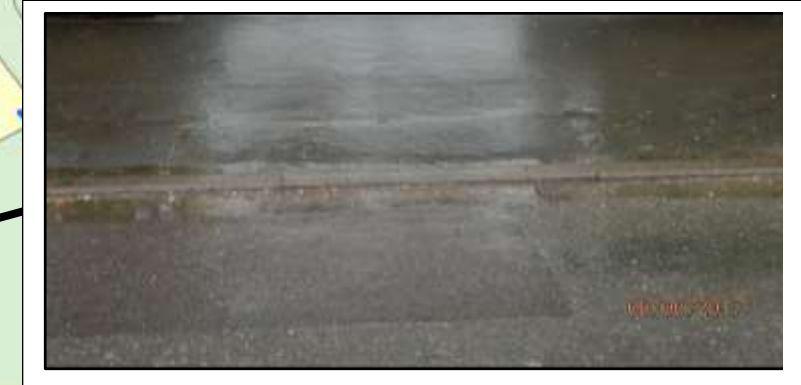
# Flooding on Overy Road, Burnham Market

**Causes** - Water was directed from a neighbouring property by their roof drainage towards the affected property. Surface run-off from rainfall that had made its way onto the highway and then flowed over the dropped kerb and entered the property through the low threshold at the entrance.

**Recommendations** - Norfolk County Council would consider an application from the property owner to raise the kerb outside of the property in order to route flood water on the highway away from the affected properties.

The property owners should protect their building through flood protection measures where appropriate. NCC will communicate with local residents to advise them of the appropriate measures they could take to protect their property.

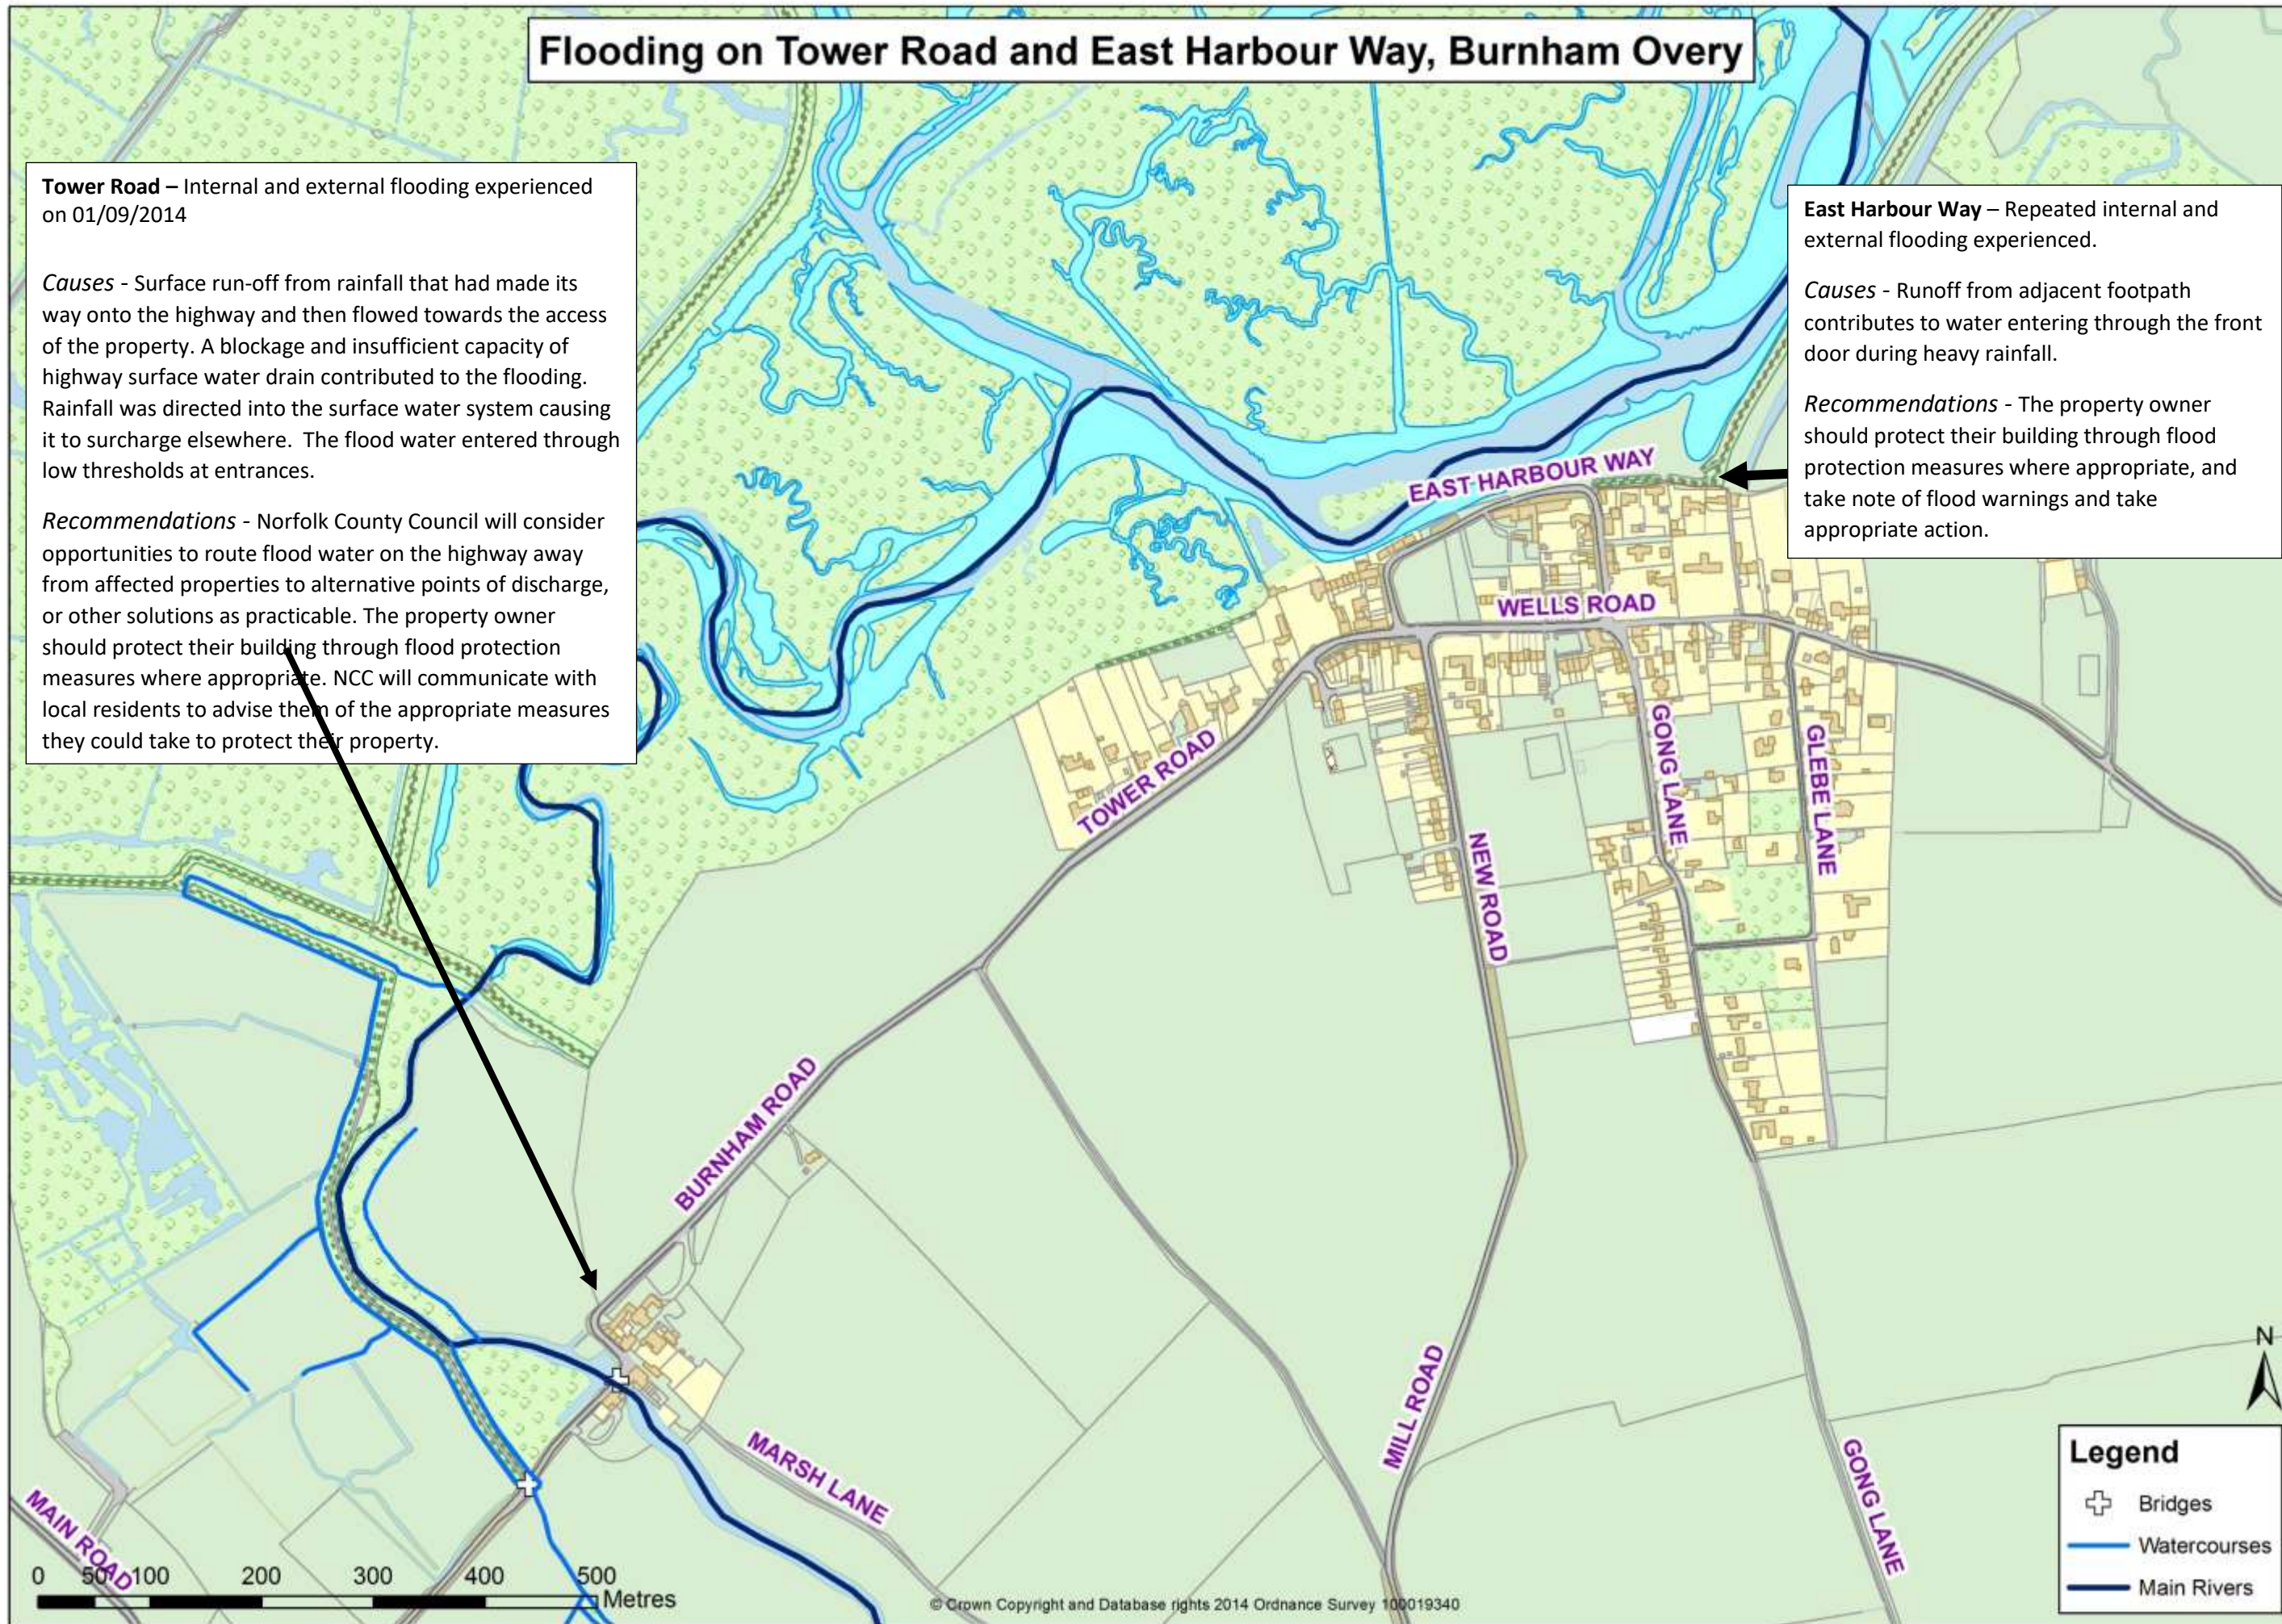
## Flooding on Tower Road and East Harbour Way, Burnham Overy

**Tower Road** – Internal and external flooding experienced on 01/09/2014

*Causes* - Surface run-off from rainfall that had made its way onto the highway and then flowed towards the access of the property. A blockage and insufficient capacity of highway surface water drain contributed to the flooding. Rainfall was directed into the surface water system causing it to surcharge elsewhere. The flood water entered through low thresholds at entrances.

*Causes* - Runoff from adjacent footpath contributes to water entering through the front door during heavy rainfall.

*Recommendations* - Norfolk County Council will consider opportunities to route flood water on the highway away from affected properties to alternative points of discharge, or other solutions as practicable. The property owner should protect their building through flood protection measures where appropriate. NCC will communicate with local residents to advise them of the appropriate measures they could take to protect their property.

*Recommendations* - The property owner should protect their building through flood protection measures where appropriate, and take note of flood warnings and take appropriate action.

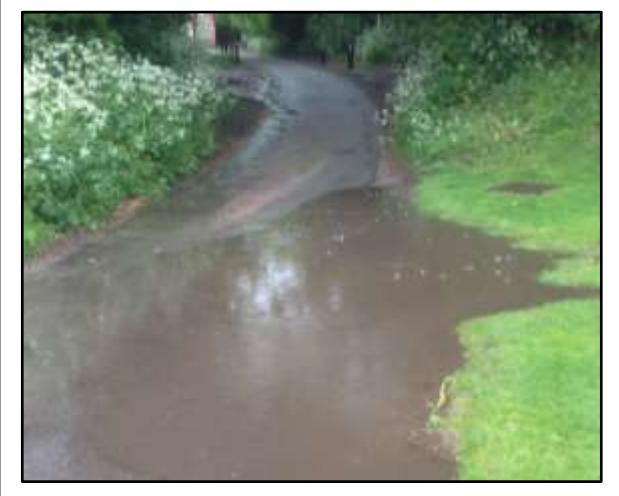
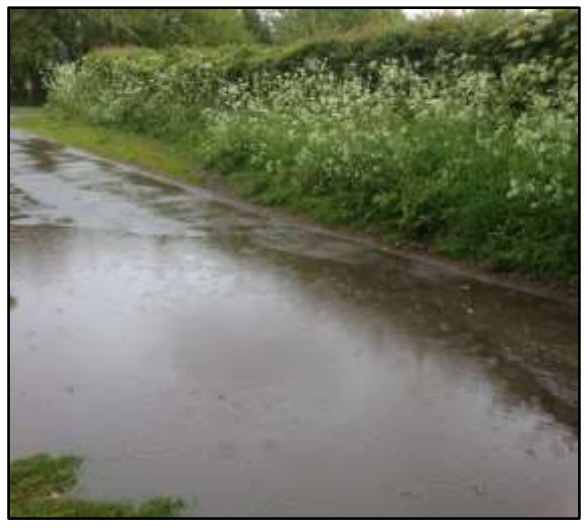
*Causes* – Surface run-off from rainfall made its way onto the highway and pooled at a low point and flowed onto the accesses of the affected property situated lower than the highway. Water entered the property through low thresholds at entrances.

*Recommendations* - Norfolk County Council will consider opportunities to route flood water on the highway away from the affected property. Property owners should protect their buildings through flood protection measures where appropriate. NCC will communicate with local residents to advise them of the appropriate measures they could take to protect their property. NCC will lead on developing a partnership funding solution to mitigate the risk experienced at this location.

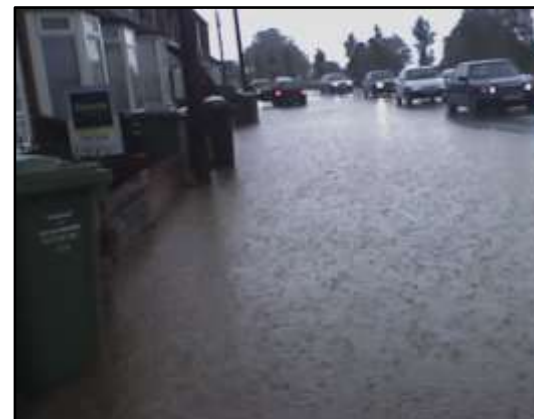
*Causes* - Run-off from rainfall was concentrated along overland flowpaths and made its way onto the highway and onto the accesses of affected properties that were situated lower than these features. The surface water drainage system network was partially obstructed by structural failure reducing the efficiency of the upstream drainage system. The flood water entered the properties through low thresholds at entrances.

*Recommendations* - NCC will review the level of maintenance required to sustain the design efficiency of their drainage systems. Property owners should protect their buildings through flood protection measures where appropriate. NCC will communicate with local residents to advise them of the appropriate measures they could take to protect their property.

Norfolk County Council will investigate with third parties the potential to fund small scale improvement schemes to mitigate the risk experienced at this location. This could be either through the submission of a bid to secure Partnership funding or through negotiation with other organisations and the local community. It is important to note this recommendation will be subject to the priorities and availability of resources of funders. It may be dependent on those property owners affected contributing towards a solution.

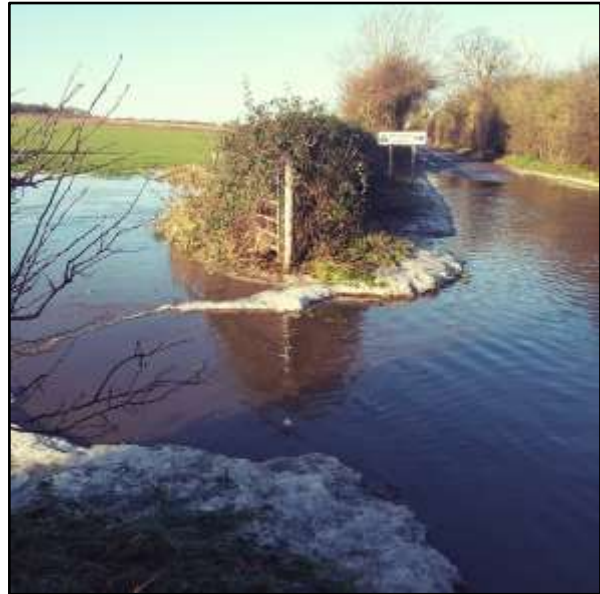
*Causes* – Surface water pooling on adjacent farmland due to rainfall and frozen ground conditions, reducing infiltration. Water flowed onto highway, where existing surface water drainage were unable to cope with water due to insufficient capacity &/or blockage.

*Recommendations* – NCC to review maintenance requirements of the drainage system.  
Landowners to address issues with surface water pooling and flow from farmland onto highway.

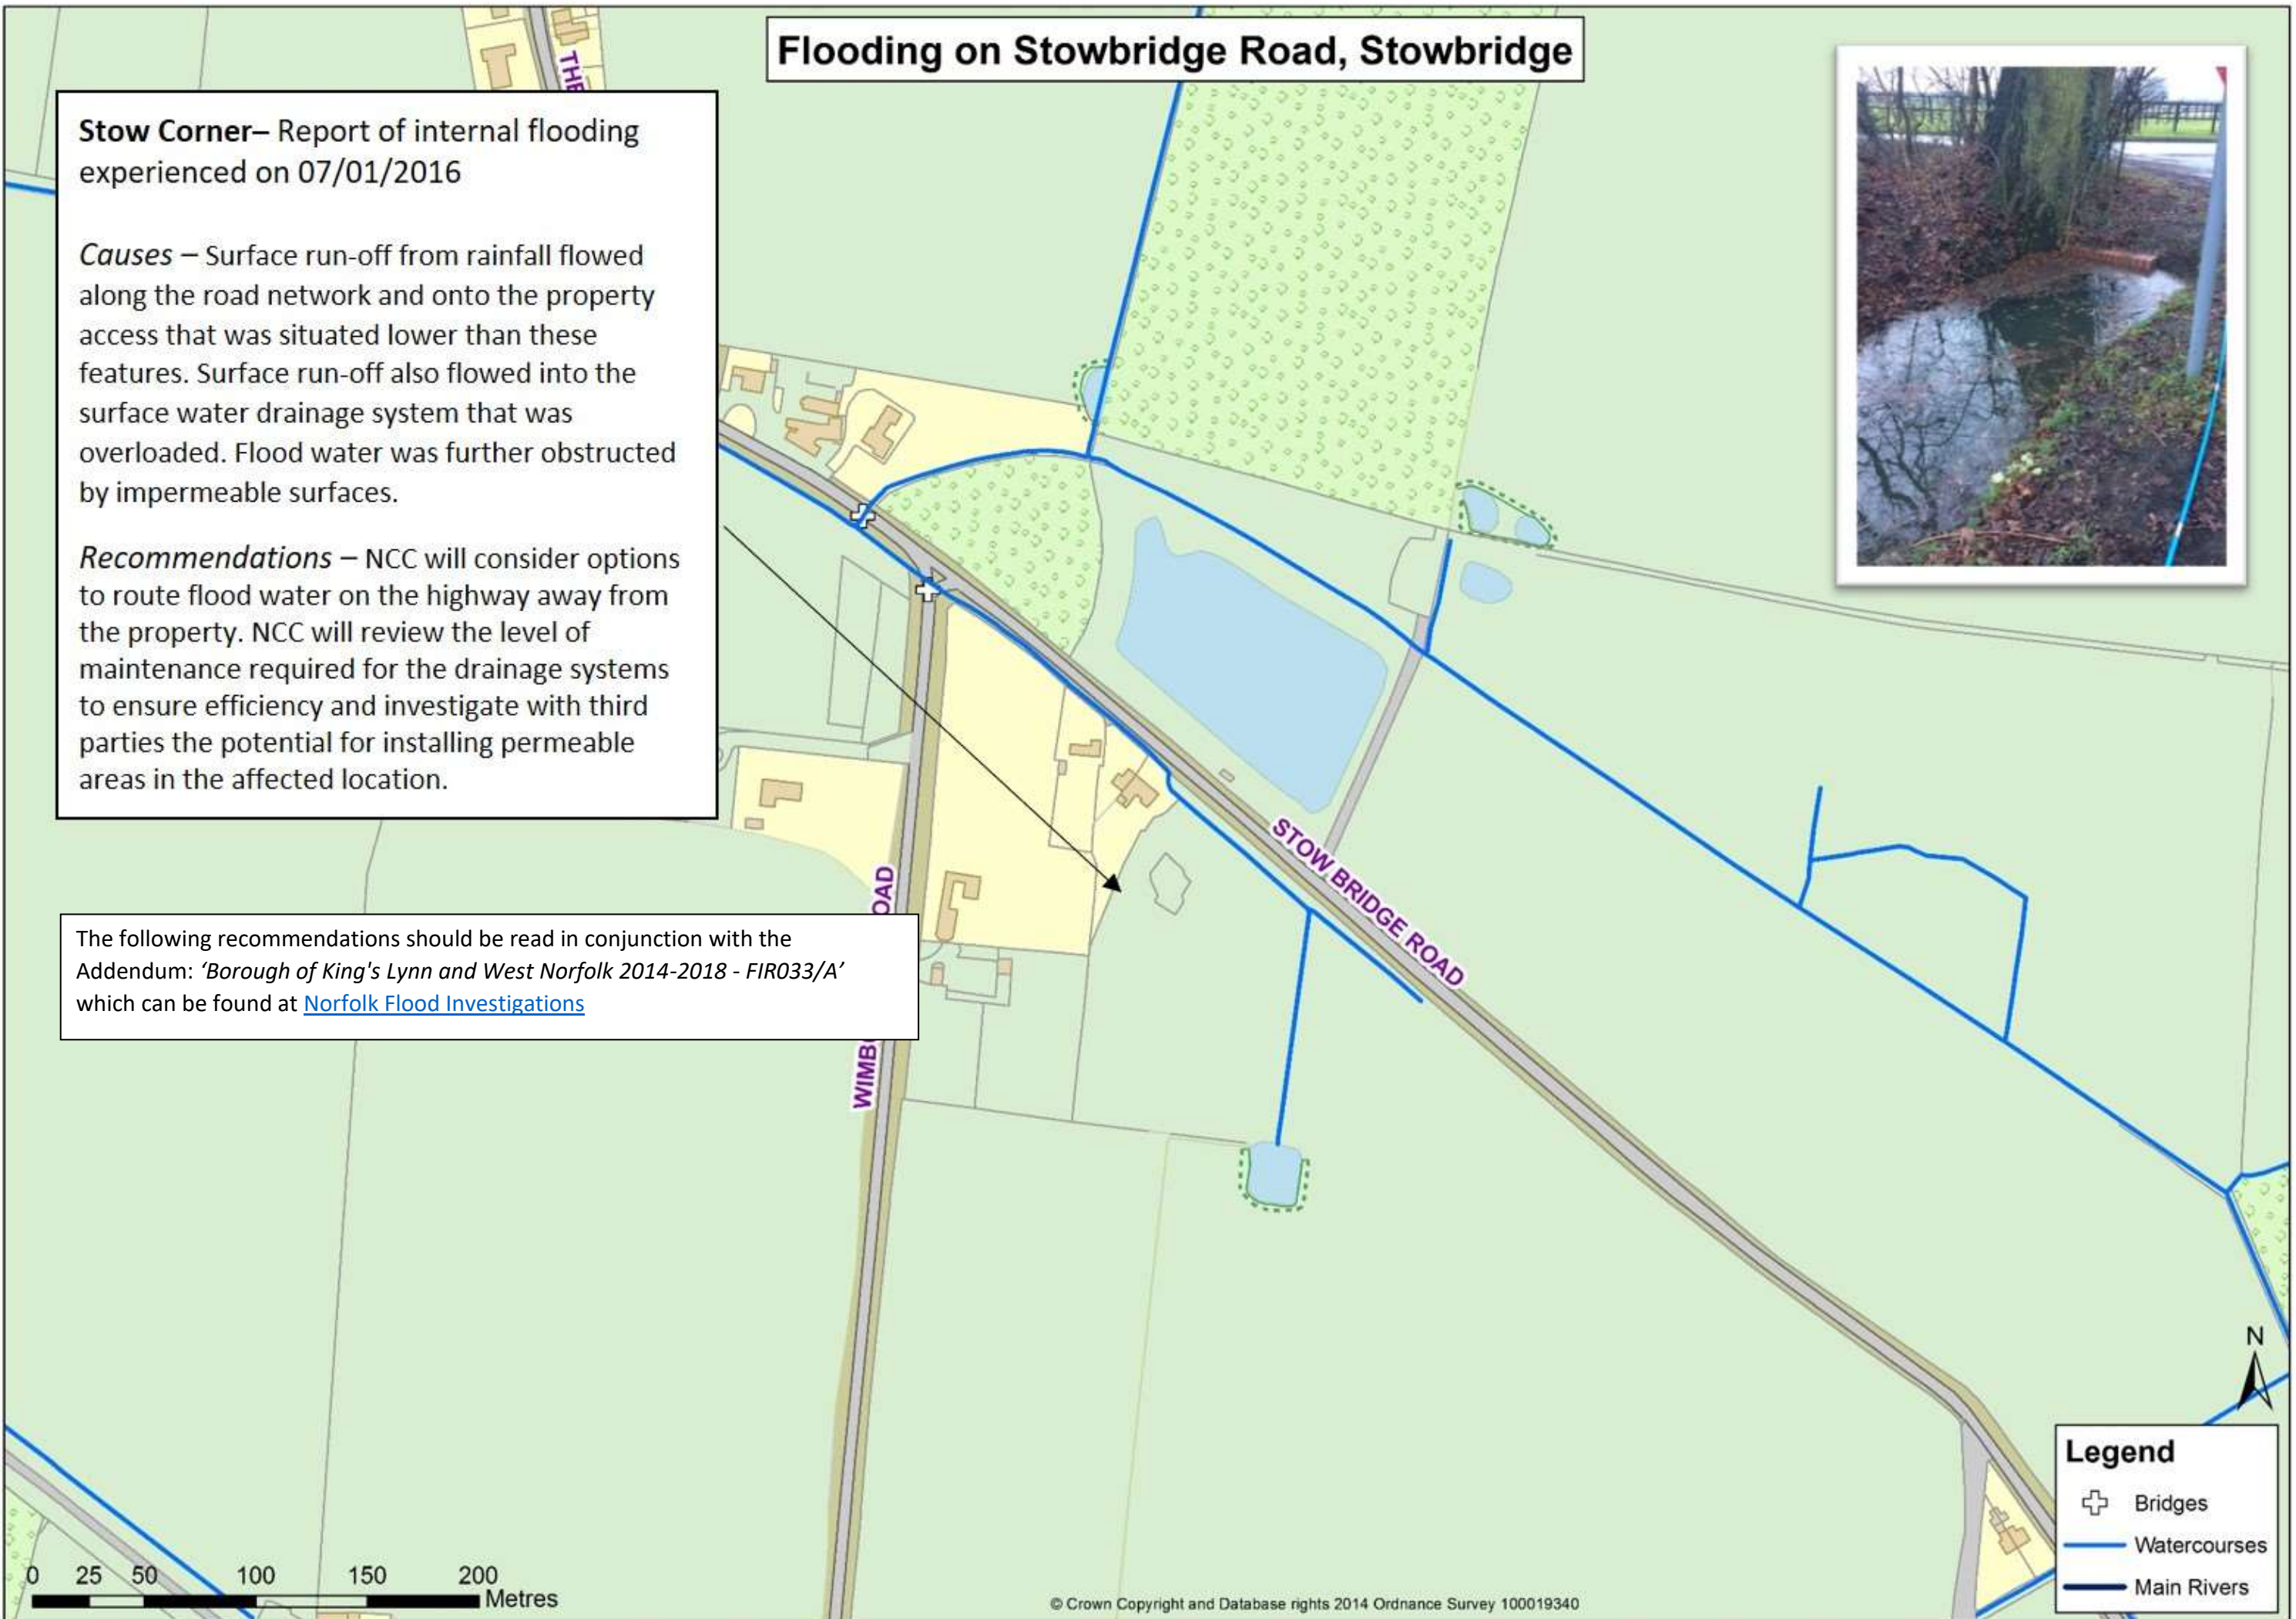
# Flooding on Church Road, Wereham

Church Road— Internal and external flooding experienced on 11/10/2014 & 19/07/2017

*Recommendations* – NCC will consider options to route flood water on the highway away from the property. NCC will review the level of maintenance required for the drainage systems, the level of water entering the systems and consider alternative points of discharge.

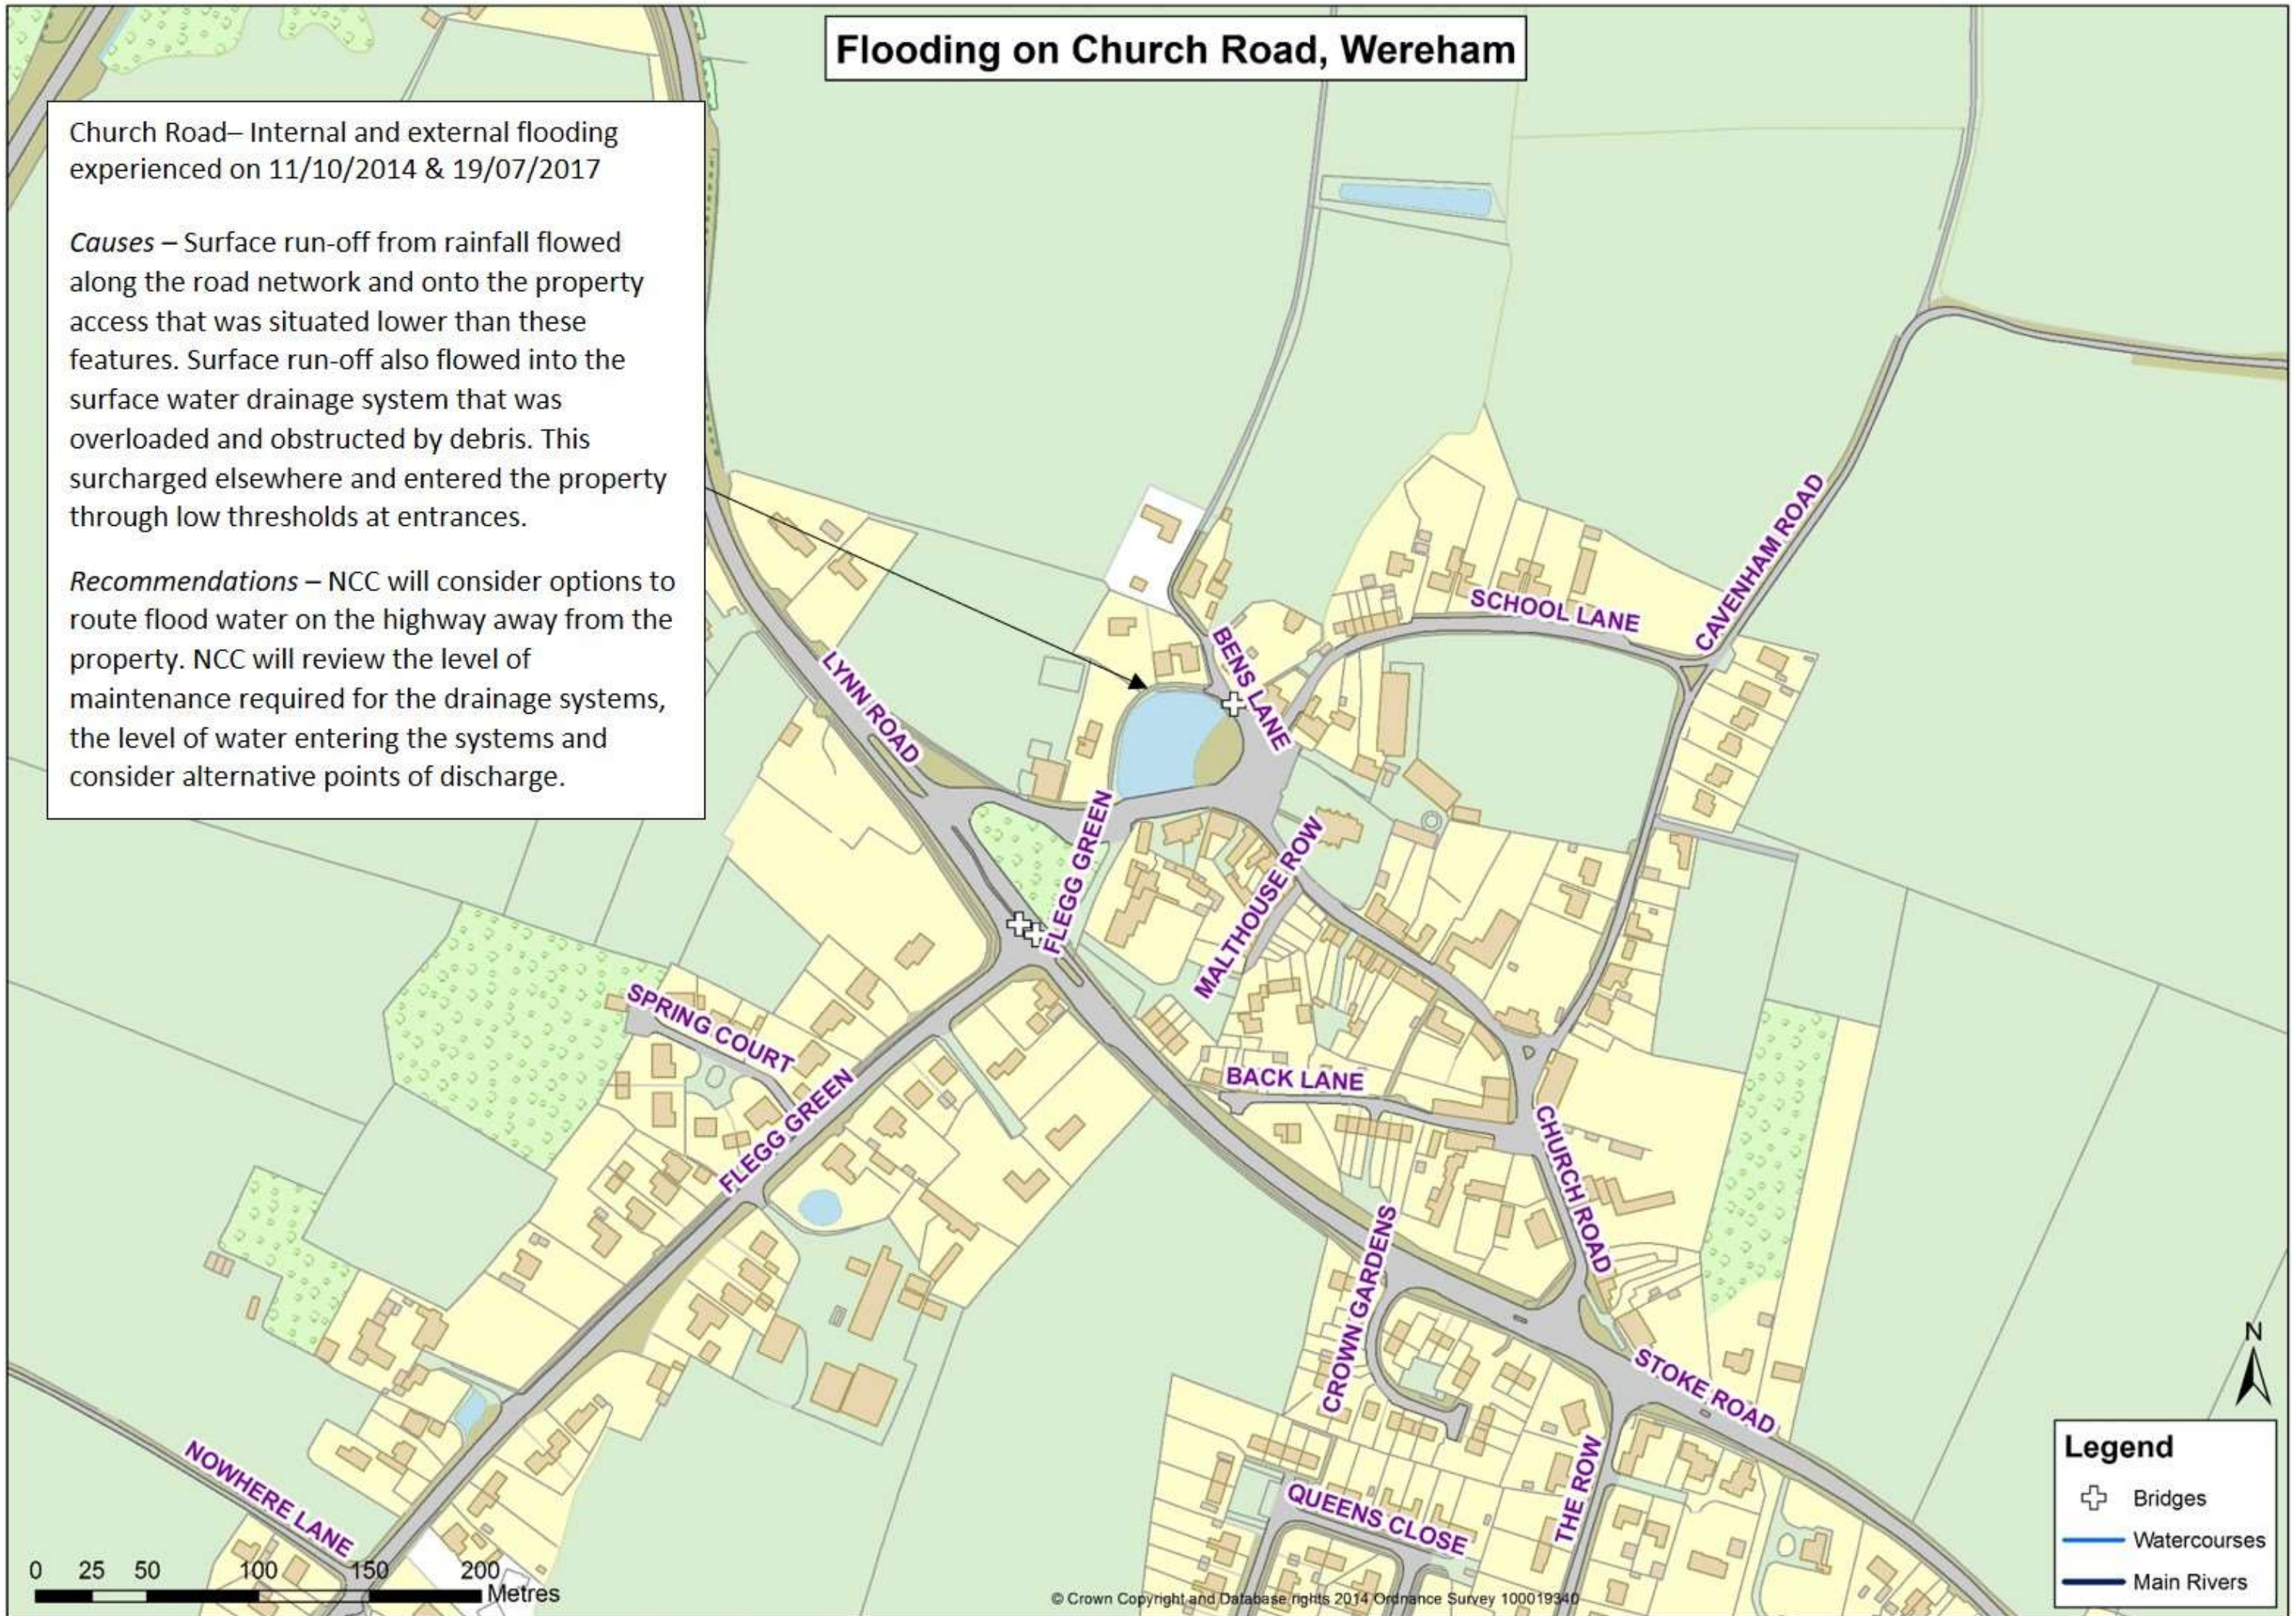
# Flooding on Main Road, Crimplasham

Main Road– Internal flooding experienced on 25/06/2018 & 21/08/2016

*Recommendations* – Norfolk County Council will investigate with third parties the potential to fund small scale improvement schemes to mitigate the risk experienced at this location. Norfolk County Council will consider opportunities to route flood water on the highway away from affected properties. NCC will review maintenance levels of drainage systems and the amount of water entering them. NCC will liaise with local property owners to help them protect their buildings through flood protection measures

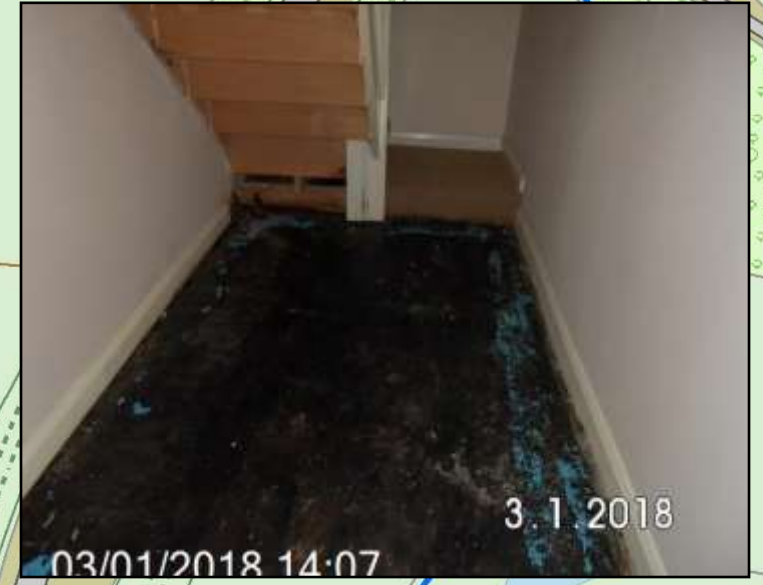
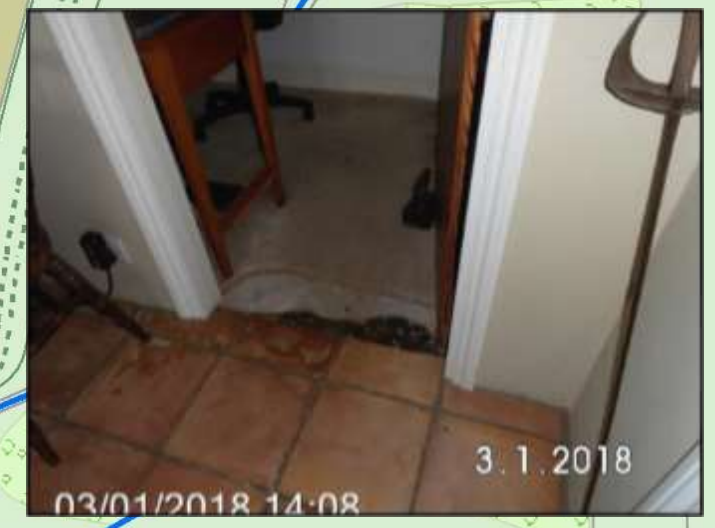
# Flooding on Ely Road, Denver

*Causes* – Surface run-off from rainfall made its way onto the highway and flowed along the road network and onto the access of the affected property situated lower than the road. Any water directed towards surface water drainage network could not be flow away as the network was incomplete so flood water pooled against the property and entered through low thresholds at entrances.

*Recommendations* – Norfolk County Council will investigate with third parties the potential to fund small scale improvement schemes to mitigate the risk experienced at this location. Norfolk County Council will consider opportunities to route flood water on the highway away from the affected property. NCC will review maintenance levels of drainage systems and the amount of water entering them, identifying methods of removing excess surface water. NCC will liaise with local property owners to help them protect their buildings through flood protection measures.

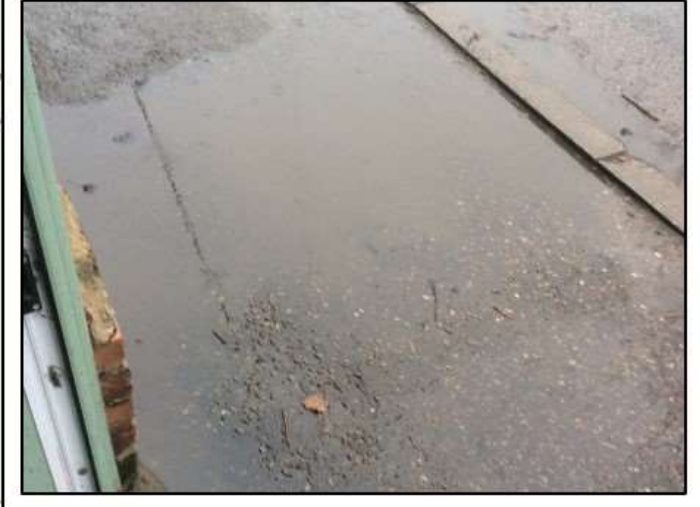
*Causes* – Surface run-off from rainfall made its way along the highway towards the property which sits below the road structure. Flood water entered the property through low thresholds at the entrances.

*Recommendations* – NCC could assess opportunities to divert the water away from the property. The property owner should protect their property using flood protection measures where appropriate. NCC should support property owners to identify appropriate measures.

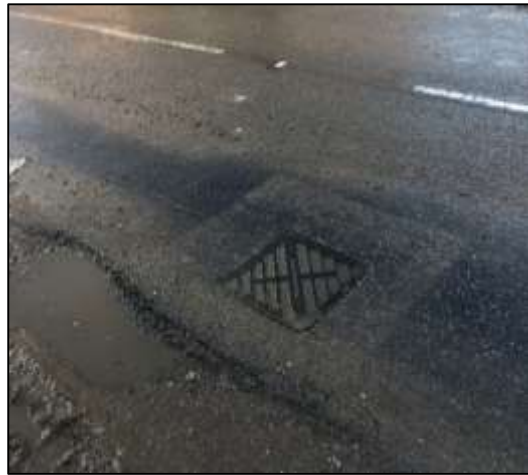
**Causes** – Due to the development of impermeable surfaces localised ground conditions caused run-off to be directed quickly from where it fell as rain to the areas of flooding. Surface run-off from rainfall made its way onto the highway and flowed onto the access of the property. Run-off directed towards the surface water drainage network and could not be accommodated as the system was overloaded.

**Recommendations** – Norfolk County Council will investigate with third parties the potential to fund small scale improvement schemes to mitigate the risk experienced at this location. Norfolk County Council will consider opportunities to route flood water on the highway away from the affected property. NCC should work with partner organisations to identify the potential for managing the surface water entering their drainage system in flood events. Property owners should protect their buildings through flood protection measures where appropriate. NCC will communicate with local residents to advise them of the appropriate measures they could take to protect their property.

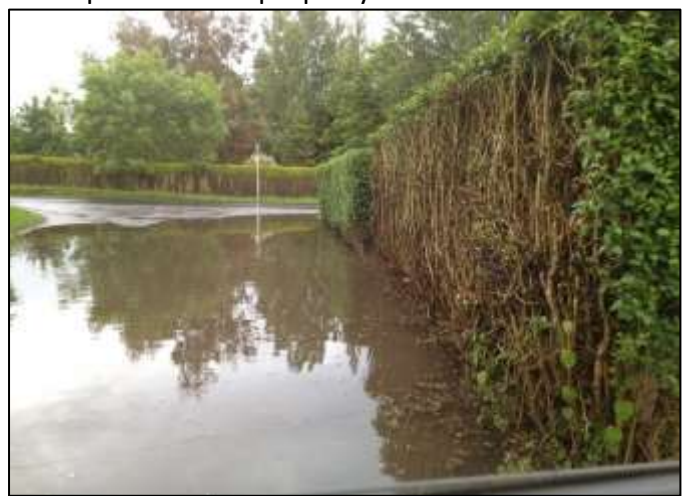
*Causes* – Run-off from rainfall pooled at a low point within the area affecting property. Surface run-off from rainfall made its way onto the highway and flowed onto the access of the property. The surface water drainage system network was partially obstructed by debris or silt, reducing the efficiency of the upstream drainage system.

*Recommendations* – Norfolk County Council will investigate with third parties the potential to fund small scale improvement schemes to mitigate the risk experienced at this location. Norfolk County Council will consider opportunities to route flood water on the highway away from the affected property. NCC will review the level of maintenance required to sustain the design efficiency of their drainage systems NCC should work with partner organisations to identify the potential for managing the surface water entering their drainage system in flood events. Property owners should protect their buildings through flood protection measures where appropriate. NCC will communicate with local residents to advise them of the appropriate measures they could take to protect their property.
