Norfolk County Council

Investigation Report into the flooding in Kings Lynn & West Norfolk Borough in Winter 2020-2021

Report Reference: FIR066

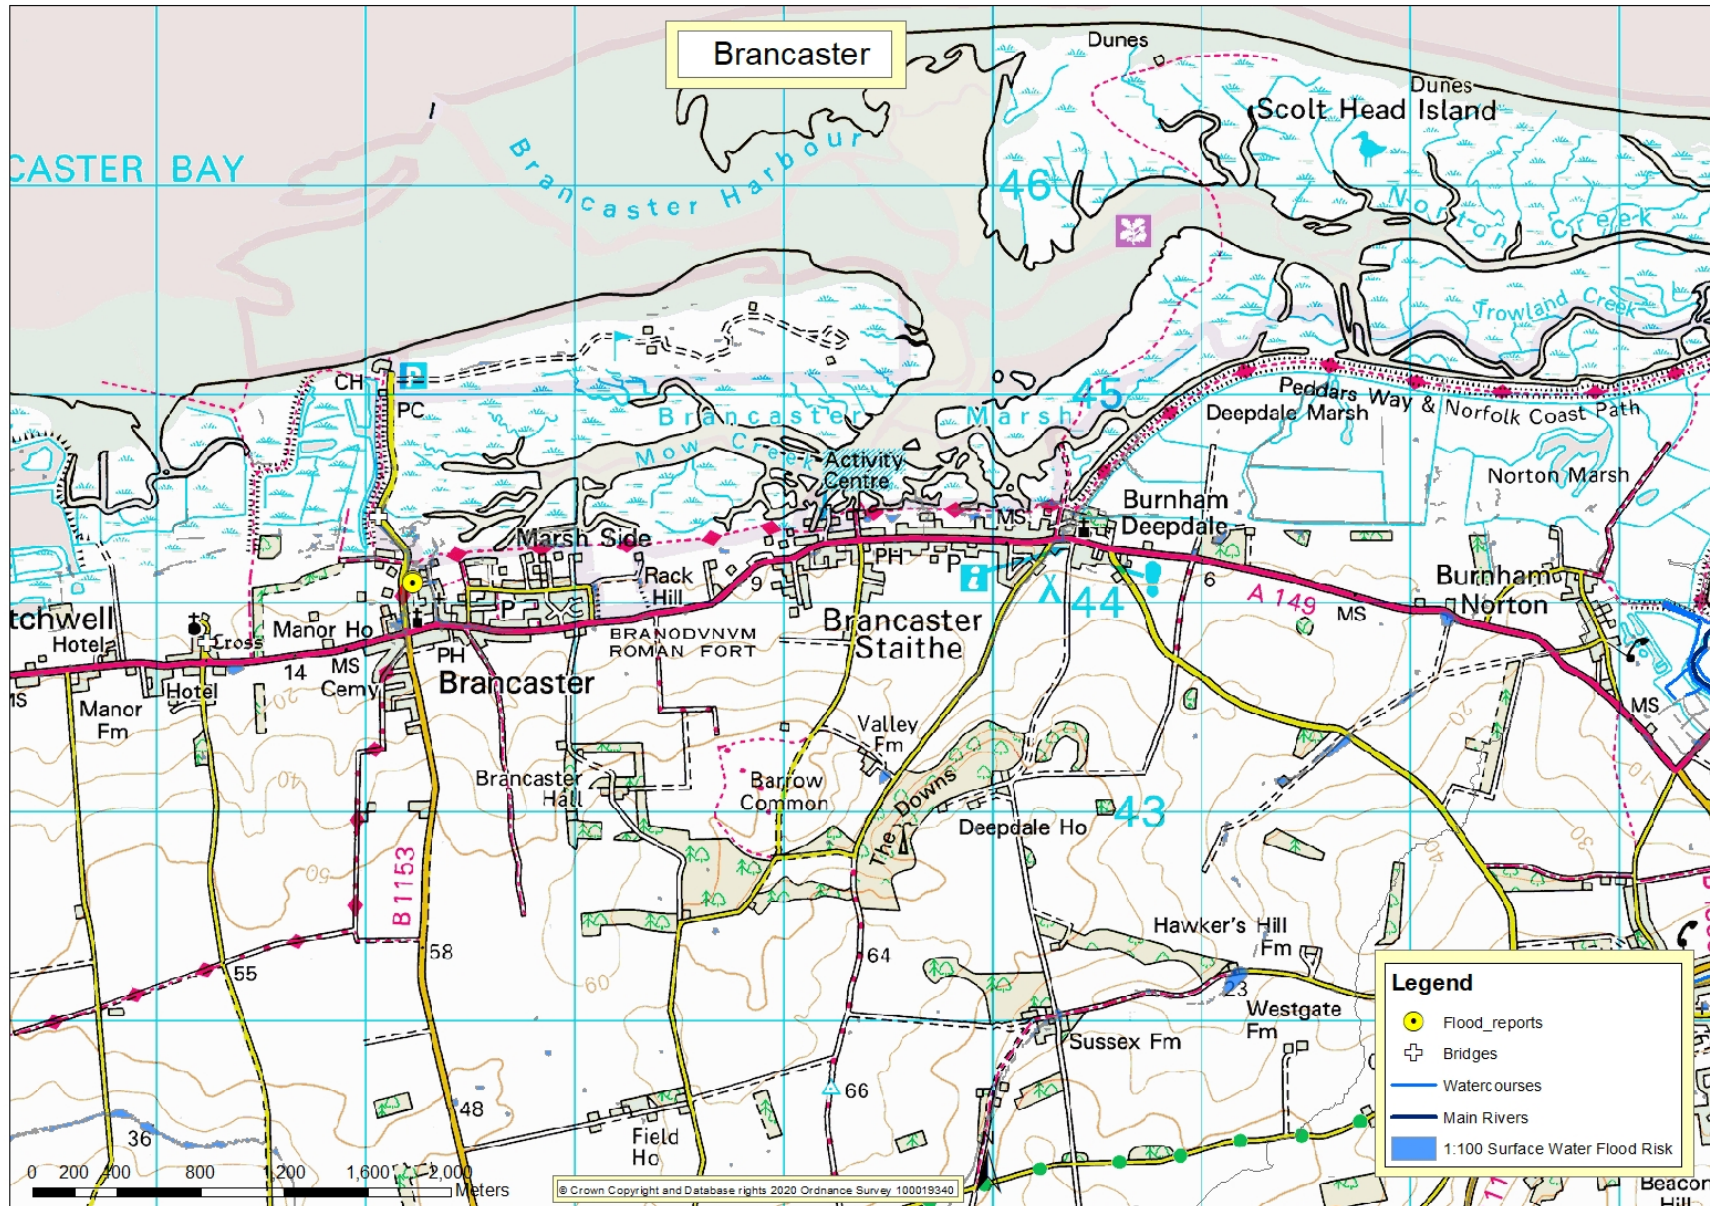
Flooding and flood risk in Brancaster
