# Norfolk County Council

## Investigation Report into the flooding across Norfolk on the 6<sup>th</sup> October 2019

Report Reference: FIR048

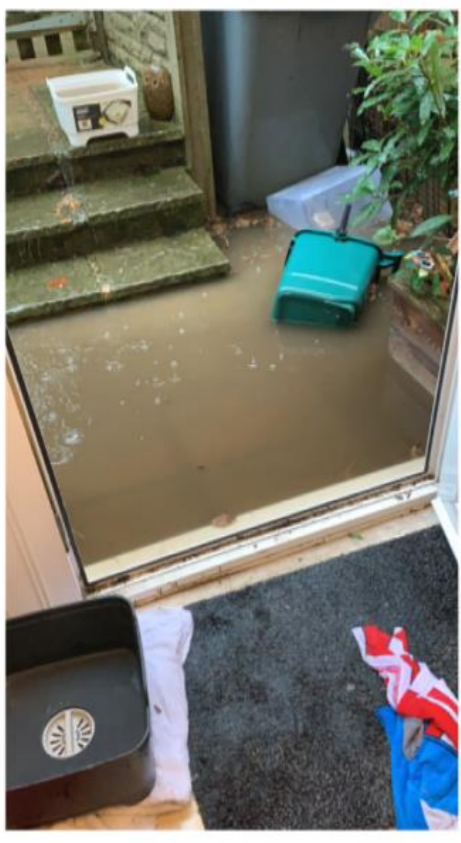
Location: Rose Walk, Brundall

**Rose Walk**– Report of internal flooding on 6<sup>th</sup> October to four properties.

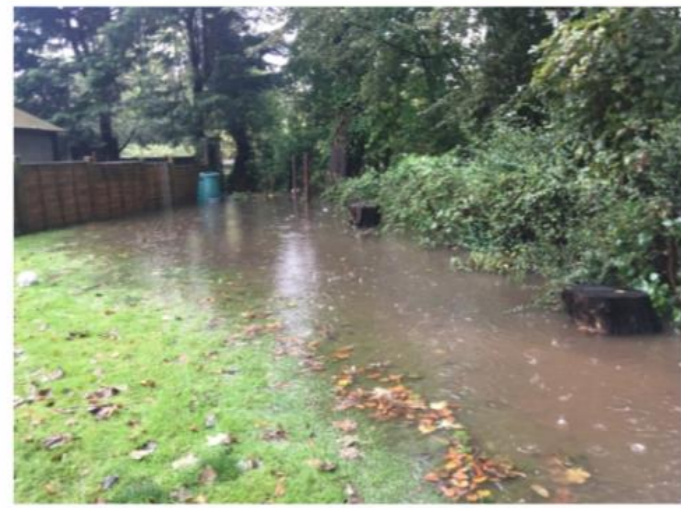
Location: Oakdale, Brundall

**Oakdale**– Report of internal flooding on 6<sup>th</sup> October to one property and external flooding to the road.

- Run-off from significant rainfall pooled at a low point within the catchment where there is no drainage affecting properties.
- An illegally constructed private land drain pipe obstructed the flow of water and caused it to surcharge in the garden of the affected property. This land drain is illegally connected to the surface water drainage network causing this network to become quickly overloaded.

- Norfolk County Council will investigate with third parties the potential to fund small scale improvement schemes to mitigate the risk experienced at this location. This could be either through the submission of a bid to secure Partnership funding or through negotiation with other organisations and the local community. It is important to note this recommendation will be subject to the priorities and availability of resources of funders. It may be dependent on those property owners affected contributing towards a solution.

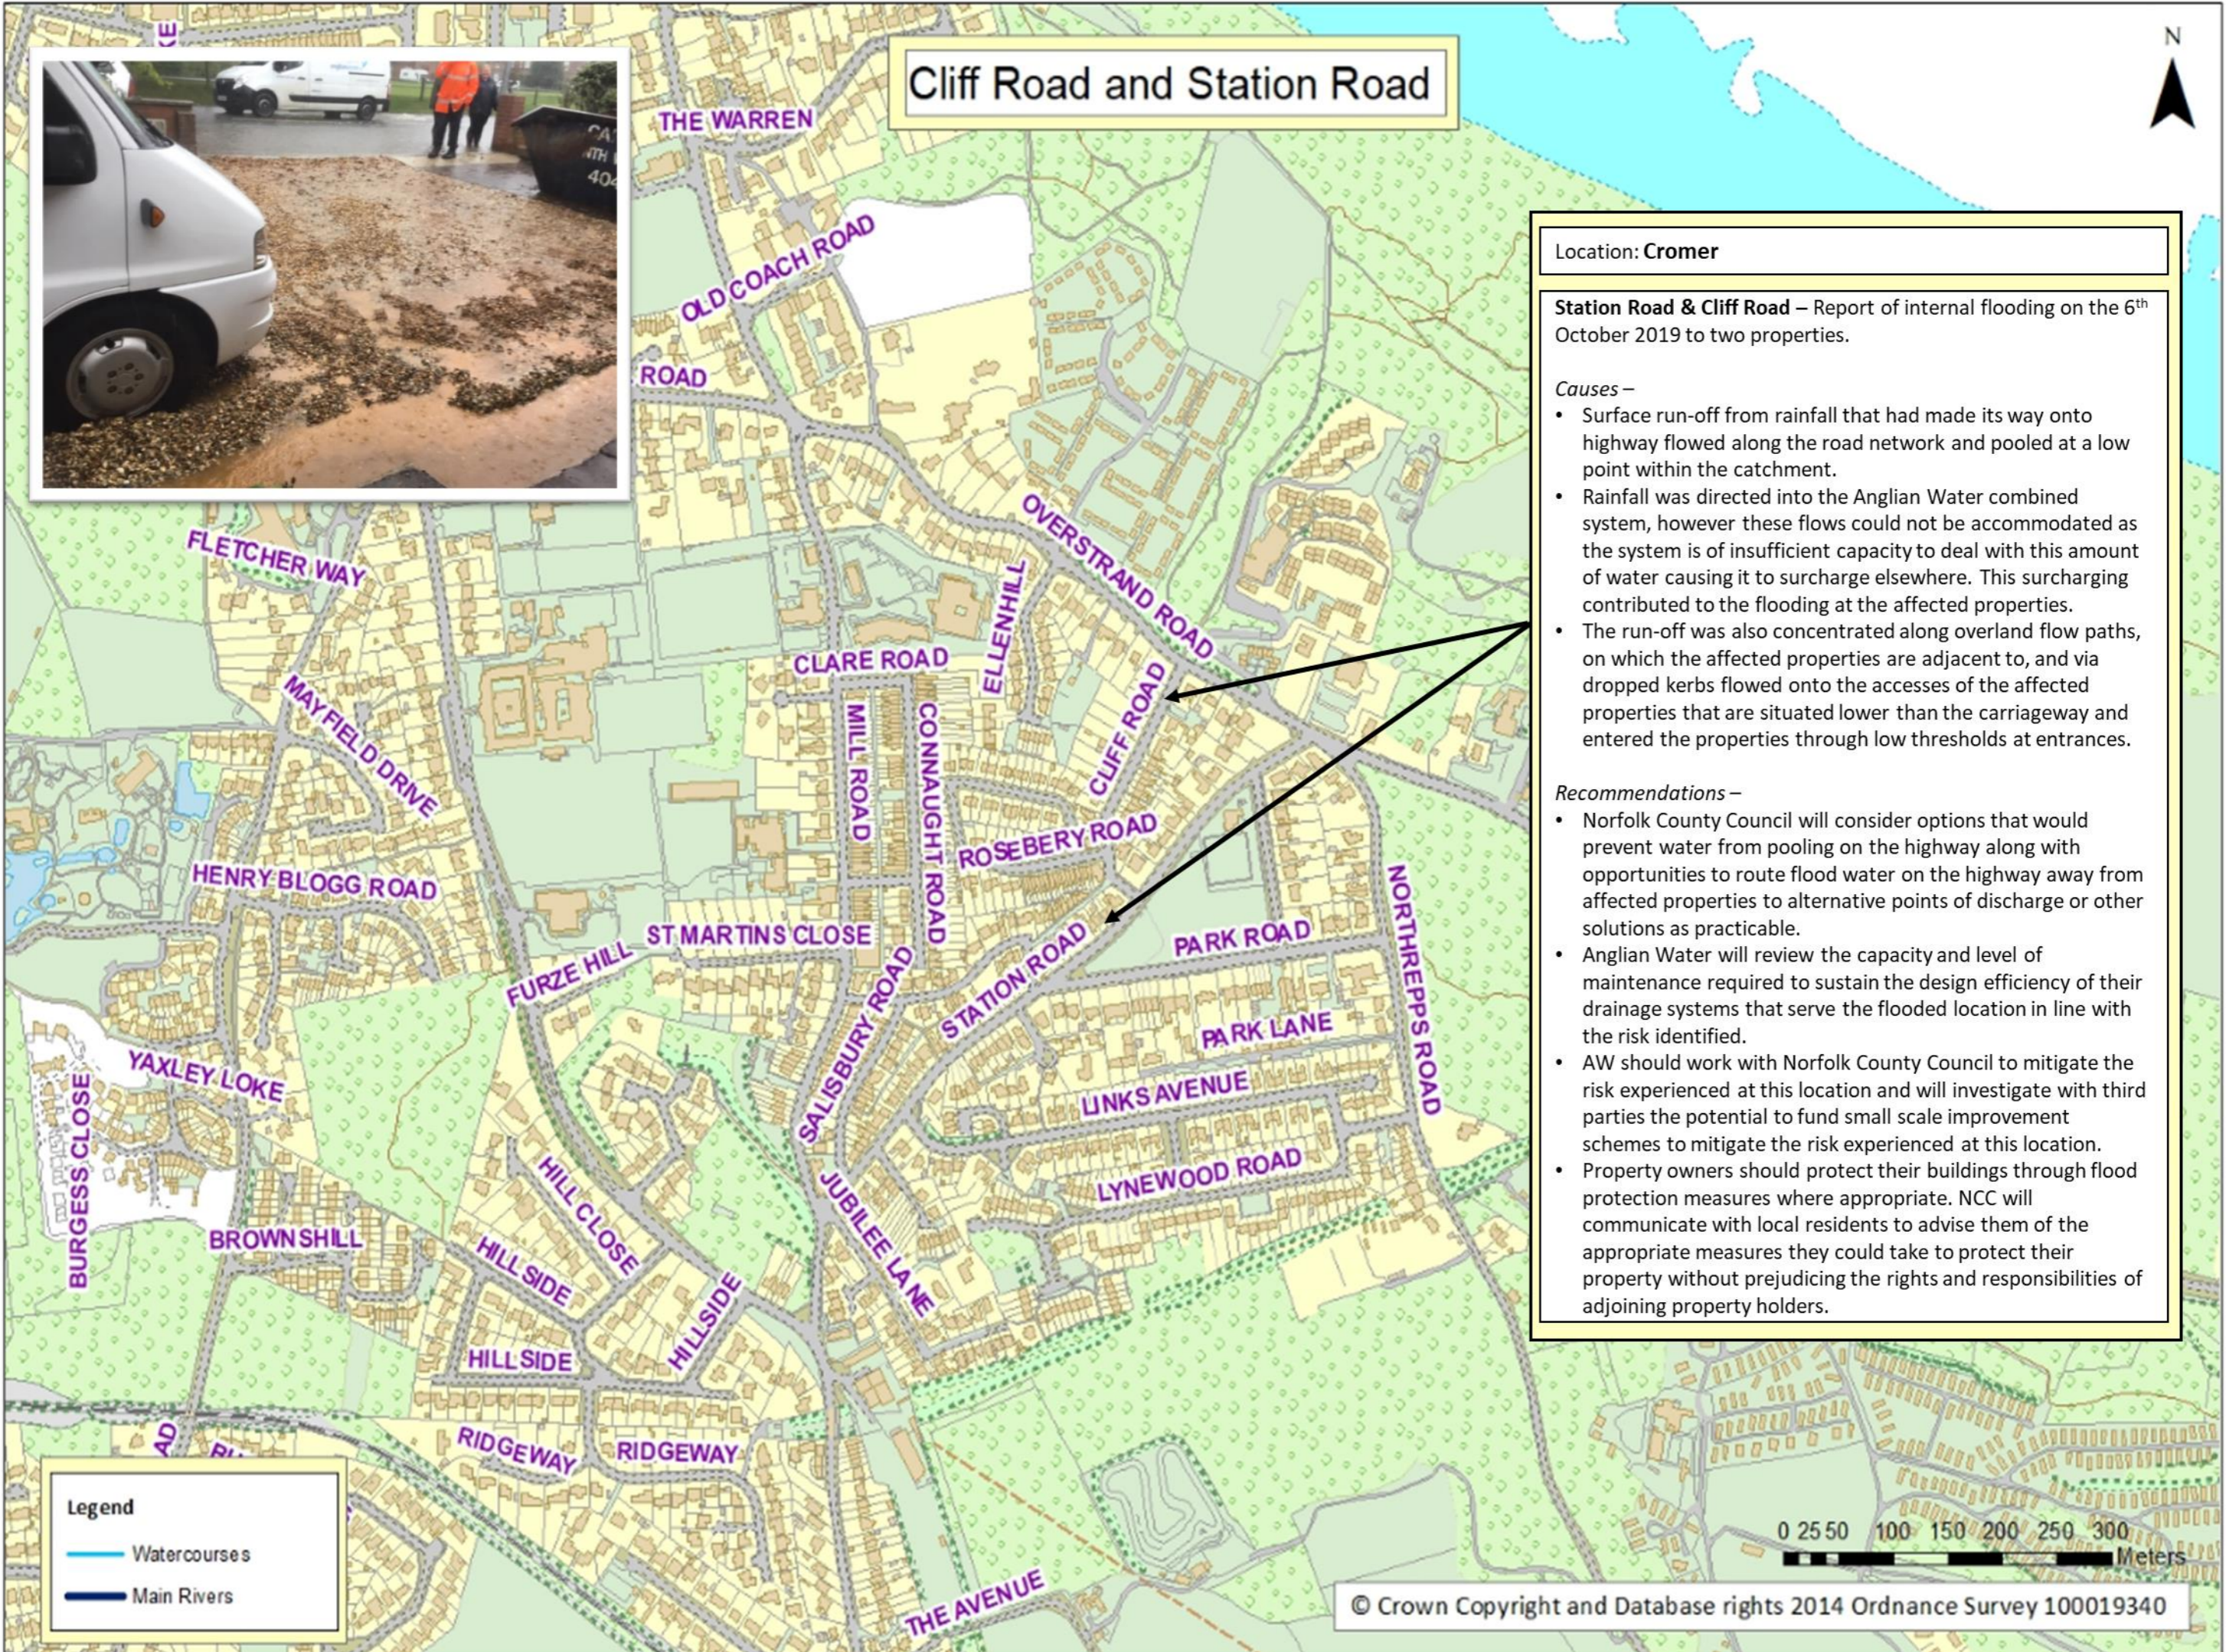
- AW should work with Norfolk County Council to mitigate the risk experienced at this location and will investigate with third parties the potential to fund small scale improvement schemes to mitigate the risk experienced at this location.

- Property owners should protect their buildings through flood protection measures where appropriate. NCC will communicate with local residents to advise them of the appropriate measures they could take to protect their property without prejudicing the rights and responsibilities of adjoining property holders.

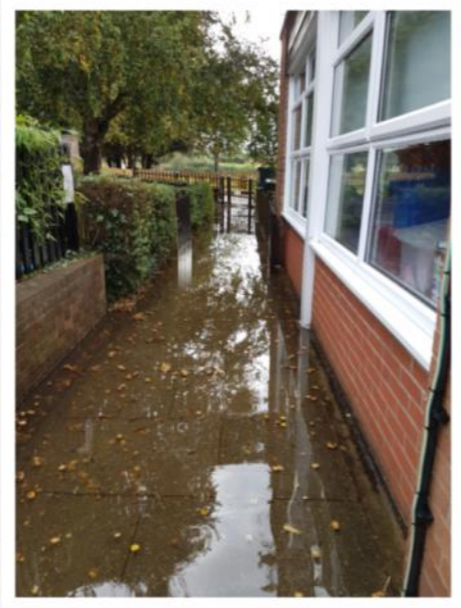
- Anglian Water will review the capacity and/or level of maintenance required to sustain the design efficiency of their drainage systems that serve the flooded location in line with the risk identified.
- NCC will consider opportunities to route flood water on the highway away from affected properties to alternative points of discharge as well as working with partner organisations to identify the potential for managing the amount or rate of surface water entering the drainage system in flood events.
- Property owners should protect their buildings through flood protection measures where appropriate. NCC will communicate with local residents to advise them of the appropriate measures they could take to protect their property without prejudicing the rights and responsibilities of adjoining property holders.

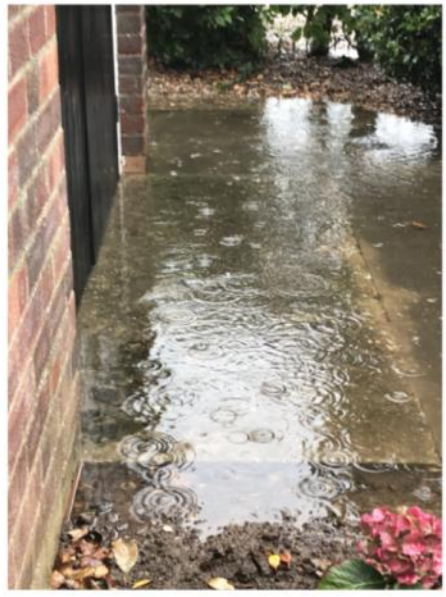
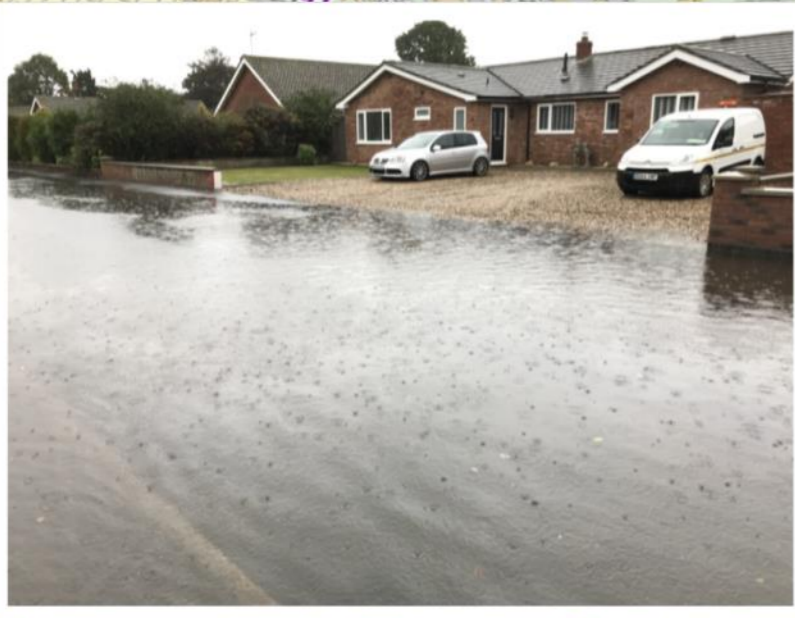
- Causes* –
- Surface run-off from rainfall that had made its way onto the highway flowed towards the surface water drainage network. These flows could not be accommodated as the system was already overloaded and/or obstructed by debris resulting in the pooling of surface water at a low point in the road network.
  - Vehicles using the highway then passed through the flood water causing it to wash towards the affected property. The flood water then entered the property through low thresholds at the entrance.

- Recommendations* –
- Norfolk County Council will review the capacity and level of maintenance required to sustain the design efficiency of their drainage systems that serve the flooding location in line with the risk identified.
  - NCC will consider options that would prevent water from pooling on the highway as well as investigate opportunities to route flood water on the highway away from affected properties to alternative points of discharge, or other solutions as practicable.
  - Property owners should protect their buildings through flood protection measures where appropriate. NCC can advise on the appropriate measures that can be taken to protect the property without prejudicing the rights and responsibilities of adjoining property holders.

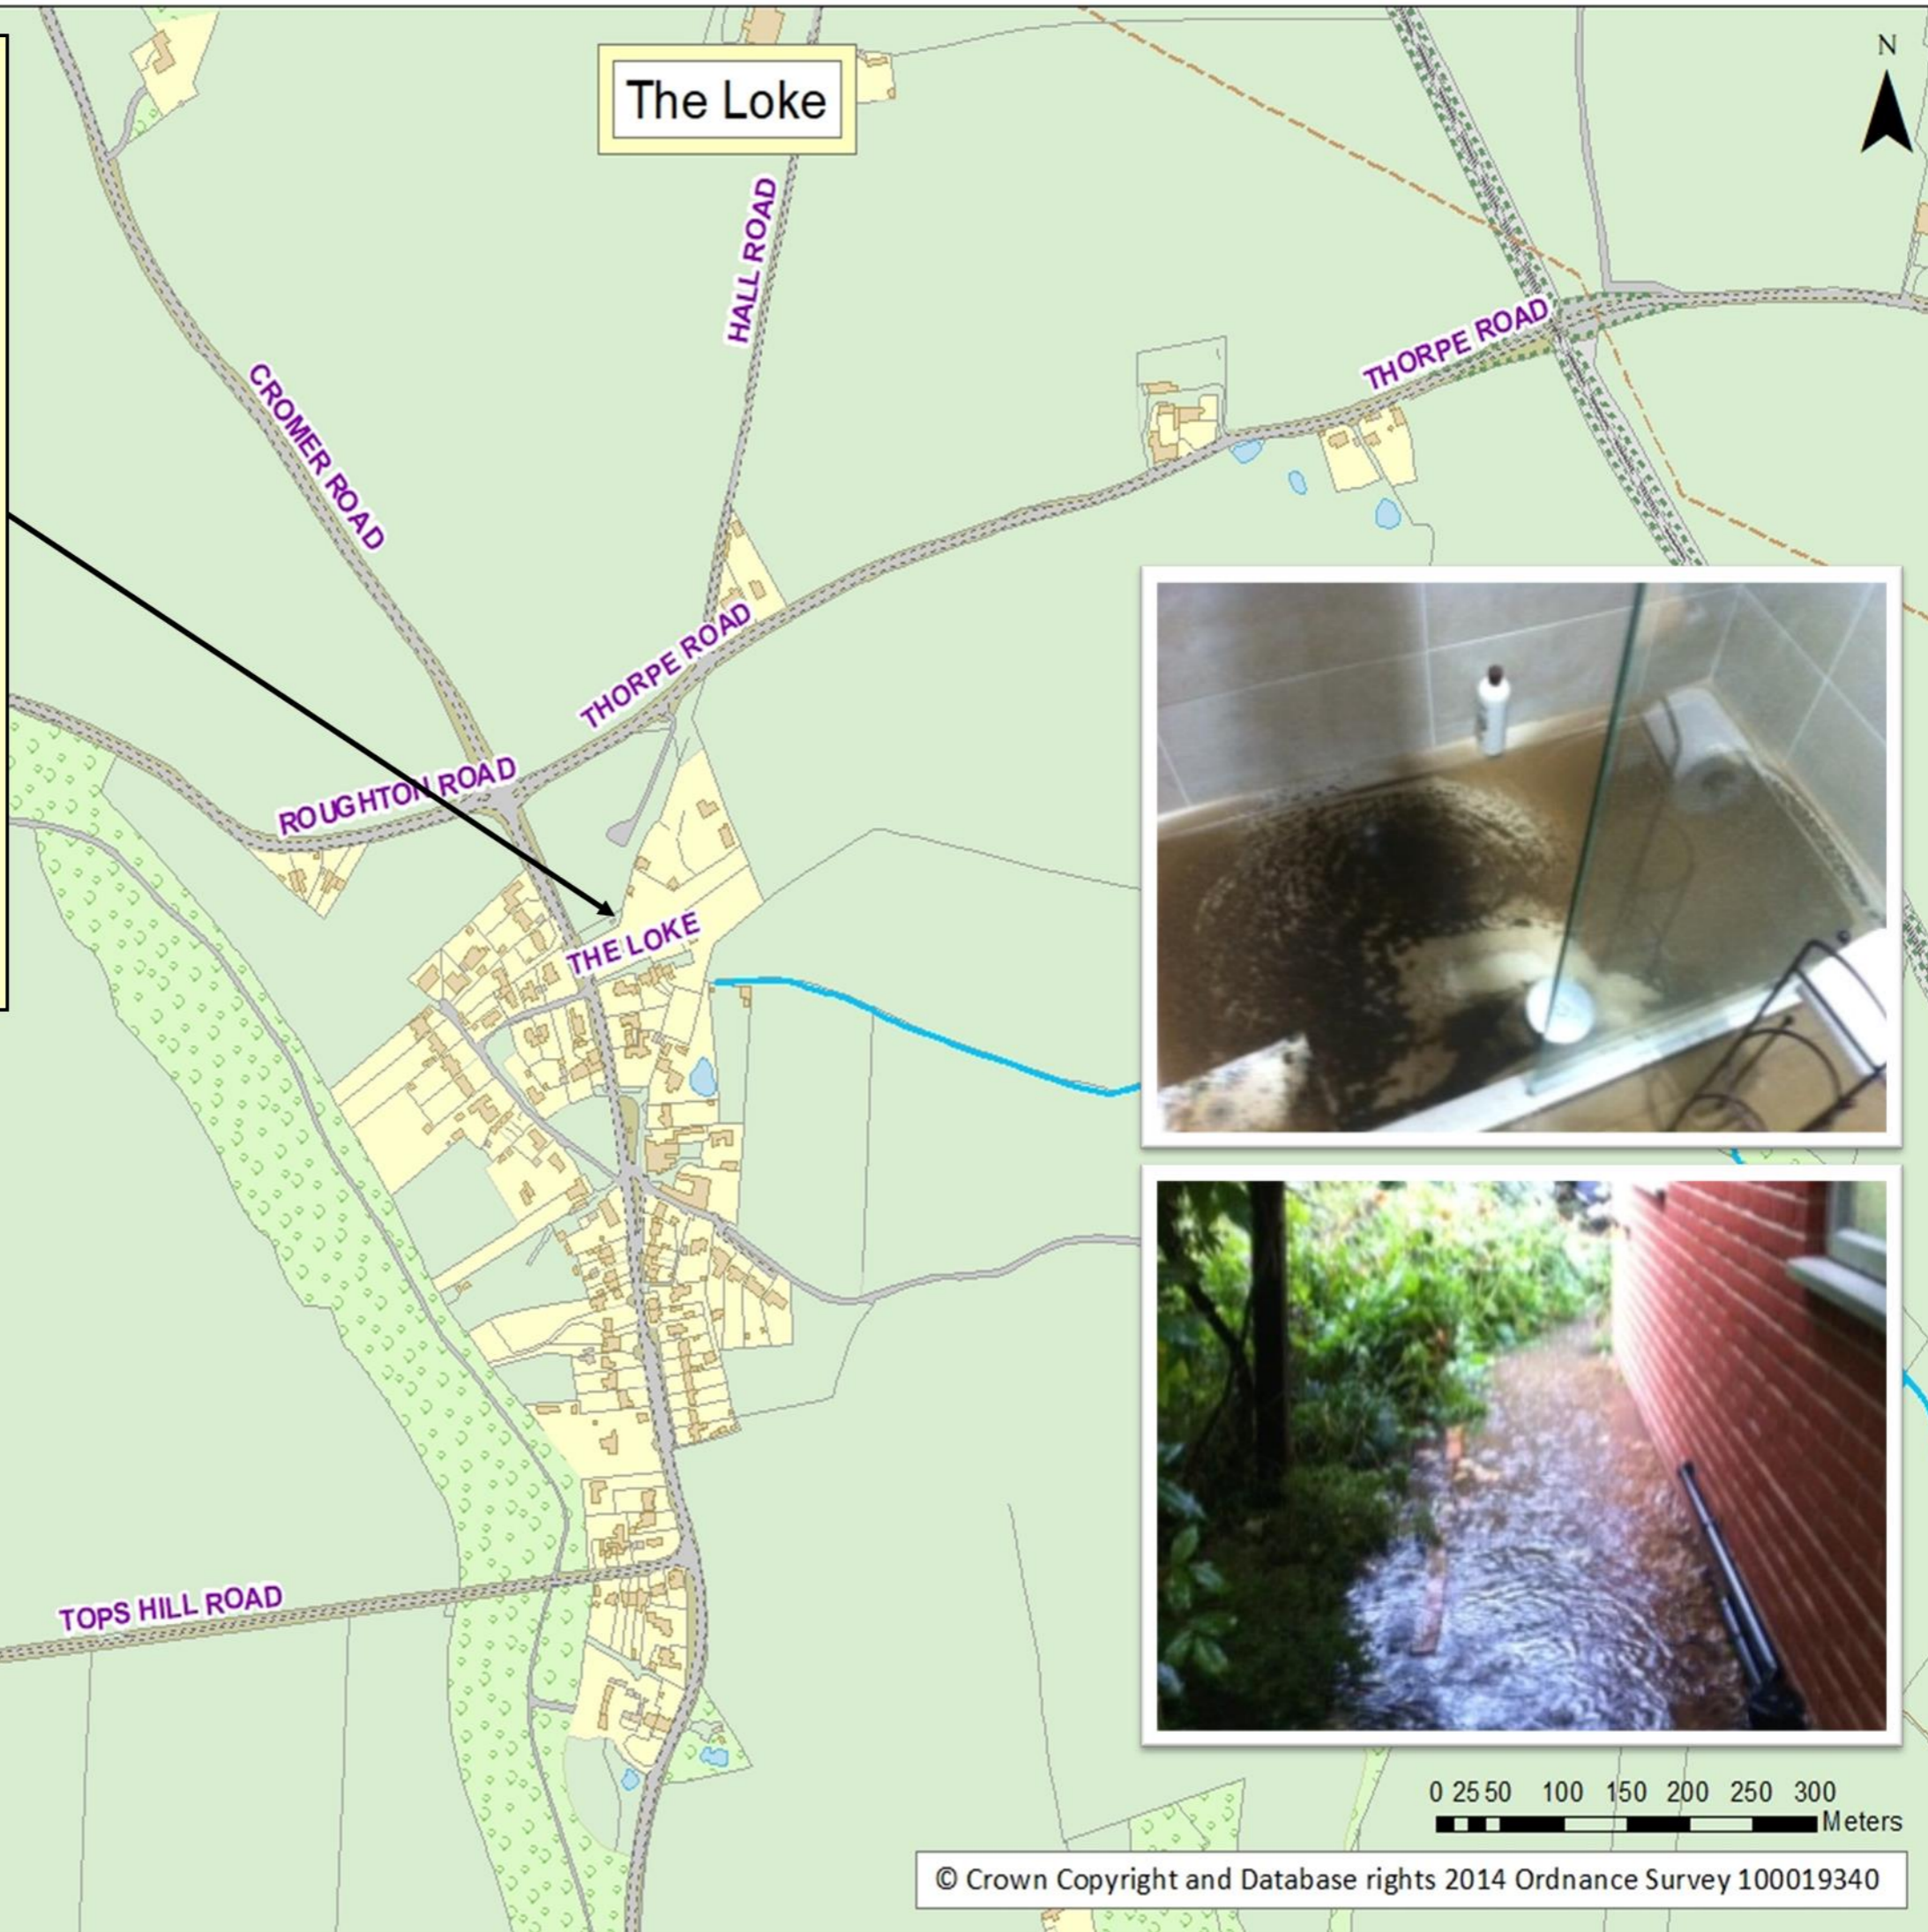
- Report from residents suggests failure of local pumping station, linked to the foul drainage system, being responsible for high water levels in the downstream network causing a partial obstruction. This reduced the efficiency of the upstream drainage system contributing to flooding at the affected property.
- Rainfall was directed into the foul system causing it to surcharge at the affected property. This surcharging caused the flooding at the affected property.

- Anglian Water will review the capacity and level of maintenance required to sustain the design efficiency of their drainage systems that serve the flooding location in line with the risk identified.
- Anglian Water and Norfolk County Council should work with partner organisations to identify the potential for managing the amount or rate of surface water entering their drainage system in flood events.

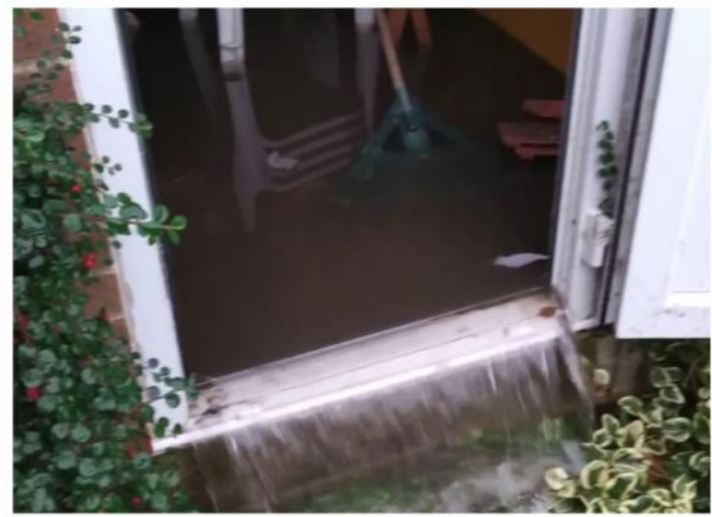
Hillside

The findings of the investigation are detailed on the following map.

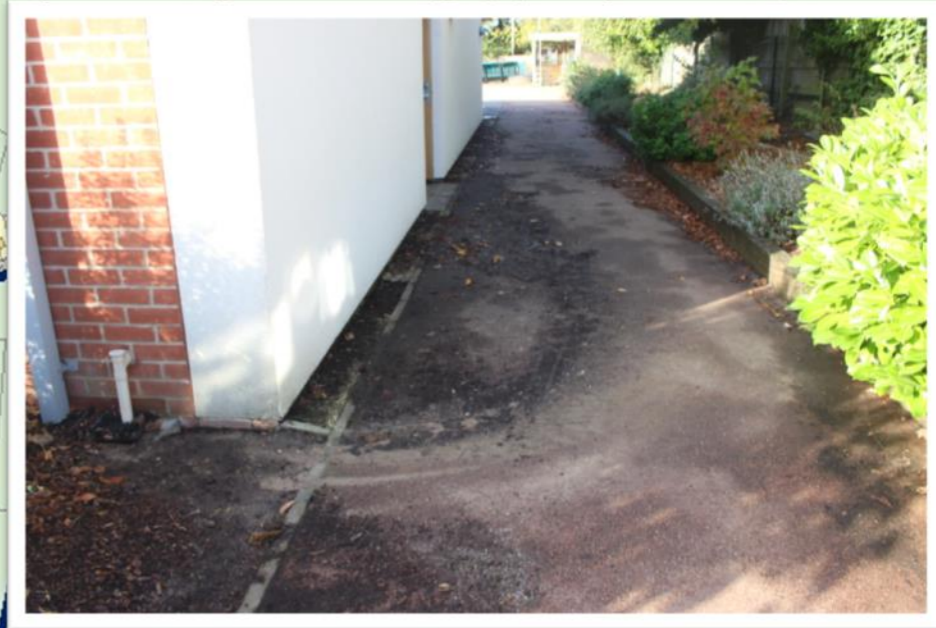
**Ashby Road**

- The foul drainage system was potentially obstructed by debris and high water levels downstream.
- Rainfall was directed into the foul system causing it to surcharge within the affected property. This surcharging caused the flooding at the affected property.

- Anglian Water will review the capacity and level of maintenance required to sustain the design efficiency of their drainage systems that serve the flooding location in line with the risk identified.
- Anglian Water and Norfolk County Council should work with partner organisations to identify the potential for managing the amount or rate of surface water entering their drainage system in flood events.
