Norfolk County Council

Investigation Report into the flooding in North Norfolk District Council

Report Reference: FIR035

Draft Report prepared by Mark Henderson on 09 May 2019

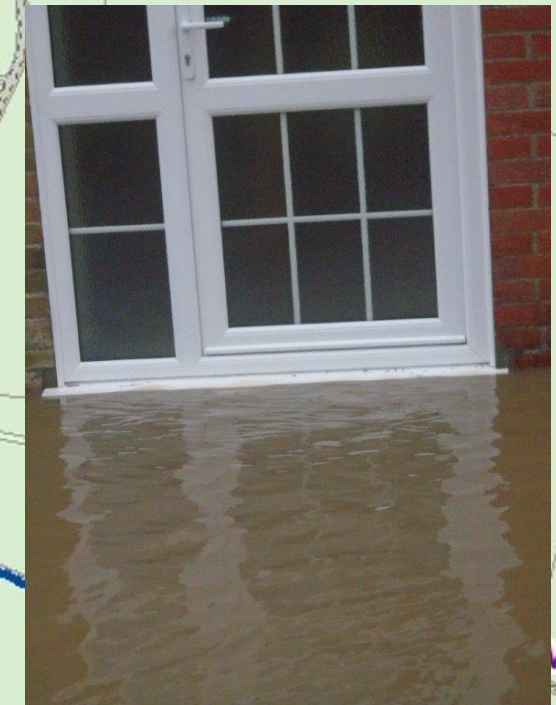
Wells Road, Hindringham – Internal flooding experienced January 1st 2016

Causes - Run-off from rainfall was concentrated along overland flowpaths on which the affected property is adjacent to. Individual property drainage was partially obstructed by structural failure downstream of the property. This caused the failure of the upstream drainage system contributing to the accumulation of surface flood water at the affected property.

The riparian owners should instigate a regular regime of maintenance to ensure the system is free from obstruction (i.e. tree leaves / roots) at all times.

The property owner should protect their buildings through flood protection measures where appropriate. Norfolk County Council will communicate with local residents to advise them of the appropriate measures they could take to protect their property without prejudicing the rights and responsibilities of adjoining property holders.
