Investigation Report into the flooding in North Walsham from 2016 – 2018

Report Reference: FIR018

Draft Report prepared by Abygail Hadley on 22 March 2019

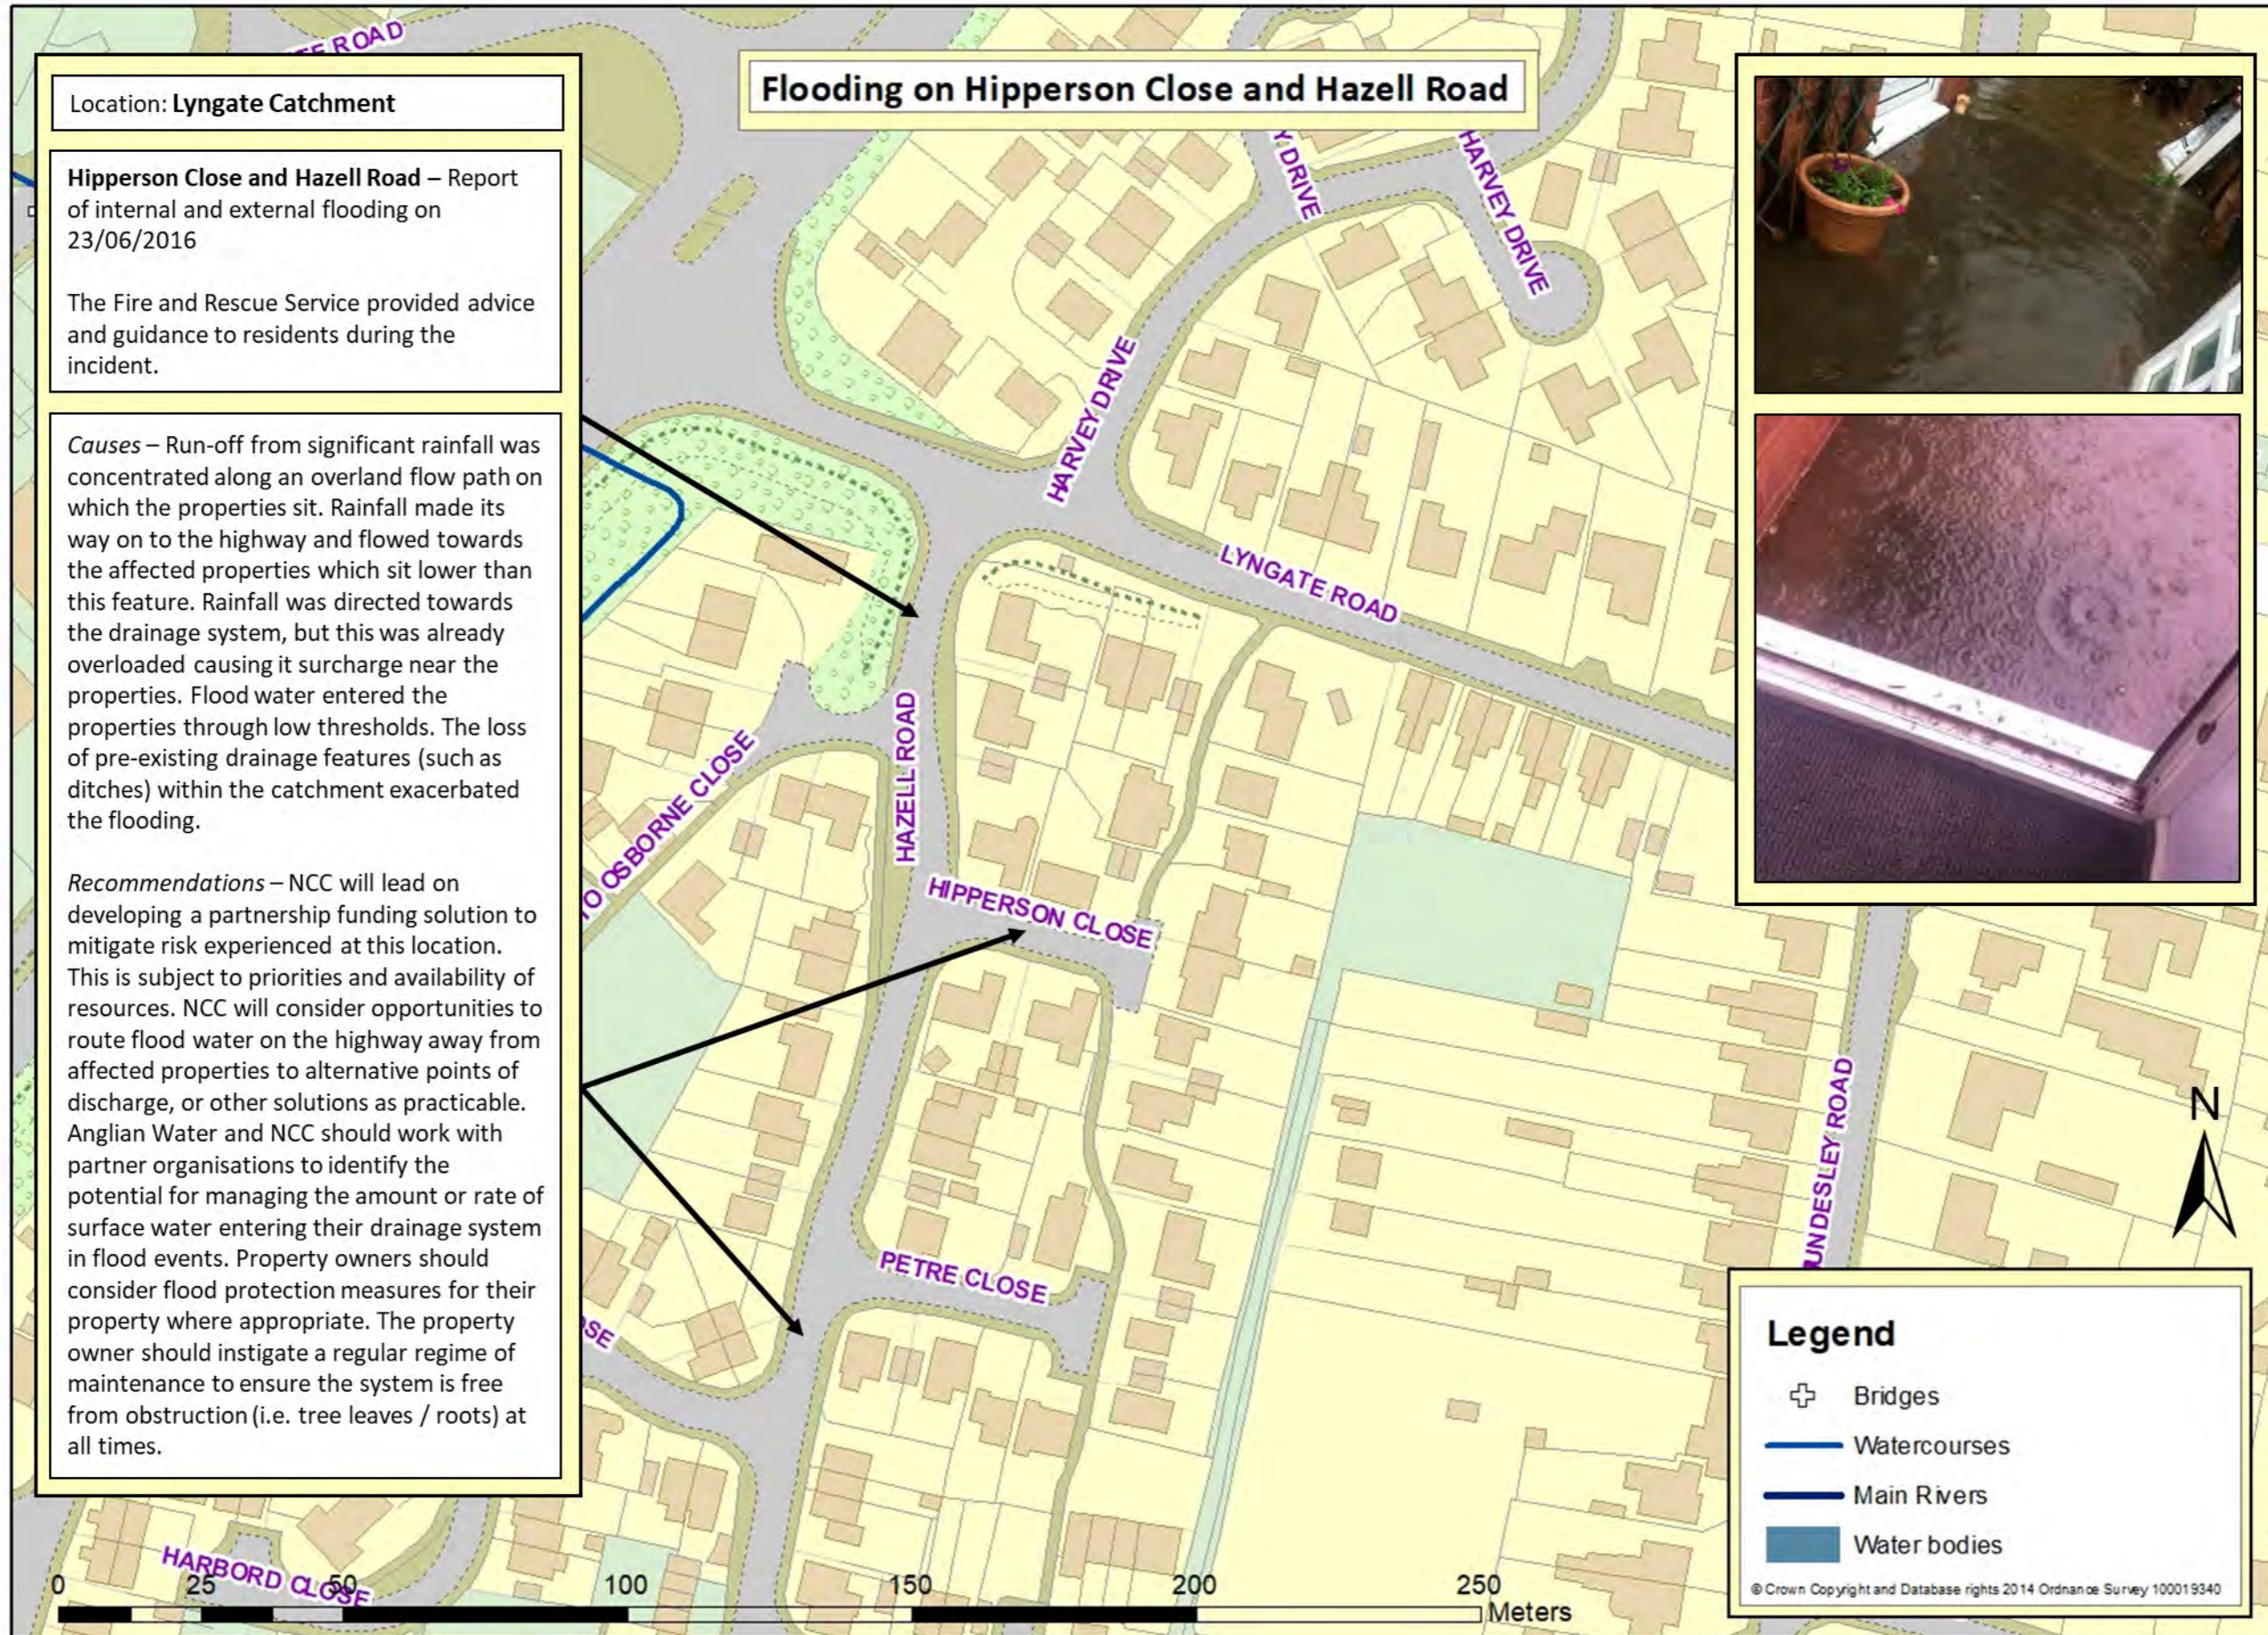
Flooding on Corbett Road and Lynfield Road

Corbett Road and Lynfield Road– Report of internal and external flooding on 23/06/2016

Causes – Run-off from significant rainfall was concentrated along an overland flow path on which the properties sit. Rainfall made its way on to the highway and flowed towards the affected properties which sit lower than this feature. Rainfall was directed towards the foul and surface drainage system, but this was already overloaded causing it surcharge near the properties. Flood water entered the properties through low thresholds. The loss of pre-existing drainage features (such as ditches) within the catchment exacerbated the flooding.

Recommendations – NCC will lead on developing a partnership funding solution to mitigate risk experienced at this location. This is subject to priorities and availability of resources. NCC will consider opportunities to route flood water on the highway away from affected properties to alternative points of discharge, or other solutions as practicable. NCC and Anglian should work with partner organisations to identify the potential for managing the amount or rate of surface water entering their drainage system in flood. Property owners should consider flood protection measures for their property where appropriate. The property owners in the area should instigate a regular regime of maintenance to ensure the system is free from obstruction (i.e. tree leaves / roots) at all times.
