Norfolk County Council

Investigation Report into the flooding in Norwich Urban Area: 2016 to 2018

Report Reference: FIR030

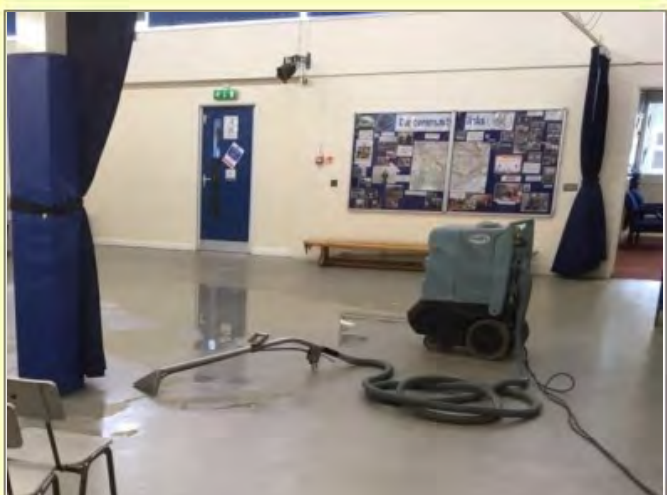
Mile End Road

1 property was flooded internally on 23/06/2016. This incident was reported by Norwich City Council.

Causes – Surface run-off from rainfall that had made its way onto roads and the highway flowed along the road network and onto the accesses of affected properties that were situated lower than these features.

Anglian Water Services Ltd assessed the capacity of their drainage system after the incident.

Recommendations – Norfolk County Council and relevant RMAs to explore funding for flood mitigation, attenuation and flood routing. Property owners should protect their buildings through flood resilience measures where appropriate.

Recommendations – Anglian Water should work with partner organisations to identify the potential for managing the amount or rate of surface water entering their drainage system in flood events.

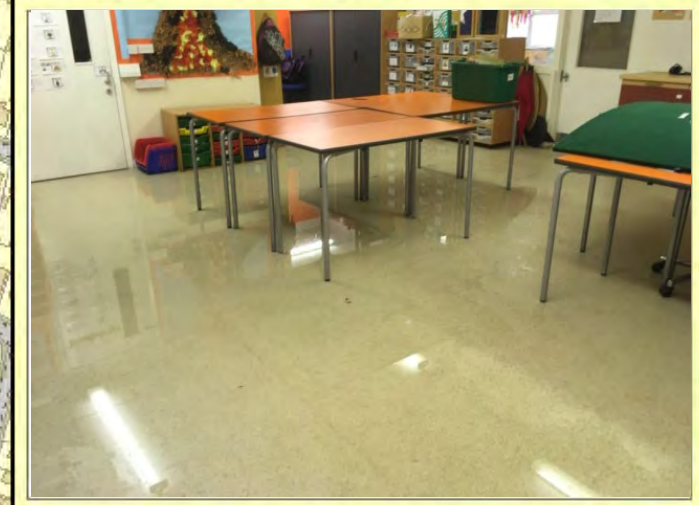
Ipswich Road

1 property was internally flooded on Ipswich Road 06/07/2017. This incident was reported by the media via an article on 07/07/2017.

Causes - The affected property had structural issues that did not cope with heavy rainfall, e.g. (failure of roof / guttering etc). Run-off from significant rainfall pooled at a low point within the catchment affecting property.

The property owner carried out measures to minimise the impact of flooding during the incident.

Property owners should protect their buildings through flood resilience measures where appropriate. NCC will advise them of the appropriate measures they could take to protect their property without prejudicing the rights and responsibilities of adjoining property holders.

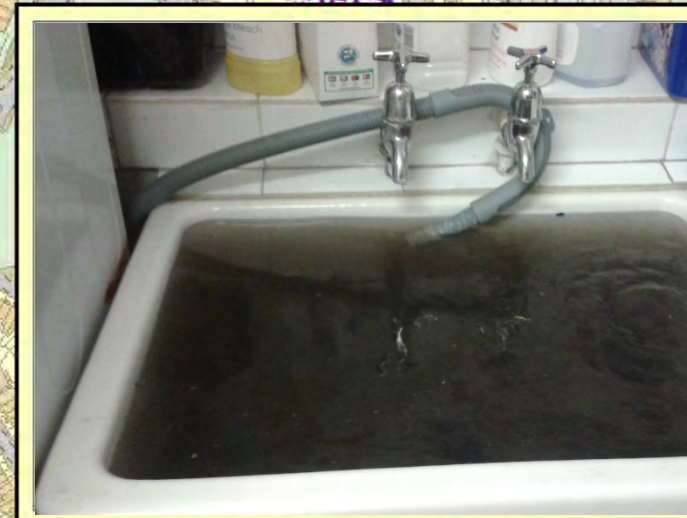
Avenue Road

Causes – significant rainfall was directed into the surface water sewer system causing it to surcharge elsewhere. This surcharging contributed to the flooding at the affected property.

The affected property had structural issues that did not cope with heavy rainfall, e.g. (failure of roof / guttering etc).

Recommendations – Anglian Water should work with partner organisations to identify the potential for managing the amount or rate of surface water entering their drainage system in flood events.

Property owners should protect their buildings through flood resilience measures where appropriate. NCC will advise them of the appropriate measures they could take to protect their property without prejudicing the rights and responsibilities of adjoining property holders.

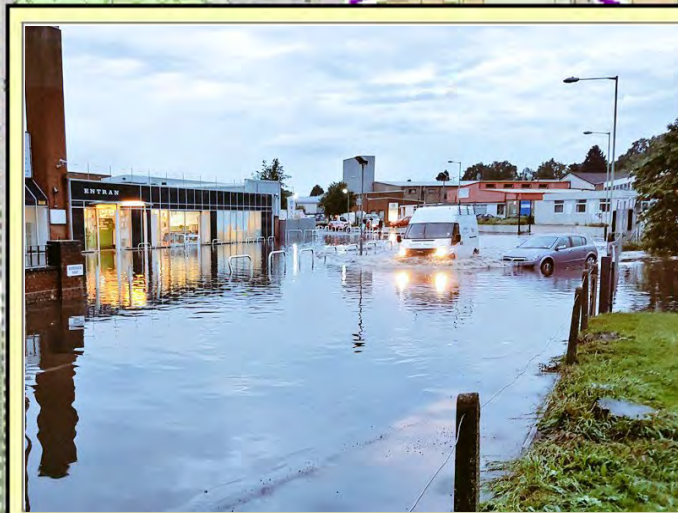
Low Road

1 property was flooded internally on 23/06/2016, 12/08/2017 and was reported by an online form.

Causes – Surface run-off from rainfall that had made its way onto roads and the highway flowed along the road network and onto the accesses of affected properties that were situated lower than these features.

Causes – Surface run-off from rainfall that had made its way onto roads and the highway flowed along the road network and onto the accesses of affected properties that were situated lower than these features. Significant rainfall was directed into the surface water sewer system causing it to surcharge elsewhere. This surcharging contributed to the flooding at the affected property.

Recommendations – Norfolk County Council will consider opportunities to route flood water on the highway away from affected properties to alternative points of discharge, or other solutions as practicable.

Recommendations – Norfolk County Council and relevant RMAs to explore funding for flood mitigation, attenuation and flood routing. Property owners should protect their buildings through flood resilience measures where appropriate.

Recommendations – Anglian Water should work with partner organisations to identify the potential for managing the amount or rate of surface water entering their drainage system in flood events.

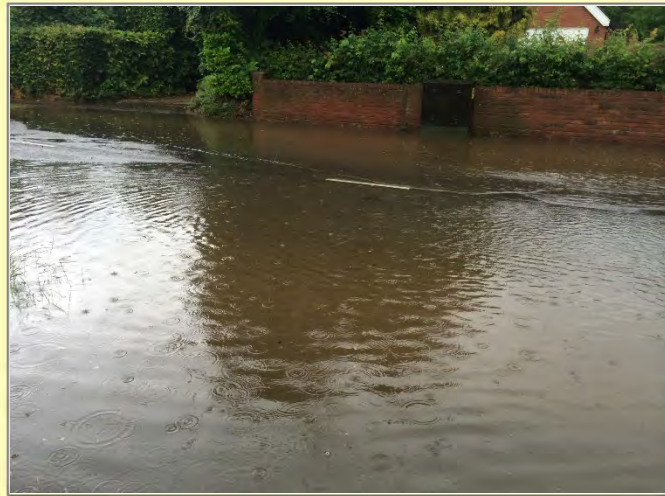
Unthank Road

Causes – Surface run-off from rainfall that had made its way onto roads and the highway flowed along the road network and onto the accesses of affected properties that were situated lower than these features. Significant rainfall was directed into the surface water sewer system causing it to surcharge elsewhere. This surcharging contributed to the flooding at the affected property.

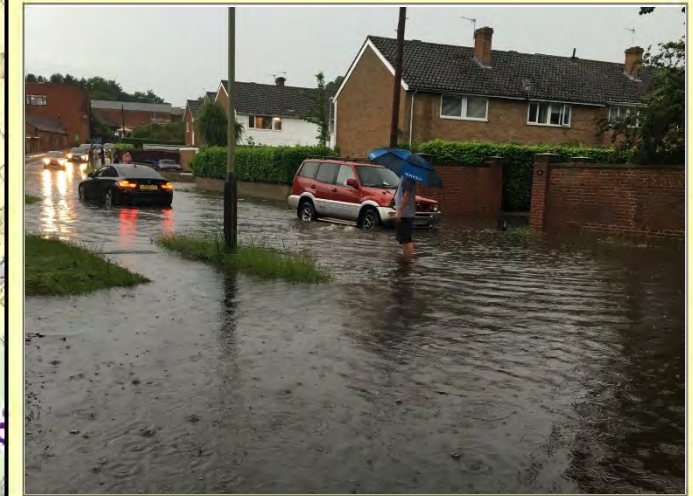
Church Lane

1 property was flooded internally on 23/06/2016 and was reported by a resident via email correspondence.

A resident carried out measures to minimise the impact of flooding during the incident. Anglian Water Services Ltd, Norwich City Council and Norfolk County Council visited affected residents to offer advice and to gather information after the incident.

Causes – Surface run-off from rainfall that had made its way onto roads and the highway flowed along the road network and onto the accesses of affected properties that were situated lower than these features. Significant rainfall was directed into the surface water sewer system causing it to surcharge elsewhere. This surcharging contributed to the flooding at the affected property.

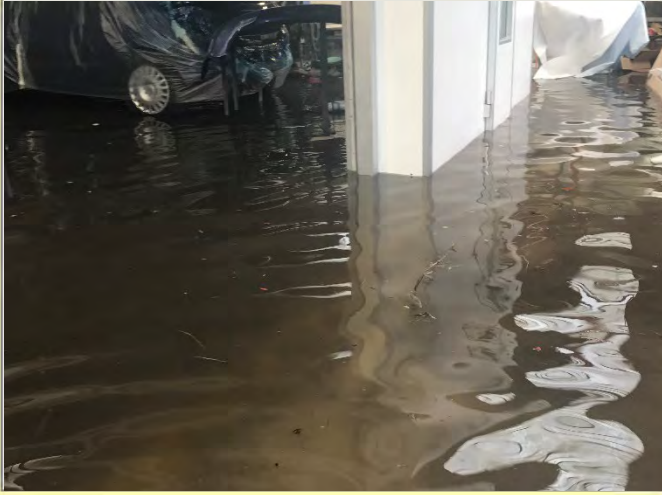
D6 – Detail Map

Within this catchment 1 incident of internal flooding has been assessed as part of this investigation. These incidents are detailed below. 2 reports of external or unconfirmed incidents of flooding have also been recorded in this catchment in this timescale. These are on Hall Road on 06/07/2017.

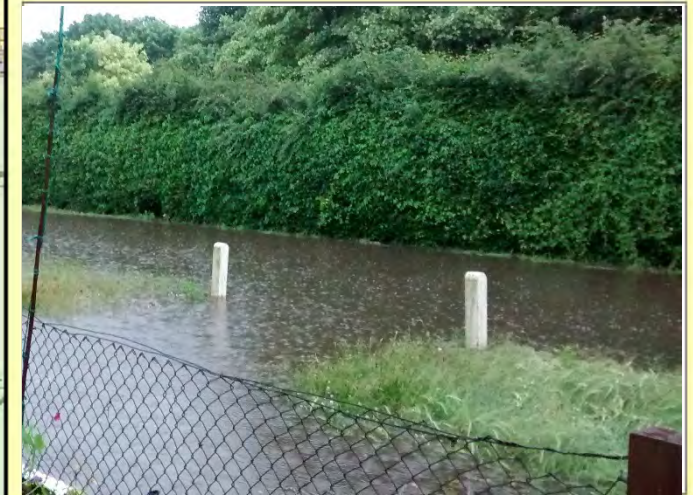
North Park Avenue

Causes – run-off from significant rainfall was concentrated along overland flowpaths and pooled at a low point within the catchment.

Causes – significant rainfall was directed into the surface water sewer system causing it to surcharge elsewhere.

Recommendations – Norfolk County Council will consider opportunities to route flood water on the highway away from affected properties to alternative points of discharge, or other solutions as practicable.

Recommendations – Anglian Water should work with partner organisations to identify the potential for managing the amount or rate of surface water entering their drainage system in flood events.

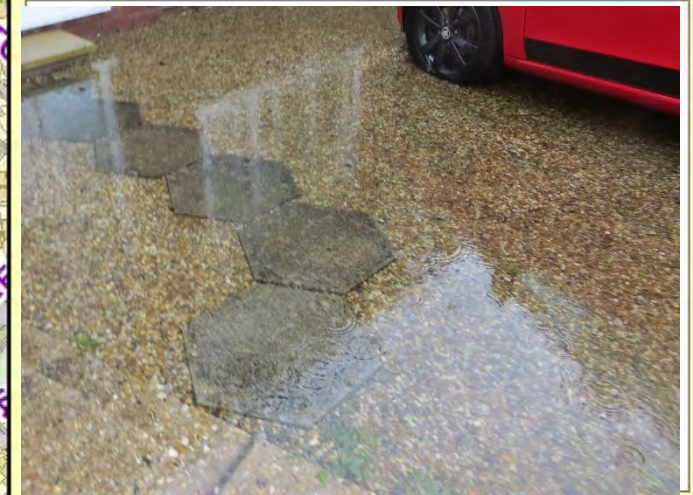
Davidson Close

The flood water entered the property through low thresholds at entrances.

Norfolk County Council (Highways) assessed the capacity of their drainage system after the incident

Causes – run-off from significant rainfall was concentrated along overland flowpaths and pooled at a low point within the catchment.

Recommendations – Norfolk County Council should identify the potential for managing the amount or rate of surface water entering their drainage system in flood events. Property owners should protect their buildings through flood resilience measures where appropriate.
