Norfolk County Council

Investigation Report into the flooding County Wide on the 16th August 2020

Report Reference: FIR/061

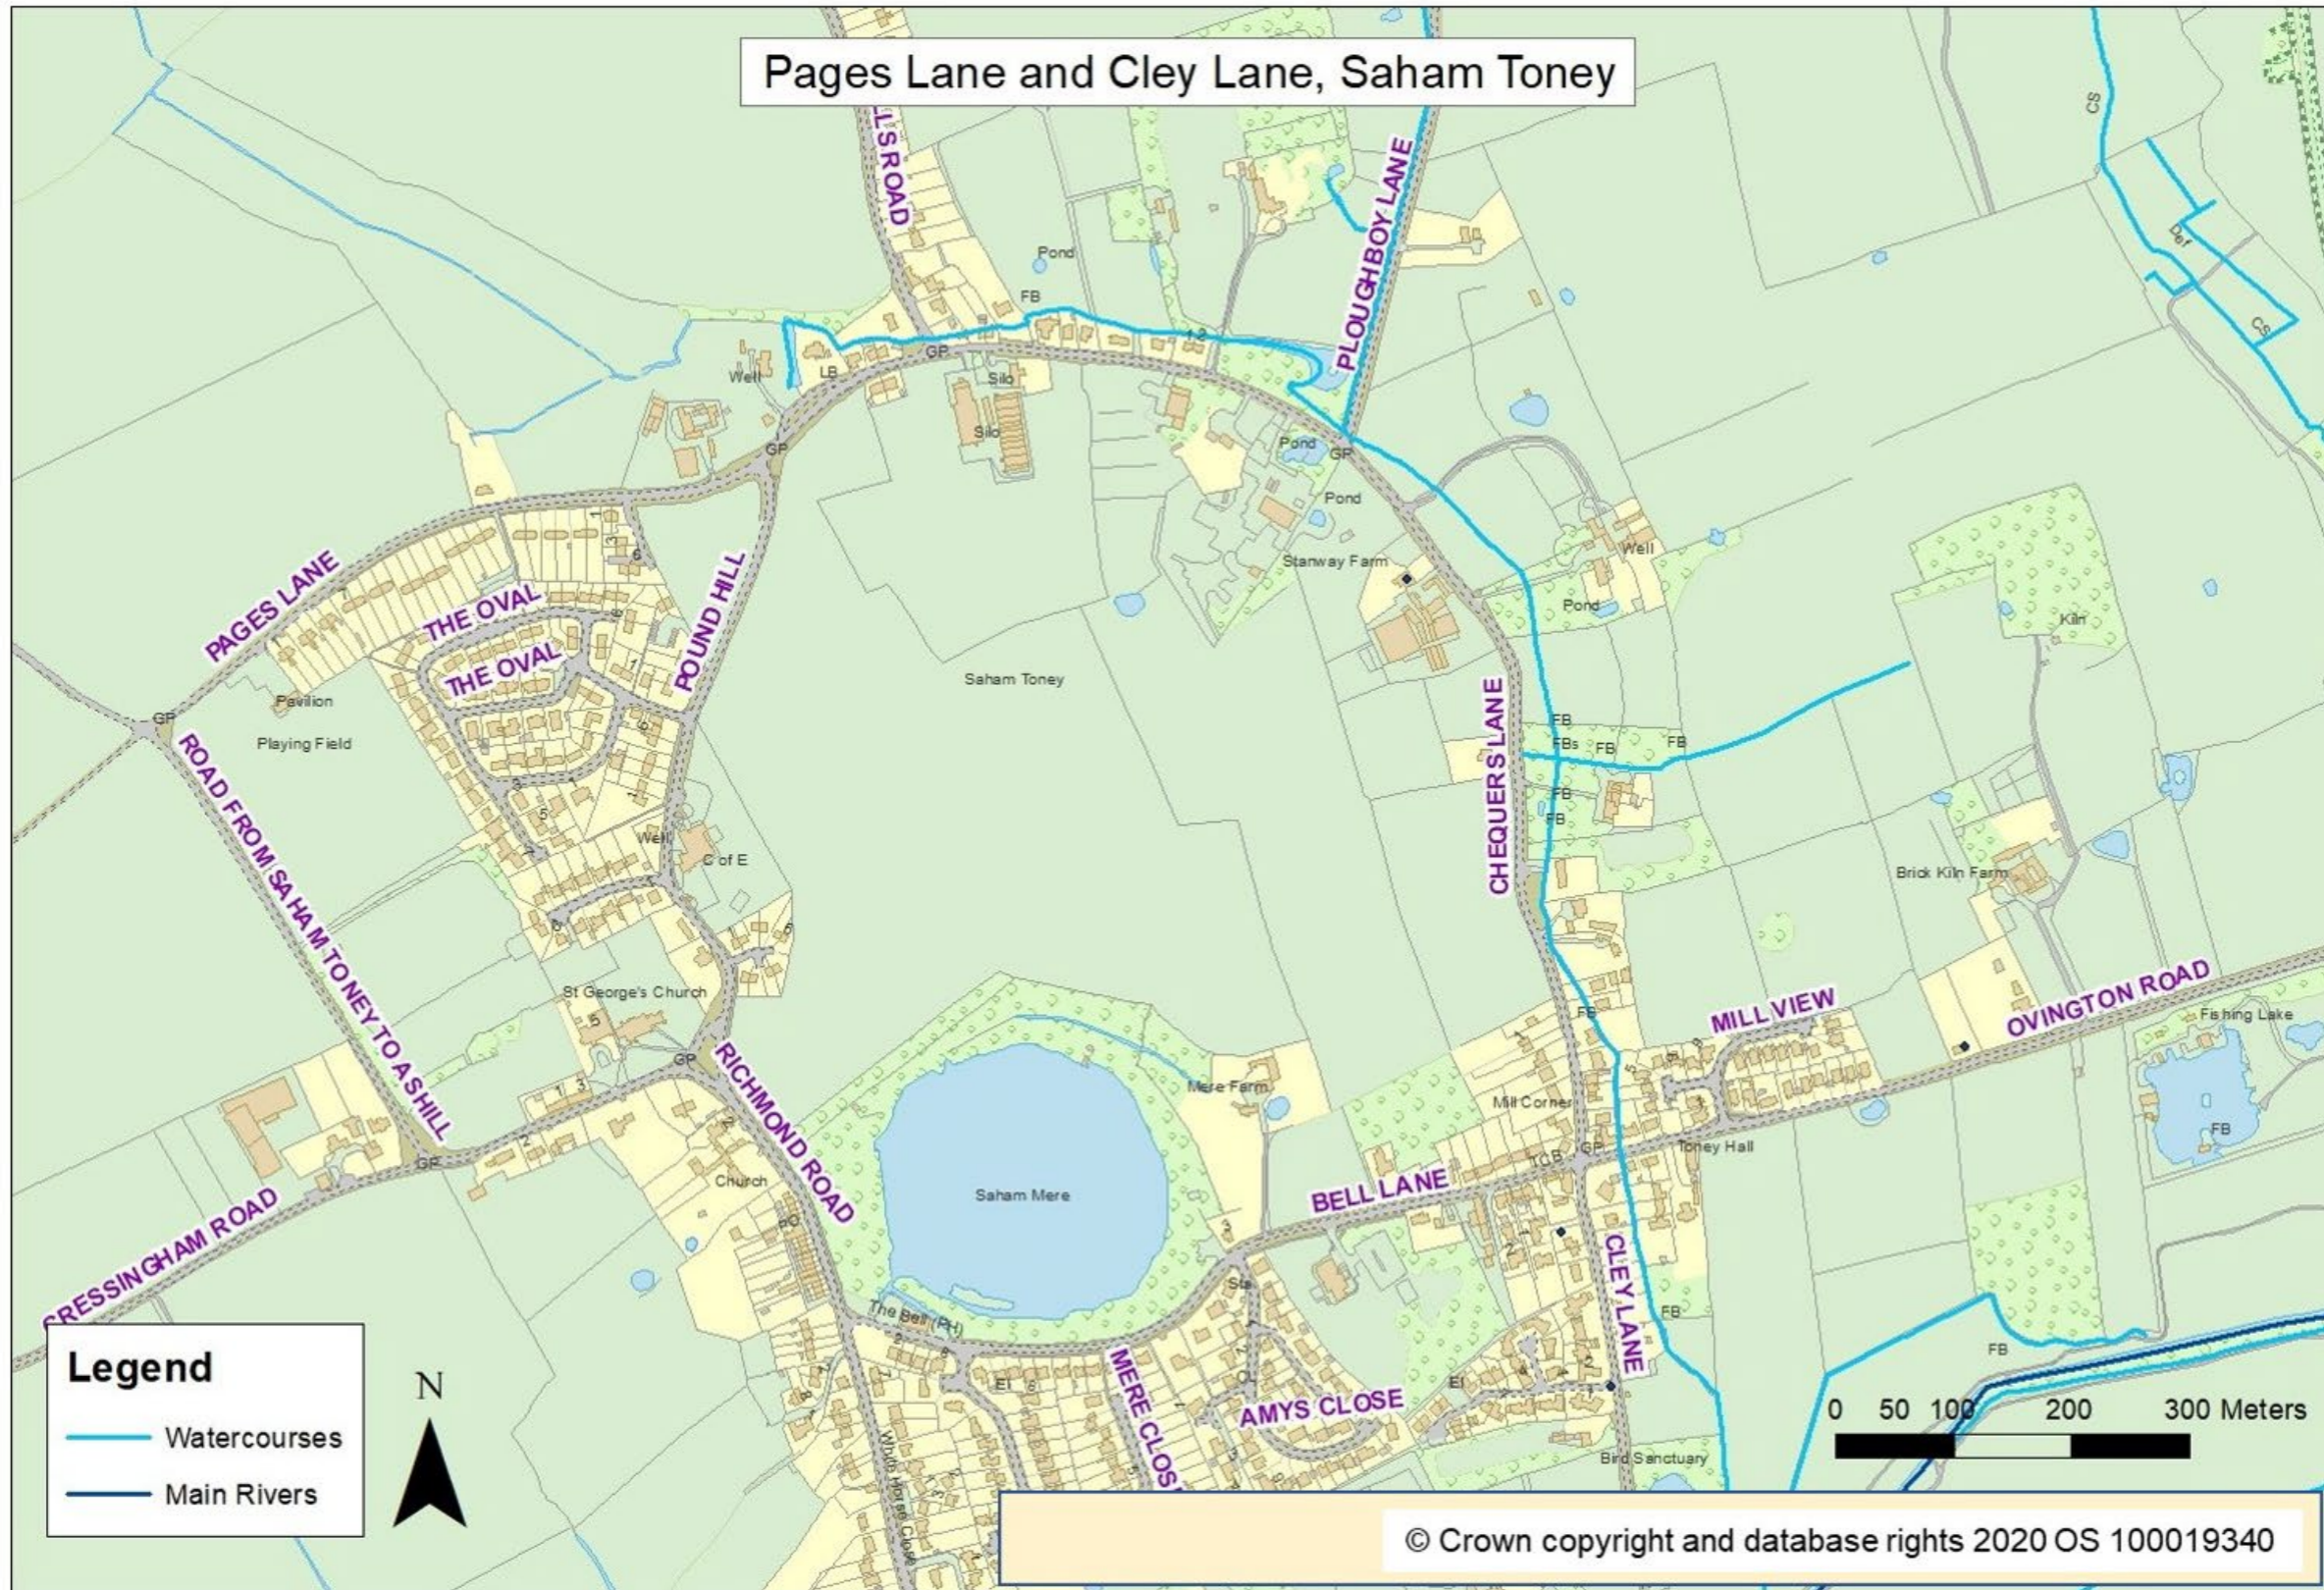
Pages Lane and Cley Lane, Saham Toney

Location	Causes	Recommendations
<p>Pages Lane - Report of internal flooding to one property on the 16th August 2020</p>	<ul style="list-style-type: none"> • Run-off from significant rainfall was concentrated along overland flow paths on which the affected property sits • Surface run-off from significant rainfall flowed along the road network and onto the accesses of a neighbouring property and then was directed towards the affected property • The surface water drainage system is constricted by a pinch point downstream causing the water to back up 	<ul style="list-style-type: none"> • NCC should undertake maintenance on the ditch alongside Pages Lane to allow water from the road to flow to the ditch • NCC should work with partner organisations to identify the potential for managing the amount or rate of surface water entering their drainage system in flood events. • Norfolk County Council should considering removing the trash screen on the culvert at the junction of Hills Road and ensure this does not impact the culverts structural integrity.

<p>Cley Lane - Report of internal flooding to two properties on the 16th August 2020</p>	<ul style="list-style-type: none"> • Run-off from significant rainfall was concentrated along overland flow paths on which the affected property sits • Surface run-off from significant rainfall flowed along the road network and onto the accesses of affected properties that were situated lower than these features • Rainfall was directed towards the surface water drainage network. These flows could not be accommodated as the system was already overloaded. • The foul system surcharged within the property 	<ul style="list-style-type: none"> • NCC will investigate with third parties the potential to fund small scale improvement schemes to mitigate the risk experienced at this location. It is important to note this recommendation will be subject to the priorities and availability of resources of funders. • Anglian Water should work with partner organisations to identify the potential for managing the amount or rate of surface water entering their drainage system in flood events. • Norfolk County Council should consider Natural Flood Management options in the upper catchment that would reduce and delay the peak of flood water.

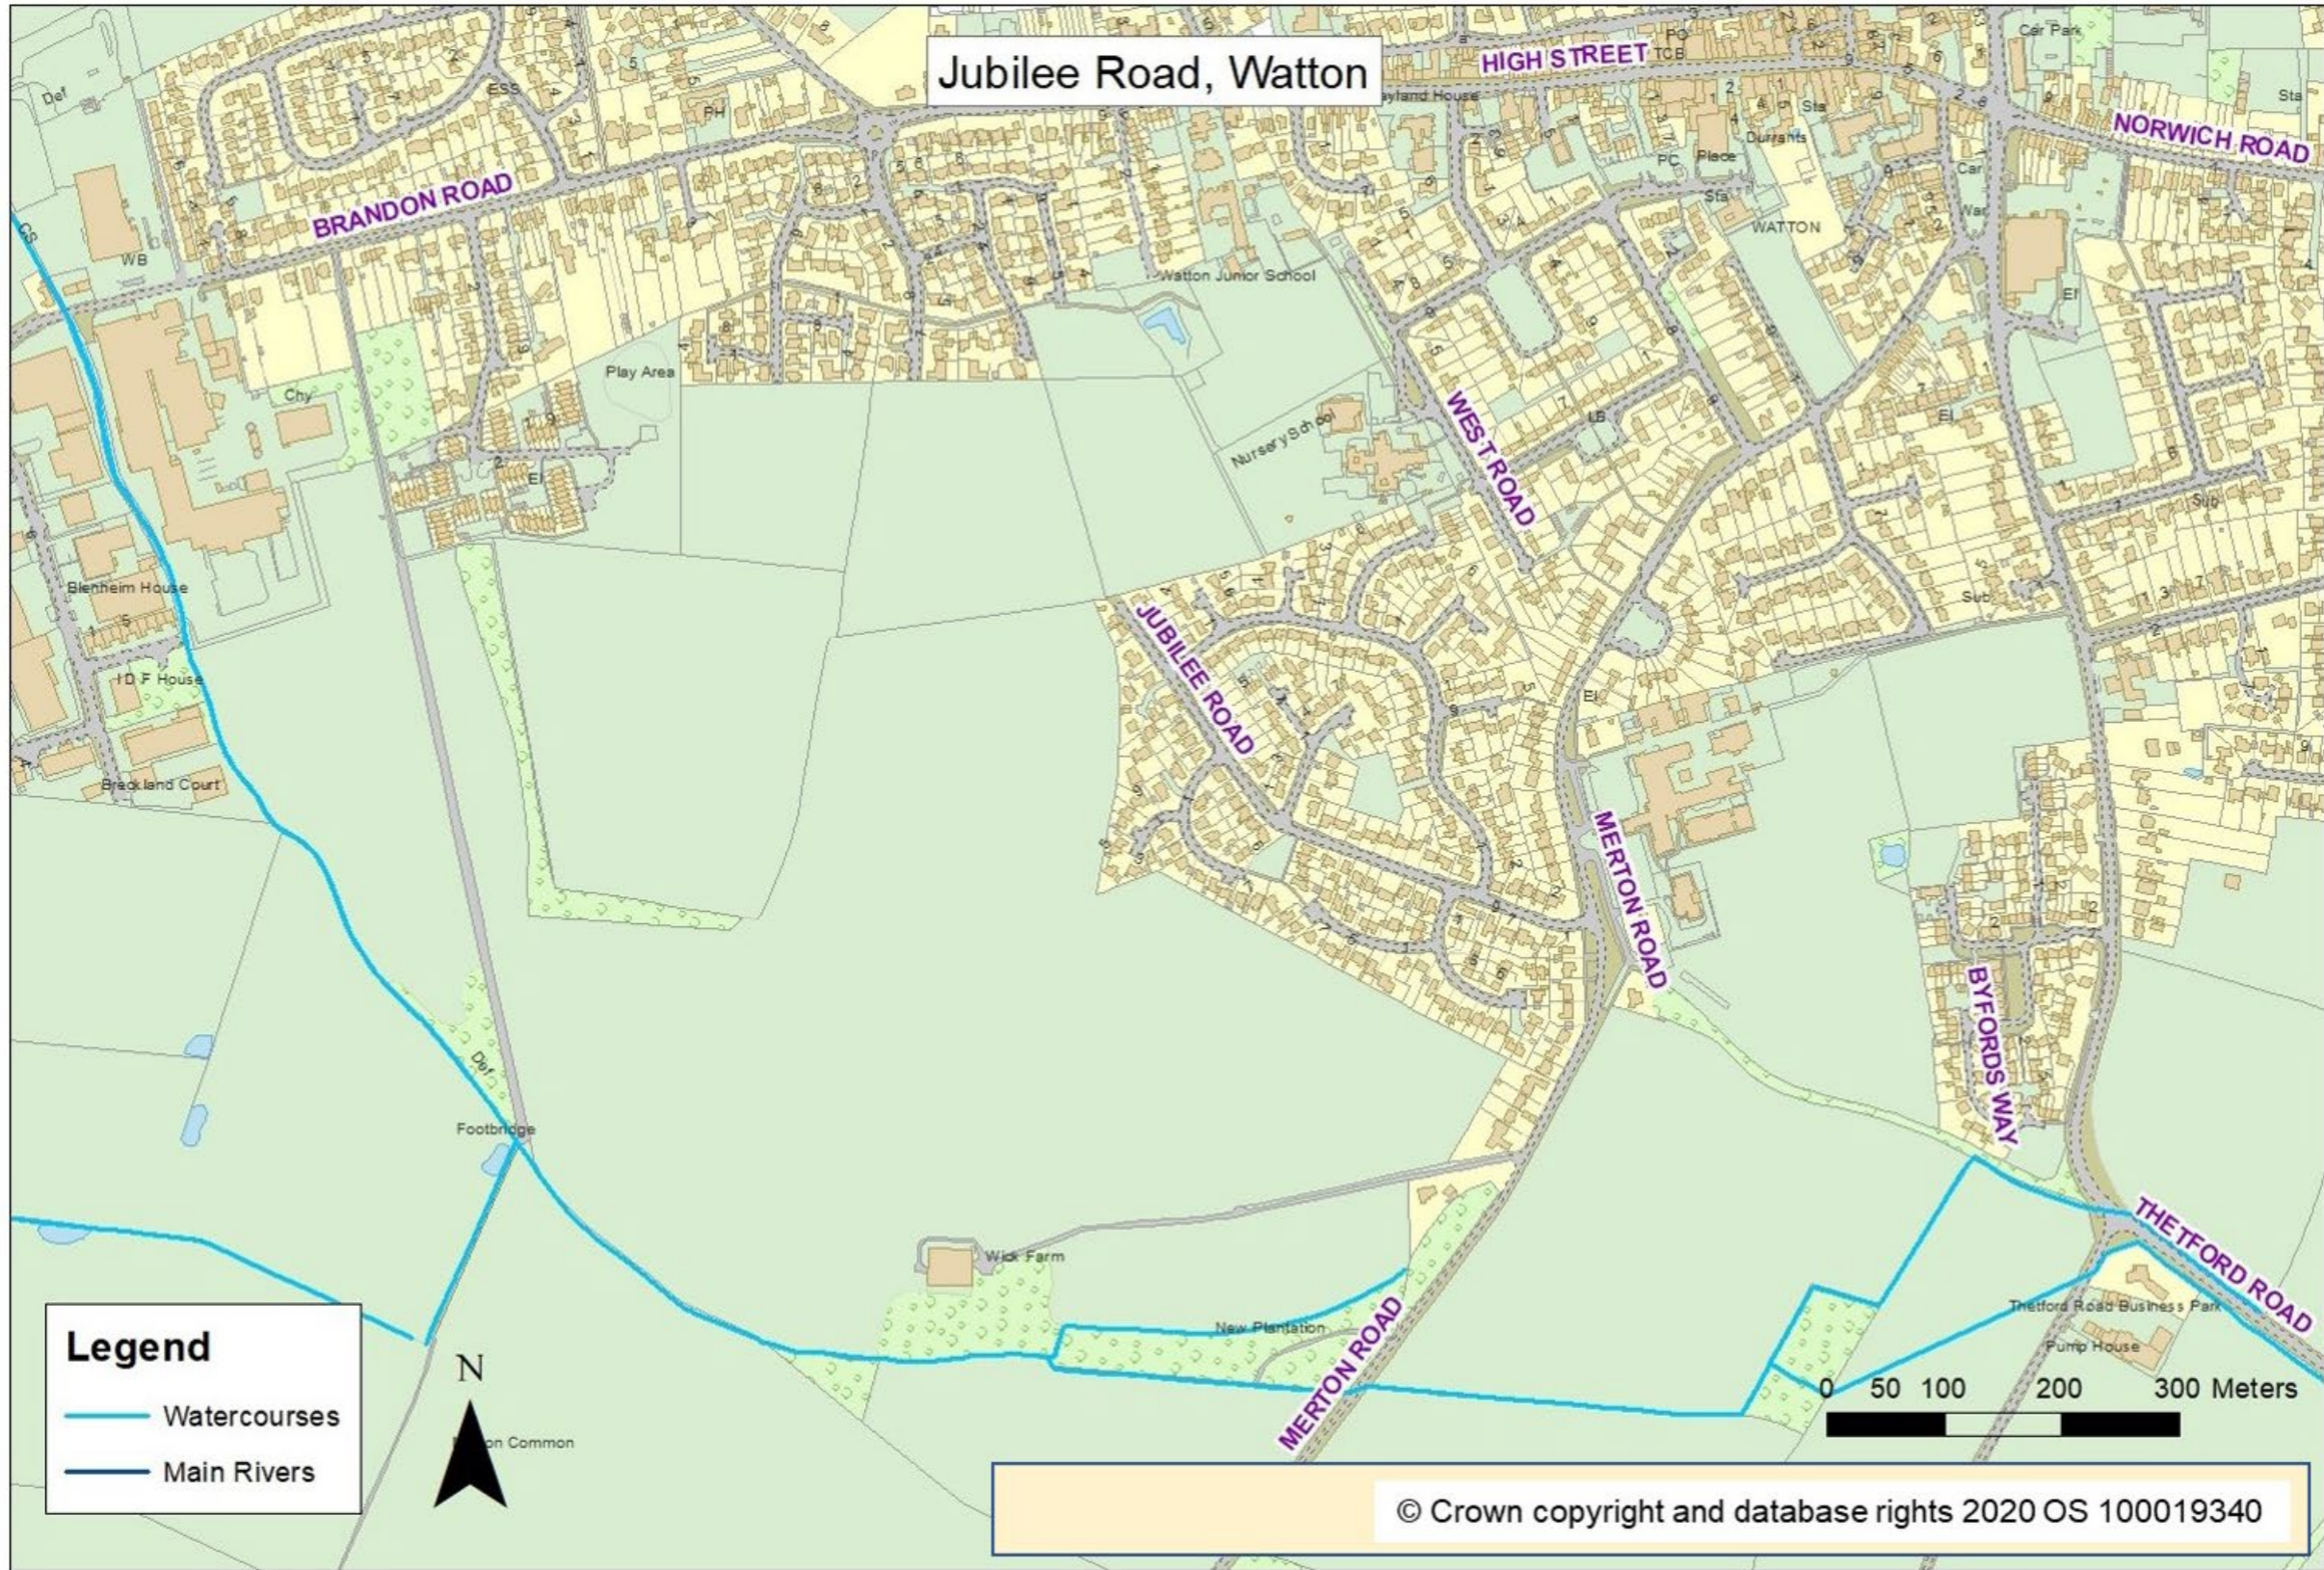
Location	Causes	Recommendations
<p>Jubilee Road - Report of internal flooding to one property on the 16th August 2020</p>	<ul style="list-style-type: none"> • Run-off from significant rainfall was directed towards the surface water drainage network. These flows could not be accommodated as the system was already overloaded. This directed flood water towards the affected properties. • The loss of pre-existing drainage features such as drains, dykes, ditches etc. within the catchment exacerbated the flooding. 	<ul style="list-style-type: none"> • NCC will consider opportunities to route flood water on the highway away from affected properties to alternative points of discharge, or other solutions as practicable. • NCC could confirm, where possible, the existence of any connections to a wider drainage network. This work should seek to confirm where the drainage network conveys flows to. • Property owners should protect their buildings through flood protection measures where appropriate. NCC will communicate with local residents to advise them how they may apply for grants available. These grants are subject to a funding application.

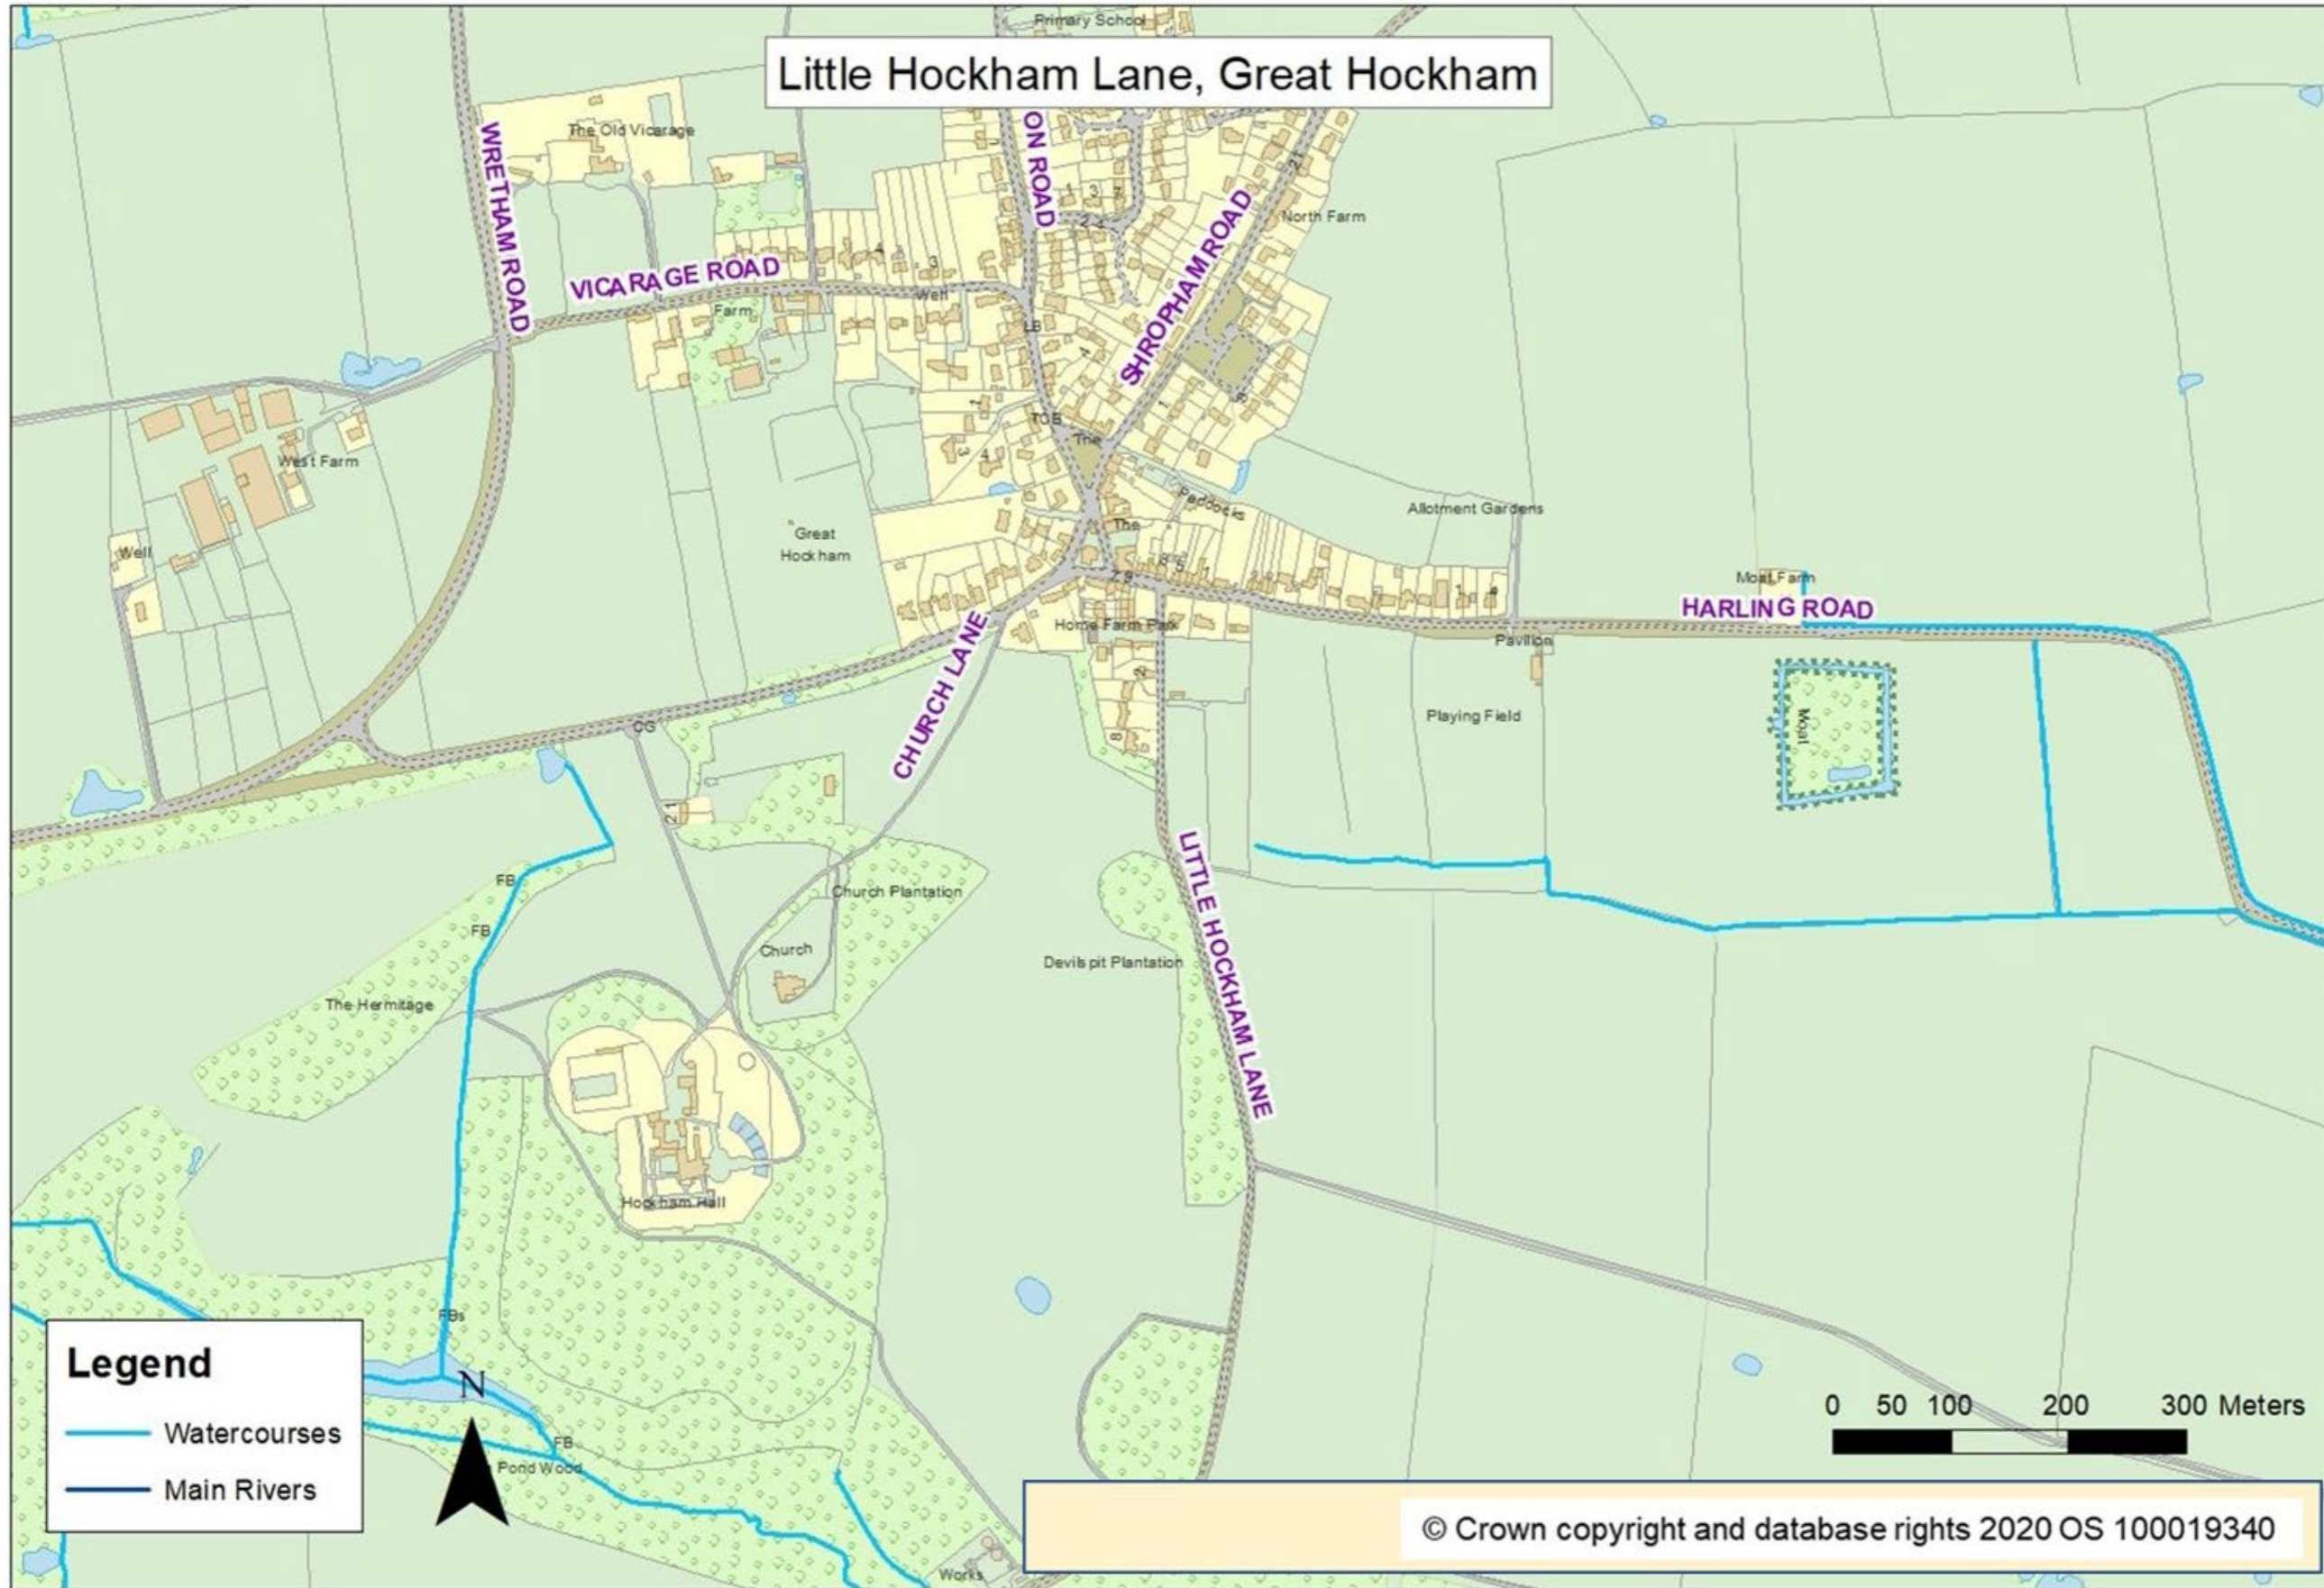
Location	Causes	Recommendations
<p>Little Hockham Lane - Report of internal flooding to one property on the 16th August 2020</p>	<ul style="list-style-type: none"> • Surface run-off from rainfall flowed along the road network and onto the accesses of affected property which sits below the level of the road and pools around the property. • Water was directed from the private shared car park to towards the affected property. • The flood water entered the properties through low thresholds at entrances. 	<ul style="list-style-type: none"> • Norfolk County Council will consider opportunities to route flood water on the highway away from affected properties to alternative points of discharge, or other solutions as practicable. • Property owners should protect their buildings through flood protection measures where appropriate. NCC will communicate with local residents to advise them how they may apply for grants available. These grants are subject to a funding application. • The property owner should determine the adequacy of the on-site drainage and where appropriate increase on-site storage capacity and system efficiency.

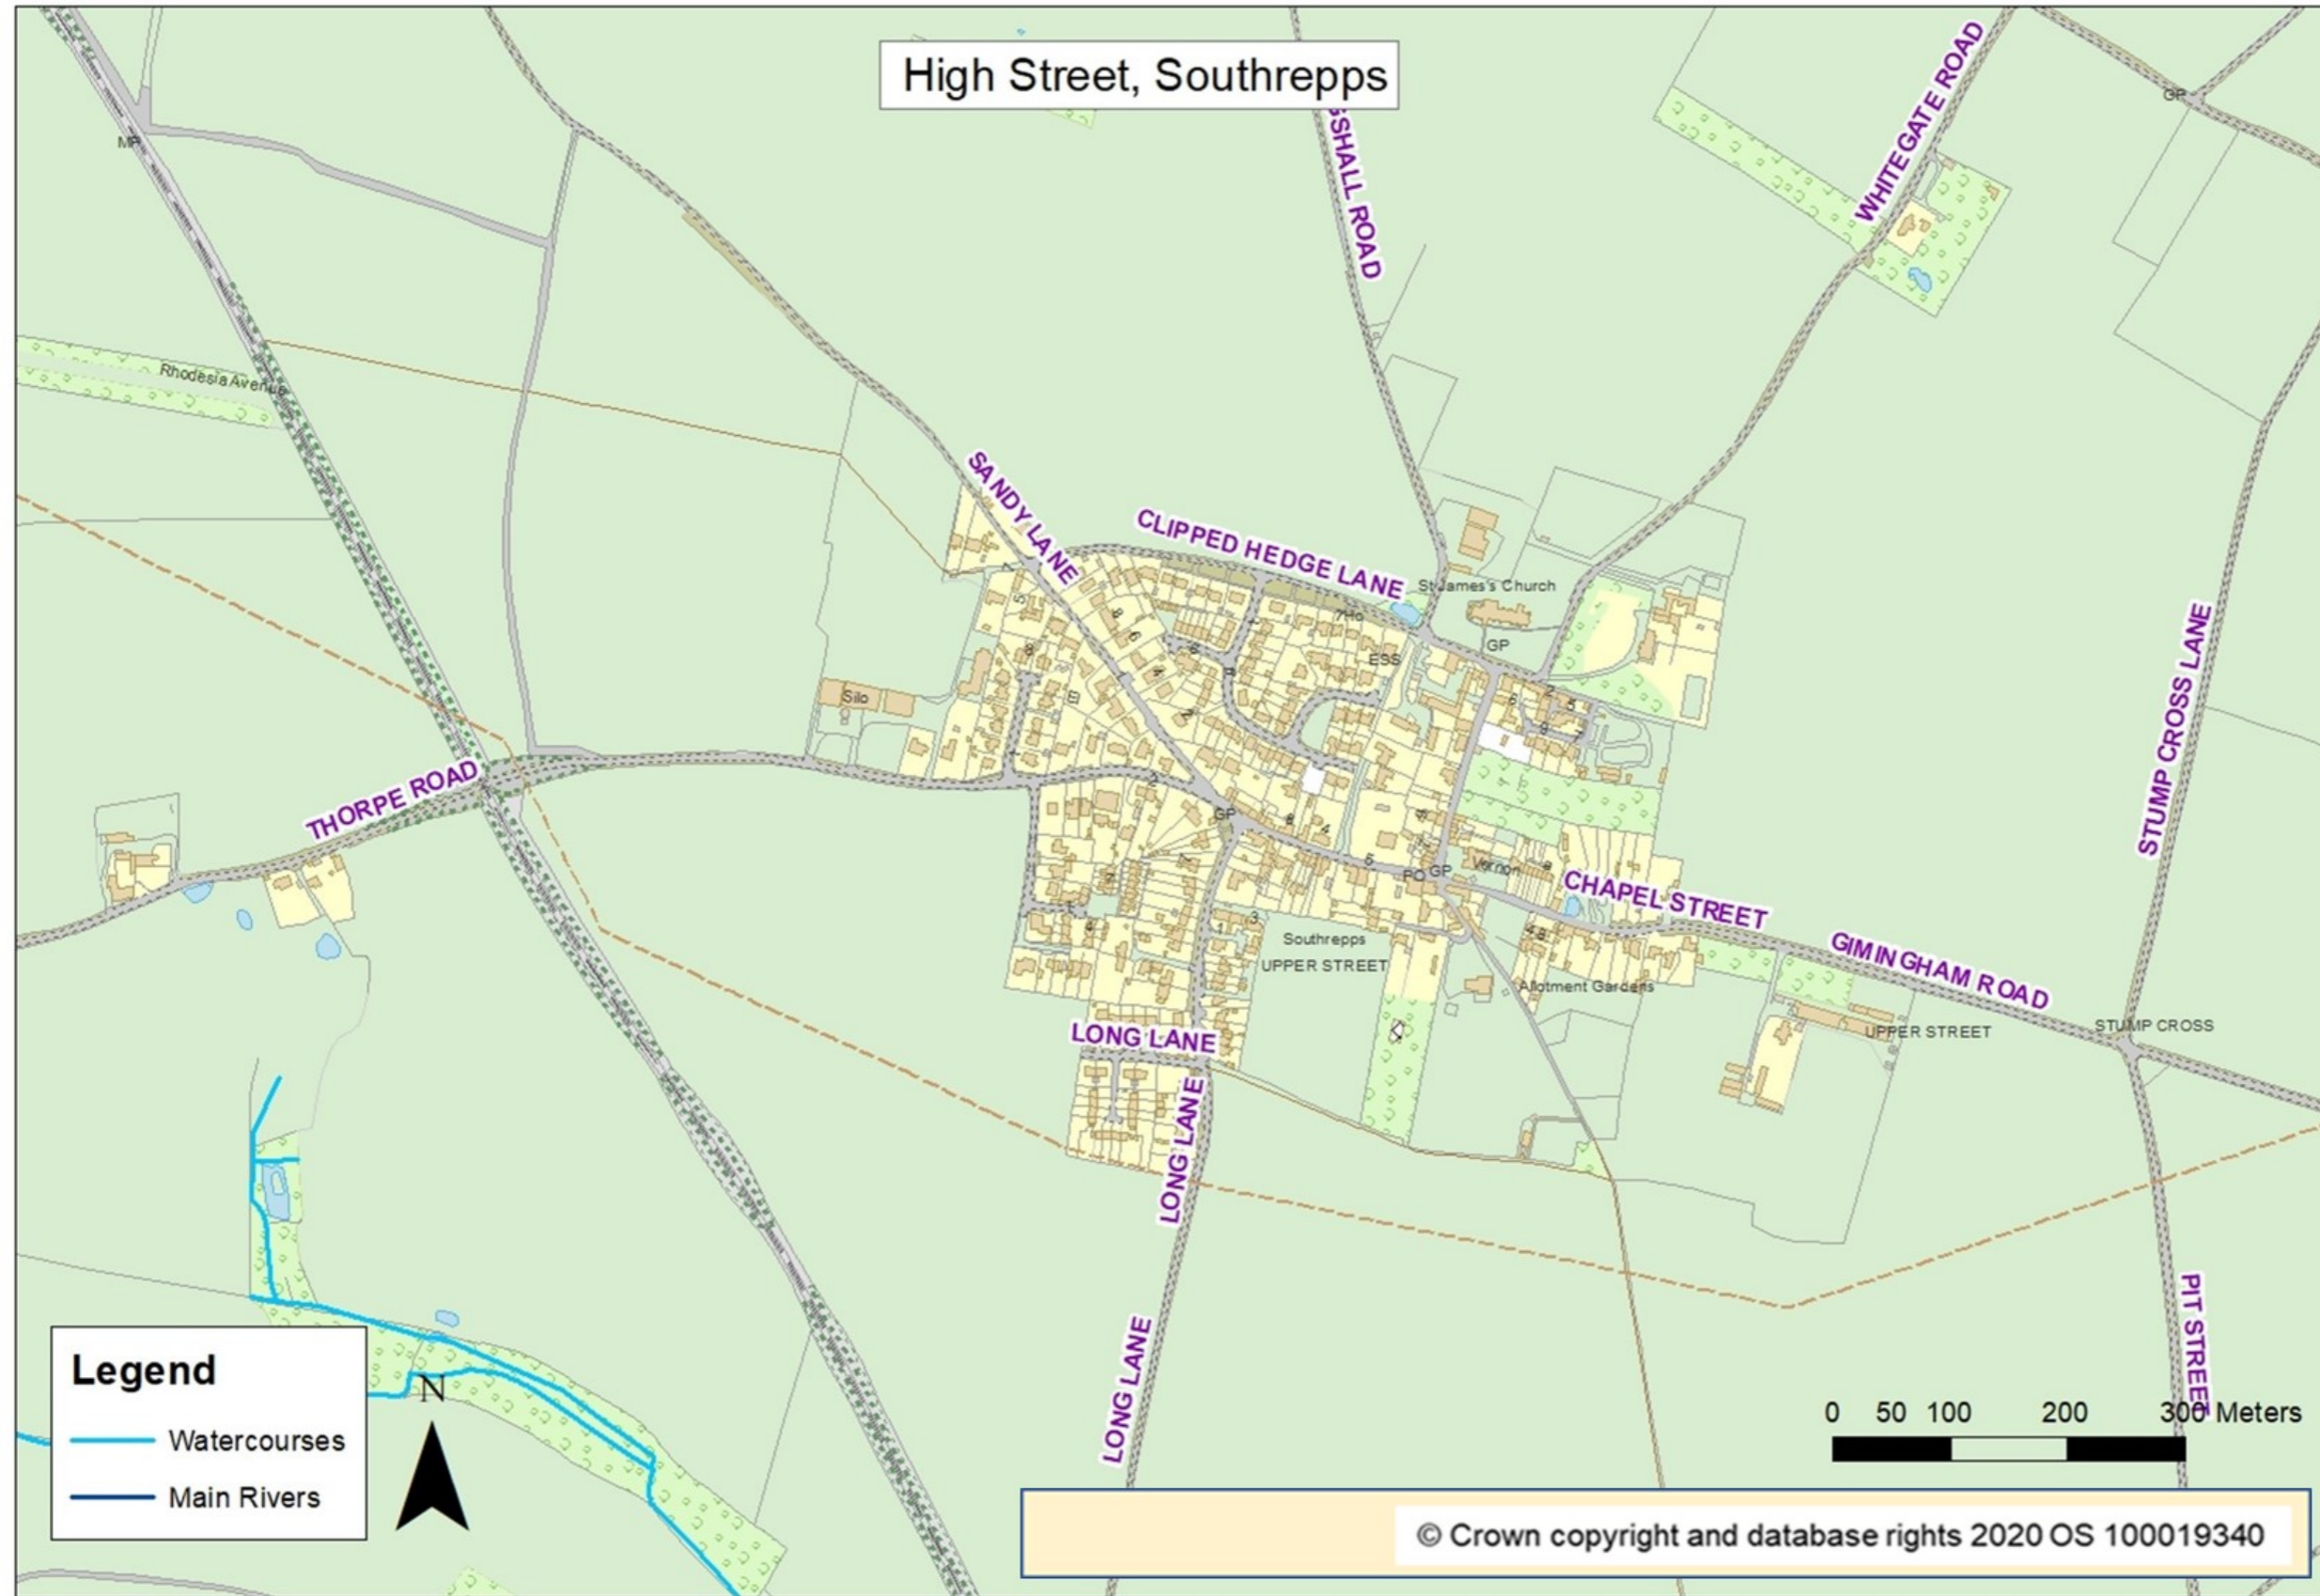
Location	Causes	Recommendations
<p>High Street - Report of internal flooding to two properties on the 16th August 2020</p>	<ul style="list-style-type: none"> • Run-off from significant rainfall was concentrated along overland flow paths on which the properties are situated • Surface run-off flowed along the road network and onto the driveway of the affected properties, it then flowed behind the properties where it pooled at a low point in the catchment and entered the properties through the back doors. 	<ul style="list-style-type: none"> • Norfolk County Council will consider opportunities to route flood water on the highway away from affected properties to alternative points of discharge, this could be achieved through a small scale improvement scheme to mitigate the risk experienced at this location. It is important to note this recommendation will be subject to the priorities and availability of resources of funders. • Property owners should protect their buildings through flood protection measures where appropriate.
