Norfolk County Council

Investigation Report into the flooding in South Norfolk District in 2014-2018

Report Reference: FIR_029

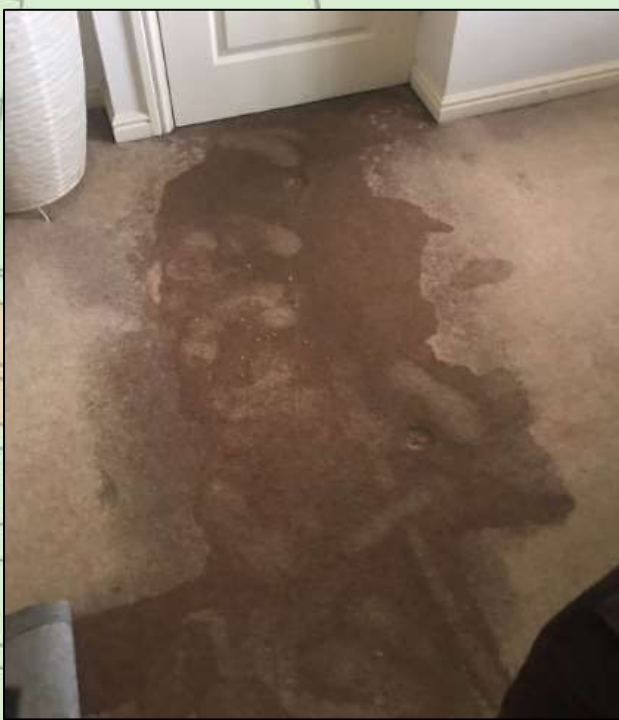
Causes - Rainfall was directed into the combined system. Failure of a hydraulic pump caused the system to surcharge in the vicinity of the affected property

Recommendations - Anglian Water Services Ltd should work with partner organisations to manage the surface water entering their drainage system in flood events.

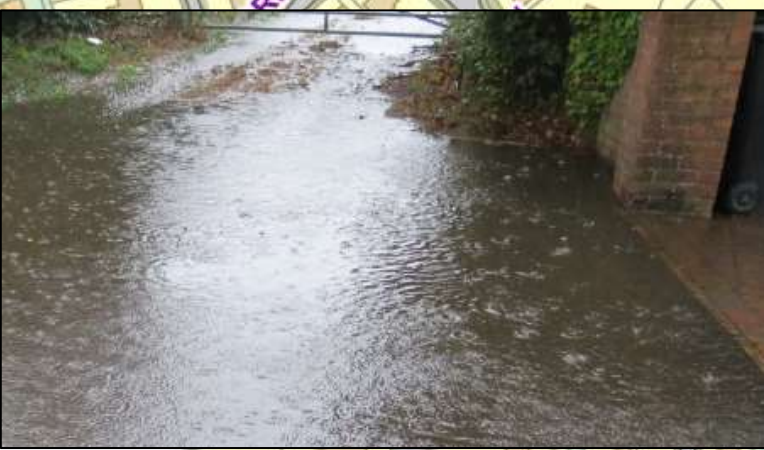
Causes - Run-off from rainfall pooled at a low point within the catchment and was concentrated along overland flowpaths on which the affected property is adjacent to. The surface water drainage system network was partially obstructed by debris or silt, reducing the efficiency of the upstream drainage system. Surface run-off from rainfall made its way onto the highway and flowed along the road network and onto the accesses of affected property situated lower than the highway.

Recommendations - Norfolk County Council will investigate with third parties the potential to fund small scale improvement schemes to mitigate the risk experienced at this location. NCC will review the level of maintenance required to sustain the design efficiency of their drainage systems that serve the flooding location in line with the risk identified. NCC will consider opportunities to route flood water on the highway away from the affected property.

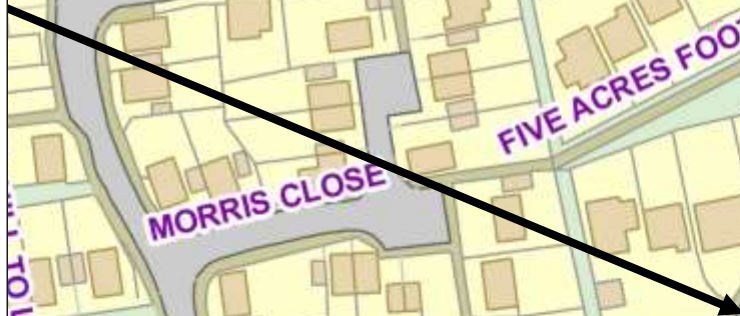
Causes – Due to the saturation of soils, localised ground conditions caused run-off to pool at a low point within the catchment. Surface run-off from rainfall made its way onto the highway and flowed along the road network and onto the accesses of affected properties that were situated lower than the highway

Recommendations – Norfolk County Council will investigate with third parties the potential to fund small scale improvement schemes to mitigate the risk. NCC will consider opportunities to route flood water on the highway away from affected properties. NCC will investigate with third parties the potential for retro-fitting permeable areas and other methods of small scale sustainable drainage systems.

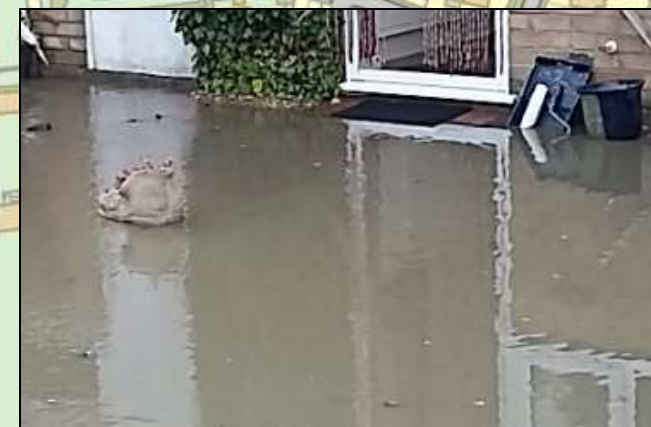
Causes - Run-off from Rainfall was directed towards the surface water drainage network. These flows could not be accommodated as the system was already overloaded, causing it to surcharge elsewhere.

Recommendations - NCC should work with partner organisations to identify the potential for managing the amount or rate of surface water entering their drainage system in flood events.

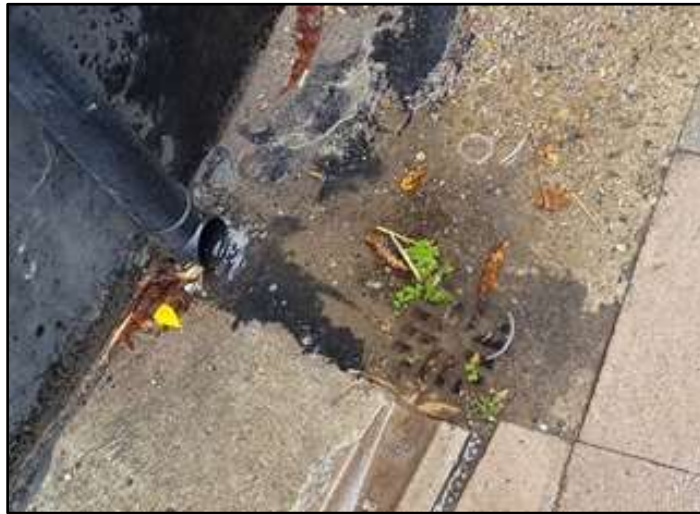
Market Place, Diss - Internal and external flooding experienced on 30/06/2017.

Causes – Surface run-off from rainfall made its way onto the highway and flowed onto the access of the affected property situated lower than the highway. The flood water entered the property through low thresholds at entrances.

Recommendations - Norfolk County Council will consider opportunities to route flood water on the highway away from the affected property. Property owners should protect their buildings through flood protection measures where appropriate. NCC will communicate with local residents to advise them of the appropriate measures they could take to protect their property.

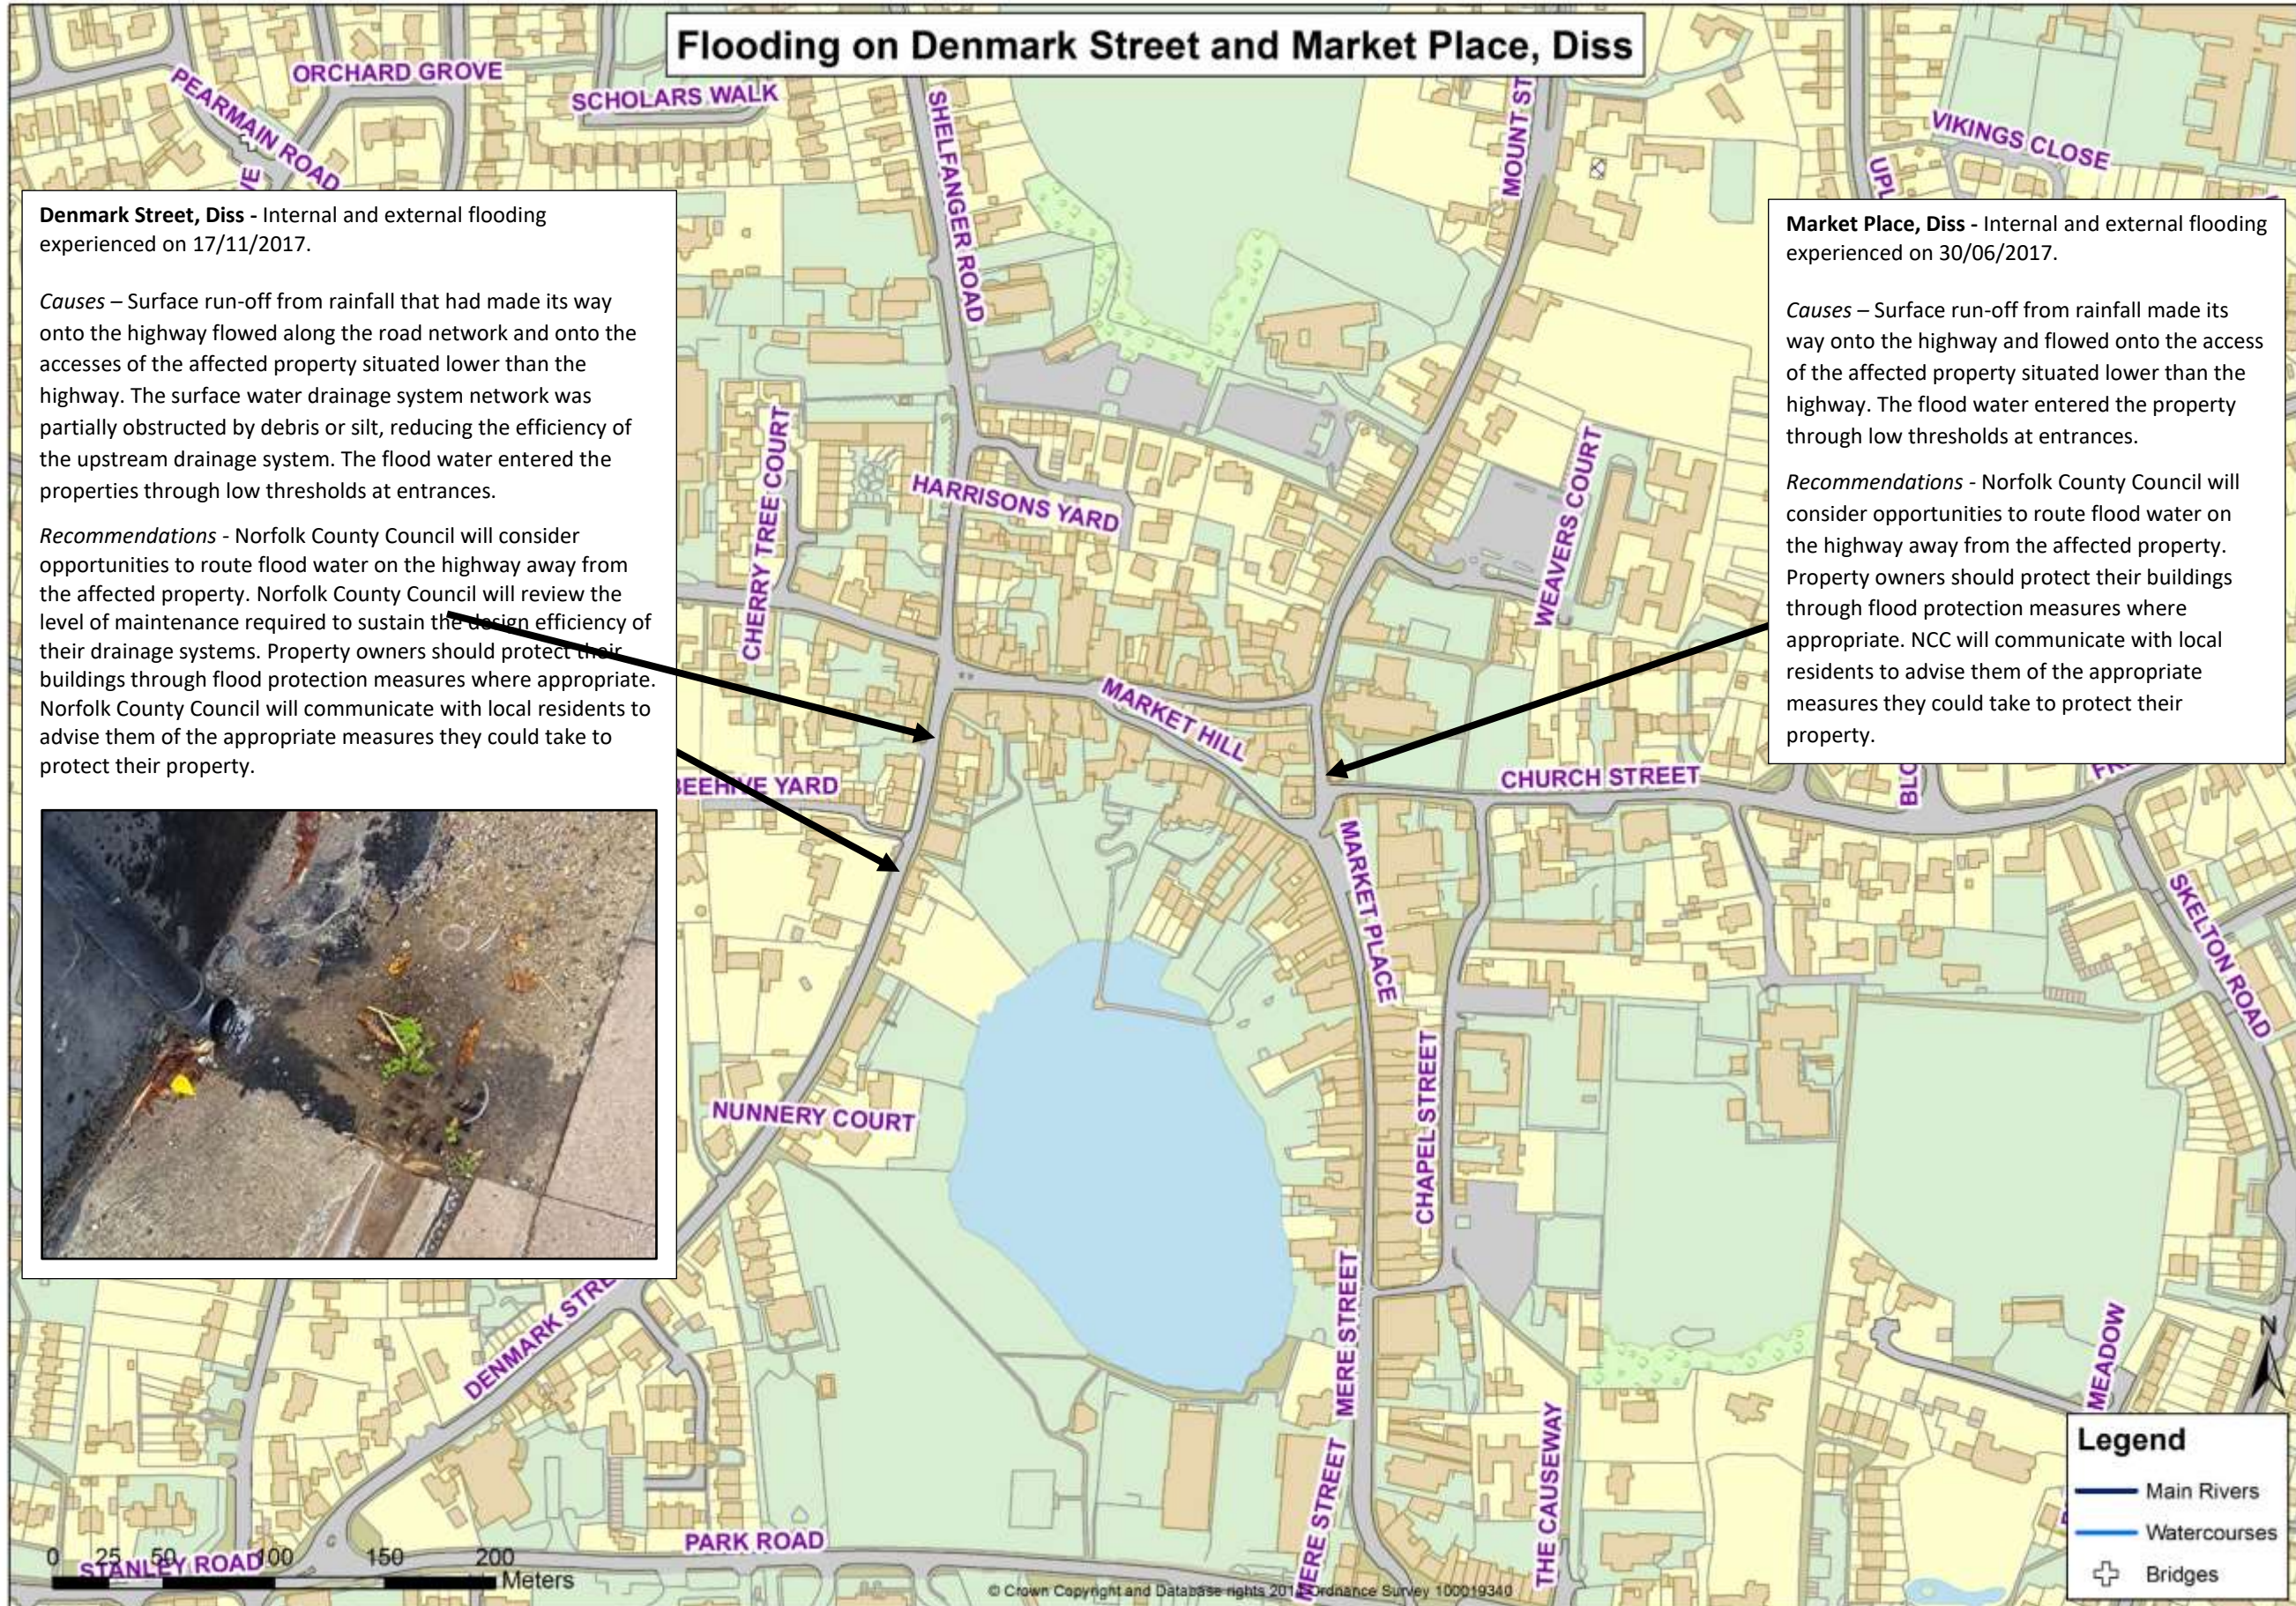
Flooding on Hall Road, Toft Monks

Hall Road, Toft Monks - Internal and external flooding experienced on 01/01/2018.

Causes - Run-off from rainfall flowed along surface water flow paths, pooled at a low point and made its way onto the highway and flowed onto the access of the affected property situated lower than the highway. The surface water drainage system network was partially obstructed by debris or silt, reducing the efficiency of the upstream drainage system. Run-off could not be accommodated as the system was already overloaded. Rainfall was directed into the surface water system causing it to surcharge elsewhere.

Recommendations - Norfolk County Council will investigate with third parties the potential to fund small scale improvement schemes. NCC will consider opportunities to route flood water on the highway away from the affected property. NCC will review the level of maintenance required to sustain the design efficiency of their drainage systems. NCC should work with partner organisations to identify the potential for managing the amount or rate of surface water entering their drainage system in flood events.
