Norfolk County Council

Investigation Report into the flooding in South Norfolk District in Winter 2020-2021

Report Reference: FIR066

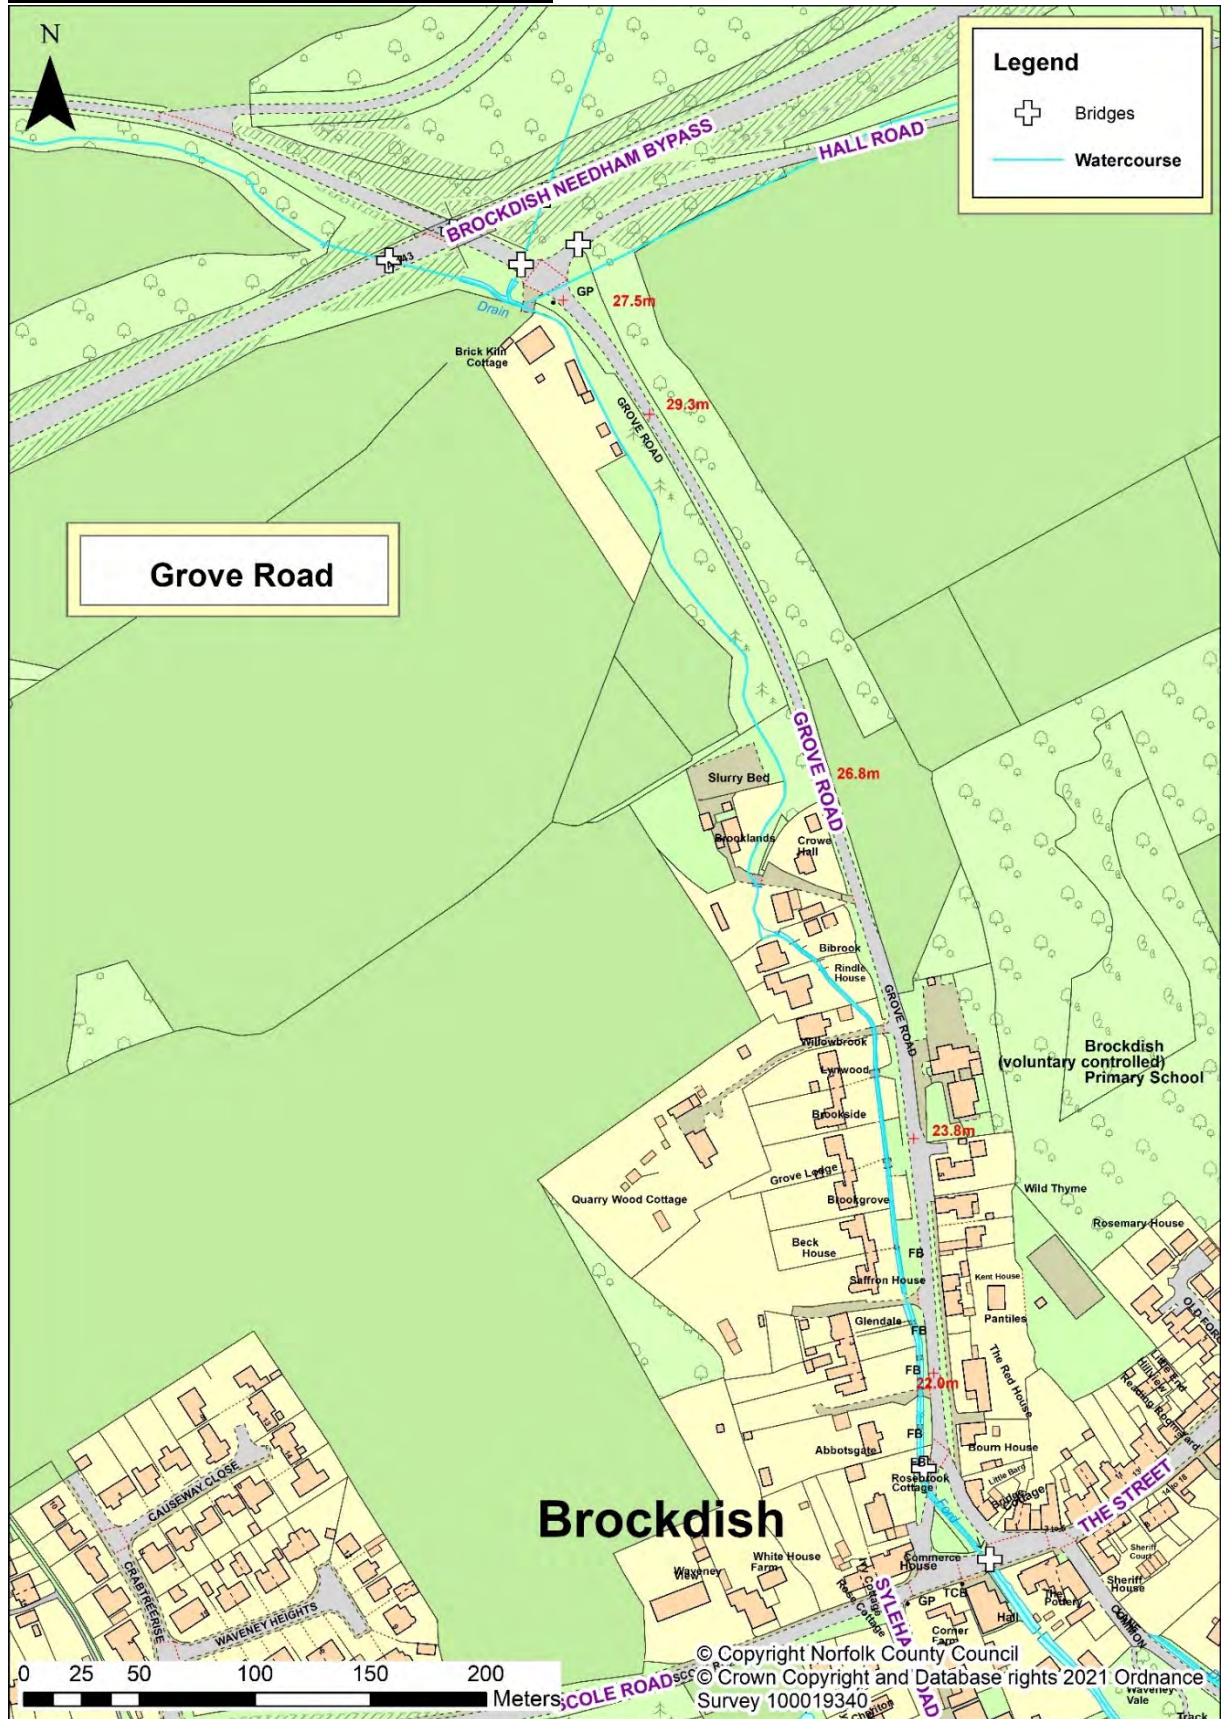
Grove Road, Brockdish - 23/12/2020

Causes of flooding	Risk Management Authority with Relevant Flood Risk Function
<p>A substantial amount of rain fell on the 23rd Dec onto a catchment with prior high saturation levels. The catchment is 3.8km² upstream of Brockdish generating a flashy response to which local ordinary watercourses and drainage infrastructure could not cope.</p> <p>Grove Rd watercourse was high all night but not out of bank at 7.30pm however in space of 30 minutes overtopped its bank(s) adjacent to properties south of A143. Locals describe a large surge that lasted just a few hours for some properties. For others water levels remained high until around 2am. . Water started receding at about 10pm.</p> <p>Likely causes are flashy runoff from the upstream catchment, of which is split into two main flow paths that converge underneath the A143. Site visits have confirmed there are two large 1.2m dia culverts under bridge that convey flows from watercourses north of Brockdish Hall and west of Grove Rd.</p> <p>Its unconfirmed but a large pool of flooding on the A143 bridge was released into the Brook following local observations of emergency maintenance works to clear two 750mm outfalls underneath the A143 bridge hence causing a sudden surge downstream which led to overtopping.</p> <p>Watercourse is naturally constrained in a valley bounded by high ground to the west and Grove Rd immediately east. The inability of the river to spread out over a wider floodplain led to the severe depths witnessed and properties are situated within the centre of the flow corridor.</p> <p>Flood water entered the properties through front and rear entrances via low thresholds/ the air bricks / the electricity conduits. Wrack marks on garages indicate 400mm deep in places.</p>	<p>Norfolk County Council (LLFA): Regulatory body for ordinary watercourses/surface water</p> <p>Norfolk County Council (Highways): Public highway maintenance, land & asset owner</p> <p>Highways England: Trunk Road infrastructure</p>

Causes of flooding	Risk Management Authority with Relevant Flood Risk Function
<p>Constrictions and blockages were identified at several locations along this stretch of watercourse associated with private access structures and pedestrian footbridges. These structures also trapped massive accumulations of debris including large household waste – hay bales, sleepers, fencing material and a 5m long roll of agricultural membrane were removed by Fire service.</p> <p>A small rectangular culvert/bridge structure over the Brook, acts as a pinch point just upstream of the Ford crossing at the village Green, this structure is much older and much smaller than most vehicular accesses culverts in the general location.</p> <p>Worth noting that two private access roads off Grove Rd, orientated perpendicular to main flow path acted as a retaining structure, holding back flooding until the wall failed structurally.</p>

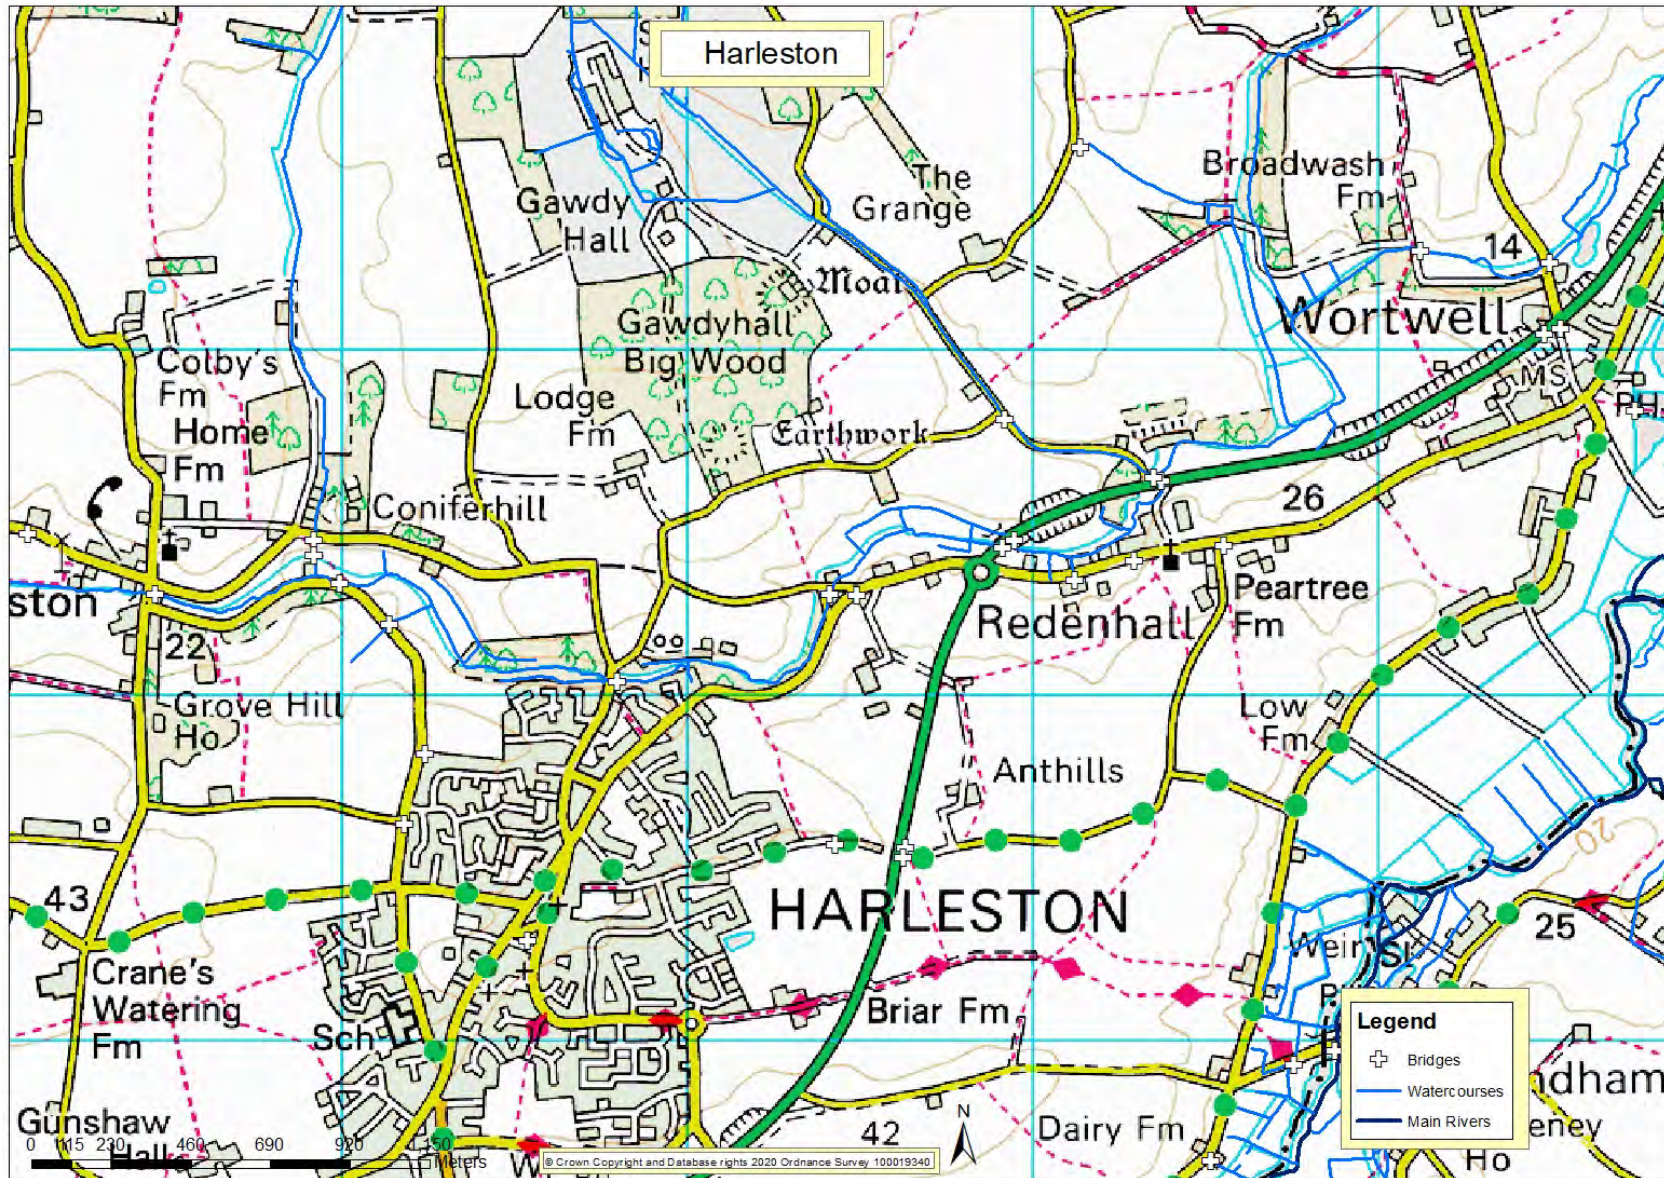
Redenhall Road, Titlow Road and Mendham Lane – Harleston

Location and date of flooding	Causes of flooding	Risk Management Authority with Relevant Flood Risk Function
Redenhall Road, Redenhall with Harleston, 23/12/2020 Titlow Road, Redenhall with Harleston, 23/12/2020	A substantial amount of rain fell on the 23rd Dec onto the catchment with prior high saturation levels. Run-off from significant rainfall was concentrated along surface water flowpaths.	
Redenhall Road, Redenhall with Harleston, 23/12/2020	Surface run-off from significant rainfall made its way onto the highway and flowed along the road network and onto the accesses of affected properties. The highway surface water drainage system was obstructed by debris or silt caused the failure of the upstream drainage system contributing to flooding at the affected properties.	Norfolk County Council: Highways - Public highway maintenance & asset owner
Titlow Road, Redenhall with Harleston, 23/12/2020 Mendham Lane, Redenhall with Harleston, 23/12/2020	Due to the saturation of soils localised ground conditions caused run-off to be directed quickly from where it fell as rain to the areas of flooding.	Landowner/Property Owner

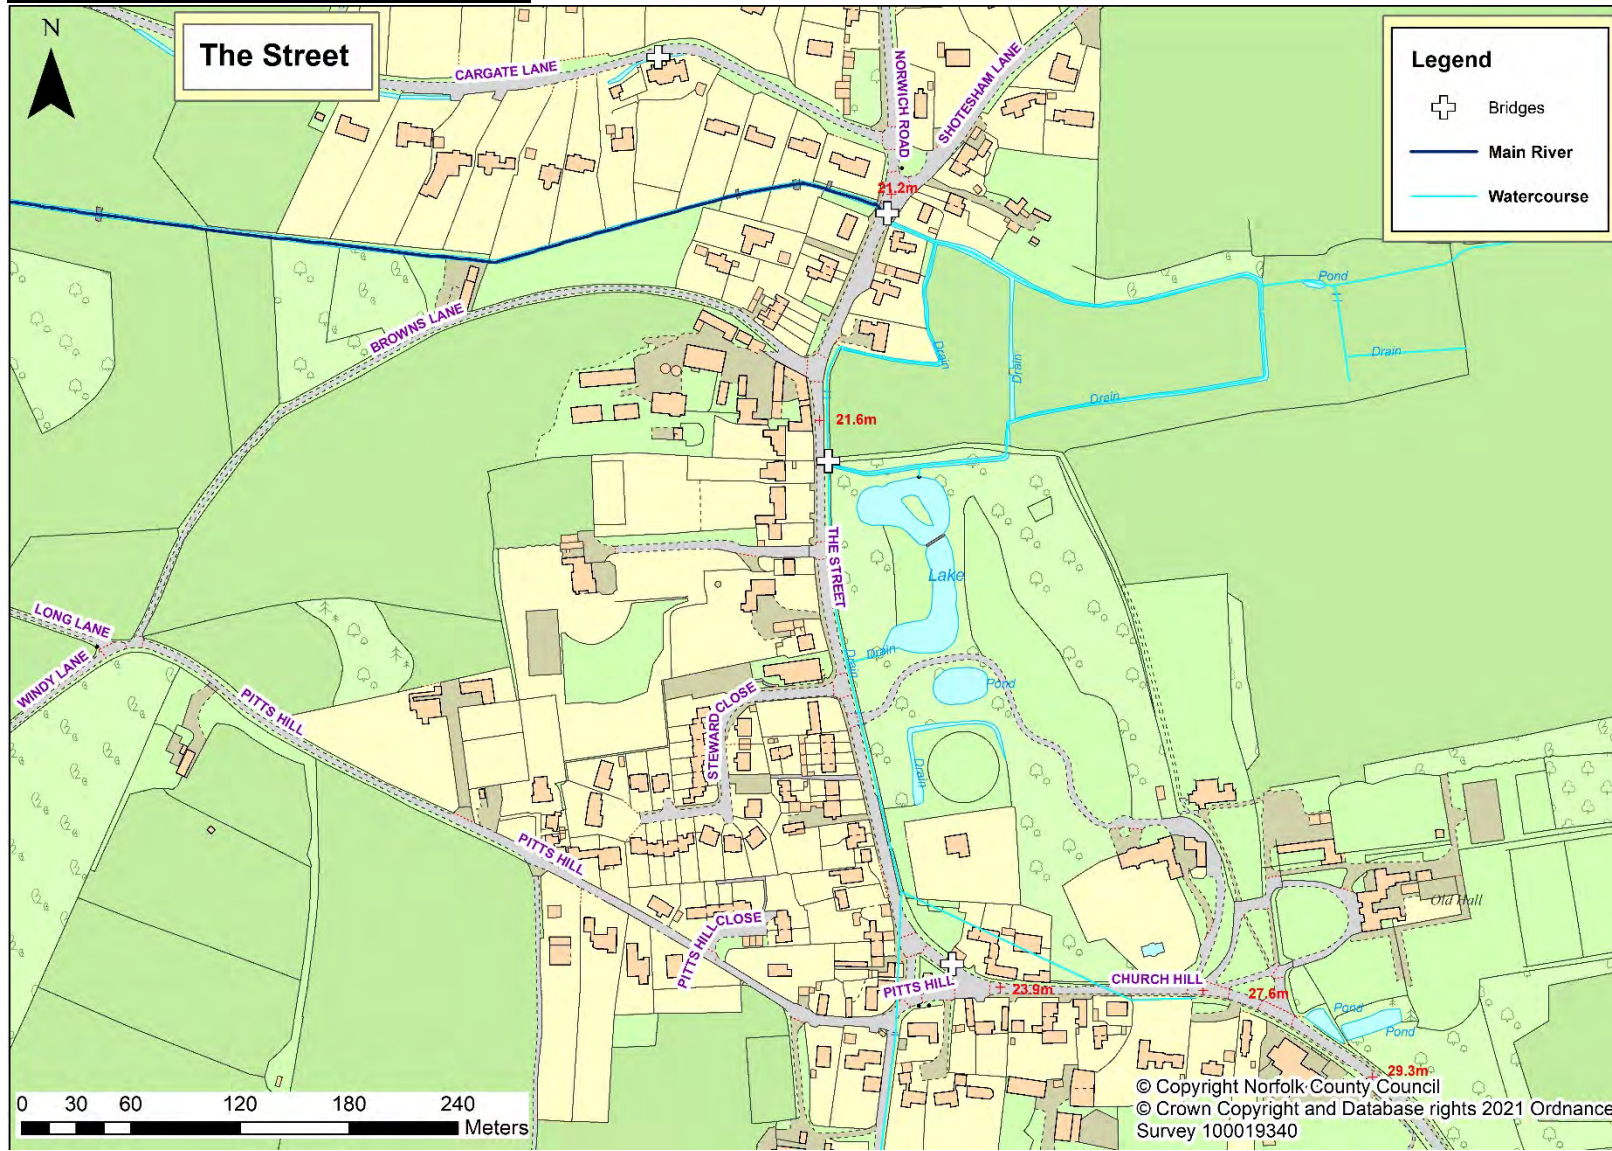
The Street, Saxlingham 23/12/2020

Causes of flooding	Who has responsibilities to manage the cause(s) of the flood?
<p>A substantial amount of rainfall fell on the 23rd Dec onto a catchment with preceding high saturation levels (See Figure 1 for catchment area).</p> <p>Due to the saturation of soils localised ground conditions caused run-off to be directed quickly from where it fell as rain to the local watercourses</p> <p>Surface run-off from rainfall flowed off adjacent fields and towards natural lows/areas of flooding especially the the Wash Lane watercourse upstream of the village.</p>	
<p>Local observations witnessed local watercourses breaching and leading to the flooding observed in The Street during the event on the 23rd Dec.</p> <ol style="list-style-type: none"> 1) The Wash Lane (Bridleway) watercourse was flowing out of channel onto The Street near the War Memorial and then flowing overland in a Northerly direction within the Street. The wash lane watercourse is piped under the War Memorial but its inlet structure is very small and liable to blockage. 2) The floodwater was unable to re-enter the watercourse once in the Street due to how the road is hung. Hence the road acted as conduit and essentially became the watercourse. Furthermore, the actual channel in the Street is severely undersized and constrained by the highway boundary which does not help matters and private field access where culverts again act as a bottleneck. Vehicles using the highway passed through the flood water causing it to wash towards the affected properties. 3) Run-off from significant rainfall was concentrated along overland flowpaths on which the affected properties are positioned on/adjacent to. 4) Bank Stabilisation works to the main river near Cargate Lane have also been undertaken which appear to be unconsented, however residents did not observe any flooding from this system on the 23rd. 	<p>Norfolk County Council (LLFA): Regulatory body for ordinary watercourses/ surface water</p> <p>Norfolk County Council (Highways): Public highway maintenance, land & asset owner</p>

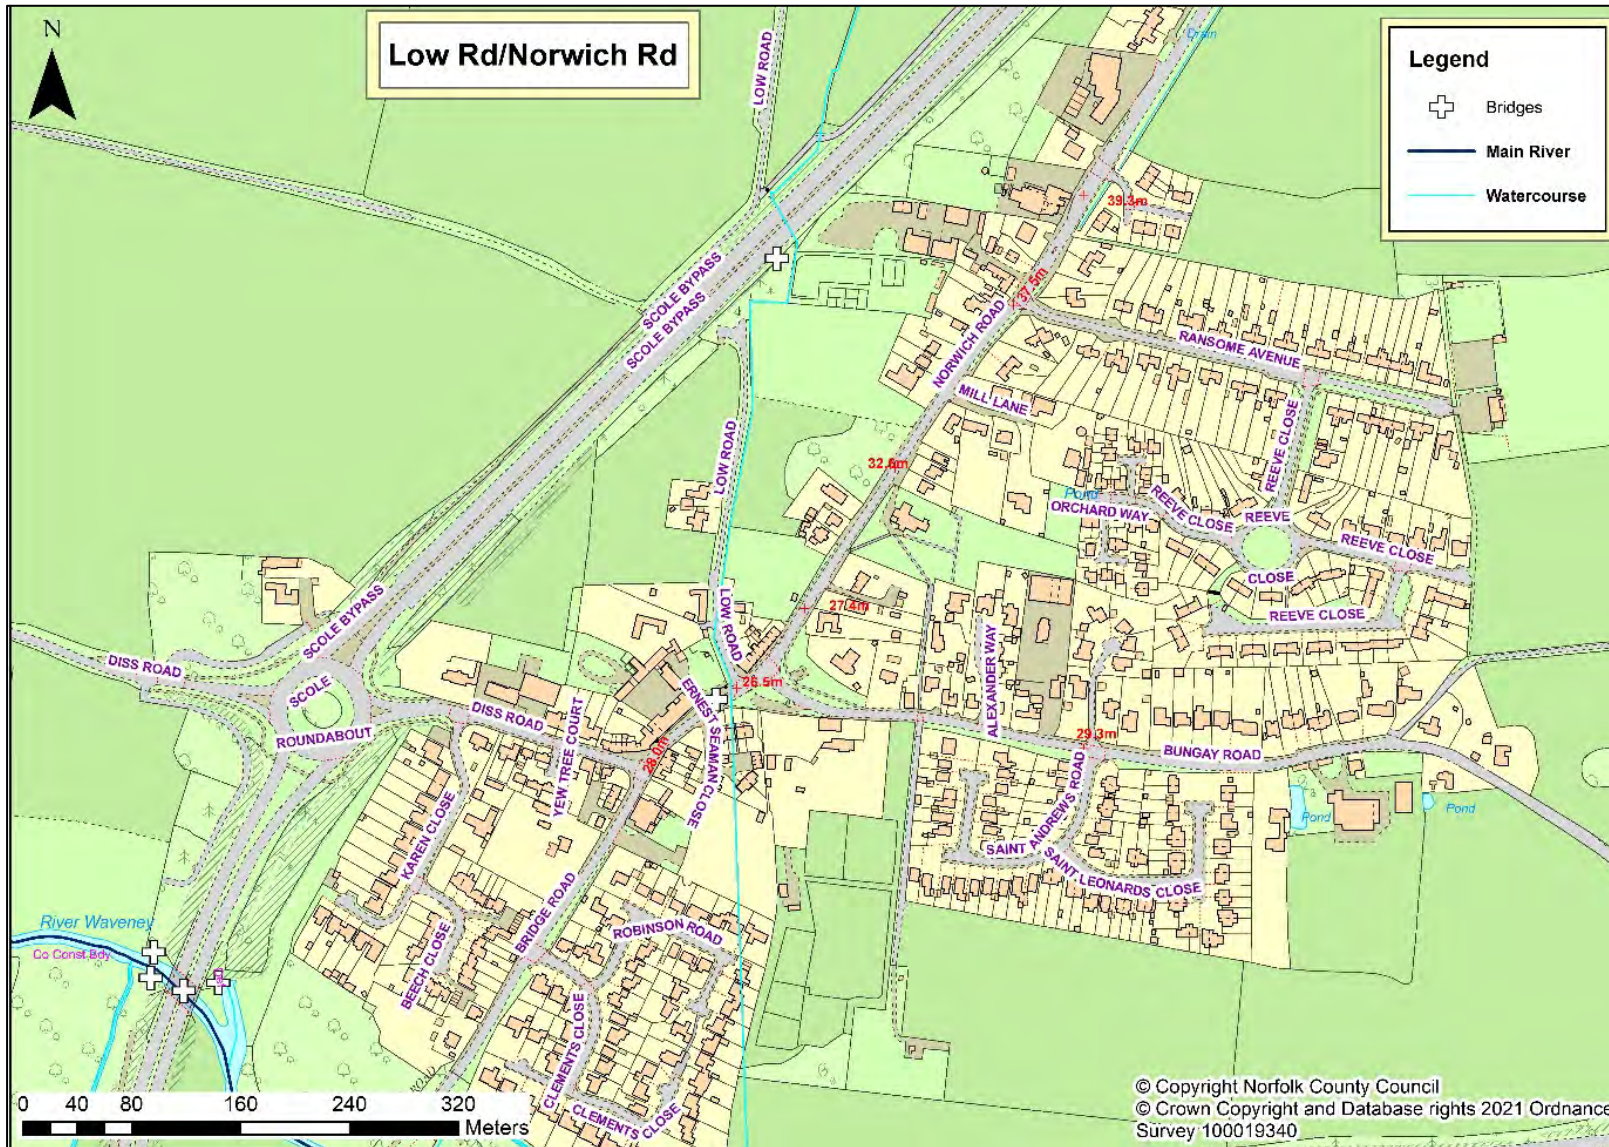
Low Road/Norwich Road – Scole – 24/12/2020

Causes of flooding	Risk Management Authority with Relevant Flood Risk Function
<p>A substantial amount of rain fell on the 23/24rd Dec onto a catchment with prior high saturation levels. The catchment is 4.3km² upstream of Low Road generating flashy high flows to which local watercourses and drainage infrastructure could not cope.</p> <p>Run-off from significant rainfall pools at a low point within the catchment affecting a property. Property sits at the lowest point on Norwich Road in the centre of the village where an ordinary watercourse is located.</p> <p>The main problem is that the water that accumulates in the area does not have adequate drainage to the Main river Waveney.</p> <p>Two mechanisms of flooding occurred in Norwich Rd/Low Rd:-</p>	
<p>1) Fluvial flooding directly from the Scole Common watercourse within Low Road which flows North to South towards Norwich Rd.</p>	
<p>Following site visits, multiple constrictions were evident along the watercourse, downstream of A140. The upper catchment emerges from a 450mm pipe under the A140 at the North end of Low Rd. There follows a trail of blocked pipes, damaged drains, undersize pipes that criss-cross underneath Low Rd, blocked ditches and a security screen on the Norwich Rd Culvert. All these deficiencies likely resulted with breaches into Low Road and deep pool at the low spot in the Norwich Rd/Low Rd Junction.</p> <p>The Norwich Rd Culverts capacity to convey floodwater from this point is unclear as it travels underneath dwellings on the Southern side of Norwich Rd.</p>	<p>NCC Highways (asset owner)</p>

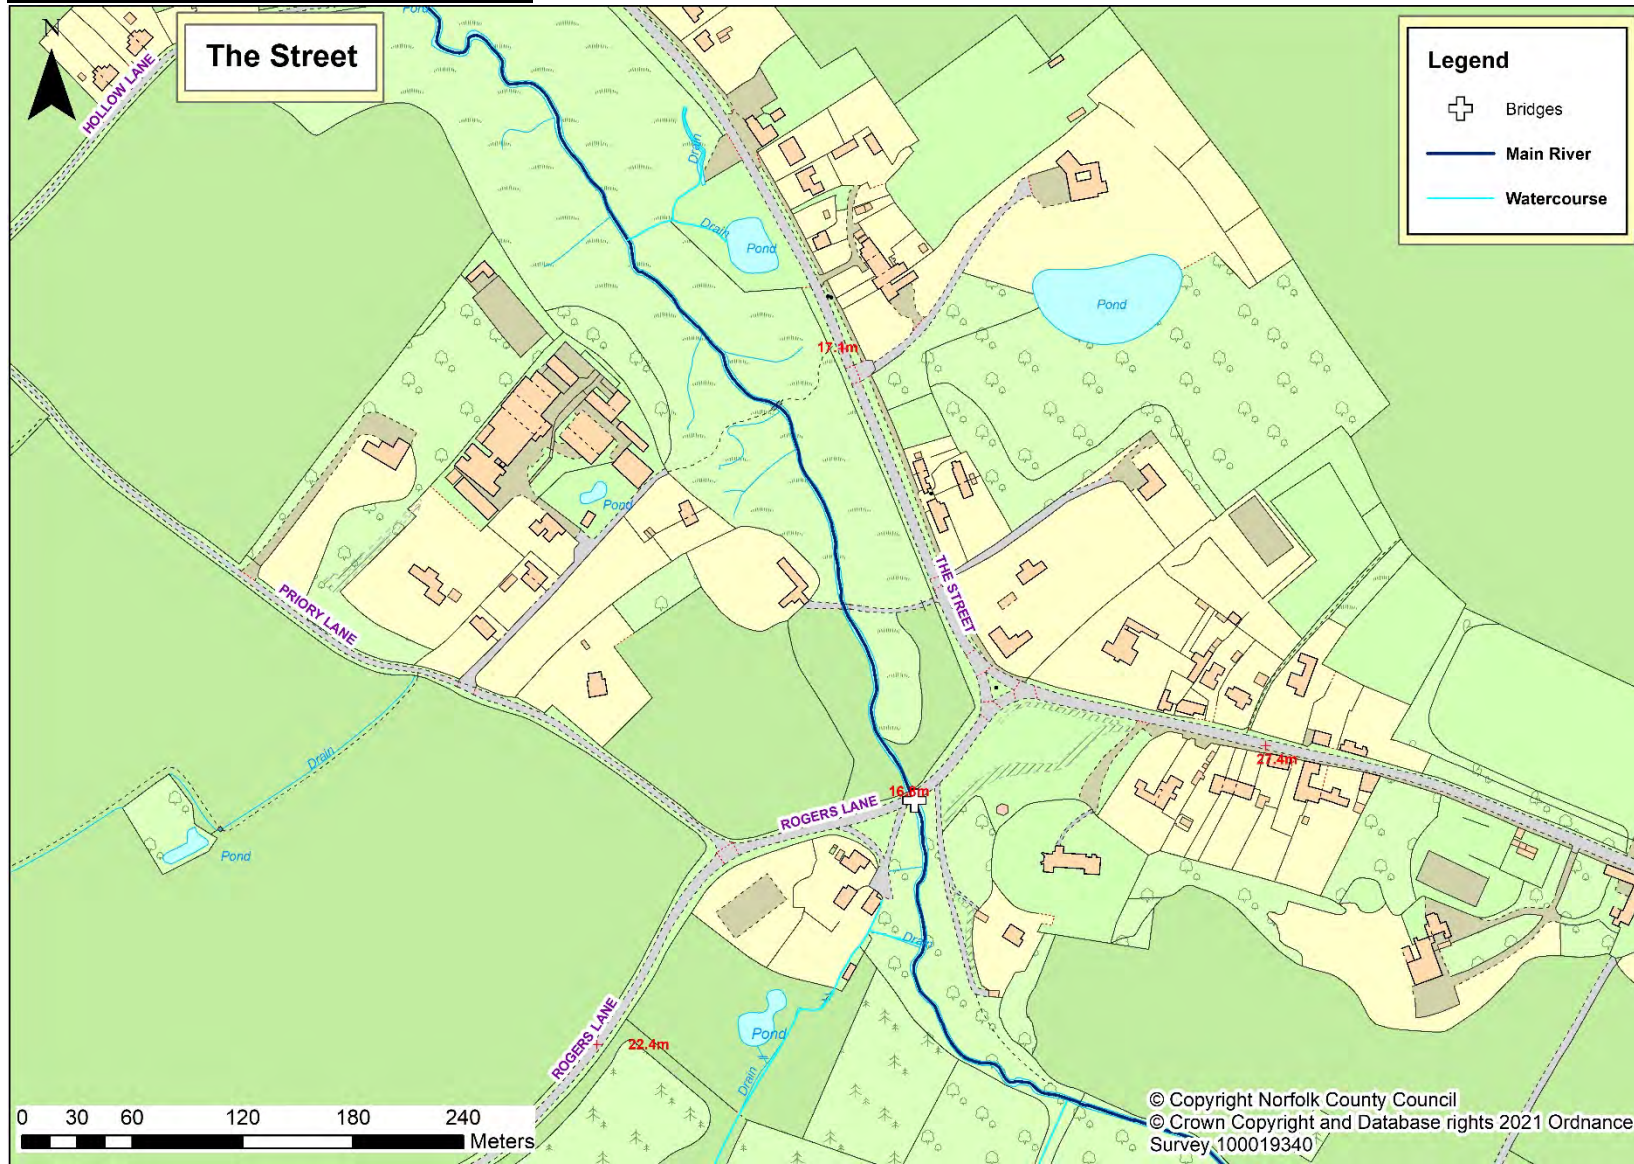
The Street, Shotesham, 23/12/2020

Causes of flooding	Who has responsibilities to manage the cause(s) of the flood?
<p>A substantial amount of rainfall fell on the 23rd Dec onto a catchment with preceding high saturation levels (See Figure 1 for catchment area).</p> <p>Due to the saturation of soils localised ground conditions caused run-off to be directed quickly from where it fell as rain to the local watercourses causing flash flooding.</p> <p>These high river flows within the catchment affected property within the channels natural floodplain in the Common. However additional overland runoff came onto the Common on the night of 23rd December and did so down Rogers Lane, and across the back of the Common via low fields from the west of Priory Lane. This has little to do with the natural course of the floodplain, but does relate to drainage ditches which funnel the water from surrounding fields towards the Common.</p>	EA, NCC (LLFA) and Landowners

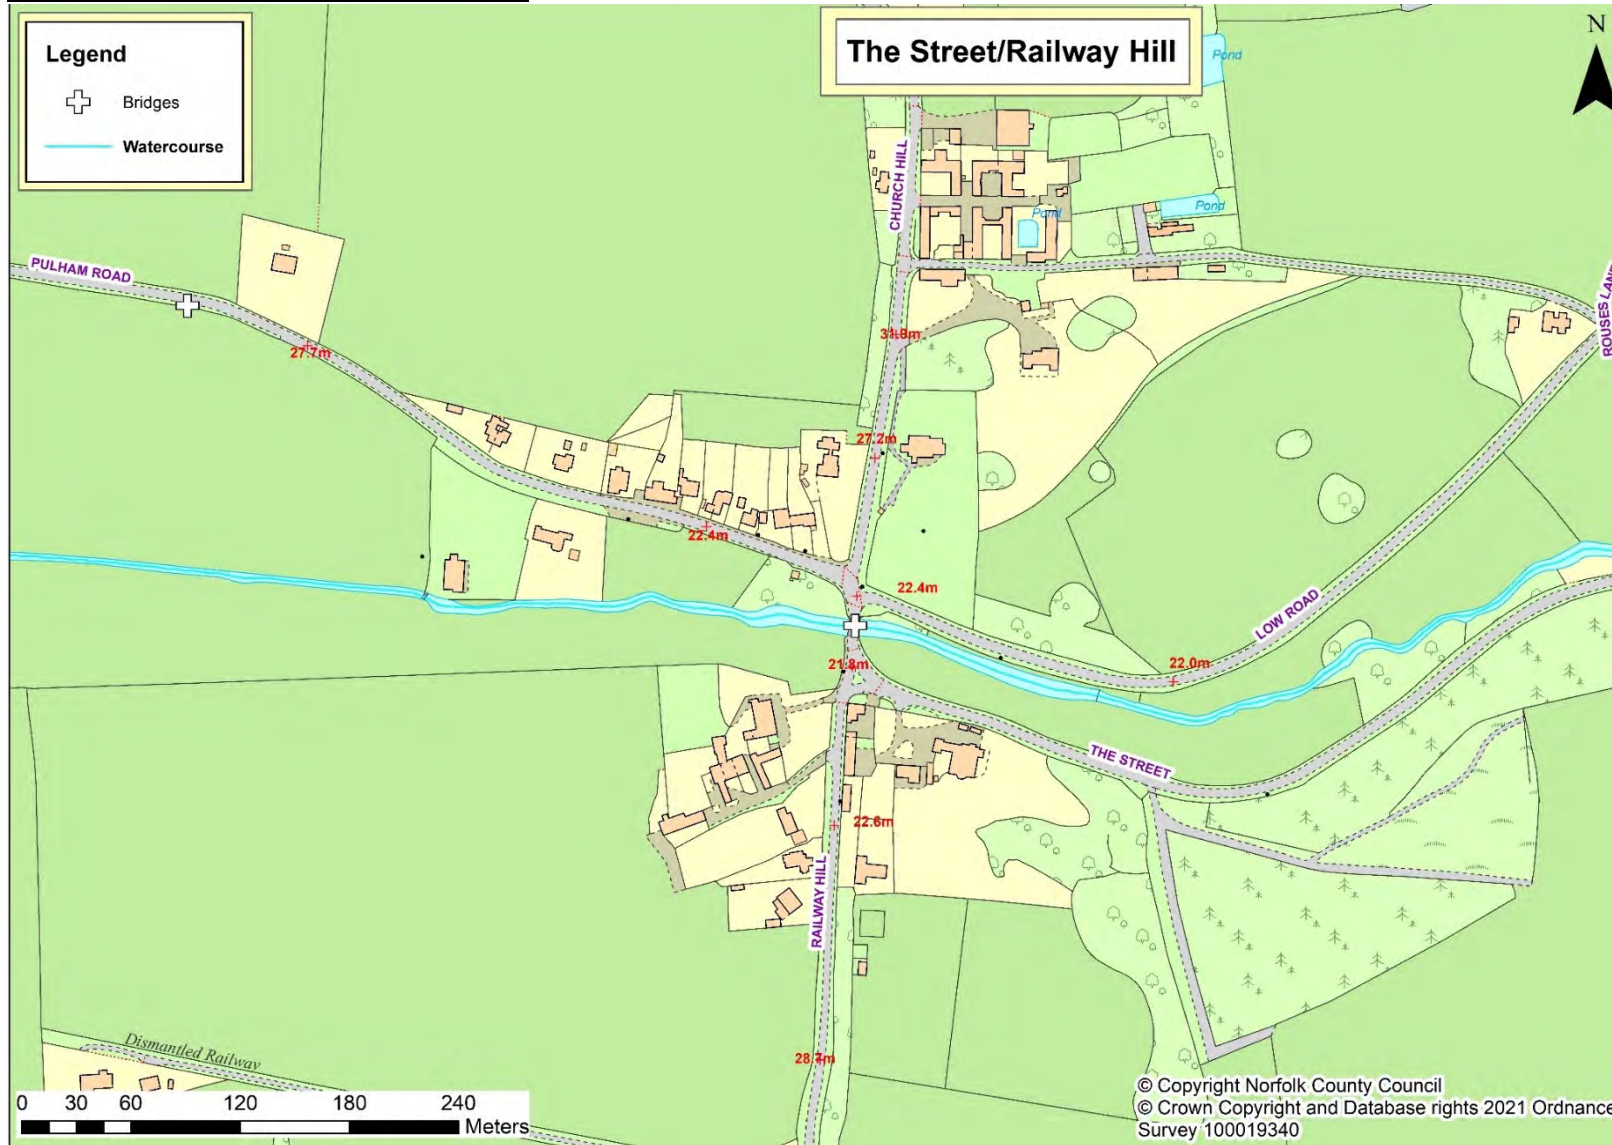
Railway Hill, Starston – 23/12/2020

Causes of flooding	Risk Management Authority with Relevant Flood Risk Function
<p>A substantial amount of rain fell on the 23rd Dec onto a catchment with prior high saturation levels. The catchment is 38km² upstream of Railway Hill generating flashy high flows to which local watercourses and drainage infrastructure could not cope.</p>	
<p>Fluvial flooding directly from the Beck watercourse in the bottom of the valley (Flood zone 3). The watercourse was out of bank both upstream and downstream of the village.</p>	<p>IDB – Waveney, Lower Yare and Lothingland board</p>
<p>Several hydraulic structures including weirs may have inhibited floods flow, but its more likely these were drowned out during the event.</p> <p>Similar to other villages in the Pulhams, road culverts and bridges like the one in The Street likely exacerbated flood depths and evidence of water flooding over the deck from Parish Council reports and flooding The Street. Thus, bottlenecks need reviewing for their hydraulic efficiency.</p>	<p>IDB (regulatory authority) NCC Highways (asset owner) AW (asset owner)</p>
