Flood Investigation Report

Flooding in Watton and surrounding area on 23 June 2016

Report Reference: FIR015
Draft Report Final, prepared by Mark Ogden on 12 December 2017

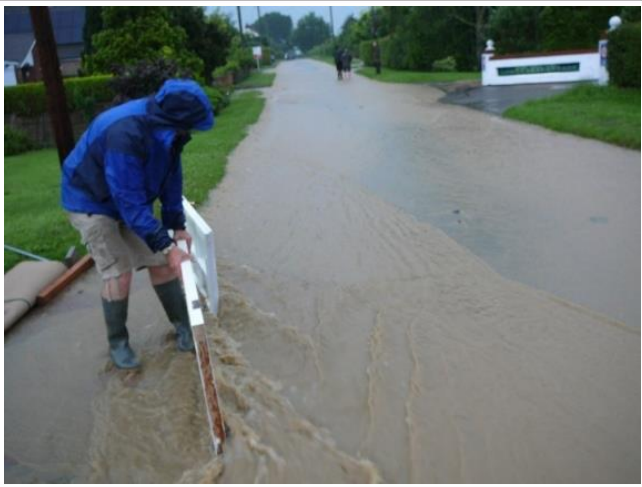
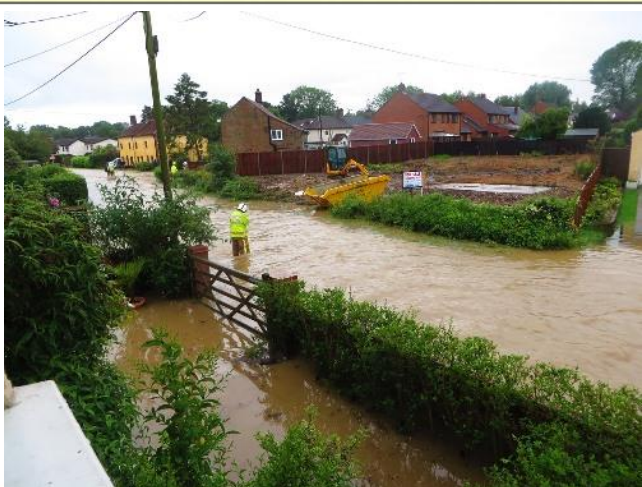
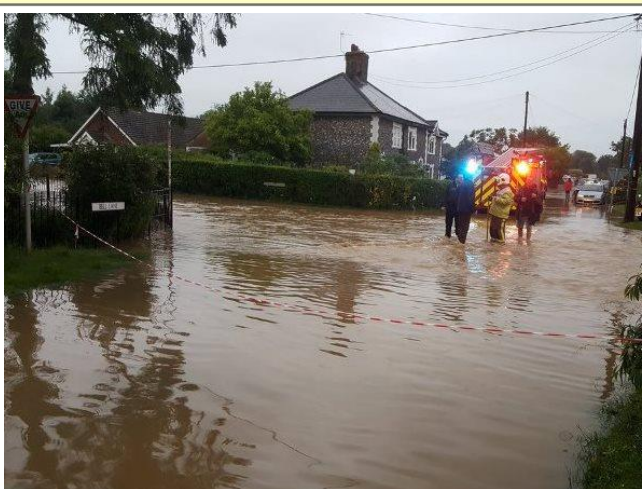
Location: **Saham Toney Watercourse**

External flooding – 15 other reports of external or unconfirmed internal flooding were also received.

Causes – Significant rainfall caused run-off to exceed the capacity of the receiving watercourse. Run-off also directed onto the road that conveyed flows onto property accesses.

Recommendations – Norfolk County Council to explore funding for flood mitigation and to determine flood routing opportunities. Riparian owners to maintain watercourse.

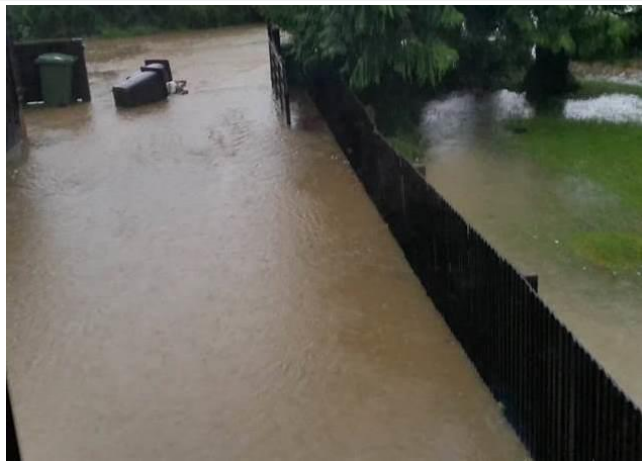
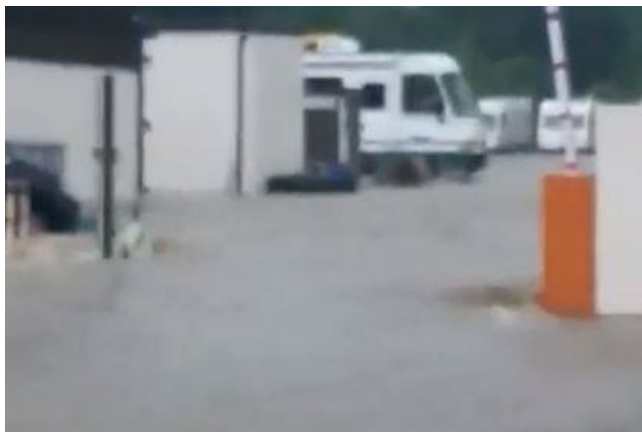
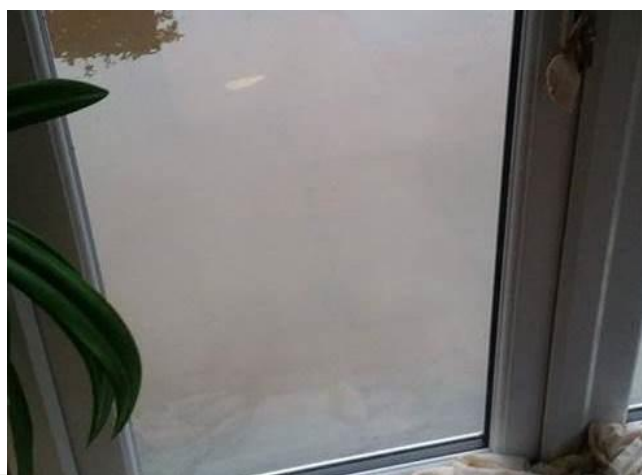
Saham Road – Internal and external flooding experienced on 23 June 2016

Causes – Significant rainfall caused run-off to exceed the capacity of the receiving watercourse and flow into properties positioned across the flow path.

Recommendations – Norfolk County Council to explore funding for flood mitigation and to determine flood routing opportunities. Riparian owners to maintain watercourse.

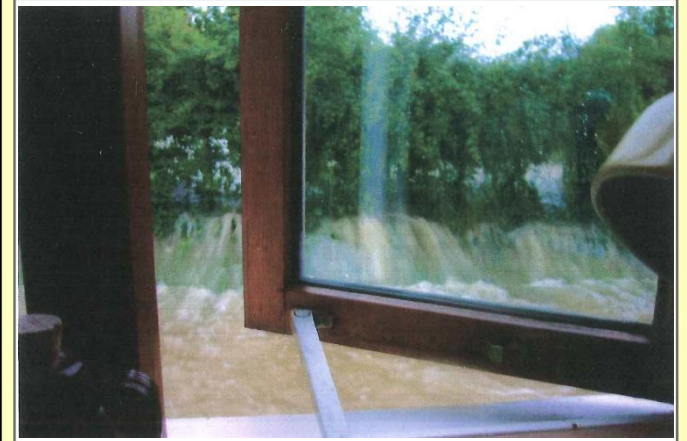
Dereham Road – Internal flooding experienced on 23 June 2016

Causes – Significant rainfall caused run-off to exceed the capacity of the receiving watercourse and flow into properties positioned across the flow path.

Recommendations – Norfolk County Council to explore funding for flood mitigation and to determine flood routing opportunities. Riparian owners to maintain watercourse.

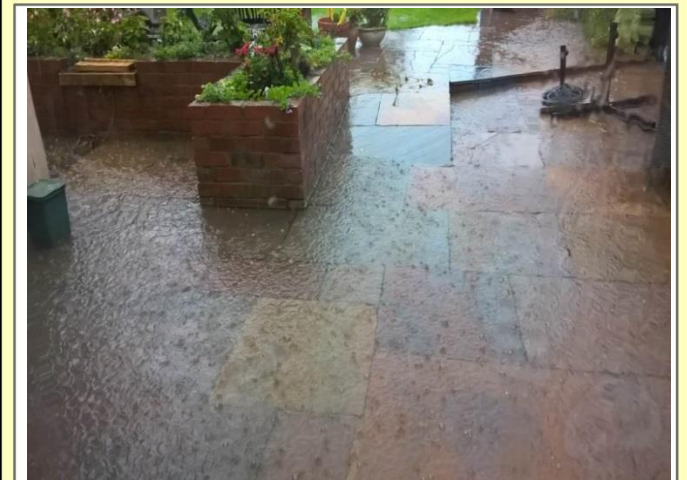
A1075 – Flooding affecting highways users.

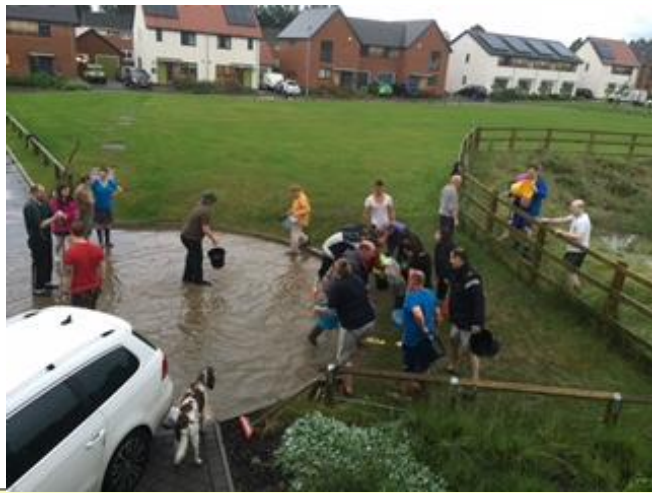
Horseshoe Close and Lovell Gardens – Internal flooding experienced on 23 June 2016

Causes –Run-off from significant rainfall was concentrated along overland flowpaths which cross green space, gardens, highway and the locations of the affected properties

Recommendations – Norfolk County Council to explore funding for flood mitigation. Anglian Water to explore managing the amount of surface water entering their drainage system.

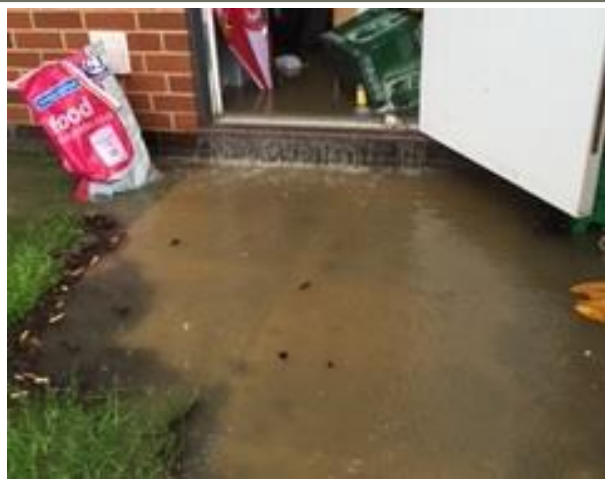
External flooding – 16 other reports of external or unconfirmed internal flooding were also received from Lovell Gardens, Norwich Road, Nicosia Court.

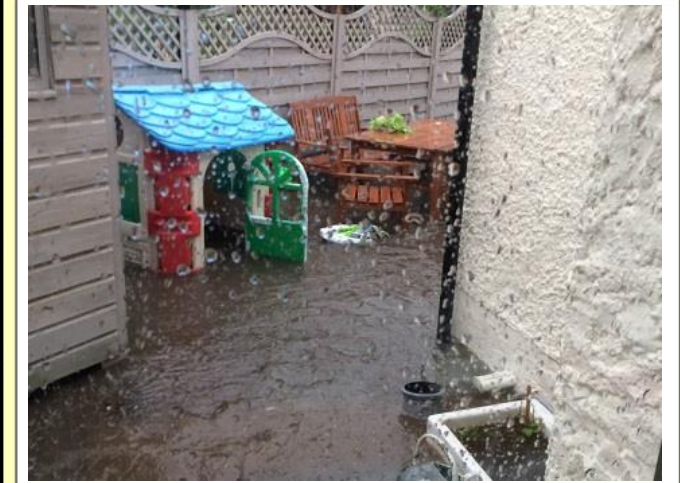
Watton Green – Internal flooding experienced on 23 June 2016

Causes –Run-off from significant rainfall was concentrated along overland flowpaths which cross green space, gardens, highway and the locations of the affected property

Recommendations – Norfolk County Council to explore funding for flood mitigation. Anglian Water to explore managing the amount of surface water entering their drainage system.

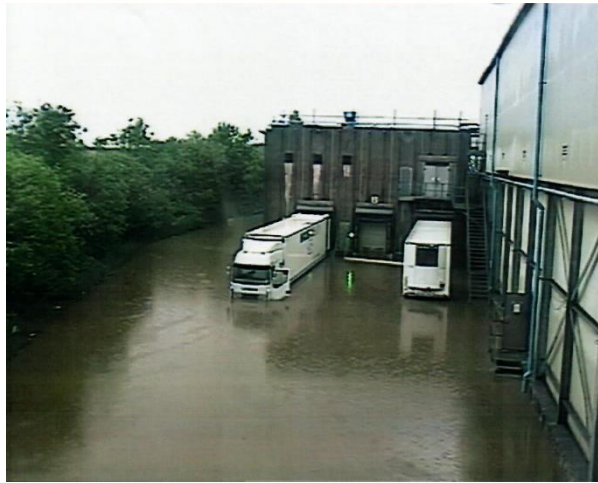
Threxton Road Industrial Estate – Internal flooding experienced on 23 June 2016

Causes – Significant rainfall caused run-off to exceed the capacity of the receiving watercourse and connected drainage.

Recommendations – Norfolk County Council to explore funding for flood mitigation and attenuation. Riparian owners to maintain watercourses. Role of obstructions on watercourses such as culvert to be assessed.

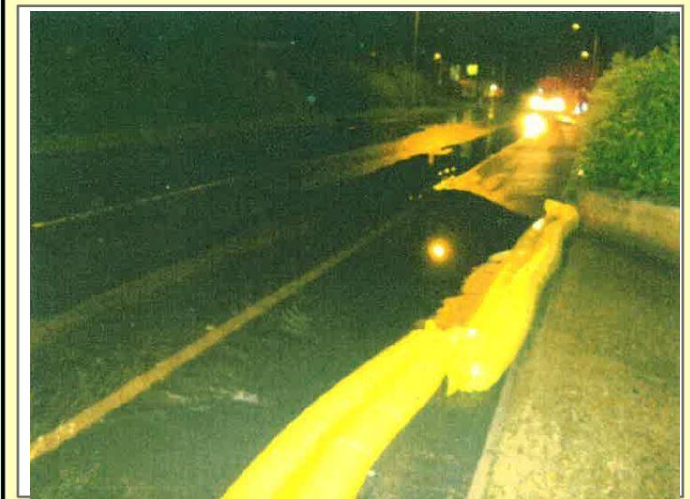
Watton Centre Catchment

Causes – Significant rainfall caused run-off to exceed the capacity of the ditches and drainage networks. Exceedance flows ran off onto private tracks and roads eventually flowing onto the highway and into properties positioned across the flow path.

Recommendations – Norfolk County Council to explore funding for flood mitigation and to determine flood routing opportunities.

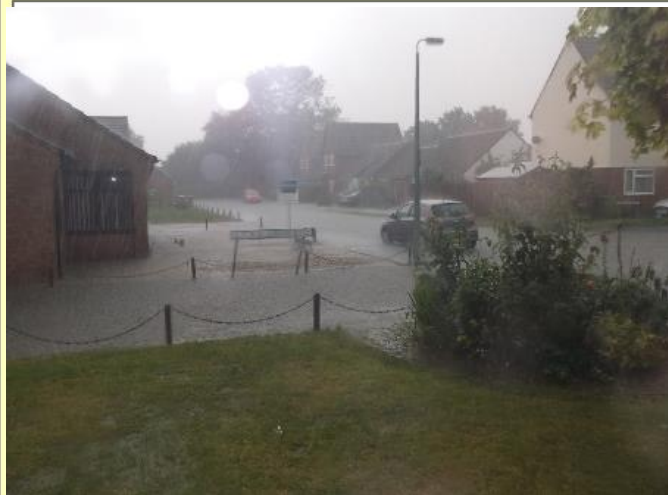
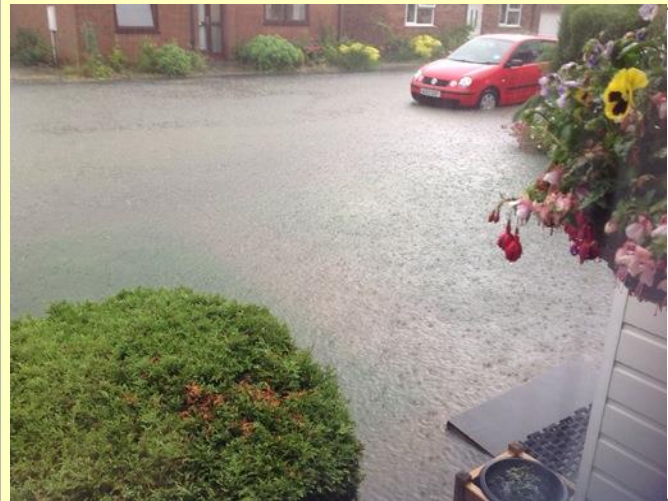
Jubilee Road – Internal flooding experienced on 23 June 2016

Causes – Run-off from significant rainfall that fell on the urban and green spaces within the catchment was concentrated along overland flowpaths and roads on which the affected properties are positioned

Recommendations – Norfolk County Council to explore funding for flood mitigation, attenuation and flood routing.

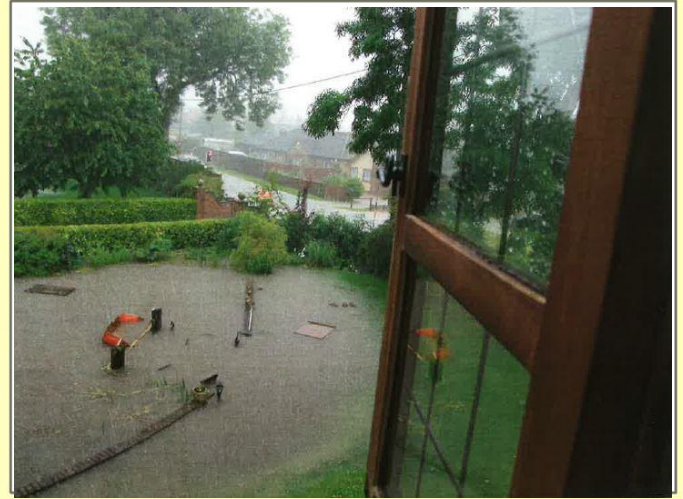
Meadow Grove – Internal flooding experienced on 23 June 2016

Causes – Significant rainfall caused run-off to concentrate on flowpaths and low points where the affected properties are located.

Recommendations – Norfolk County Council to explore funding for flood mitigation, attenuation and flood routing.

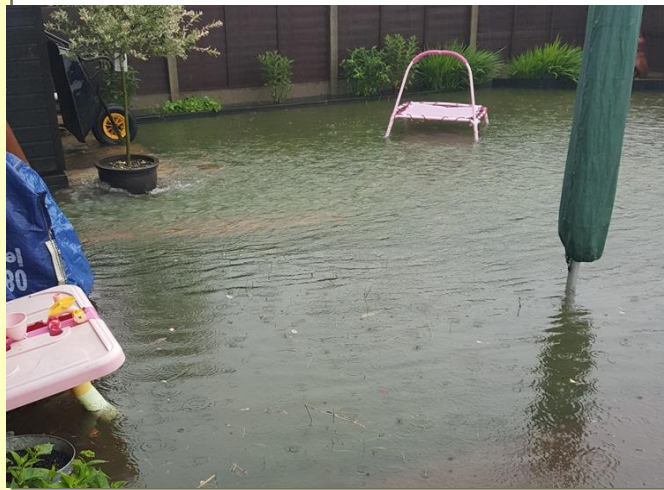
Sharman Avenue – Internal flooding experienced on 23 June 2016

Causes – Run-off from significant rainfall that fell on the urban and green spaces within the catchment was concentrated along overland flowpaths on which the affected properties are positioned

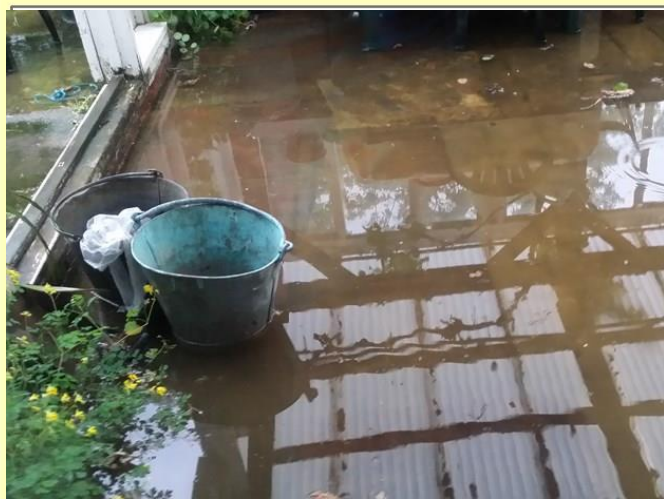
Location: **Watton Centre Catchment**

Causes – Run-off from significant rainfall that fell on the green spaces within the catchment was concentrated along overland flowpaths on which the affected properties are positioned

External flooding – 17 other reports of external or unconfirmed internal flooding were also received from Brandon Road, Tom Milford Place, St Giles Road, Swaffham Road, High Street, Tern Close, Heys Close, Jubilee Road.

Recommendations – Norfolk County Council to explore funding for flood mitigation, attenuation and flood routing.

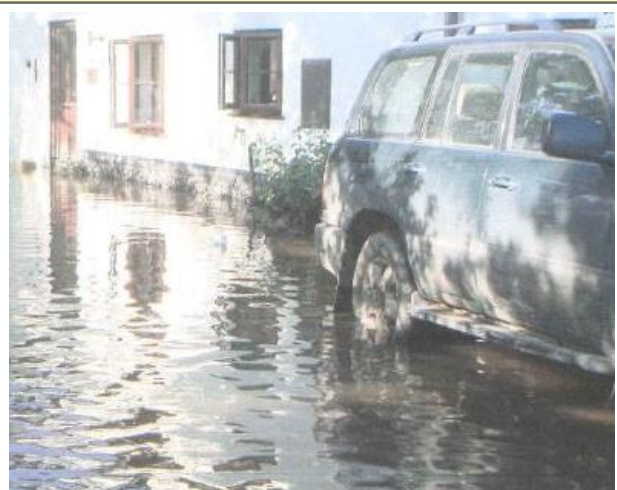
Brandon Road – Internal flooding experienced on 23 June 2016

Causes – Run-off from significant rainfall that fell on the green spaces within the catchment was concentrated along overland flowpaths and ditches on which the affected properties are positioned

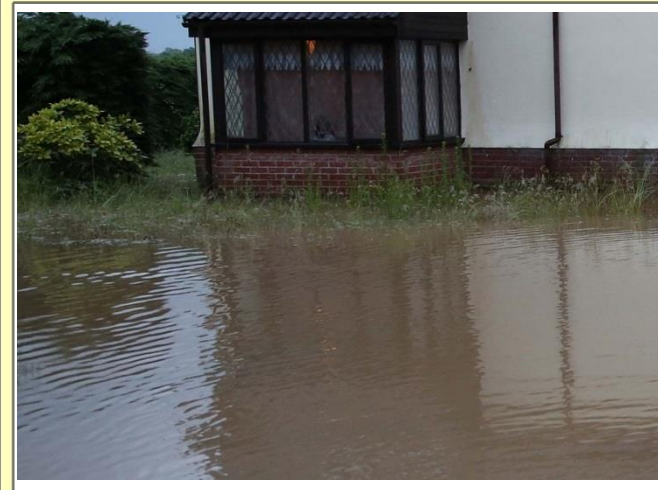
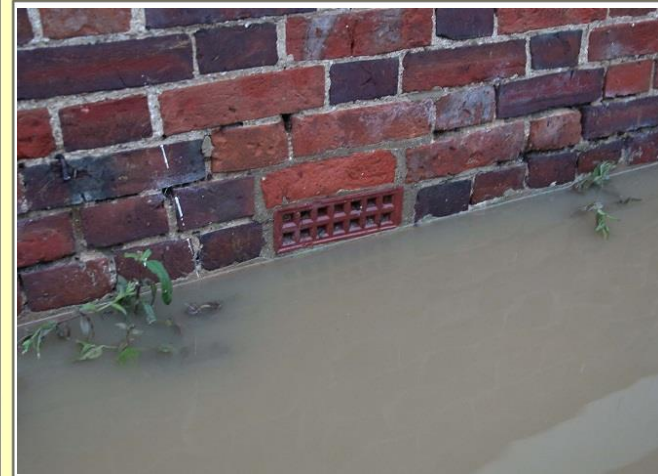
Watton Road – Internal flooding experienced on 23 June 2016

Causes – Run-off from significant rainfall that fell on the green spaces within the catchment was concentrated along overland flowpaths and ditches on which the affected properties are positioned

Recommendations – Norfolk County Council to advise residents regarding property level protection.

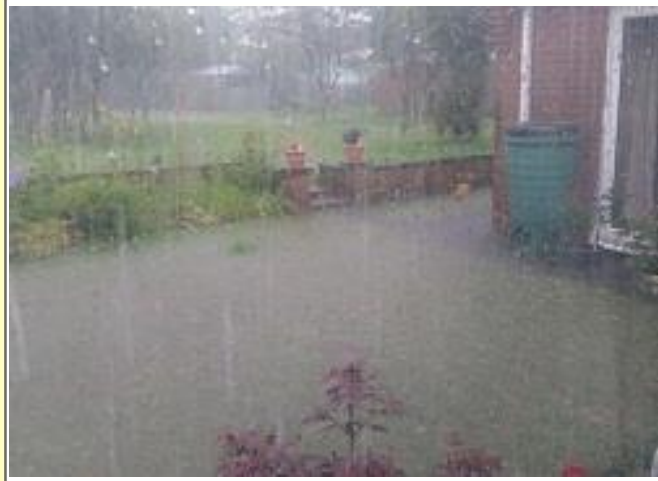
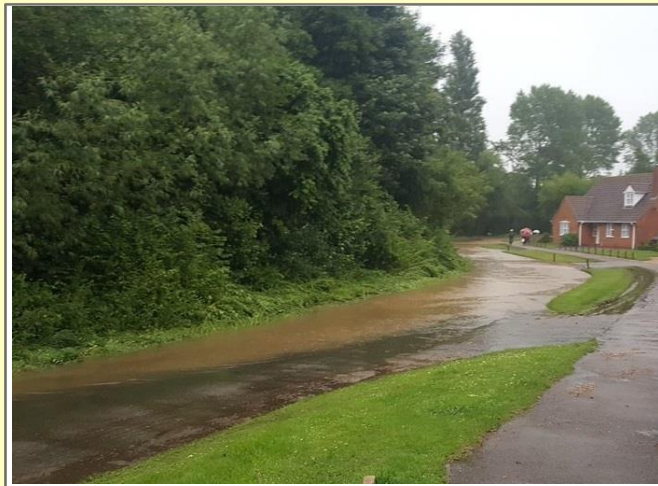
Bell Lane – Internal flooding experienced on 23 June 2016

Causes – Significant rainfall caused run-off to exceed the capacity of the receiving watercourse and connected drainage.

Recommendations – Norfolk County Council to explore funding for flood mitigation and to determine flood routing opportunities

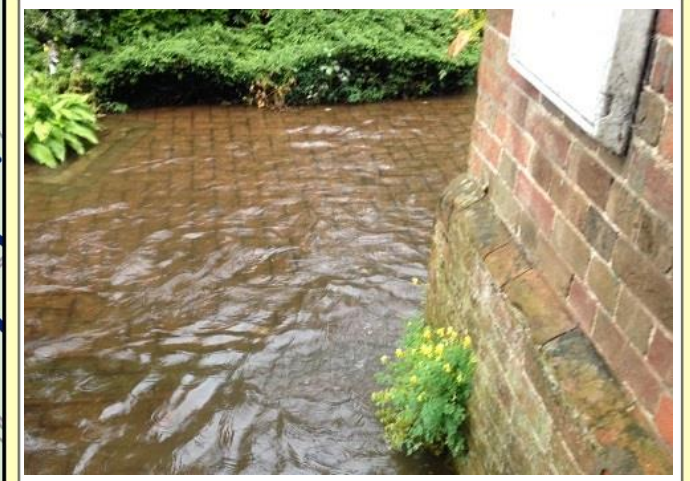
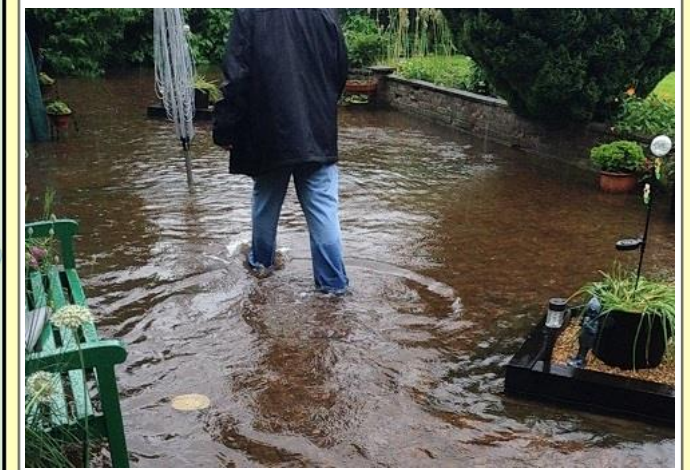
Ovington Road – Internal flooding experienced on 23 June 2016

Causes – Significant rainfall caused run-off to exceed the capacity of the receiving watercourse and connected drainage.
