Norfolk County Council

Investigation Report into the Countywide Flooding of Summer/Autumn 2022

Report Reference: FIR072

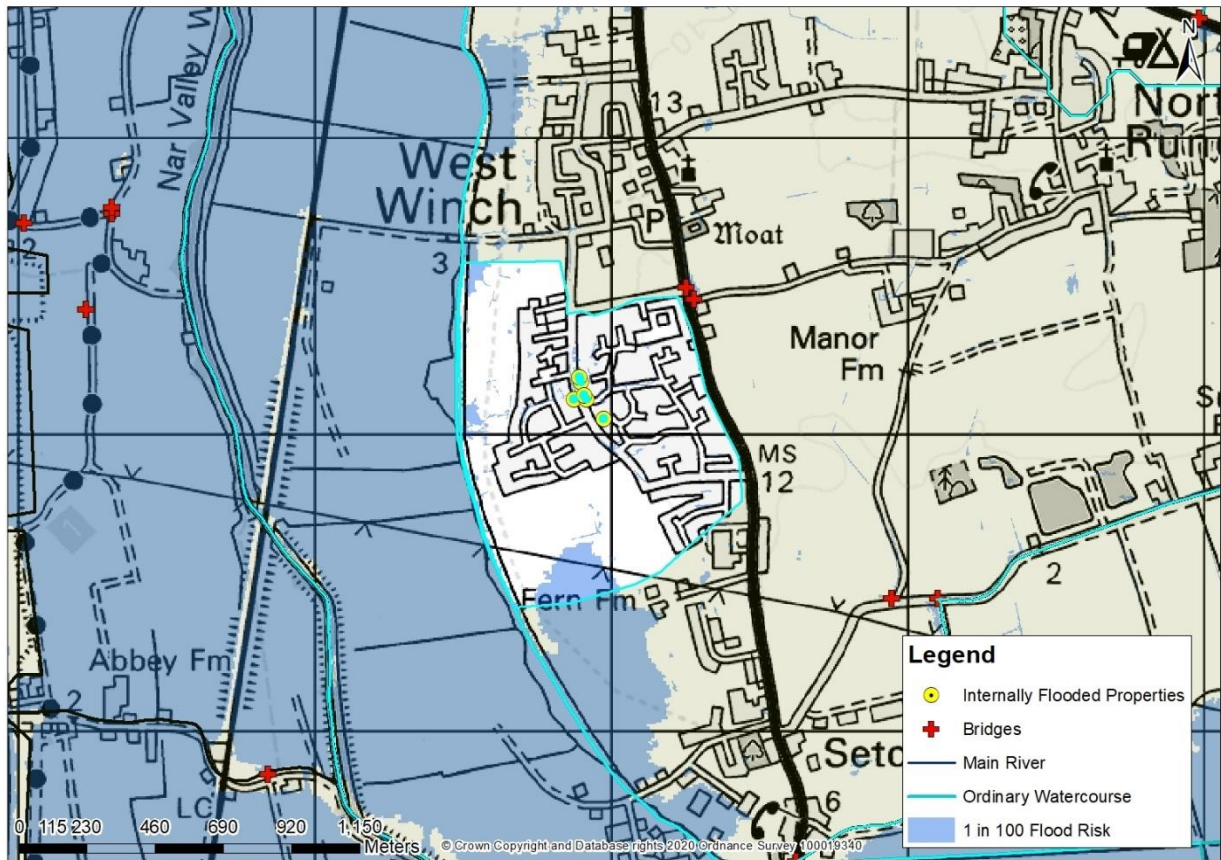
Map Showing Puny Drain Catchment and the Location of Flooded Properties in Hall Lane and Row Hill, West Winch.

The flooded properties are in West Winch in the centre of the Puny Drain Catchment, a large catchment covering rural and urban areas. West Winch is adjacent to the Downham Market Group of Internal Drainage Boards which includes the Puny Drain and the river Nar. The catchment drains to the north and drains into the River Ouse at King's Lynn. Row Hill is served by an Anglian Water surface water sewer, Hall Lane is served by a surface water drain maintained by Norfolk County Council (Highways) which drains to an Anglian Water sewer which flows west on Fir Tree Drive and outfalls to Puny Drain. The gullies on both Hall Lane and Row Hill are maintained by Norfolk County Council (Highways).

Location and Date of Flooding	Causes of Flooding	Recommendation	Risk Management Authority/Individual with Relevant Flood Risk Roles
<p>Hall Lane, West Winch, 17 August 2022</p> <p>Row Hill, West Winch, 17 August 2022</p>	<p>Surface run-off from rainfall made its way onto the highway and flowed along the road network and onto the accesses of affected properties that were situated lower than these features. Vehicles using the highway passed through the flood water causing it to wash towards the affected properties. Water was then directed towards the surface water drainage network. These flows could not be accommodated as the system was already overloaded. This directed flood water towards the affected properties.</p>	<p>Norfolk County Council (Highways) to keep a regular maintenance regime to prevent drainage system becoming blocked.</p> <p>Property owners should protect their buildings through flood protection measures where appropriate. Norfolk County Council (LLFA) should communicate with local residents if grants are available to help fund these measures. These grants are subject to an external funding application.</p> <p>Property owners could also carry out their own measures where funding is not forth coming, or residents are unwilling to wait.</p>	<p>Norfolk County Council (Highways)</p>

Location and Date of Flooding	Causes of Flooding	Recommendation	Risk Management Authority/Individual with Relevant Flood Risk Roles
Row Hill, West Winch 17 August 2022	Significant rainfall was directed towards the surface water drainage network. These flows could not be accommodated as the system was already overloaded. This directed flood water towards the affected properties.	Anglian Water should work with partner organisations to identify the potential for managing the amount or rate of surface water entering their drainage system in flood events.	Anglian Water
