Norfolk County Council

Investigation Report into the flooding in South Norfolk between 2013 - 2016

Report Reference: FIR036

Report prepared by Abygail Hadley on 2 July 2019

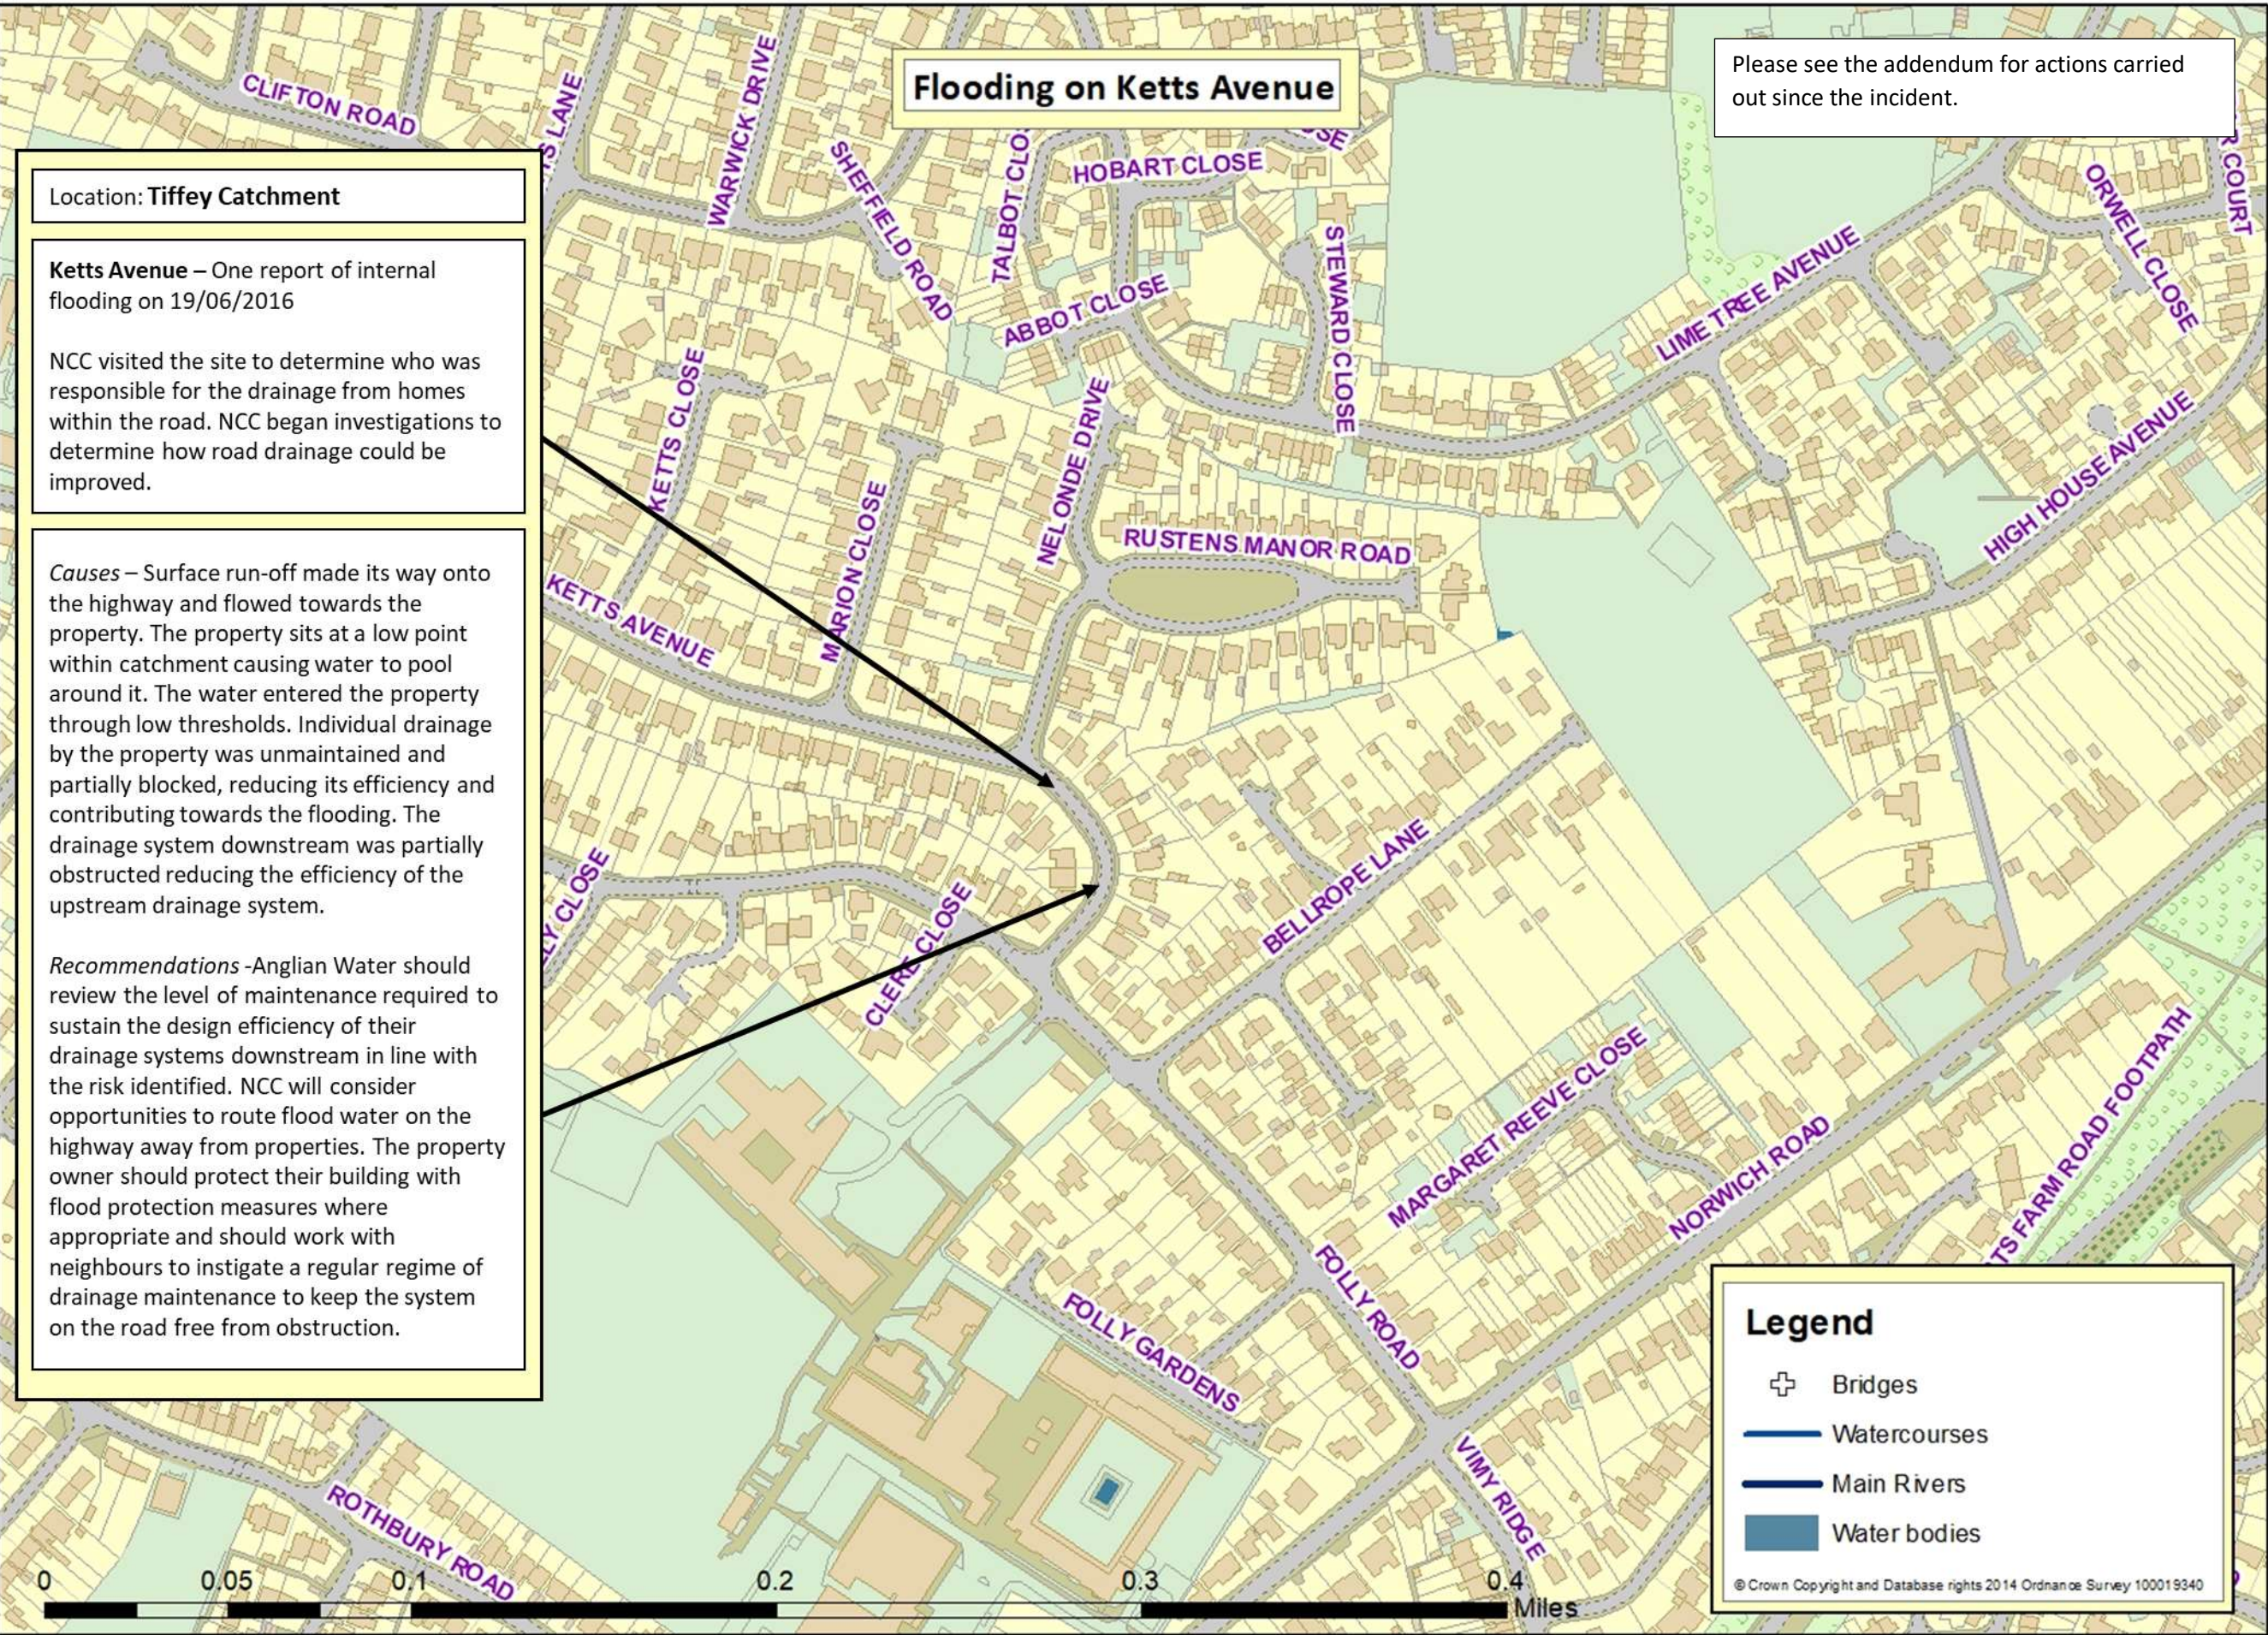
Flooding on Ketts Avenue

Causes – Surface run-off made its way onto the highway and flowed towards the property. The property sits at a low point within catchment causing water to pool around it. The water entered the property through low thresholds. Individual drainage by the property was unmaintained and partially blocked, reducing its efficiency and contributing towards the flooding. The drainage system downstream was partially obstructed reducing the efficiency of the upstream drainage system.

Recommendations -Anglian Water should review the level of maintenance required to sustain the design efficiency of their drainage systems downstream in line with the risk identified. NCC will consider opportunities to route flood water on the highway away from properties. The property owner should protect their building with flood protection measures where appropriate and should work with neighbours to instigate a regular regime of drainage maintenance to keep the system on the road free from obstruction.

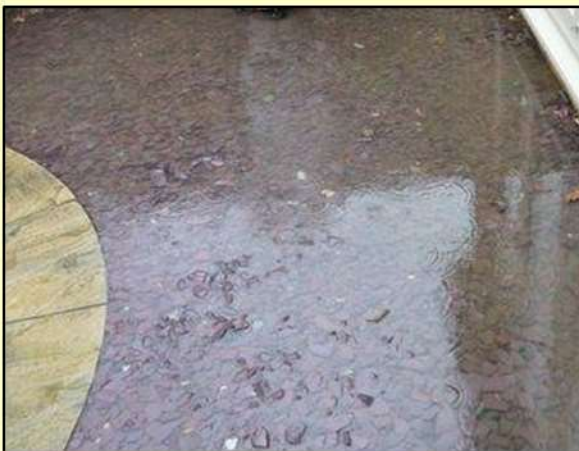
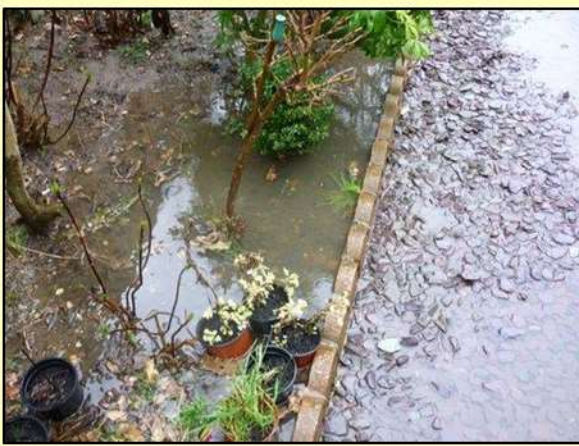
Causes – Rainfall was concentrated on an overland flow path on which the affected property sits.

Recommendations – The property owner should work with the adjacent landowner and NCC to identify appropriate flood reduction measures.

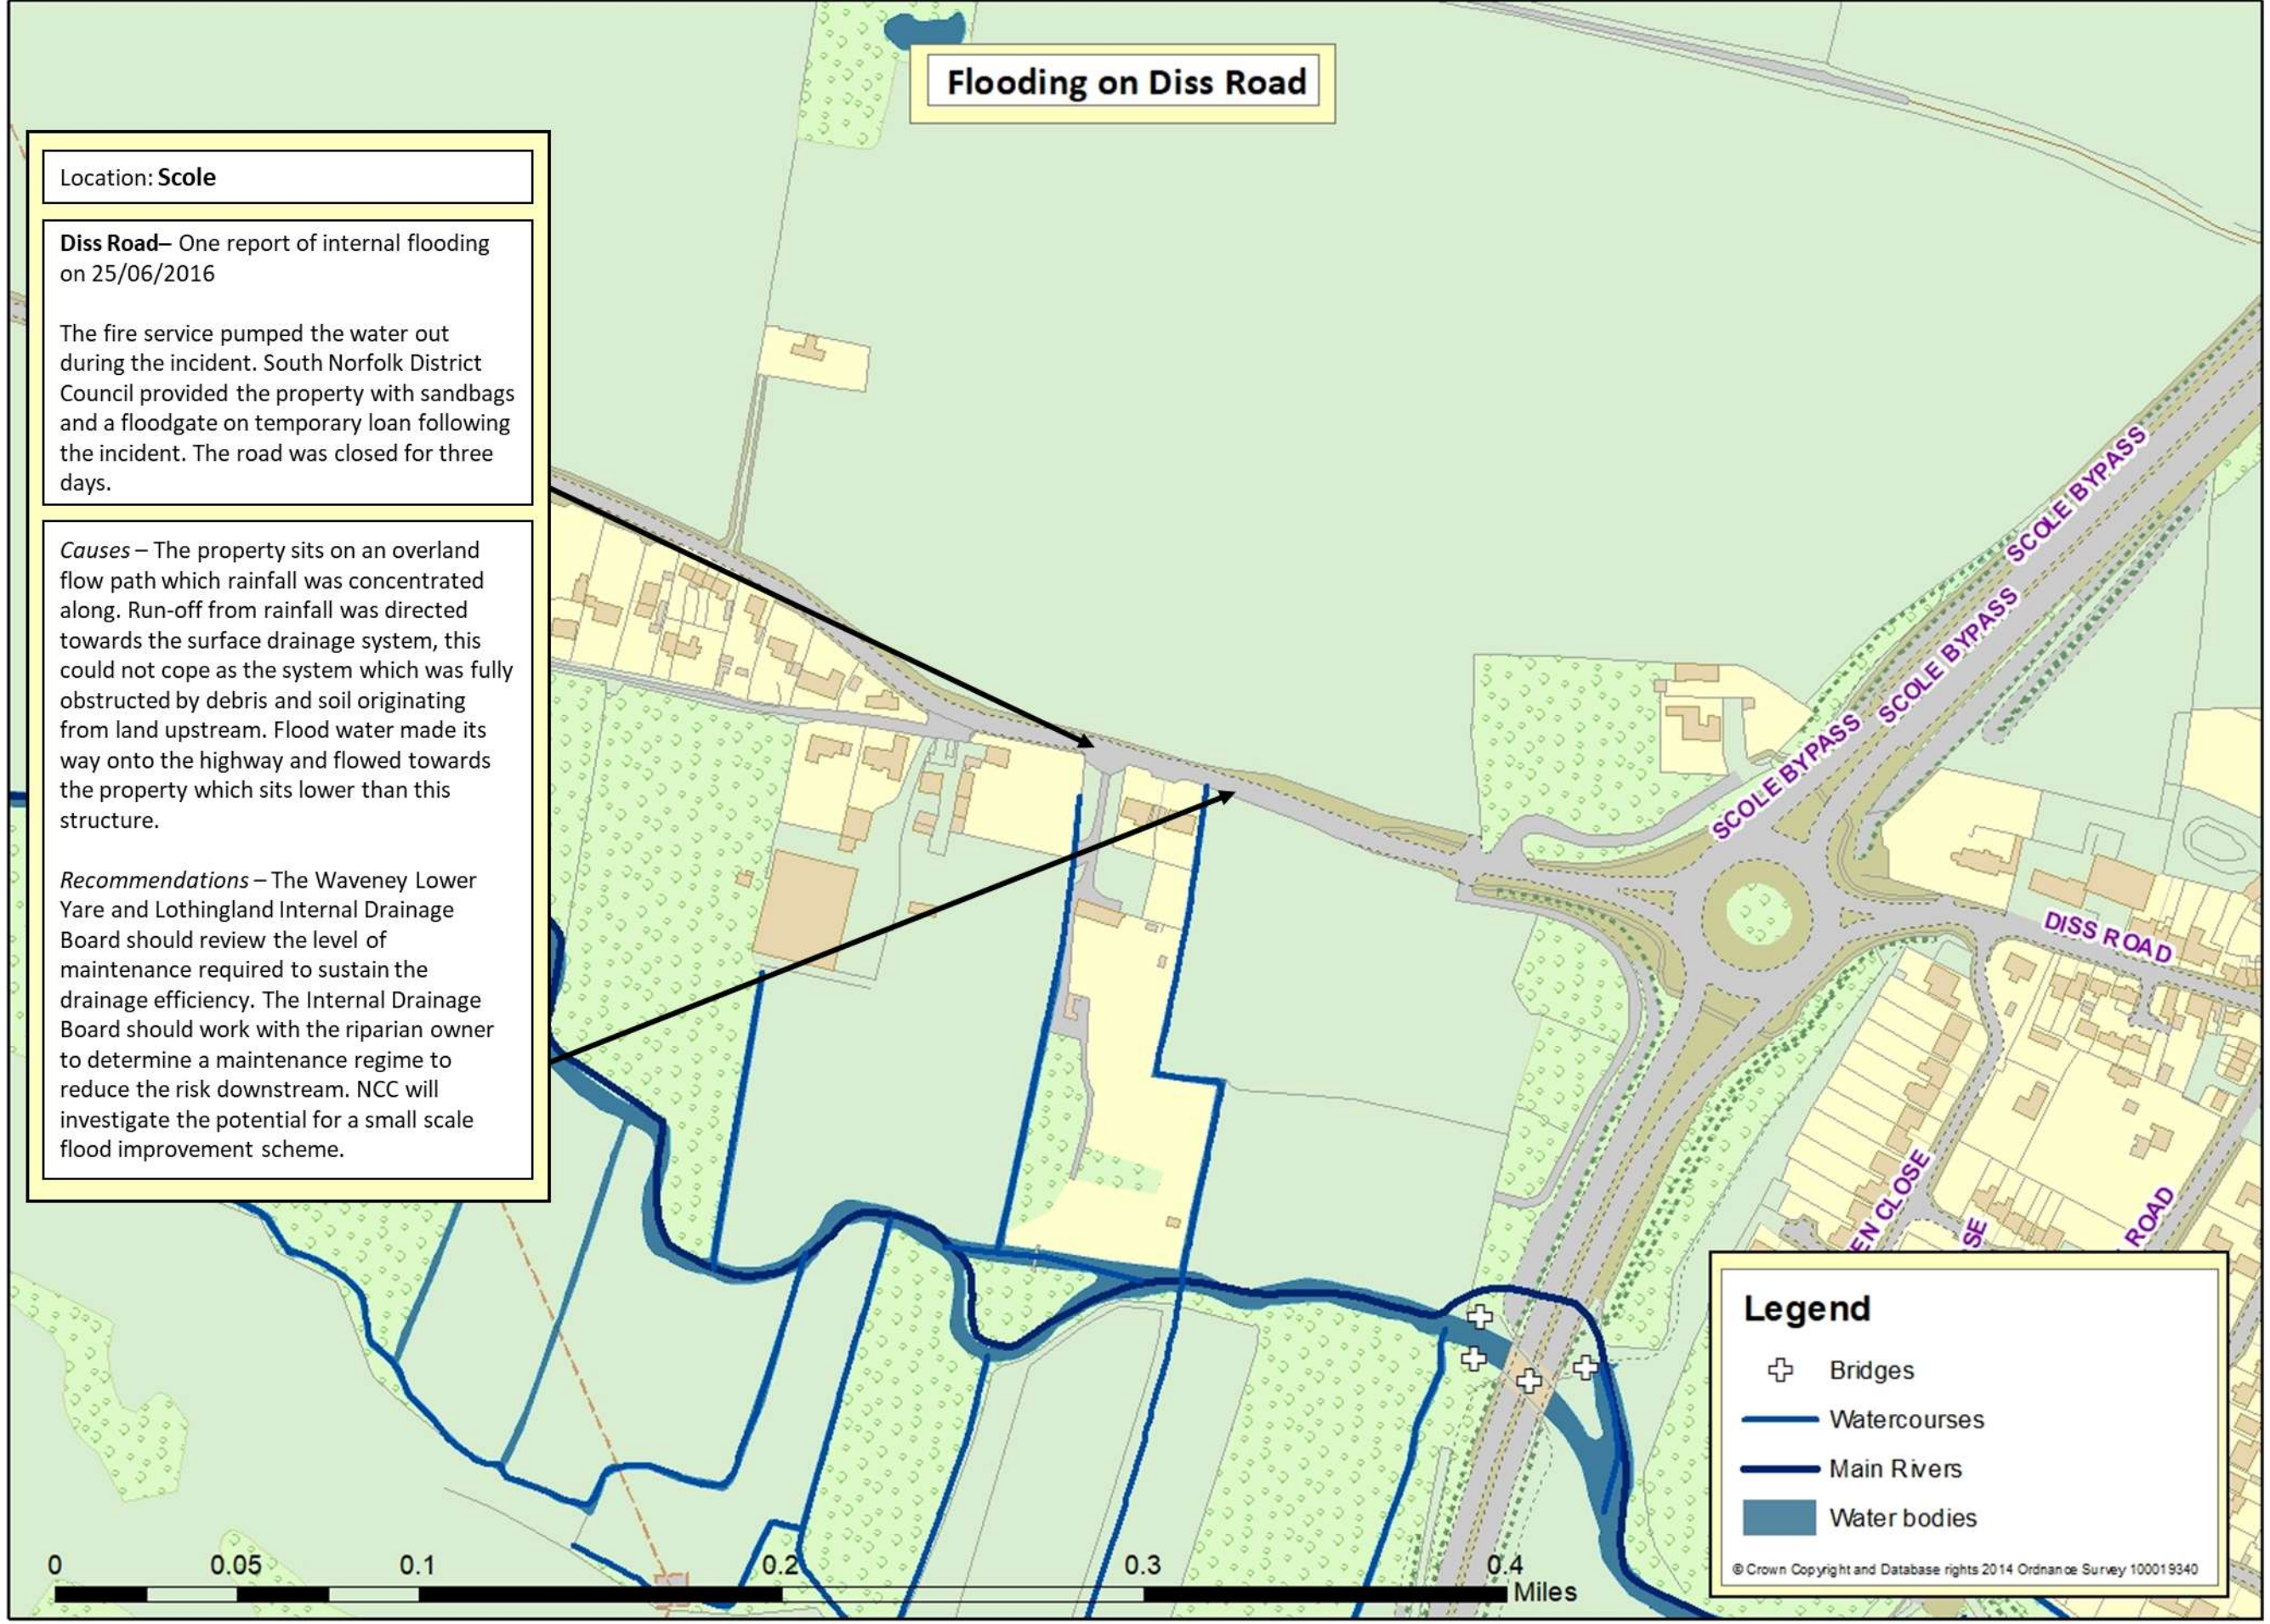
Flooding on Scole Common Road

Causes – Run off from rainfall was concentrated an overland flow path on which the property sits. Water was directed from neighbouring land towards the affected property. The run-off was directed towards the individual property drainage which was unable to cope with the capacity of water causing flooding at the affected property.

Recommendations – NCC will work with the land owner to ensure that water is not directed towards the effected property, for example through land management techniques. The property owner should ensure that ditches around the property continue to be well maintained for sufficient drainage.
