Flood Investigation Report

Walpole Cross Keys

Sutton Road

Report Reference: 000117

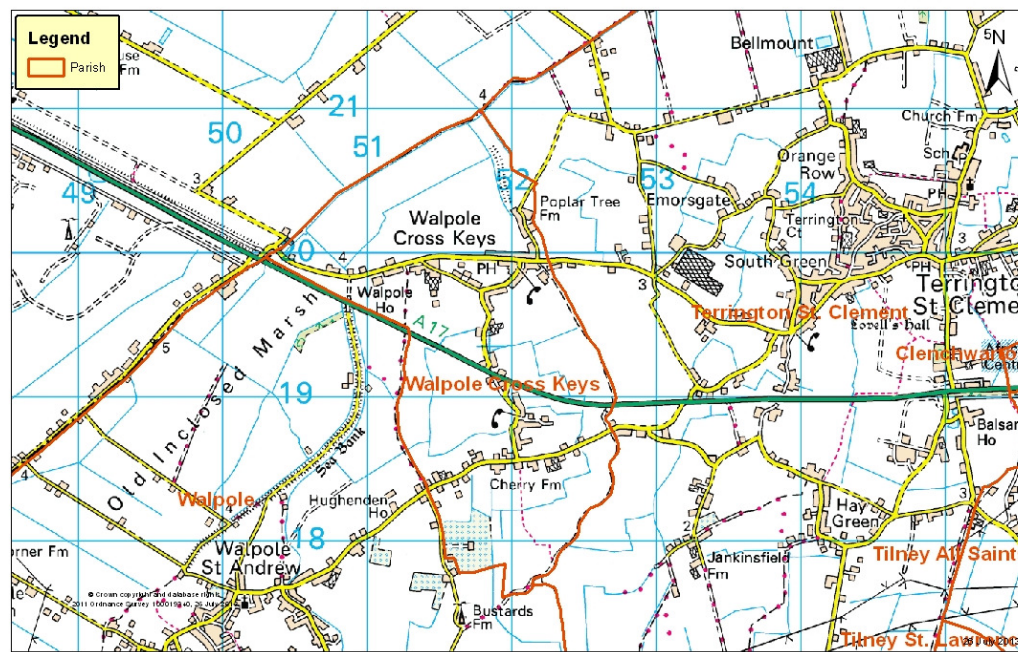
- A Location of open watercourse. Initial site investigations found this watercourse to be full and poorly maintained. Due to the connection to the downstream watercourse being in disrepair, this can not outfall effectively causing a backflow of water within the ditch.

- B General direction of surface water flow.
- C Assumed path of existing culvert (pending a camera survey to assess the extent and integrity of the system). King's Lynn & West Norfolk Borough Council have attempted to jet the system but this could not be completed due to the poor condition of the culvert.

- D Highways drainage found to run parallel with the affected property's boundary which outfalls into the open watercourse to the South. A site visit found the outfall pipe to be submerged approximately 0.3 to 0.4m below the water's surface and the chamber cover on the property's driveway to be damaged allowing additional surface water to enter the system.

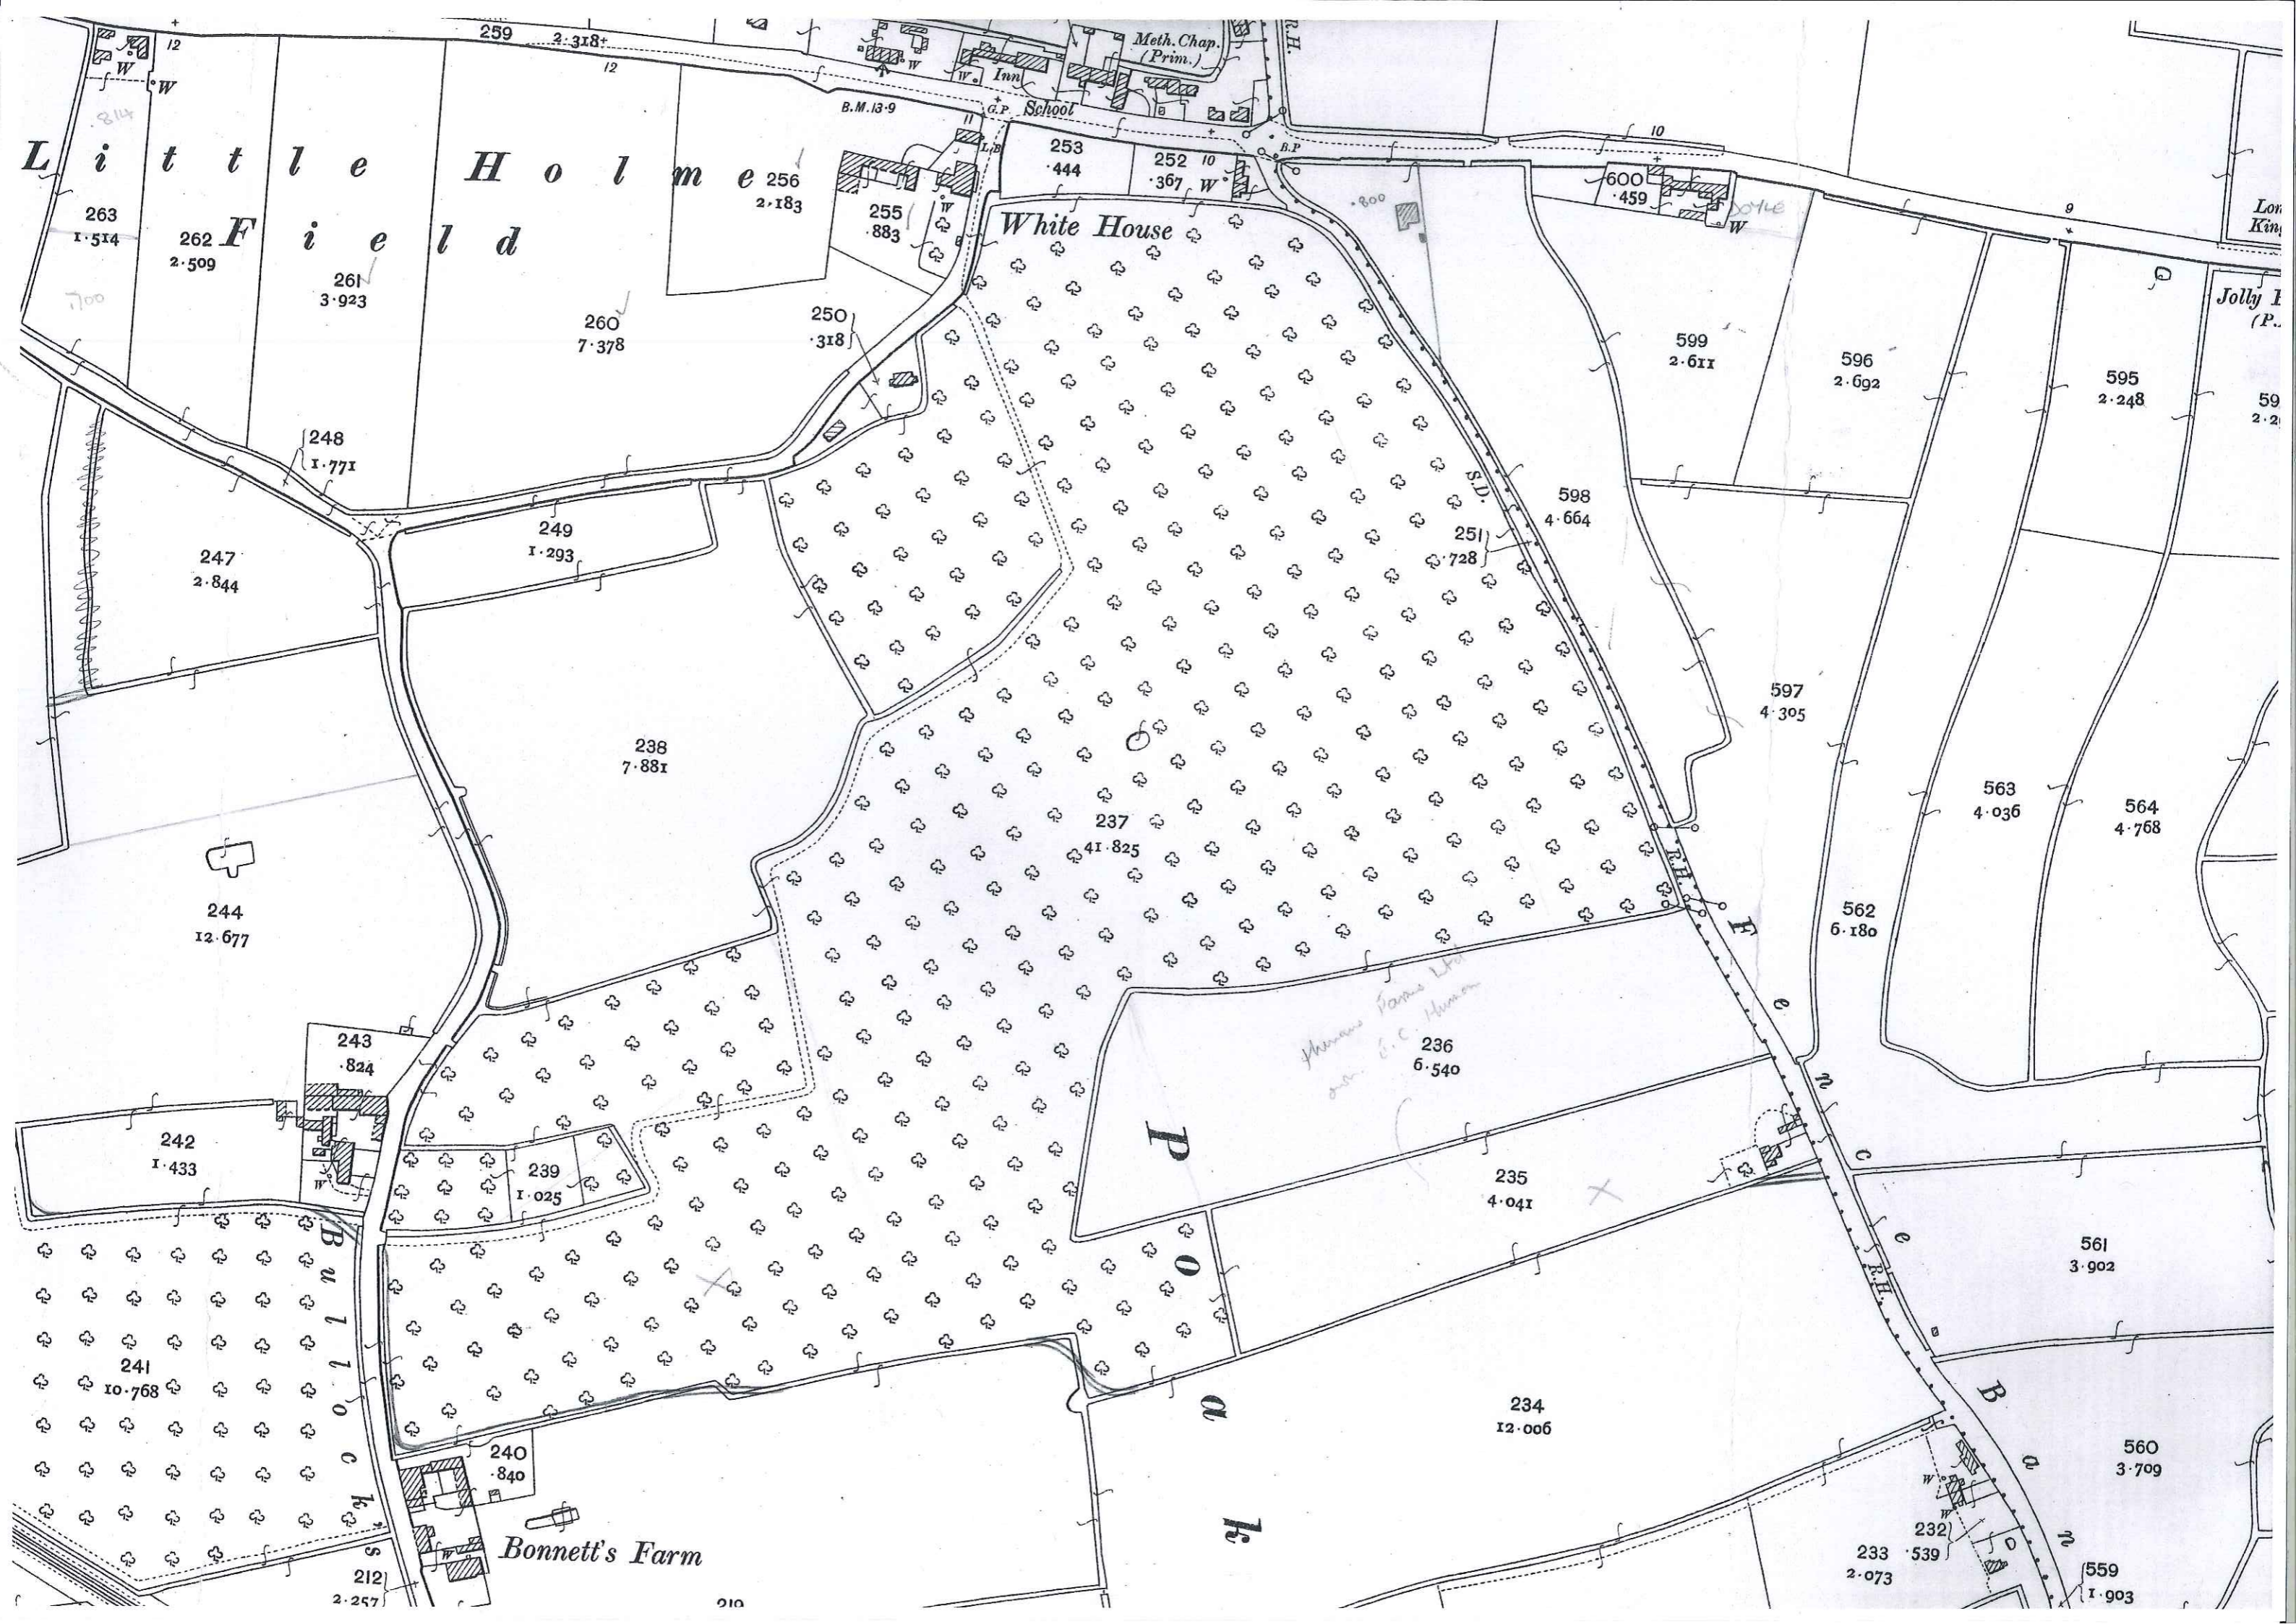
Photo 3

Considering the area more generally, there is a watercourse to the east of Fence Bank, marked as 9 on my plan (see also photo 2), which, although currently quite narrow and poorly-maintained, could potentially help to convey water from the rear of the properties on Sutton Road to Cross Keys Drain (see photo 3), if a connection is made to it. Although there is currently no continuation of the drain to the east of 27 Sutton Road, I believe it may be possible, subject to landowner agreement, to construct a new drain along a route similar to the one indicatively shown by a dashed red line on my plan, and then install a new culvert under Fence Bank. Maintenance or improvement works may also be needed along the drain to the east of Fence Bank, but the extent of these and the size of any new drain could only be determined following a level survey from Cross Keys Drain back to the properties on Sutton Road.
